**CALSPAN ON-SITE CERTIFIED ADVANCED 208-COMPLIANT
VEHICLE CRASH INVESTIGATION**

CASE NO: CA05-031

VEHICLE: 2005 JEEP GRAND CHEROKEE

CRASH DATE: MAY 2005

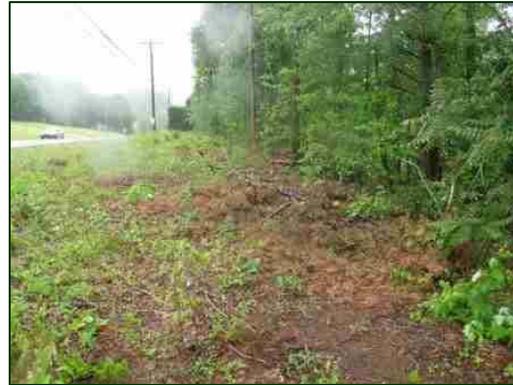
The Cherokee continued on a presumed tracking trajectory over the irregular terrain and impacted a 38 cm (15") diameter tree that was located 27.2 m (89.1') south of the east road edge (**Figure 3**). The center frontal area of the Jeep impacted the tree, which resulted in a sufficient longitudinal deceleration to deploy the driver's (CAC) frontal air bag and fired the buckle pretensioner. Due to the dismantled state of the Cherokee, the WinSMASH model was not used to calculate a velocity change for this crash. The known damage was isolated to the lower radiator support as the remaining frontal components were removed from the vehicle prior to the SCI inspection. The direction of force for this impact was 12 o'clock.

Figure 2. Off-road trajectory en route to tree impact located in center background of image.

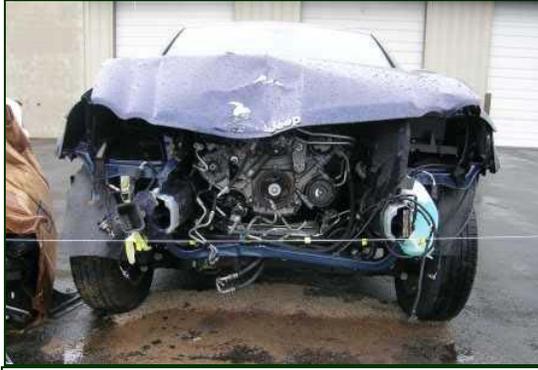
Primary – The center frontal area of the Grand Cherokee impacted a 38 cm (15") diameter spruce tree. The event was the last of six events that were involved in this crash. The direct contact damage began 4 cm (1.5") left of center and extended 33 cm (13") to the right (**Figure 4**). This damage was measured on the hood face of the vehicle as the front bumper fascia, bumper beam, grille, and the upper radiator support were removed from the vehicle prior to the on-site investigation. A crush profile was documented at the level of the lower radiator support. The engine oil filter was located aft of the lower radiator support on the forward aspect of the aluminum block. This filter

Figure 4. Frontal impacts to the Jeep Grand Cherokee.

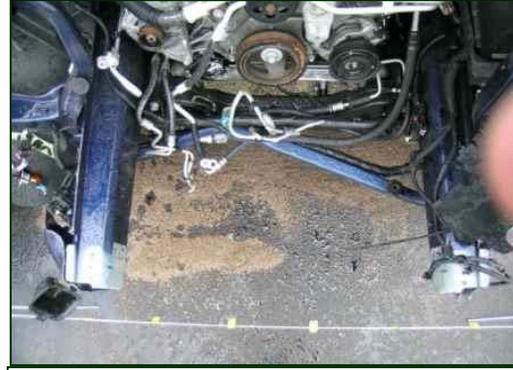
was crushed by the tree impact. Assuming the tree penetrated to the level of the lower radiator support panel, the projected maximum crush at the bumper beam was approximately 30 cm (11.75"), located 18 cm (7") right of the centerline (**Figure 5**). The crush profile at the level of the lower radiator support was as follows: C1 = 8 cm (3.25"), C2 = 13 cm (5.25"), C3 = 22 cm (8.6"), C4 = 29 cm (11.4"), C5 = 26 cm (10.25"), C6 = 22 cm (8.75"). The Collision Deformation Classification (CDC) for this tree impact was 12-FCEN-1.

Figure 5. Overhead view of the crush depth to the lower radiator support.

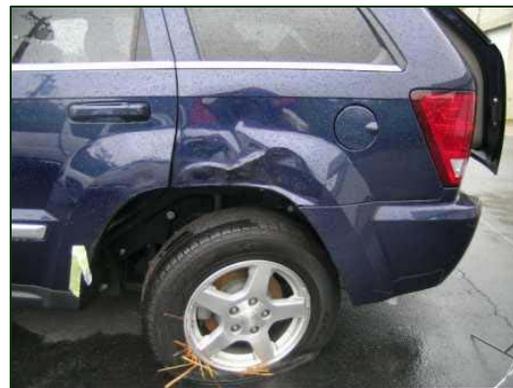
The left rear door, tire, and quarter panel area of the Jeep impacted a tree or tall stump at the crash site. The damage began on the rear edge of the rear door 36 cm (14") forward of the rear door edge and extended 79 cm (31") rearward, terminating at the mid point of the left quarter panel (**Figure 6**). The left rear tire impacted the vertical object, which displaced the axle position 24 cm (9.5") rearward. Bark was embedded into the bead of the tire at the alloy

Figure 6. Left rear impact damage.

wheel. There was no damage to the tire or wheel. A crush profile was documented along the damage length of 79 cm (31"). The crush values were as follows: C1 = 0 cm, C2 = 2 cm (0.75"), C3 = 4 cm (1.5"), C4 = 3 cm (0.9"), C5 = 0 cm, C6 = 0 cm. The CDC for this event was 12-LZES-1.

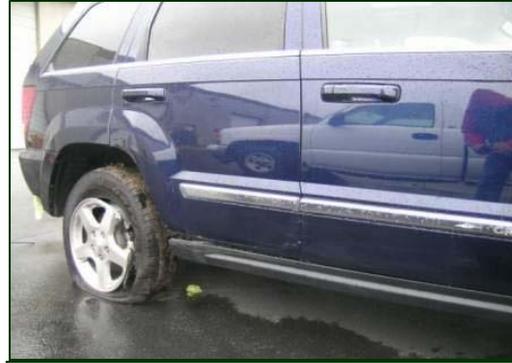
The sixth area of damage to the Jeep was located on the right side doors and right rear wheel of the vehicle. The direct contact damage, which consisted of subtle abrasions and isolated dents, began on the alloy wheel 5 cm (2") aft of the right rear door edge and continued 160 cm (63") forward onto the right front door (**Figure 7**). The maximum crush for this damage pattern was 1 cm (0.25") located on the right rear door at the location of the lower C-pillar. The right rear alloy wheel was fractured and the tire was cut from the impact. The right wheelbase was elongated 11 cm (4.2"). The CDC for this event was 12-RZES-1.

Figure 7. Right rear impact damage.

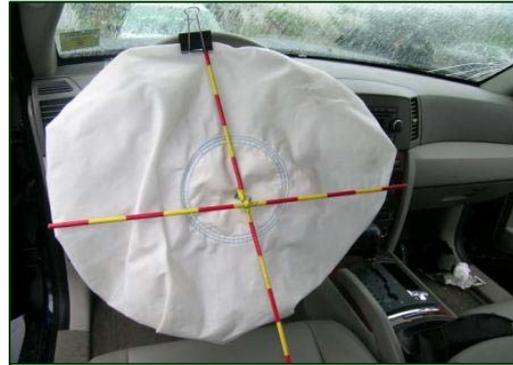
The crash sequence warranted the deployment of the driver's air bag system and firing of the buckle pretensioner. The driver's air bag deployed from an H-configuration module cover that was located within the four spokes of the steering wheel rim. The upper flap measured 7 cm (2.9") in height while the lower flap was 4 cm (1.6") in height. Both flaps were 14 cm (5.6") in width at the horizontal tear seam. The driver's air bag membrane was 64 cm (25") in diameter (deflated) and was tethered by two 13 cm (5") wide bands located at the 3 and 9 o'clock positions (**Figure 8**). The tethers were sewn to the face of the bag with a 17 cm (6.6") diameter stitch pattern. The maximum excursion of the air bag was 19 cm (7.5") located at the tether positions. The bag was vented by two ports that were 2 cm (0.75") in diameter located on the backside of the bag at the 11 and 1 o'clock positions. The ports were centered 8 cm (3") inboard of the peripheral seam.

Figure 8. Deployed front left air bag.

The center face of the bag membrane was stamped with the code B-13-1. There was no damage or contact evidence to the deployed driver's air bag.

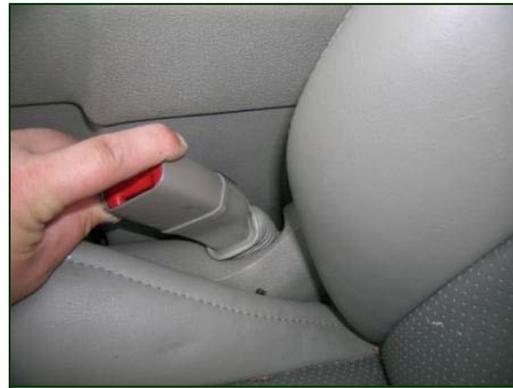
The driver was belted at the time of the crash; therefore, the safety belt buckle switch was engaged. The driver’s buckle pretensioner actuated as a result of the crash. The convoluted sleeve of the pretensioner was compressed. The barrel of the pretensioner could not be accessed to measure the stroke of the piston travel.

evidence on the belt system, usage was supported by the lack of interior contact points and the actuated position of the buckle pretensioner (**Figure 10**).

Figure 10. Actuated driver's buckle pretensioner.
