**CALSPAN ON-SITE CERTIFIED ADVANCED 208-COMPLIANT  
VEHICLE CRASH INVESTIGATION**

**CASE NO: CA05-032**

**VEHICLE: 2005 CHRYSLER 300**

**LOCATION: NORTH CAROLINA**

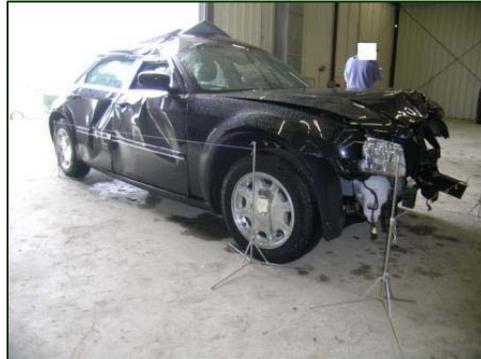
**Figure 1. Damaged 2005 Chrysler 300.**

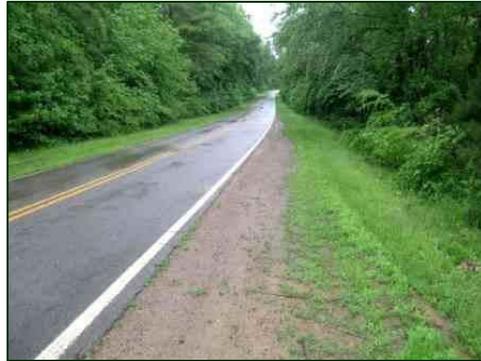
the right curve. **Figure 2** is a look back view of the roadway and point of departure. A double yellow centerline separated the travel lanes and solid white fog lines marked the road edges. There were no stabilized shoulders supporting the travel lanes. Trees and natural growth bordered a 3.5 m (11.5') wide area of grass that paralleled the south (right) road edge. Two 20 cm (8") diameter trees were struck by the vehicle as it traveled off-road into the tree line. These trees were located 7.2 m (23.6') south of the edge line. Seven additional saplings [all less than 3 cm (1")] in diameter were struck and run over by the Chrysler as it traveled through the tree line to final rest. The posted speed limit for the roadway was 89 km/h (55 mph). The Crash Schematic is included as **Figure 12** of this report.

**Figure 2. Look back view of the roadway.**

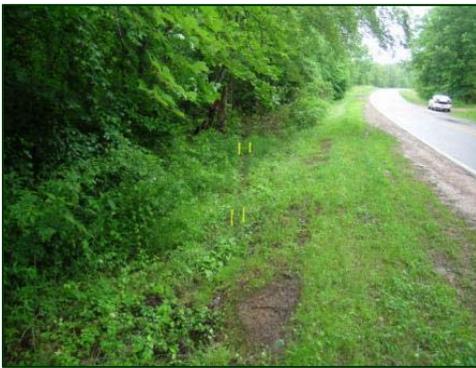
The restrained 74-year old male driver of the 2005 Chrysler 300 was traveling in a westerly direction of the two lane road. He negotiated a left curve with a downgrade that transitioned onto a straight segment. As he entered the straight segment of roadway, he allowed the vehicle to drift left across the centerline and depart the left (south) road edge at the beginning of a shallow right curve. He departed the roadway in a tracking mode as evidenced by rotating tire prints across the grassy area. The vehicle traveled across the grass and entered the tree line 18 m (59') west of the point of road departure. The vehicle's departure angle was 8 degrees. The rotating tire prints (**Figure 3**) were partially eroded at the time of the SCI investigation; however, based on the compressed grass, it did not appear that the driver braked in an attempt to avoid the crash.

**Figure 3. Departure path of the Chrysler 300 into the tree line.**

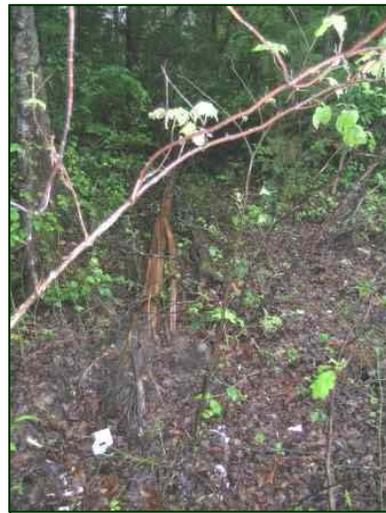
**Figure 4. Struck and uprooted tree.**

The Chrysler entered the wooded area and overrode several small diameter trees prior to impacting a 20 cm (8") diameter tree that was located 7.2 m (23.6') south of the south edge line. The offset left frontal impact crushed the bumper beam to a maximum depth of 39 cm (15.25"). The resultant direction of force for this event was within the 12 o'clock sector. The impact uprooted the tree (**Figure 4**) and displaced the tree in a westerly direction as it fell to the ground. The Chrysler overrode the downed tree and several additional small diameter trees as its center of gravity continued in a westerly direction. This initial tree impact resulted in a barrier equivalent velocity change of 23 km/h (14.3 mph) with respective longitudinal and lateral components of 23 km/h (14.3 mph) and 0 km/h. As a result of the impact, the CAC driver's air bag deployed and the retractor pretensioner fired.

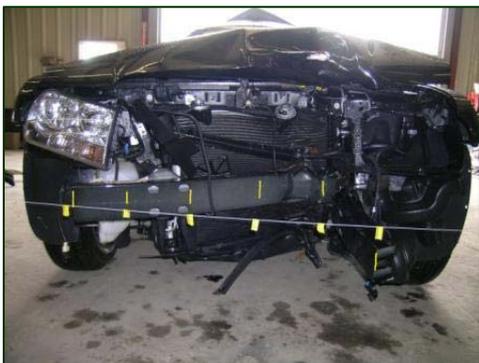
*Front* – The front bumper fascia was separated and removed from the vehicle at the time of the SCI inspection, therefore, the direct contact damage was measured on the hood. The direct contact damage began 20 cm (8") left of center and extended 18 cm (7") to the left. The impact deformed the bumper fascia to a V-shape, dented the hood, and fractured the composite upper radiator support (**Figure 5**). Maximum crush occurred at the bumper beam and measured 39 cm (15.25"), located 15 cm (6") right of center. The crush profile at the level of the bumper beam (**Figure 6**) was as follows: C1 = 0 cm, C2 = 39 cm (15.25"), C3 = 23 cm (9.25"), C4 = 12 cm (4.75"), C5 = 4 cm (1.5"), C6 = 0 cm. The Collision Deformation Classification (CDC) for this impact was 12-FYEN-2.

**Figure 5. Frontal damage to the Chrysler 300.**

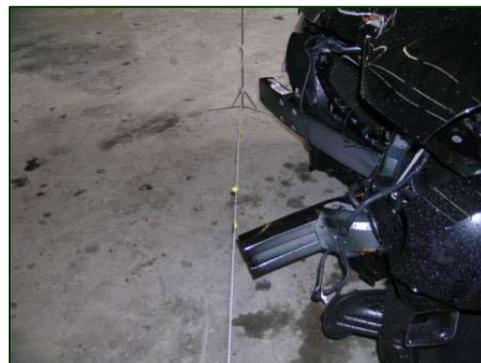
**Figure 6. Lateral view of the frontal crush profile.**

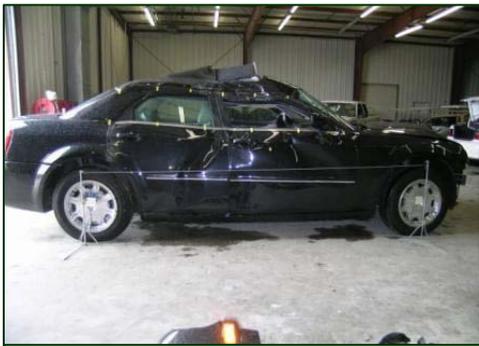
*Right Side* – The right greenhouse area of the 300 impacted an 20 cm (8”) diameter tree. The direct contact damage was isolated to the window frames of the right doors and the roof side rail area (**Figure 7**). The lateral crush associated with this impact resulted in displacement of the B-pillar. The B-pillar displacement produced remote buckling of the right doors. The direct contact damage began 56 cm (22.1”) forward of the right B-pillar and extended 79 cm (31.25”) rearward, terminating 23 cm (9.25”) aft of the B-pillar. Although this impact was sideswipe in nature and outside the scope of the WINSMASH reconstruction program, two lateral crush profiles were documented to capture the right side damage. These profiles were measured at the level of the beltline and the roof side rail, above the door window frames. The crush was measured at the edge of the roof panel, adjacent to the door window frame. The lateral crush at the level of the side rail (**Figure 8**) was documented along a damage length of 156 cm (61.25”). The side rail was not exposed for a direct line of measurements; therefore this profile is slightly under representative of the actual crush depth. The crush profile at this level was as follows: C1 = 0 cm, C2 = 2 cm (0.75”), C3 = 10 cm (3.75”), C4 = 15 cm (5.75”), C5 = 14 cm (5.4”), C6 = 0 cm. The CDC for this greenhouse impact was 01-RPGW-3.

The combined damage length at the level of the beltline was 208 cm (82”). This crush profile was as follows: C1 = 4 cm (1.5”), C2 = 7 cm (2.75”), C3 = 13 cm (5”), C4 = 11 cm (4.25”), C5 = 7 cm (2.75”), C6 = 7 cm (2.75”). Maximum crush at this level was 14 cm (5.5”) located at the right B-pillar.

**Figure 7. Right side damage to the Chrysler 300.**

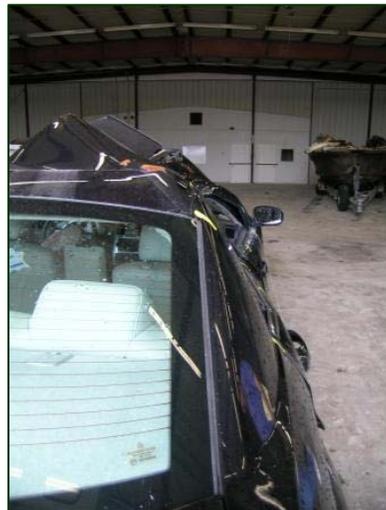
**Figure 8. Longitudinal view of the crush at the right roof side rail.**

Maximum intrusion involved 17 cm (6.75”) of lateral displacement of the right roof side rail located forward of the B-pillar. The intrusions are identified in the following table:

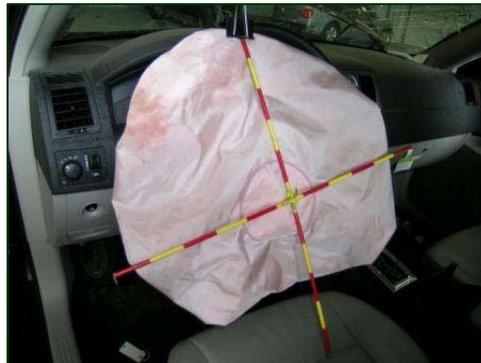
The driver's air bag deployed from a steering wheel mounted module that was concealed by H-configuration module cover flaps. The flaps were 15 cm (6") in width at the horizontal tear seam and 10 cm (3.75") and 7 cm (2.75") in height for the upper and lower flaps respectively. The air bag membrane was 56 cm (22") in diameter in its deflated state (**Figure 9**). The bag was vented by two 4 cm (1.5") diameter ports located at the 11 and 1 o'clock sectors. These ports were centered 6 cm (2.25") below the peripheral seam. The air bag was tethered by two 5 cm (2") wide straps at the 12 and 6 o'clock positions. The driver's air bag was identified by the following nomenclature stamped on the top surface of the air bag:

**Figure 9. Deployed driver's air bag.**

There was no damage or driver contact evidence on the air bag or module cover flaps.

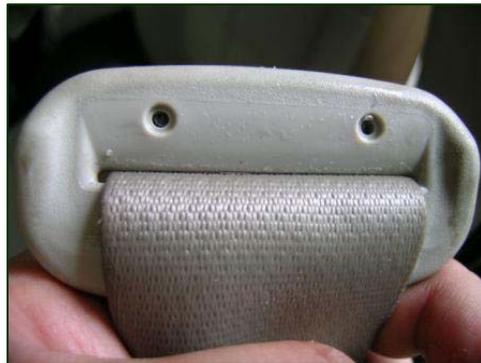
**Figure 10. Frictional abrasion of the driver's latch plate.**

The driver was restrained by the manual safety belt at the time of the crash. Belt usage was verified by loading evidence on the belt system and the firing of the retractor pretensioner. The loading evidence consisted of frictional abrasions on the plastic surfaces of the latch plate (**Figure 10**) and D-ring.

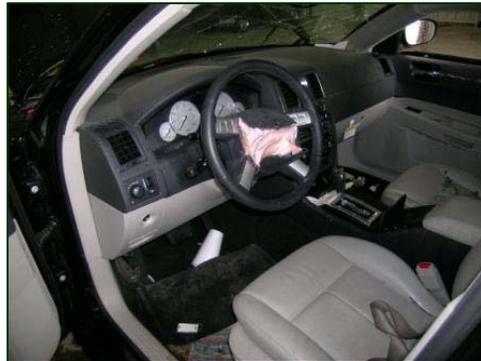
**Figure 11. Driver’s position and the lack of contact points.**

The driver was restrained by the manual 3-point lap and shoulder belt system. Belt usage was determined by the fired status of the retractor pretensioner and the frictional abrasions on the plastic surfaces of the D-ring and latch plate. **Figure 11** is a view of the driver’s adjusted seat position and the lack of contact points due to the restraint usage.
