ON-SITE CERTIFIED ADVANCED 208-COMPLIANT VEHICLE INVESTIGATION

CASE NUMBER - IN-05-032

VEHICLE - 2005 HONDA ACCORD EX

CRASH DATE - August 2005

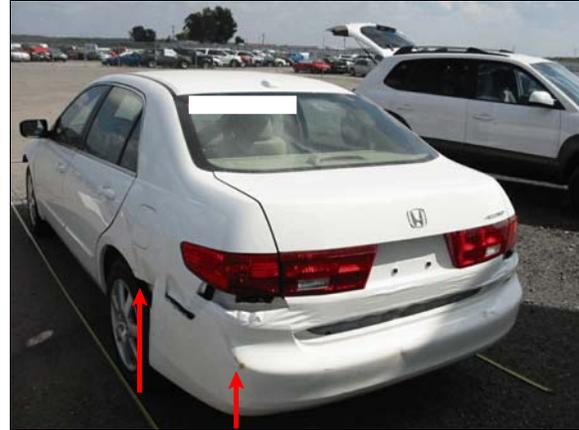
Figure 2: Overview of damage to left quarter panel (arrows) due to impact with metal fence

Crash: Following the driver’s right steer, the case vehicle’s left rear wheel and quarter panel (Figure 2) sideswiped a metal fence post (Figure 3). The case vehicle then traveled back through the ditch and up the front slope of the ditch (Figure 4) and became airborne as it reentered the roadway. The vehicle’s front undercarriage bottomed-out and gouged the roadway (Figure 5 below) as it touched down in the eastbound lane. The case vehicle then departed the south side of the roadway, traveled through a shallow ditch, and the front right (Figure 6 below) impacted a tree (Figure 7 below) causing the driver’s air bag to deploy. The case vehicle’s right fender and right front wheel then immediately sideswiped a second tree. The front right air bag did not deploy in this crash because there was no front right passenger seated in the case vehicle at the time of the crash. The case vehicle’s advanced occupant protection system properly determined the absence of a front passenger and suppressed deployment of the front right passenger air bag.

Exterior Damage: The case vehicle’s impact with the metal fence involved the left quarter panel and left rear wheel. The direct quarter panel damage began 21 centimeters (8.3 inches) rear of the left rear axle and extended rearward 76 centimeters (29.9 inches). Maximum residual crush was approximately 2 centimeters (0.8 inch) occurring at C₃. The direct damage also involved the rim flange of the left rear wheel, and red paint transfer from a fence post was observed on the flange and sidewall of the tire. The case vehicle’s first tree impact involved the right portion of the front bumper, grille and hood. These components were directly damaged and crushed rearward. Direct damage began 26 centimeters (10.2 inches) left of the front right bumper corner and extended 36 centimeters (14.1 inches) along the bumper. Crush measurements were taken at the bumper bar. The maximum residual crush was measured as 19 centimeters (7.5 inches) occurring 14 centimeters (5.5 inches) left of C₆ (**Figure 8**). The case vehicle’s second tree impact involved the right front wheel and most likely the right fender (the right fender had been removed from the case vehicle and was not inspected). The sidewall was cut and wood was jammed in the tire bead. The first table below shows the case vehicle’s crush profile for the fence impact. The second table below shows the case vehicle’s crush profile for the first tree impact.

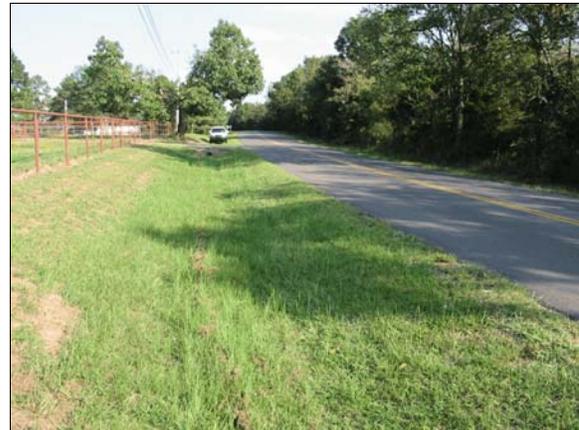
Figure 3: Overview of ditch and metal fence sideswiped by case vehicle

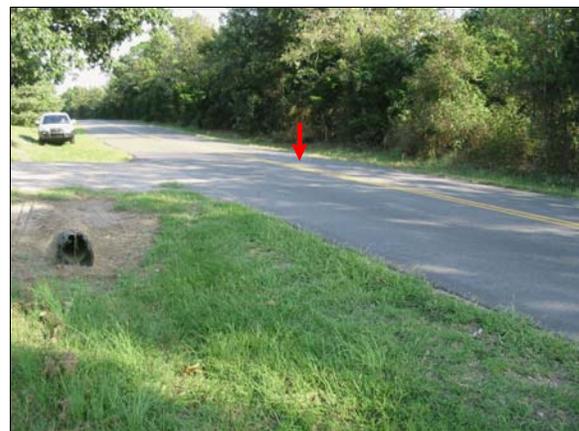
Figure 4: Area where case vehicle became airborne and reentered roadway, arrow shows gouges in roadway

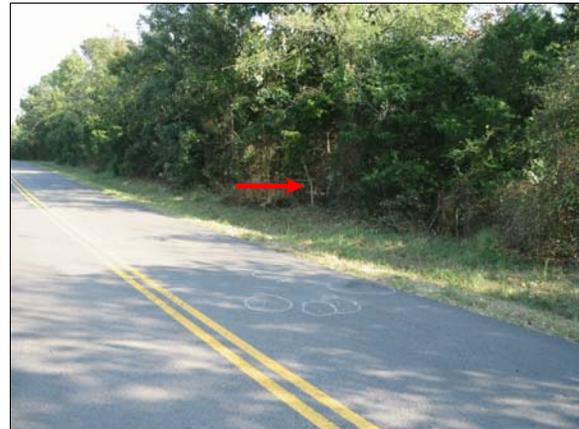
Figure 5: Gouges in roadway (three white circles in foreground) where case vehicle touched down, arrow shows area of tree impacts

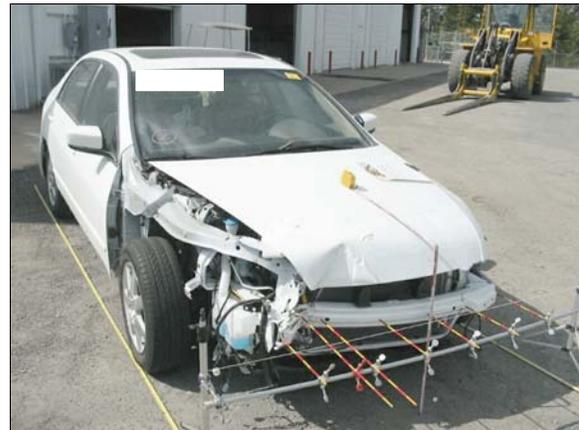
Figure 6: Overview of damage to front of case vehicle due to tree impact

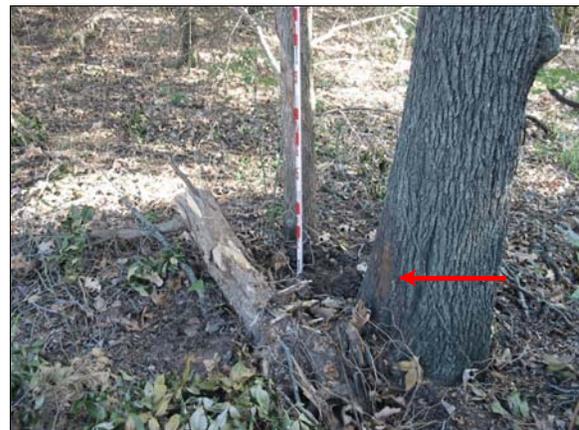
Post-Crash: The case vehicle did not appear to have rotated due to the tree impacts. It uprooted the first impacted tree, traveled a short distance and came to rest facing southeast (Figure 7 below).

Figure 7: Case vehicle’s impact to trees, arrow shows right front wheel damage to large tree, front impacted and uprooted tree on left. Increments on tape measure are in tenths of meter

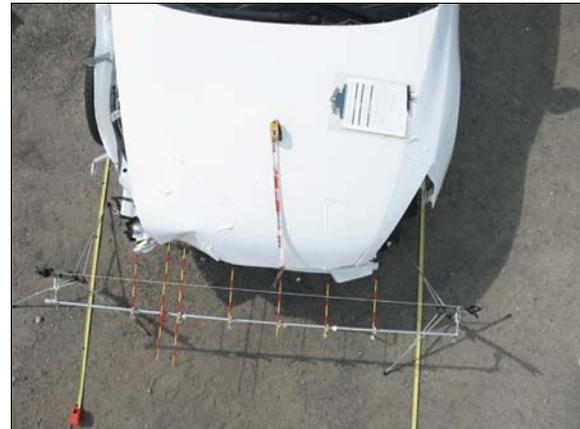
Figure 8: Top view of front crush, measurements taken to bumper bar, front bumper cover was off vehicle, each increment on rods in 5 cm (2 in)

Units	Event	Direct Damage		Field L	C ₁	C ₂	C ₃	C ₄	C ₅	C ₆	Direct	Field L
		Width CDC	Max Crush								±D	±D
cm	3	36	19	114	0	4	5	9	15	0	42	0
in		14.2	7.5	44.9	0.0	1.6	2.0	3.5	5.9	0.0	16.5	0.0

The right side wheelbase was reduced 3 centimeters (1.2 inches) while the left side wheelbase was unchanged. Induced damage involved the front bumper, grille, hood and left quarter panel. Induced damaged also involved the radiator and most likely the right fender.

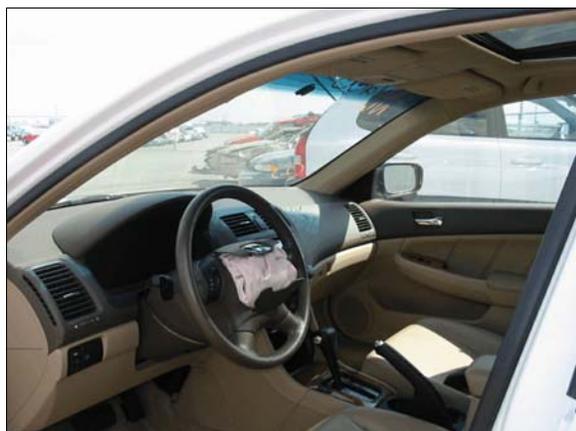
Vehicle Interior: Inspection of the case vehicle’s interior (**Figure 9**) revealed that the rearview mirror was broken off its mount. The mirror was cracked and there was a scuff on the left edge of the mirror frame. No other evidence of occupant contact to any interior surfaces or components was observed. There was no intrusion of the passenger compartment, no evidence of compression of the energy absorbing steering column, and no deformation of the steering wheel rim (**Figure 10**).

Figure 9: Overview of steering wheel, instrument panel and windshield

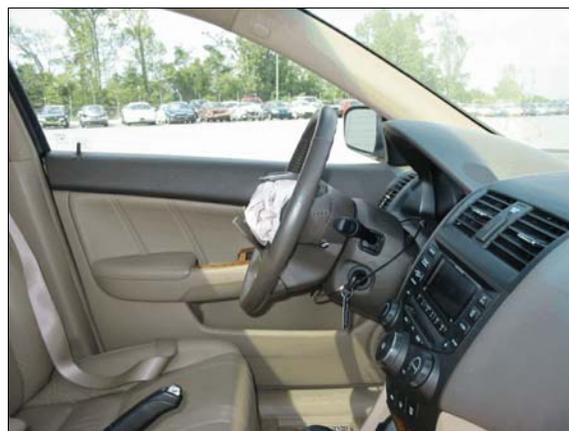
Figure 10: Right side view of steering wheel and steering column showing lack of deformation

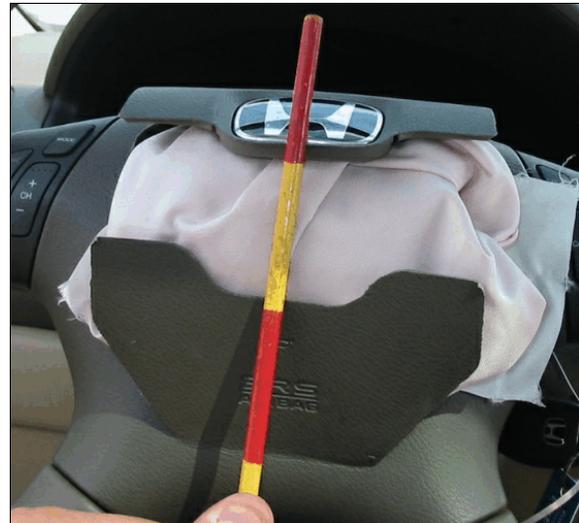
The case vehicle's driver air bag was located in the steering wheel hub. An inspection of the air bag module cover flaps (**Figure 11**) and the air bag fabric revealed that the cover flaps opened at the designated tear points. There was no evidence of damage during the deployment to the air bag module cover flaps or the air bag; however, a few scuffs were observed on the air bag that appeared related to the deployment. The module cover consisted of two asymmetrical flaps made of pliable vinyl. The top flap was approximately rectangle in shape with a manufacturer's emblem located in the center of the flap. A portion of the emblem, which was also approximately rectangular-shaped, extended from the bottom of the flap and fit into a cut-out at the center top of the bottom flap. The upper flap was 13.5 centimeters (5.3 inches) in width and 6 centimeters (2.4 inches) in height. The lower flap was approximately hexagonal-shaped and was

Figure 11: Case vehicle driver's air bag module cover flaps

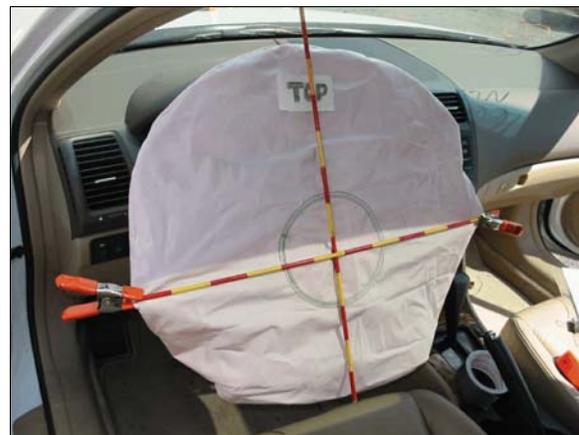
Figure 12: Case vehicle's driver air bag

13.5 centimeters (5.3 inches) in width and 6 centimeters (2.4 inches) in height. The deployed driver's air bag (**Figure 12**) was round with a diameter of approximately 59 centimeters (23.2 inches). The air bag was designed with two tethers, each approximately 7 centimeters (2.8 inches) in width and had two vent ports (**Figure 13** above), each approximately 5 centimeters (2 inches) in diameter, located near the center of the air bag at the approximate 10 and 2 o'clock positions. The distance between the mid-center of the driver's seat back, as positioned at the time of the vehicle inspection (i.e., seat at middle track position, seat back slightly reclined), and the front surface of the air bag's fabric at approximate full excursion was approximately 39 centimeters (15.4 inches).

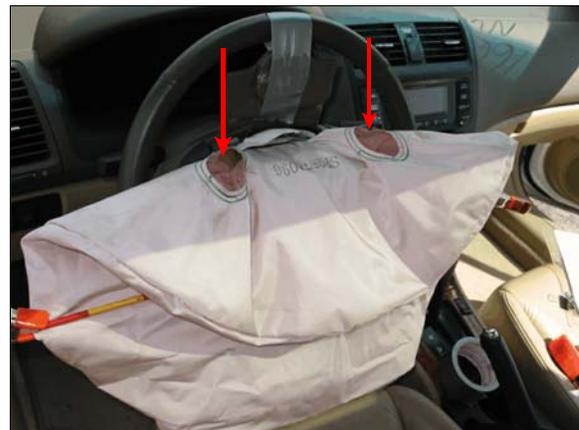
Figure 13: Arrows show case vehicle's driver air bag vent ports

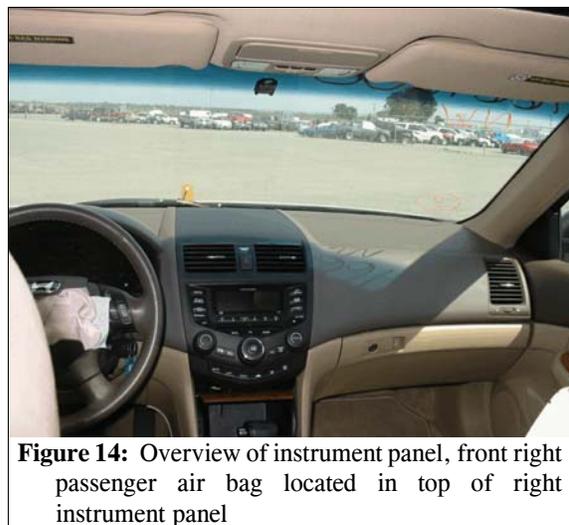
Figure 14: Overview of instrument panel, front right passenger air bag located in top of right instrument panel

The front right passenger air bag was located in the top of the instrument panel (**Figure 14** below). The deployment of the front right air bag was properly suppressed by the case vehicle's advanced occupant protection system because there was no front right passenger in the case vehicle at the time of the crash. In addition, the seat back-mounted side impact air bags and side curtain air bags did not deploy because there was no side impact severe enough to require their deployment.
