CALSPAN ON-SITE ROLLOVER CRASH INVESTIGATION

SCI CASE NO: CA05-034

VEHICLE: 2005 LEXUS RX330

CRASH DATE: MAY, 2005

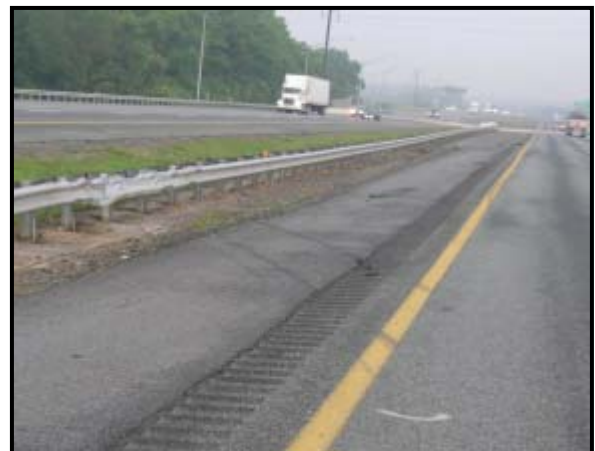
Figure 4: Westward view of the roadside departure and guardrail impact.

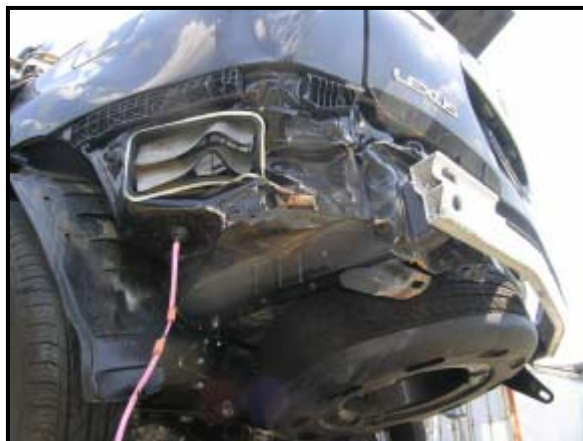
The Lexus sustained minor damage as a result of the rear impact from the Acura and severe exterior damage as a result of the impact to the guardrail and the six-quarter turn rollover. The direct damage to the rear plane began 58 cm (23 in) left of center immediately outboard of the rear bumper reinforcement. The width of the direct contact measured 23 cm (9 in) and extended to the left rear corner. The width of the undeformed rear plane measured 163 cm (64 in). The maximum deformation of the sheet metal within the rear quarterpanel measured 5 cm (1.8 in) longitudinally and 6 cm (2.2 in) laterally. The length of the contact extended forward 51 cm (20 in) from the rear bumper (**Figure 5**). The nature of the physical damage was indicative of an underride impact consistent with the interaction with the Acura. The Collision Deformation Classification of the impact was 06-BLEE-3.

Figure 5: Left rear damage to the Lexus.

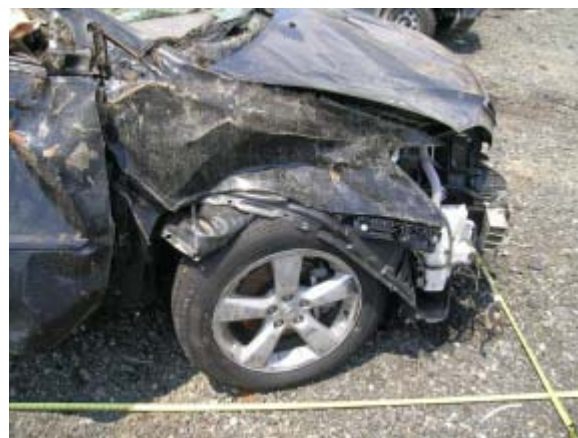
The Lexus impacted the guardrail with its right front fender area (**Figure 6**) consistent with the vehicle rotation during the roadside departure. The direct contact damage to the fender measured 102 cm (40 in) in length and began in the area of the right headlamp. The fender deformed rearward and downward. The inner fender collapsed around the right front tire. The elevation of the fender damage measured 75 cm (29.5 in) above the ground. This guardrail interaction tripped the vehicle into a right side leading roll. It should be noted that there was no impact damage to the front bumper system from the guardrail impact. The front bumper system was not involved. The front fascia separated in the rollover.

Figure 6: Impact damage to the right front fender.

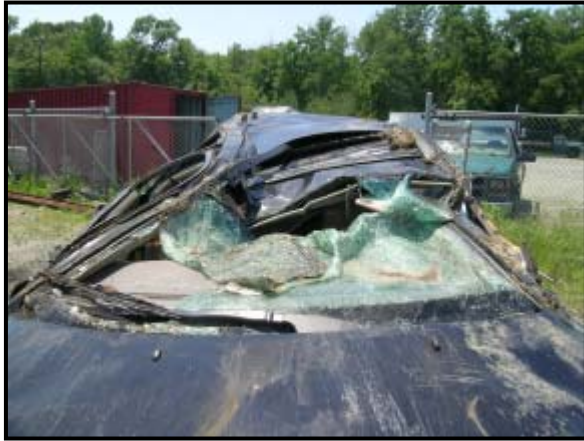
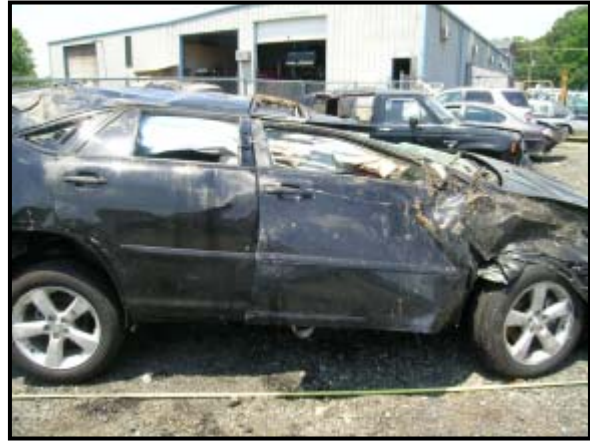
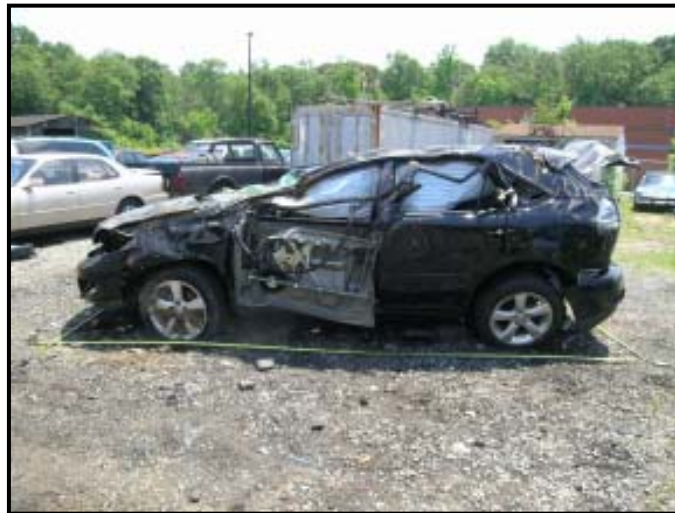
The rollover damage to the vehicle was consistent with a multiple turn rollover event. Both side planes and the top plane exhibited direct damage that consisted of bi-directional scratches, abrasions, and buckling of the body panels. **Figures 7 through 9** are the front, right side, and left side views of the Lexus, respectively. The right roof rail deformed 28 cm (11 in) inboard from ground contact. The compromised structure of the roof buckled into a V-pattern and was deformed downward to the level of the seat backs. The windshield was fractured and separated. The backlight and all side windows disintegrated. The rear tailgate remained latched and was buckled outward 10 cm (4 in) at the belt line. The left front fender was buckled down. Dirt and debris were embedded in the body panel, undercarriage, and the left front wheel from ground

contact. The left front tire was deboned. The right and left wheelbase dimensions were reduced 7 cm (2.7 in) and 6 cm (2.2 in), respectively. The overall length of the vehicle was unchanged. The doors remained closed during the crash and were operational upon inspection. However, the doors could not be relatched due to the body deformation. The Collision Deformation Classification of the rollover was 00-TDDO-4.

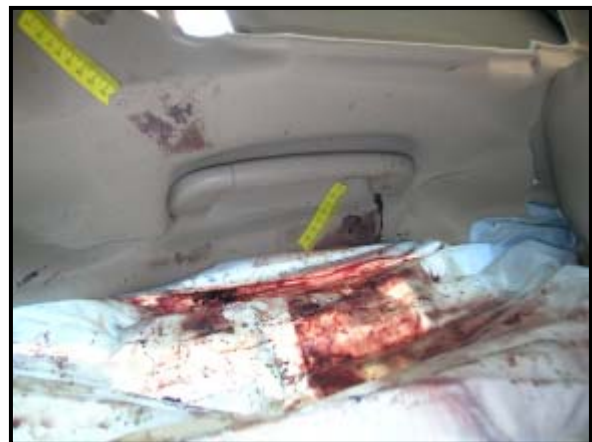
The front right passenger seat was located in a full rear track position. The seat back was reclined 18 degrees. The horizontal distance from the seat back to the vertical face of the instrument panel measured 80 cm (31.3 in). There were no contacts to the glove box door. The front right passenger's head contacted the right roof rail at the rear aspect of the grab handle, **Figure 10**. There was a large associated area of blood evidence throughout the region and on the inflatable side curtain. The passenger's head likely pocketed and remained in this area due to the buckling and deformation of the roof.

Figure 10: Front right passenger head contact at the right grab handle.

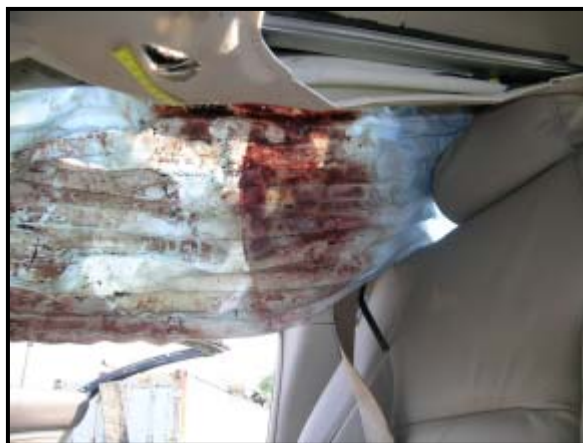
The inflatable side curtains deployed vertically downward from the respective roof-rails during the initial stages of the rollover. The side curtains were rectangular in shape and provided coverage from the A- to C-pillar. The gross dimensions of the membrane measured 165 cm by 33 cm (65 in by 13 in), length by height. A 25 cm (10 in) triangular sail panel designed for ejection mitigation was located between the forward aspect of the inflatable curtain and the A-pillar anchor point. Inspection of the left curtain was unremarkable for driver contact. The right curtain was heavily blood stained over a 71 cm (28 in) length forward of the right B-pillar from contact with the injured front right occupant. Refer to **Figure 11**.

Figure 11: Lateral view of the right side curtain.
