ON-SITE OTHER INFLATABLE OCCUPANT PROTECTION INVESTIGATION

CASE NUMBER - IN-05-039

VEHICLE - 2005 INFINITI QX56

CRASH DATE - September 2005

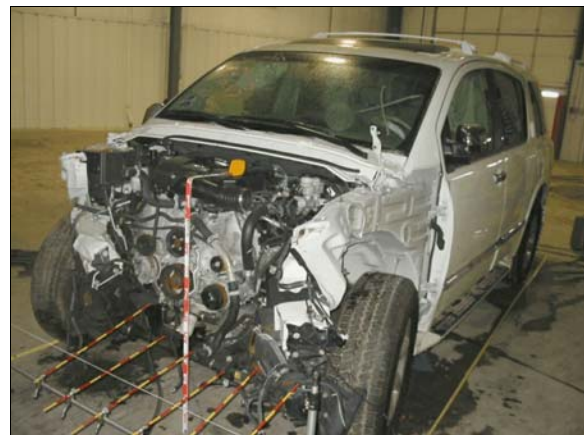
Figure 4: Overview of damage to front of case vehicle, damaged components had been removed and disposed, each increments on tape measure is tenth of meter

Exterior Damage: The case vehicle's impact with the Oldsmobile involved the front of the case vehicle. Due to the removal of the front bumper and sheet metal components, the length of direct damage is not known. However, based on the damaged components remaining on the case vehicle and the damage to the Oldsmobile, it appeared that the direct damage most likely involved the full width of the front of the case vehicle. Crush measurements were taken from the front frame members and also estimated based on a line projected across the front of the frame members. The residual maximum crush occurred at the right frame member and was determined to be 28 centimeters (11 inches). The table below shows the case vehicle's estimated crush profile.

Damage Classification: The bumper and damaged sheet metal parts had been removed from the front of the case vehicle and were not available for inspection; however based on the damaged components remaining on the case vehicle, and the resulting damage to the left front side of the Oldsmobile, the case vehicle's CDC was estimated to be: **81-FDEW-2 (30 degrees)**. The force direction was incremented due to the leftward shift of both front frame members. The WinSMASH reconstruction program, missing vehicle algorithm was used to reconstruct the case vehicle's Delta Vs. The Total, Longitudinal, and Lateral Delta Vs are, respectively: 27 km.p.h. (16.8 m.p.h.), -23.4 km.p.h. (-14.5 m.p.h.), and -13.5 km.p.h. (-8.4 m.p.h.). The case vehicle was towed due to damage.

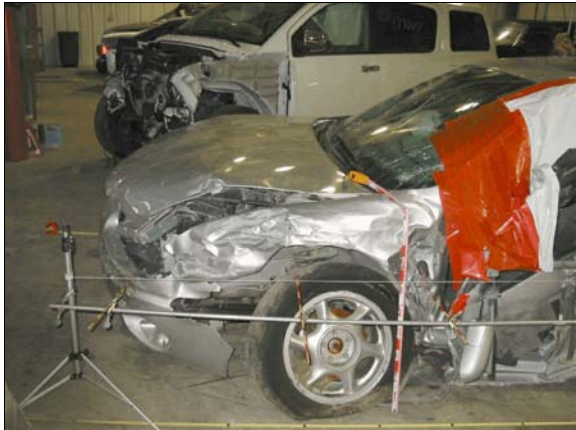
Figure 5: Damage to Oldsmobile’s left fender and left front door from impact with the case vehicle, each black mark on tape measure is 0.31 meter (1 foot)

Exterior Damage: The Oldsmobile's impact with the case vehicle involved the left fender, left front wheel and left front and rear doors. The left fender was crushed inward, and the left front wheel apparently snagged on the front of the case vehicle and was displaced rearward and angled outward. The back of the left front wheel had also contacted the left front MacPherson strut during the impact. Direct damage began 109 centimeters (42.9 inches) forward of the left rear axle and extended 232 centimeters (91.3 inches) along the left side of the Oldsmobile. Crush measurements were taken at the mid-door level; however, an accurate crush profile could not be obtained due to the missing driver's door sheet metal, broken door hinges, and what appeared to be post-crash manipulation of the door. The impact with the Geo involved the left portion of the front bumper, grille, hood and the left headlamp/turn signal assembly. The direct damage began at the front left bumper corner and extended 61 centimeters (24 inches) along the bumper. The maximum residual crush was measured as 15 centimeters (5.9 inches) occurring at C₁. The table below shows the Oldsmobile's crush profile for the front impact with the Geo.

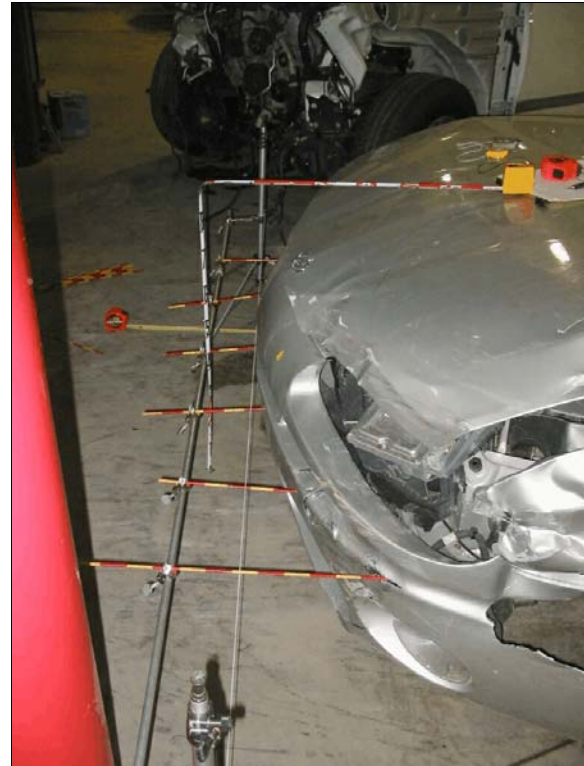
Figure 6: Damage to front of Oldsmobile from impact with the Geo, each increment on rods is 5 cm (2 in)

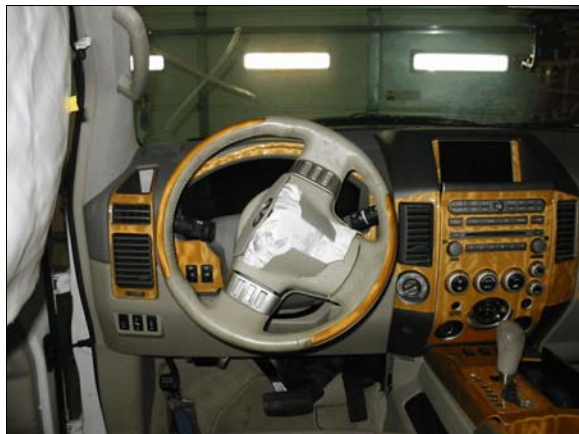
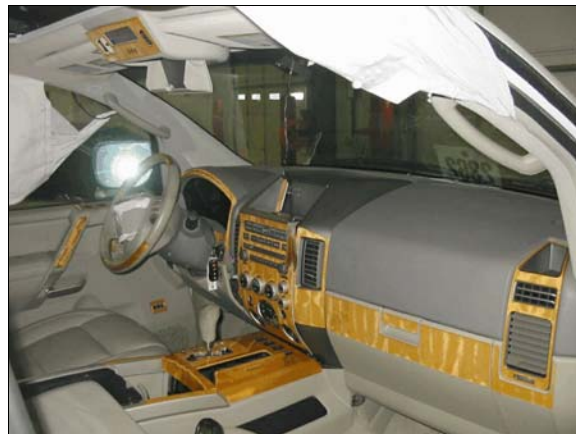
Vehicle Interior: Inspection of the case vehicle's interior (**Figures 8** and **9** below) revealed an occupant contact scuff mark on the driver's knee bolster, a small scuff on the driver's side curtain

air bag, and the rearview mirror was cracked and broken off the windshield. In addition, the driver's front air bag had several scuffs, dirt and grease marks, and a possible blood stain on it. No other occupant contact evidence was found, and no intrusion of the passenger compartment was observed. There was no deformation of the steering wheel. It is not known if the energy absorbing steering column sustained any compression.

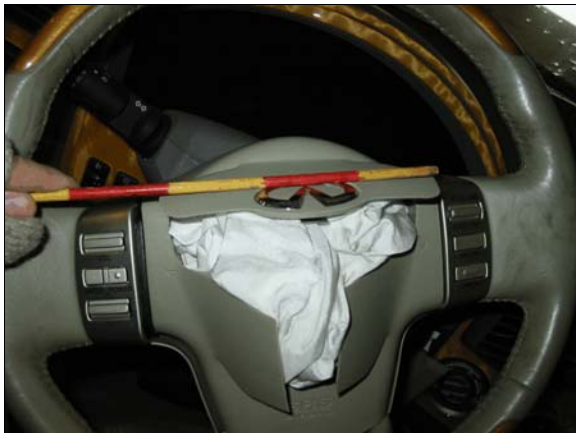
Figure 10: Case vehicle's driver air bag module cover flaps

The case vehicle's driver air bag was located in the steering wheel hub. An inspection of the air bag module cover flaps (**Figure 10** below) and the air bag fabric revealed that the cover flaps opened at the designated tear points. There was no evidence of damage during the deployment to the air bag or the air bag module cover flaps. The air bag module was designed with three cover flaps. The upper flap was constructed of pliable vinyl and approximately

rectangular in shape with a rounded contour in the middle to accommodate the Infiniti emblem. The upper flap was 15.5 centimeters in length (6.1 inches) and approximately 6 centimeters (2.4 inches) in height. The two lower flaps were constructed of pliable vinyl and were irregularly shaped with a rounded contour at the center to accommodate the rounded contour on the upper flap. Each lower flap was approximately 6.5 centimeters (2.6 inches) in height, approximately 4.5 centimeters (1.8 inches) in width at the bottom and approximately 7.8 centimeters (3.1 inches) in width at the top. The deployed driver's air bag (**Figure 11**) was round with a diameter of approximately 56 centimeters (22 inches). The air bag was designed with four tethers, each approximately 10 centimeters (4 inches) in width and had two vent ports, each approximately 2 centimeters (0.8 inches) in diameter, located on the back of the air bag near the center at the 9 and 3 o'clock positions. The tethers were attached to a double stitched internal ring of material (**Figure 11**) that was 24 centimeters (9.4 inches) in diameter. Inspection of the air bag revealed several areas of scuffs with dirt and grease on the air bag. There was also one possible blood spot noted in the left central quadrant of the air bag (**Figure 11**).

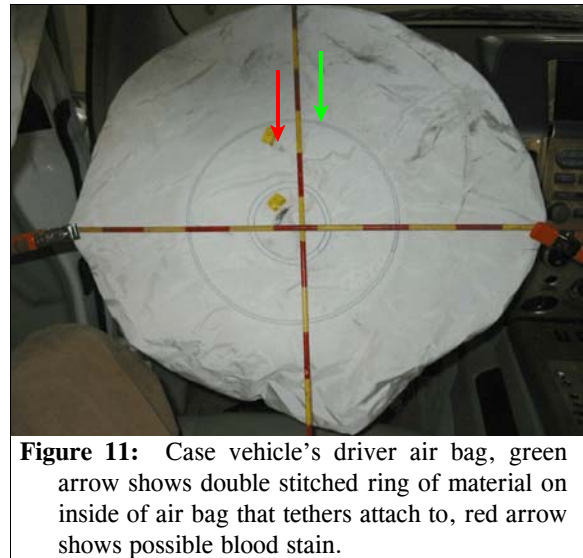
Figure 11: Case vehicle's driver air bag, green arrow shows double stitched ring of material on inside of air bag that tethers attach to, red arrow shows possible blood stain.

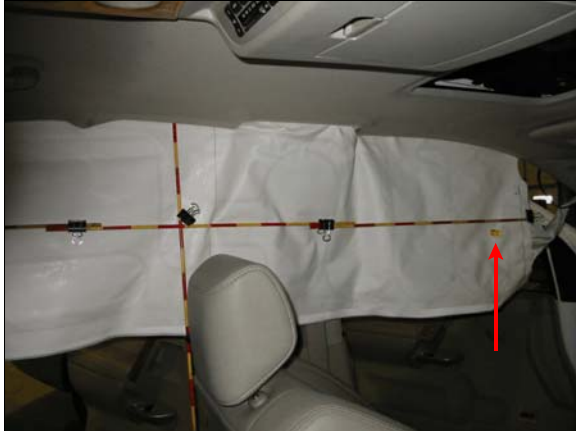
The driver/second seat left side curtain air bag was not equipped with internal tethers, and there were no visible vent ports. Inspection of the air bag revealed no evidence of damage due to deployment. One small scuff was observed on the front central portion of the air bag (**Figure 12**). This did not appear to be an occupant contact mark.

Figure 12: Case vehicle's driver and second seat left side curtain air bag, arrow shows location of a small scuff mark on the air bag

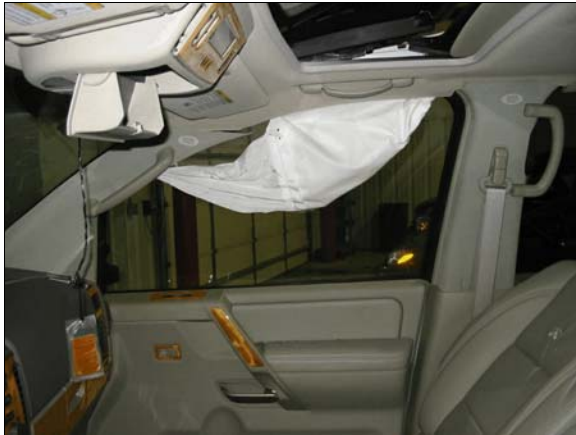
The case vehicle's right side curtain air bags also deployed in this crash. The back right side curtain air bag completely deployed; however, the front right passenger/second seat right side curtain air bag (**Figures 16 and 17** below) did not completely deploy. It did not break out of the headliner at the right "B"-pillar (**Figure 18** below). As a result, there was a gap in the air bag coverage along the right side and "B"-pillar of approximately 40 centimeters (15.7 inches).

Figure 16: Overview of front right passenger's side curtain air bag, it did not break through the headliner at the "B"-pillar during deployment

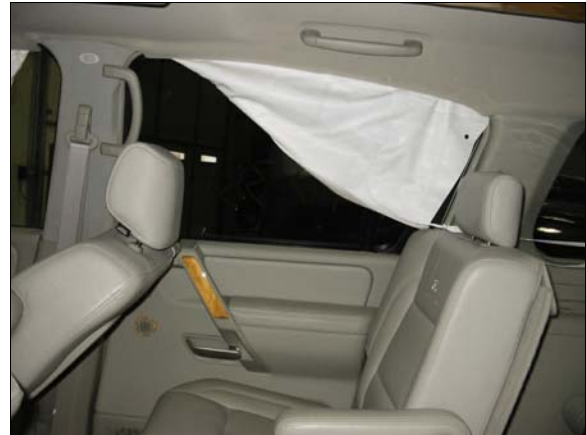
Figure 17: Overview of front right passenger's/second seat right side curtain air bag, it did not break through the headliner at the "B"-pillar during deployment

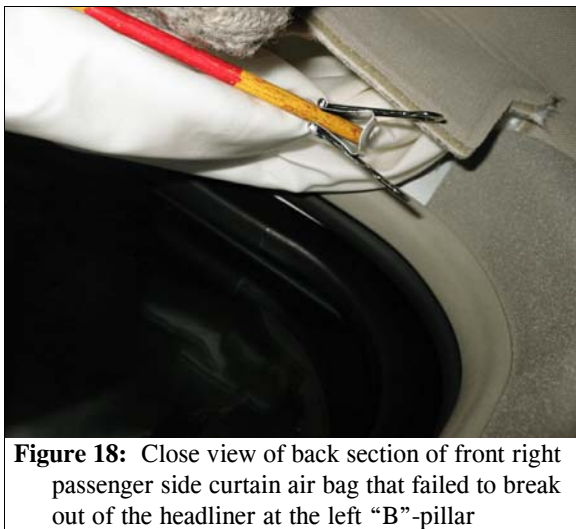
Figure 18: Close view of back section of front right passenger side curtain air bag that failed to break out of the headliner at the left "B"-pillar

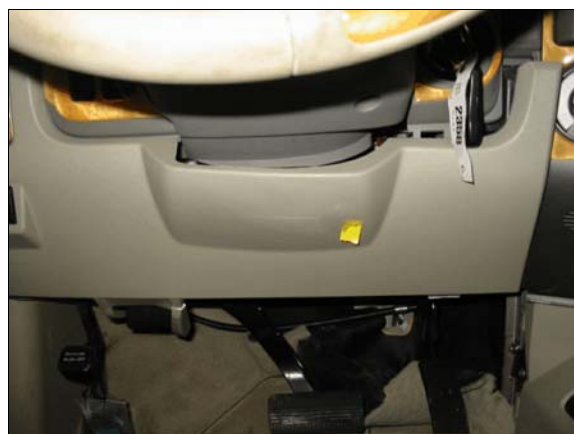
It is not known if the driver took any avoidance actions just prior to the impact. However, regardless of any possible avoidance actions, he was most likely in an upright driving posture with both hands on the steering wheel at the moment of the impact. The case vehicle's impact with the Oldsmobile caused the driver to continue forward and move to his right along a path opposite the case vehicle's 30 degree direction of principal force as the case vehicle decelerated longitudinally and accelerated laterally to the left. His face and chest impacted his deployed front air bag, and his knees impacted the knee bolster (**Figure 19**). As the case vehicle

Figure 19: Driver's knee bolster is displaced, yellow tape shows scuff from driver knee contact
