**CALSPAN REMOTE FIFTEEN-PASSENGER VAN
ROLLOVER INVESTIGATION**

CASE NO: CA05-039

VEHICLE: 2002 FORD E-350 SUPER DUTY VAN

CRASH DATE: JUNE 2005

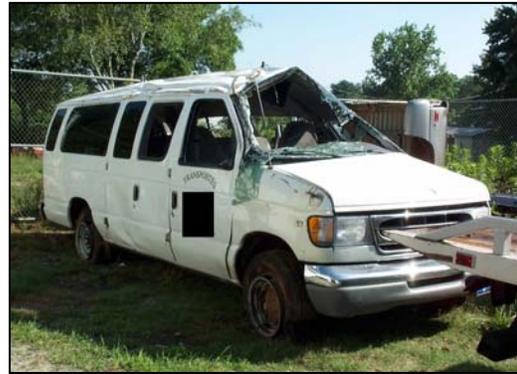
This remote investigation focused on the cause and severity of a rollover of a 2002 Ford E-350 Super Duty 15-passenger van (**Figure 1**). The Ford was utilized as a business transportation van and was en-route to Springfield, Virginia from Houston, Texas. The Ford was operated by a 32-year old male driver and occupied by another rotating driver seated in the front right position and 11 paid adult passengers seated in rows 2-5. The driver and front right passenger were police reported as belted while the remaining rear seated passengers were unrestrained.

Figure 1 - Damaged 2002 Ford E-350

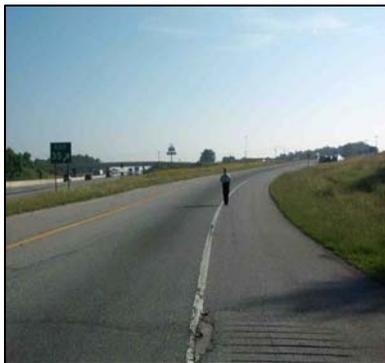
The 32-year old male driver of the Ford E-350 was traveling in a northerly direction in the right lane of a three-lane interstate highway and was approaching an exit ramp stemming to the right. The left rear tire tread separated. Police images of the tire revealed a 360 degree circumferential separation of the tread. It was unknown if the tire aired out as a result of the tread separation. The driver stated to the investigating officer that he experienced a steering problem and exited the interstate onto the off-ramp. He estimated his travel speed at 97 km/h (60 mph). The driver traveled an estimated 105 m (350') onto the ramp which curved to the right with a positive grade (**Figure 2**). As the driver approached the apex of the curve, the van departed the travel lane onto the right shoulder. He probably braked which induced a slight clockwise yaw. The front tires began to mark on the asphalt shoulder. Based on the images and a scaled police crash schematic, the tire markings flowed in a gradual clockwise arch approximately 80 m (265') before rapidly deflecting into a counterclockwise (CCW) direction another 23 m (75'). The van departed the right edge of the shoulder with the right side tires overriding the worn asphalt secondary shoulder. The driver applied a rapid left steering maneuver in an attempt to regain the travel lane. The van began to yaw CCW as the right side tires remained on the worn asphalt secondary shoulder (**Figures 3 and 4**). As the van's right rear wheel transitioned from the secondary shoulder onto the asphalt shoulder, the right rear wheel gouged into the asphalt, which tripped the van into a lateral right side leading rollover.

Figure 2 - 2002 Ford departs right roadside.

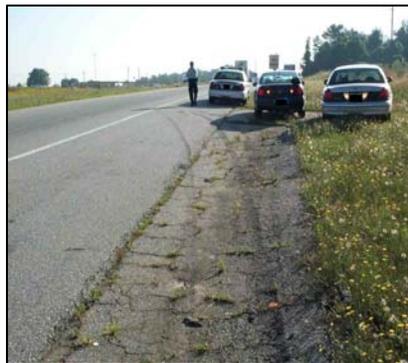
Figure 3 - Vehicle reenters roadway while yawing CCW.

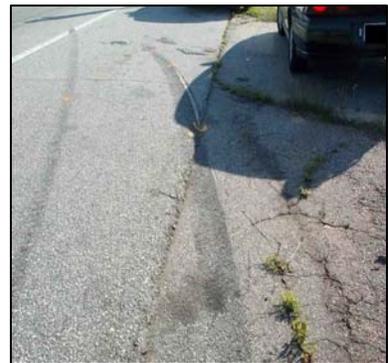
Figure 4 - Gouge on asphalt shoulder from right rear wheel.

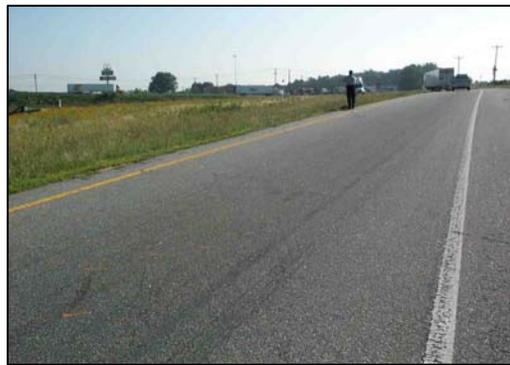
The van began to overturn right side leading at approximately the inboard edge of the right shoulder on the one-lane exit ramp. Gouges associated with the rollover were present in the travel lane (**Figure 5**). The vehicle continued to overturn on the roadway and as the vehicle entered its third quarter turn, the left rear wheel contacted the asphalt road surface (**Figure 6**). A significant circular gouge was present at this location and correlative damage was present on the left rear wheel rim (**Figure 7**). The vehicle continued overturning and departed the north roadside and came to final rest after a total of nine-quarter turns. The vehicle traveled approximately 45 m (150') during the rollover event before coming to rest on its right side approximately 8 m (25') outboard of the left (north) shoulder. During the course of the rollover, two occupants were ejected from the vehicle through the second row left window opening and killed. It was unknown where the ejected victims came to rest, although the police did indicate they were not trapped under the vehicle.

Figure 5 - Area of initial rollover.

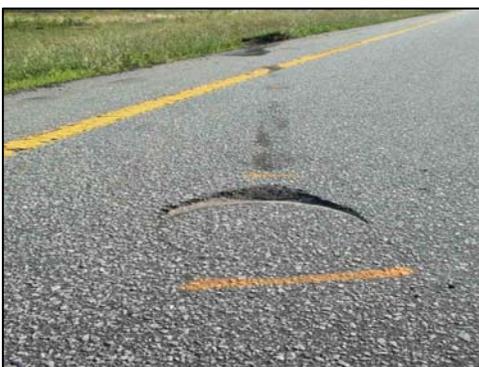
Figure 6 - Gouge from left rear wheel rim.

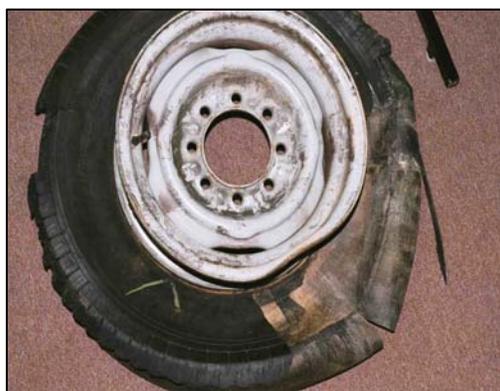
Figure 7 - Correlative damage on wheel rim.

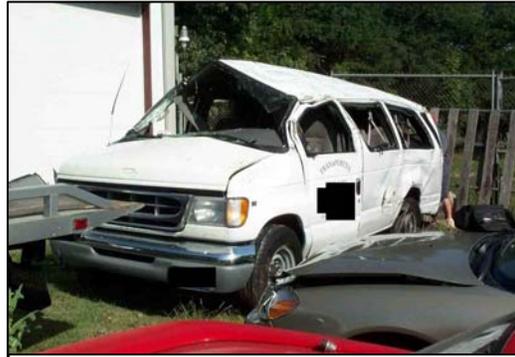
The 2002 Ford E-350 sustained moderate damage to its roof and minor damage to its left and right sides due to the rollover (**Figure 8**). Precise measurements were not available for this SCI remote investigation. Based on police provided images of the vehicle’s exterior, the maximum crush on the vehicle’s roof was located at the left A-pillar. The A-pillar was deformed rearward and downward and the roof crushed vertically approximately 13 cm (5”). The midline of the roof buckled resulting in a near complete separation of the windshield. The entire left roof side rail was slightly crushed downward. The Collision Deformation Classification (CDC) for this impact was 00-TDDO-3.

Figure 8 - Damaged 2002 Ford E-350 Van.

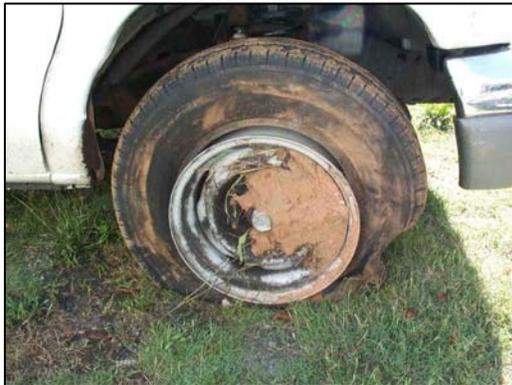
The right side also sustained minor damage beginning near the forward aspect of the fender and extending rearward to the back aspect of the right rear door. The second and third right side windows were shattered during the crash. Both right side tires were deflated and grass and dirt was embedded into the wheel rims (**Figures 9 – 10**).

Figure 9 - Damaged RF wheel.

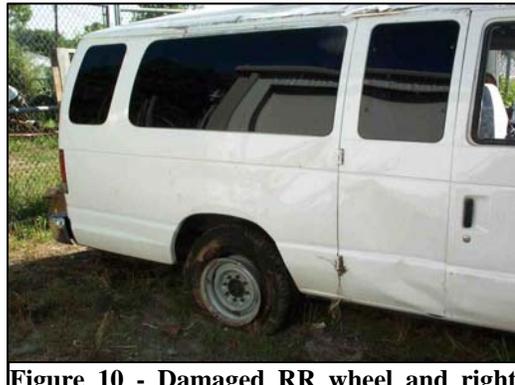
Figure 10 - Damaged RR wheel and right side of Ford E-350.

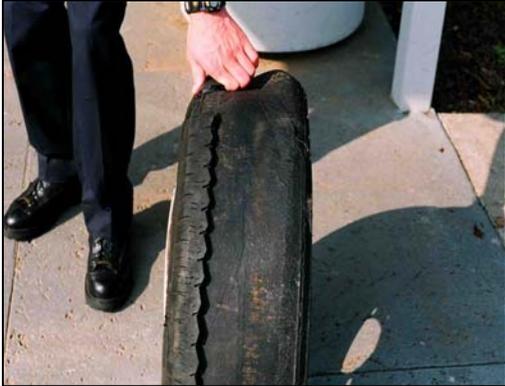
The left rear tire experienced a 360 degree circumferential separation of the tread (**Figure 11**). The investigative officer noted that the tire displayed a bluish color indicating excessive heat buildup from rotation. Distinguishable tire marks were present on the outboard aspect of the left rear wheel opening of the van due to the tire tread slapping the quarter panel while still in a longitudinal direction (**Figure 12**). The rim was deformed and the tire sustained an abrasion when the wheel impacted the asphalt roadway during

the third quarter-turn of the rollover. The general condition of the left rear tread appeared to be satisfactory prior to the crash and the PAR noted its condition as good. Additional damage to the left tire included tears in the sidewall and multiple abrasions. Positioning the tire with the valve stem representing 12 o'clock, a tear was present in the sidewall at 3 o'clock and another at 10 o'clock. A large section of the tread separated; however, exact measurements could not be determined.

Figure 11 – Left rear tread separation.

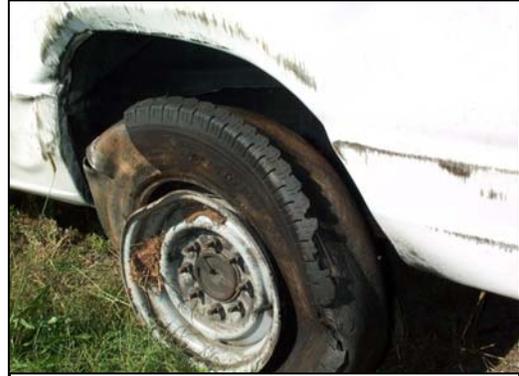
Figure 12 - Left rear tire transfers onto wheel opening.

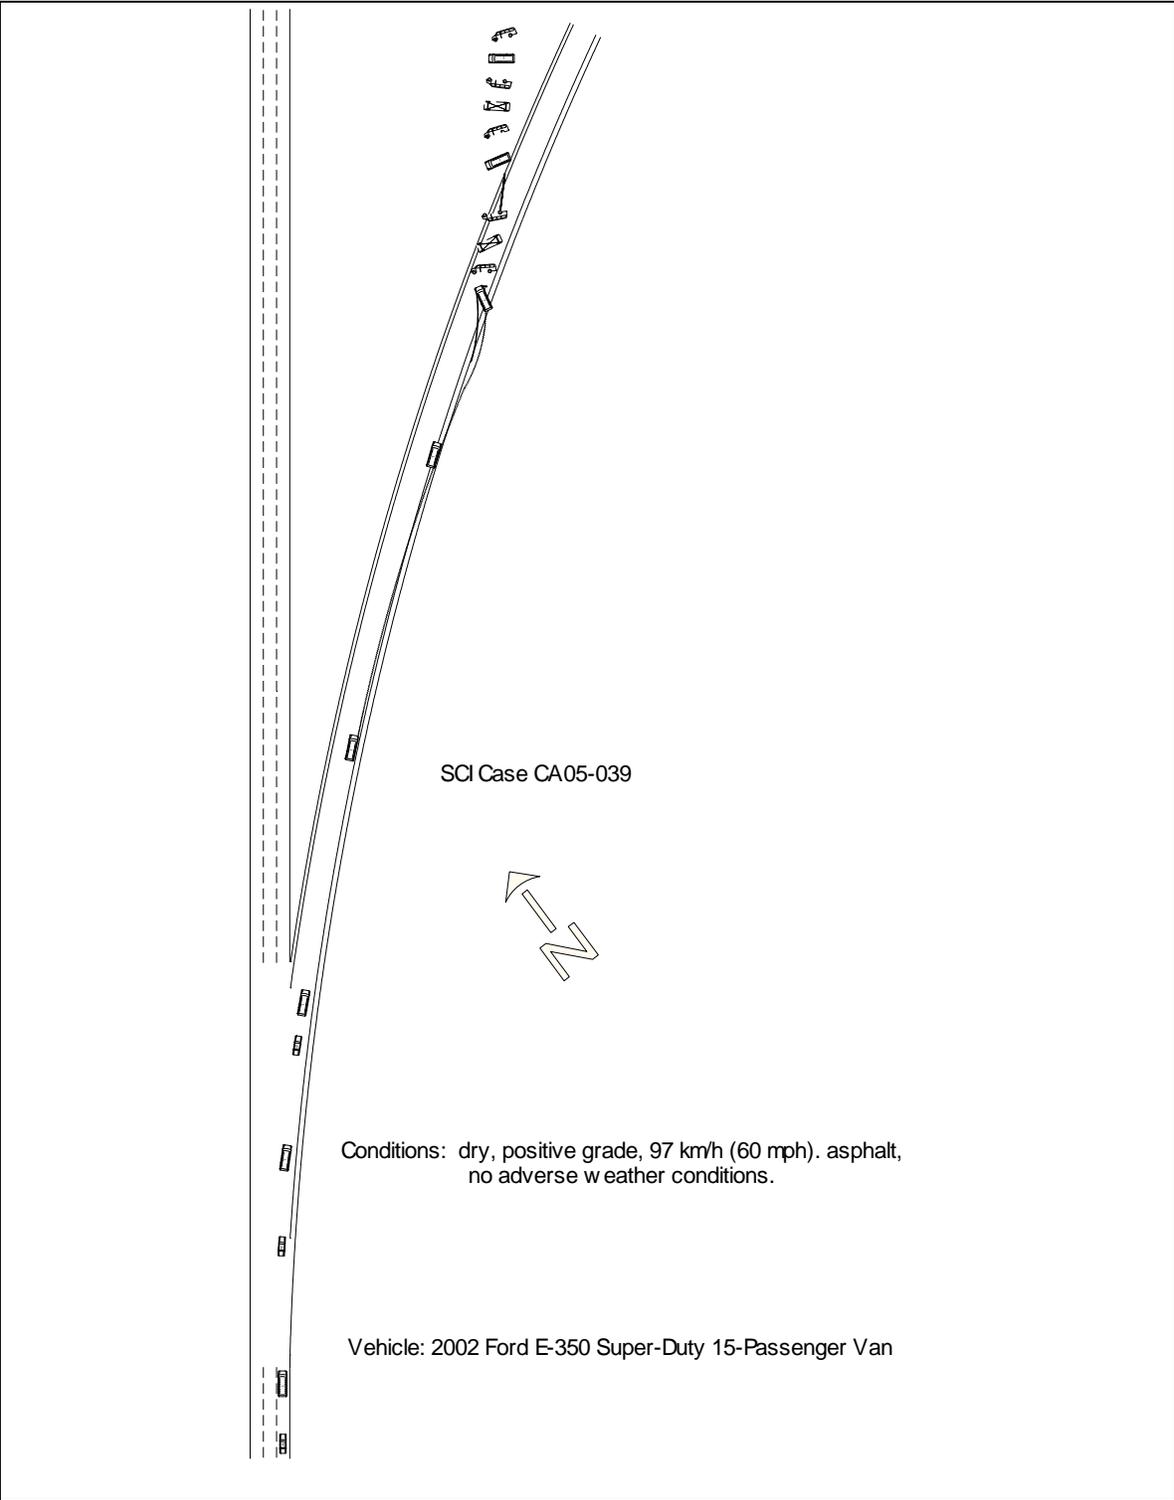
Figure 13 – SCI Crash Schematic

This single vehicle crash occurred on a one-lane exit-ramp stemming from a divided interstate highway. At the time of the crash, the asphalt roadway was dry and there were no adverse weather conditions. The eastbound exit-ramp was curved to the right with no sight obstructions on a positive grade. A painted white fog line delineated the right edge of the roadway and a painted yellow line delineated the left edge. The roadside environment consisted of asphalt shoulders that were approximately 2 m (7') in width and grassy roadsides. A worn asphalt secondary shoulder was located outboard of the south (right) shoulder and began at the vehicle's point of departure. The police-reported speed limit was 97 km/h (60 mph). An SCI crash schematic based on the police sketch is included as **Figure 13** at the end of this narrative report.
