**CALSPAN ON-SITE CERTIFIED ADVANCED 208-COMPLIANT
VEHICLE CRASH INVESTIGATION**

SCI CASE NO: CA05-045

**VEHICLE: 2005 TOYOTA CAMRY
LOCATION: MARYLAND
CRASH DATE: JUNE 2005**

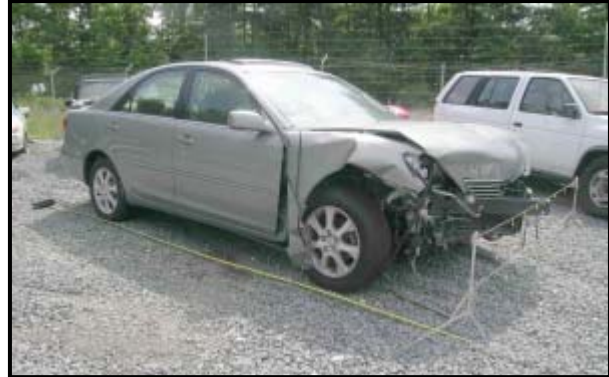
Figure 1: Front right view of the Toyota Camry.

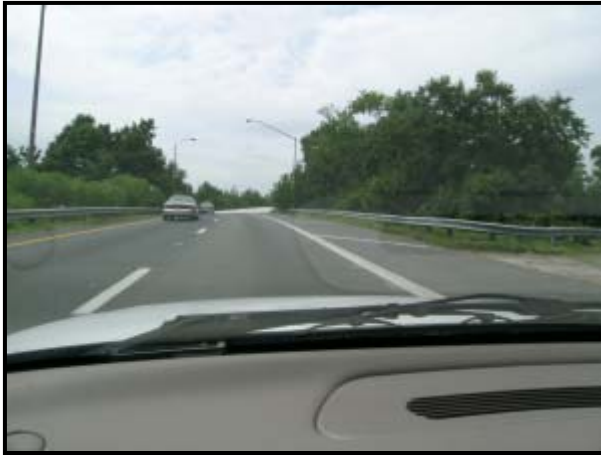
Figure 2: Trajectory view of the Toyota.

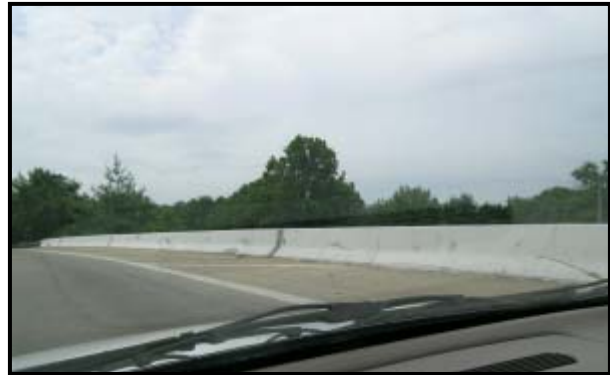
Figure 3: Area of the impact.

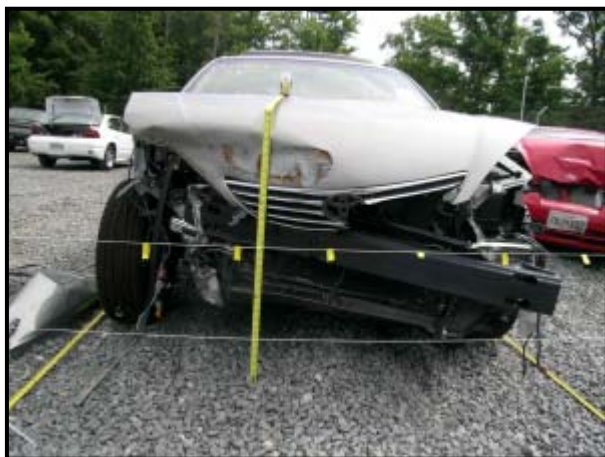
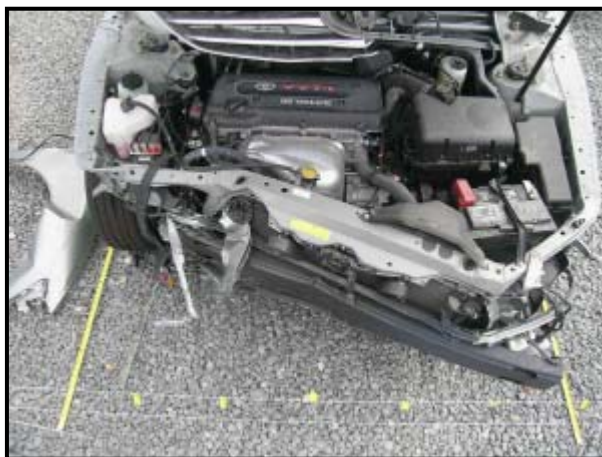
Figures 4 and 5 are front views of the subject Toyota Camry. The Toyota sustained a combined width of direct and induced damage that extended across the vehicle's entire 147 cm (58 in) frontal end width. The direct contact damage of the bumper reinforcement measured 62 cm (28 in) in width. The direct contact began 13 cm (5 in) right of the vehicle's centerline and extended to the right corner of the front bumper. The front bumper fascia separated in the crash and was not with the vehicle. The hood buckled at the fold points. The length of the longitudinal direct contact damage to the surface of the hood measured 18 cm (7 in) at the hood's front right aspect. The maximum crush was located at the right front bumper corner (C6). The residual crush measured at the bumper elevation was as follows: C1 = 0, C2 = 9 cm (3.5 in), C3 = 20 cm (7.9 in), C4 = 30 cm (11.8 in), C5 = 36 cm (14.2 in), C6 = 39 cm (15.3 in). The right wheelbase was reduced 3 cm (1 in). The left wheelbase was unchanged. All the doors remained closed during the crash and were operational at the time of the SCI inspection. The windshield was not fractured and there was no damage to the side window glazings. The Collision Deformation Classification was 12-FZEW2.

Figure 4: Front view of the Toyota Camry.

Figure 5: Overhead view of the Camry depicting the extent of crush.

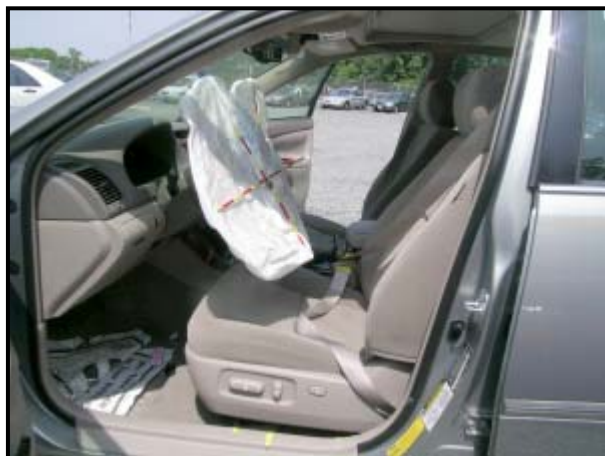
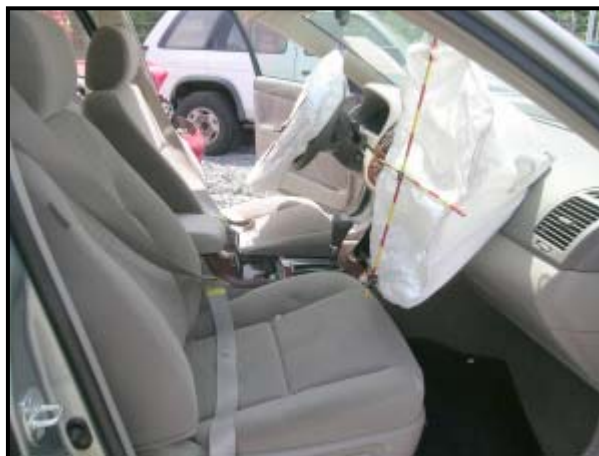
The interior damage to the Toyota was limited to the deployment of the vehicle's safety systems. There was no intrusion or interior damage related to the exterior force of the crash. There was no residual evidence of occupant contact to the hard structures of the interior. **Figures 6 and 7** are the left and right interior views of the vehicle, respectively.

Figure 6: Left interior view.

Figure 7: Right interior view.

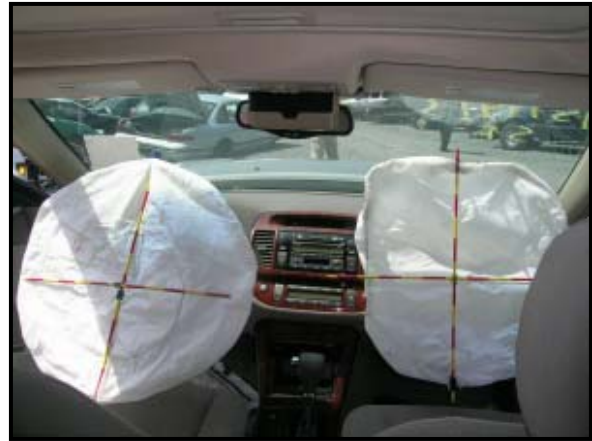
The Certified Advanced 208-Compliant (CAC) frontal air bag consisted of advanced dual stage air bags for the driver and front right passenger, front safety belt buckle switches, front safety belt buckle pretensioners and a front right occupant detection sensor. The frontal air bag system was certified by the manufacturer to have met the requirements of the advanced FMVSS No. 208. The system was controlled and monitored by an Air bag Control Module located under the center console. Additionally, two crash sensors, symmetrically located on forward frame rails, were used to aid in crash detection and assess crash severity. **Figure 8** is an overall view depicting the deployed frontal air bags.

Figure 8: View of the deployed frontal air bags.

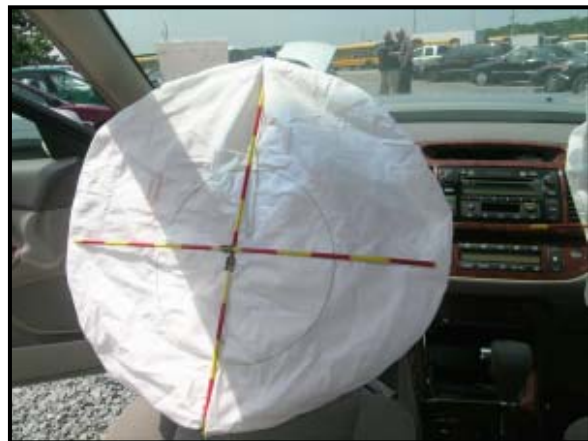
Figure 9 is a view of the deployed driver air bag. The driver air bag deployed from an H-configuration module located in the center hub of the steering wheel rim. The symmetrical upper and lower flaps measured 10 cm x 13 cm (4 in x 5 in), height by width, respectively. The flaps opened at the designed tear seams during the deployment sequence and were free from occupant contact. The deployed driver air bag measured 64 cm (25 in) in diameter. The bag was tethered by two 10 cm (4 in) wide straps in the 3/9 o'clock sectors and was vented by two 2 cm (0.8 in) diameter ports located in the 11/1 o'clock sectors. An 8 cm (3 in), vertically oriented, red lipstick transfer was identified in the 10 o'clock sector of the air bag. The transfer was located 19 cm (7.3 in) left of the vertical centerline of the air bag and 11 cm (4.5 in) above the bag's horizontal centerline. The orientation and position of the transfer was consistent with a 90 degree clockwise (right) rotation of the steering wheel at the time of the air bag inflation and occupant contact. This steering maneuver was consistent with the reconstruction of the crash dynamics.

Figure 9: Deployed driver air bag.

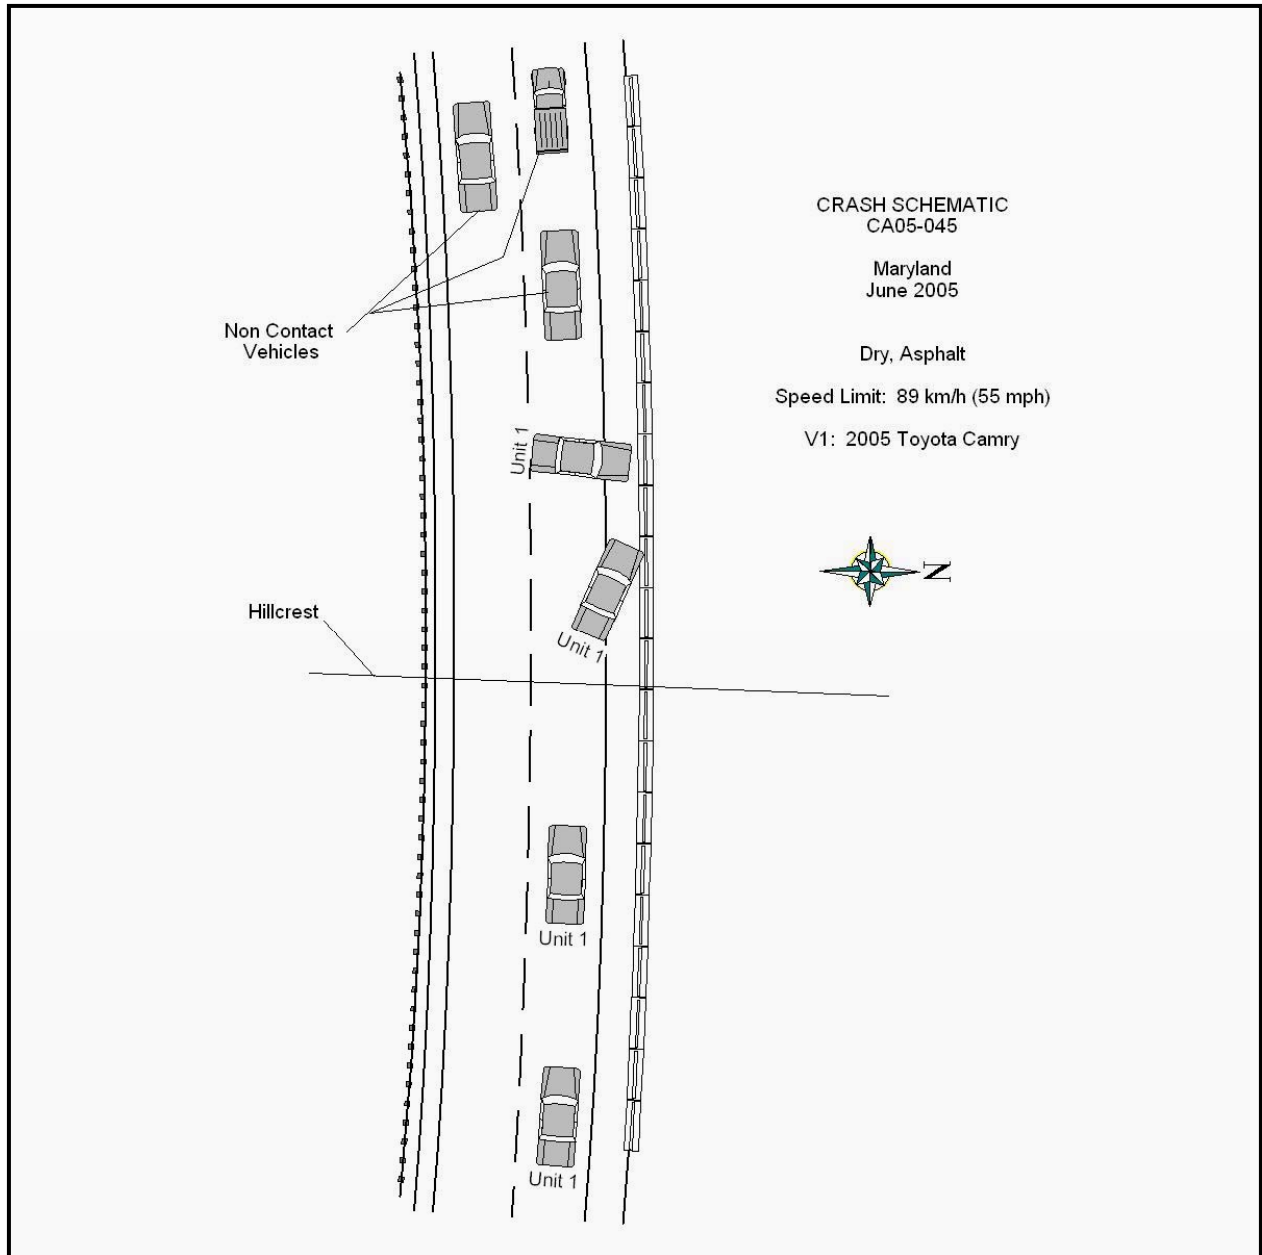
The 2005 Toyota Camry was westbound in the right lane driven by a 49 year old female. She was restrained by the vehicle's three-point lap and shoulder belt. The front right passenger was a 19 year old restrained female. The driver failed to react to the slowing/stopped traffic ahead of her until late in this pre-crash phase. The driver steered suddenly right to avoid a vehicle in her lane and lost directional control of the vehicle. The Toyota traveled through the outboard shoulder and struck the roadside barrier. A schematic of the crash is attached to the end of this report as **Figure 10**.

Figure 10: Crash schematic.
