**CALSPAN ON-SITE CERTIFIED ADVANCED 208-COMPLIANT  
VEHICLE CRASH INVESTIGATION**

**SCI CASE NO: CA05-046**

**VEHICLE: 2005 ISUZU ASCENDER  
LOCATION: FLORIDA  
CRASH DATE: MAY, 2005**

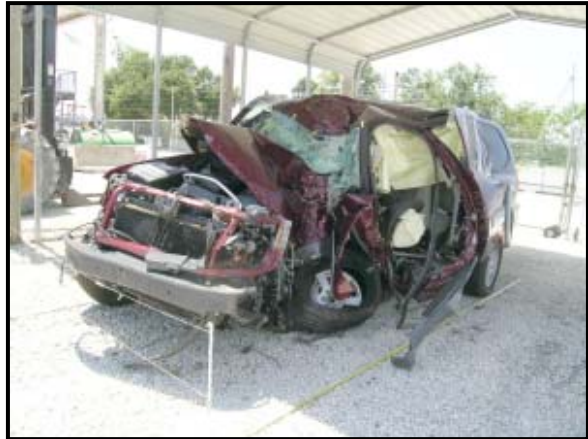
**Figure 1: Left front oblique view of the Isuzu.**

The Isuzu was northbound in the inboard lane of a two-lane divided interstate highway and was driven by a 46 year old restrained female driver. For unknown reasons, the driver lost control of the vehicle and entered a counterclockwise yaw. The police investigation documented approximately 51.8 m (170 ft) of tire marks attributed to the right side tires of the Isuzu prior to its roadside departure. The vehicle departed the left side of the highway, entered the center median, traveled through a brush line and impacted a tree located 16.7 m (55.5 ft) west of the road edge. The force of the crash resulted in the deployment of the vehicle's frontal air bag. The inflatable side curtains also deployed during the crash sequence. The driver sustained blunt trauma to the head and torso and was pronounced deceased at the scene of the crash.

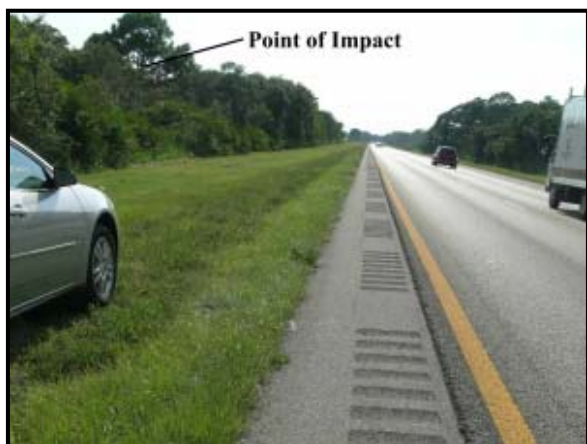
This single vehicle crash occurred during the nighttime hours of May 2005. At the time of the crash, it was dark without artificial lighting and the weather was not a factor. The crash occurred within the center median of a north/south interstate highway in a rural area of the state. At the crash site, the asphalt northbound roadway was straight and level and consisted of two 3.7 m (12 ft) traffic lanes. The lanes were separated by a broken white center line. The west (inboard) edge of the travel lane was bordered by a solid yellow line and a 1.3 (4.3 ft) wide shoulder. Rumble strips were incorporated into the construction of the road shoulder. West of the paved shoulder was a 9.1 m (30 ft) wide area of grass that terminated into a line of small diameter trees

and brush. The grass terrain had an average negative slope of 16 percent over its 7.3 (24 ft) width and then leveled at the brush line. A 38 cm (15 in) diameter coniferous tree was located beyond the brush line in an open area. The tree was located 18.3 m (60 ft) west of the pavement edge and was the point of impact. The tree was scarred from the ground to a height of 213 m (84 in) about 75 percent of its circumference due to the crash. There was a paved median crossover 102 m (335 ft) south of the point of impact that served as the reference point. **Figure 3** is a northbound view of the highway in the area of the road side departure. **Figure 4** is a trajectory view at the point where the Isuzu penetrated the brush line. The posted speed limit in the area of the crash was 113 km/h (70 mph).

**Figure 3: Northward view of the crash site.**

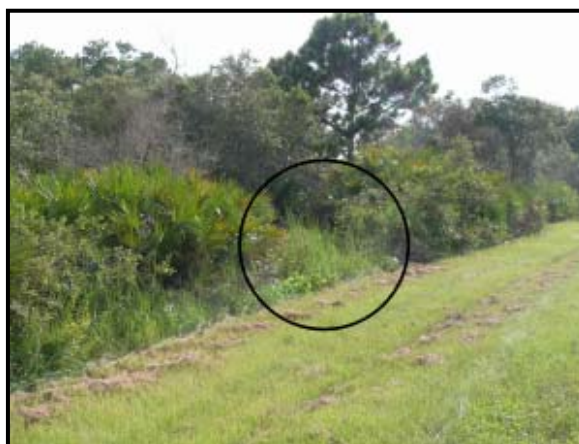
**Figure 4: Trajectory view at the point where the Isuzu entered the brush.**

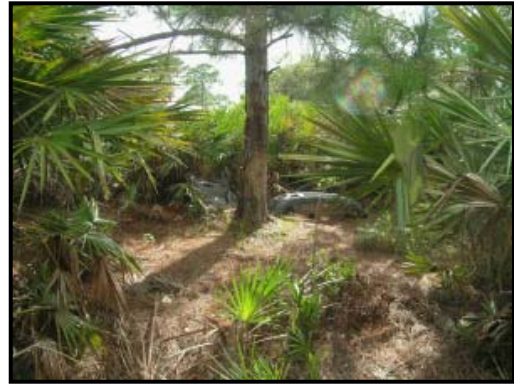
**Figure 5** is a view of the point of impact. The crash occurred with the Isuzu impacting the 38 cm (15 in) diameter tree with its left corner. The initial engagement was located outboard of the vehicle's left frame rail at the extreme left end of the bumper reinforcement bar. The principle direction of the impact force was in the 11 o'clock sector. The force of the impact separated the left front wheel assembly from the lower suspension and drove those components rearward into the lower A-pillar and cowl. The vehicle pitched down and the tree pocketed in the deformation with the direct contact extending onto the roof. The Isuzu remained in contact with the tree and rotated approximately 60 degrees clockwise coming to rest facing northeast.

**Figure 5: View of the point of impact.**

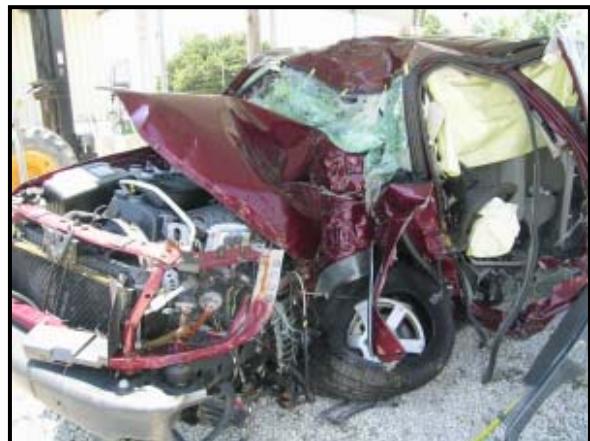
The Isuzu Ascender, **Figure 6**, sustained direct contact damage to the front and left side planes as a result of the crash. The direct contact began at the left corner extending rearward beyond the windshield header and inboard to the approximate centerline of the vehicle. The impact resulted in pocketing damage at the left aspect of the cowl.

The direct contact on the front plane began 55 cm (21.8 in) left of center and extended 34 cm (13.2

**Figure 6: Left oblique view of the damaged Isuzu.**

in) to the left corner. The combined width of the direct and induced damage extended across the vehicle's entire 178 cm (70 in) end width. The bumper fascia separated during the impact and was located at the scene. The residual crush of the front bumper was as follows: C1 = 72 cm (28.3 in), C2 = 31 cm (12.2 in), C3 = 27 cm (10.6 in), C4 = 16 cm (6.3 in), C5 = 11 cm (4.3 in), C6 = 16 cm (6.3 in). The maximum crush was located at the left corner.

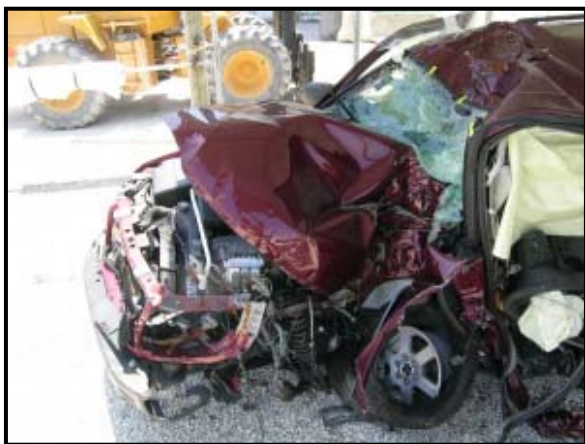
As the vehicle continued forward, the left front fender and left front wheel assembly engaged the tree. **Figure 7** is a left side view of the Isuzu. The left front wheel assembly separated at the lower control arm and the drive shaft and was crushed rearward into the cowl. The rim fractured and the tire was cut. The left frame rail was bowed inboard between the left front suspension and the left B-pillar. The maximum lateral deformation measured approximately 10 cm (4 in). The left aspect of the cowl, immediately forward of the driver's position, was deformed 33 cm (13 in) rearward from direct contact. This area of the vehicle was deformed into a U-pattern that measured 33 cm (13 in) in width. The windshield was in place and totally fractured. There was direct contact between the tree and the windshield header, **Figure 8**. The roof was buckled and exhibited direct contact that extended 99 cm (39 in) rearward of the deformed header. The direct contact damage to the header began 16 cm (6.2 in) inboard of the left corner and extended 60 cm (23.5 in) to the right. The direct contact damage ended 10 cm (4 in) right of center. The maximum crush measured 41 cm (16.1 in) and was located 10 cm (4 in) left of center. The residual crush across the windshield header was as follows: C1 = 72 cm (28.3 in), C2 = 31 cm (12.2 in), C3 = 27 cm (10.6 in), C4 = 16 cm (6.3 in), C5 = 11 cm (4.3 in), C6 = 16 cm (6.3 in). The left wheelbase was reduced 42 cm (16.7 in). The right wheelbase lengthened 4 cm (1.5 in) due to frame distortion. The longitudinal deformation of the left B-pillar measured 6 cm (2.3 in). The left doors were jammed shut due by impact damage. The left front door was removed during the driver's extrication. The left rear door overlapped the C-pillar 5 cm (2 in). The welds along the left lower sill and floor pan separated to the C-pillar due to overload. The right doors remained operational but could not be latched due to body deformation. The Collision Deformation Classification (CDC) of the impact was 11-FLAE9.

**Figure 7: Left side view of the Isuzu.**

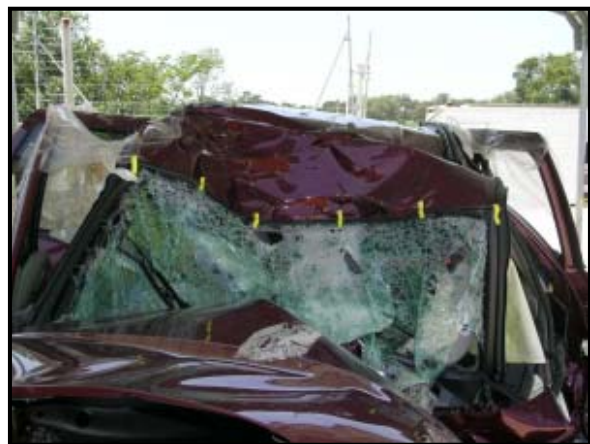
**Figure 8: Front view of the damage header.**

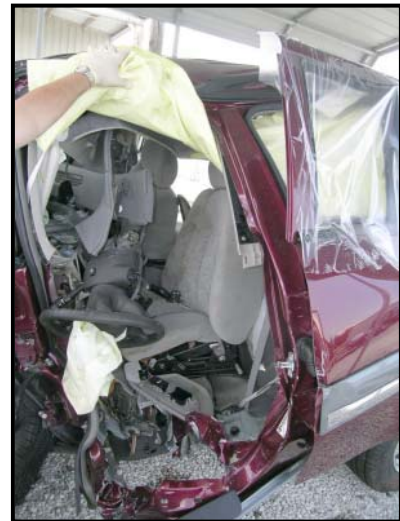
**Figure 9** is a view of the driver's seat. The driver seat was adjusted to a mid-track position 8 cm (3.1 in) forward of full rear. The total seat track travel measured 21 cm (8.3 in). The track position of the driver seat was determined through the use of exemplar measurements. The floor pan forward of the driver seat was buckled. The driver seat was pitched down. The angle of the deformed seat cushion measured zero degrees. The seat back was vertical.

**Figure 9: Left front interior view.**

The steering wheel assembly fractured at the knuckle of the tilt mechanism and the steering wheel was suspended by the electrical harness. The horizontal distance from the seat back to the knuckle at the end of the steering column measured 27 cm (10.5 in). The top sector of the steering wheel rim was deformed forward. The deformation in the 12 o'clock sector measured 3 cm (1 in). There was no separation of the steering column's shear capsules.

The intruded knee bolster was in contact with the driver seat cushion. The left aspect of the bolster exhibited two scuffs from contact with the driver's lower extremities. The most outboard scuff mark measured 5 cm x 5 cm (2 in x 2 in). The scuff mark was located 38 cm (15 in) left of the steering column center line and 13 cm (5 in) below the top edge of the bolster. An 8 cm (3 in) diameter scuff mark was located 30 cm (12 in) left of the steering column center line and 3 in below the top edge of the bolster.

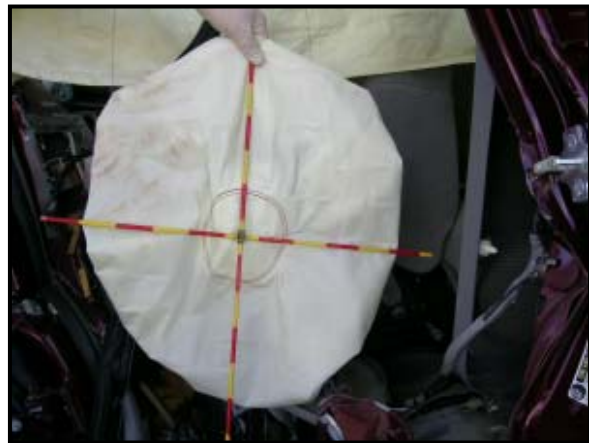
The driver air bag, **Figure 10**, deployed as designed from an I-configuration module mounted in a conventional manner in the center of the steering wheel rim. The symmetrical cover flaps measured 8 cm x 11 cm (3 in x 4.5 in), width by height, respectively. The flaps opened at the designed tear seams during the deployment

**Figure 10: Driver air bag.**

sequence and were not damaged. There was no evidence of occupant contact to the flaps. The deployed driver air bag measured 61 cm (24 in) in diameter. The bag was tethered by two 10 cm (4 in) wide straps in the 3/9 o'clock sectors and was vented by two 3 cm (1.2 in) diameter ports located in the 11/1 o'clock sectors. The 10 o'clock sector of the air bag was soiled from its post-crash exposure to the elements. There was no residual evidence of occupant contact identified on the air bag.
