CALSPAN ON-SITE CHILD SAFETY SEAT INVESTIGATION

SCI CASE NO. – CA05-047

SUBJECT VEHICLE – 2003 FORD F-150 PICK-UP TRUCK

CRASH DATE – JUNE 2005

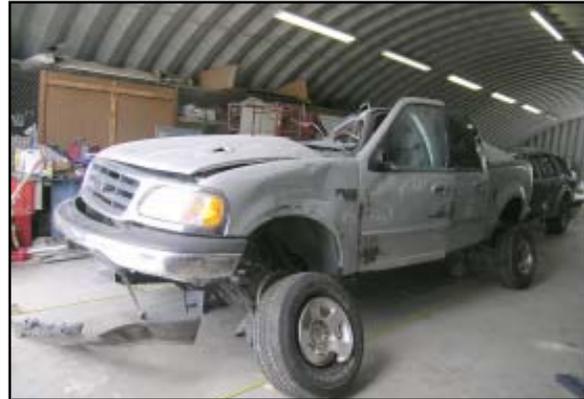
Figure 1: Left front oblique view of the 2003 Ford F-150.

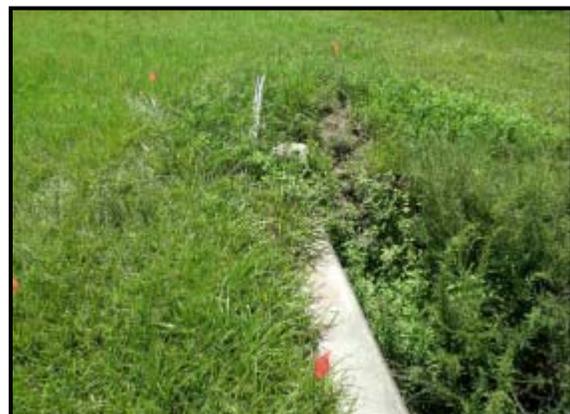
The center right aspect of the Ford's front plane struck and overrode a delineator post located at the end of headwall. The Ford's front right tire drove off the concrete wall and dropped approximately 46 cm (18 in) due to the change in elevation for the ditch. The front right undercarriage contacted the ground evidenced by a 1.2 m x 1 m (3.8 ft x 3 ft) gouge that was located adjacent to the post. Refer to **Figure 4**.

Figure 4: Concrete headwall, delineator post and gouge.

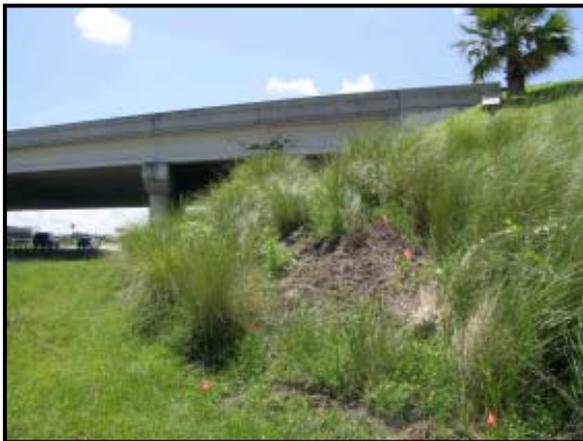
The Ford then traveled approximately 7 meters (23 feet) and encountered the 30 degree embankment. **Figure 5** is a trajectory view of the embankment impact. The front undercarriage

impacted the embankment evidenced by a gouged area that measured 1.9 m x 4.7 m (6.2 ft x 15.3 ft). The force of this impact was sufficient to cause the driver's front seat belt pretensioner to fire and the vehicle's frontal air bags to deploy. Due to its speed, the Ford vaulted and became airborne as it ascended and crested the top of the embankment.

Figure 5: Southbound trajectory view at the embankment

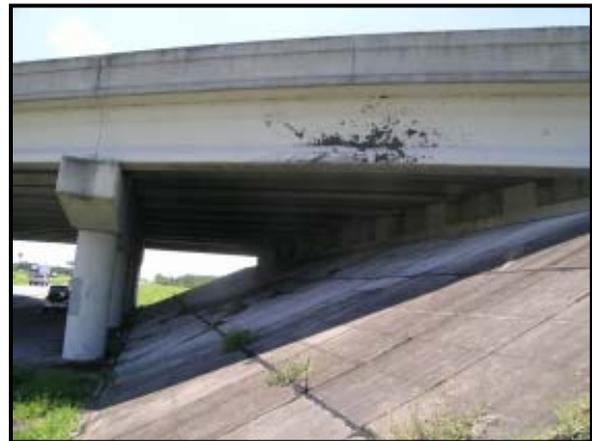
The Ford continued airborne approximately 9 meters (30 feet) and impacted the concrete sidewall of the overpass with the windshield header. **Figure 6** is a view of the overpass impact. Multiple abrasions, black transfer and dirt/debris displaced from the embankment evidenced the impact area. At impact, the Ford had rolled an estimated 20 to 30 degrees left about its longitudinal axis exposing the right aspect of the header. The impact separated the windshield and the front right header section deformed rearward to the B-pillar area. The roof was crushed down. The impact arrested the forward momentum of the vehicle and the unrestrained front right passenger was ejected through the windshield opening. The front right passenger came to rest under the overpass near the vehicle. The Ford continued to roll to the left and landed onto its left side coming to final rest against an overpass support pillar. The restrained driver and the restrained 2 year old female remained in the vehicle.

Figure 6: Overpass impact and final rest.

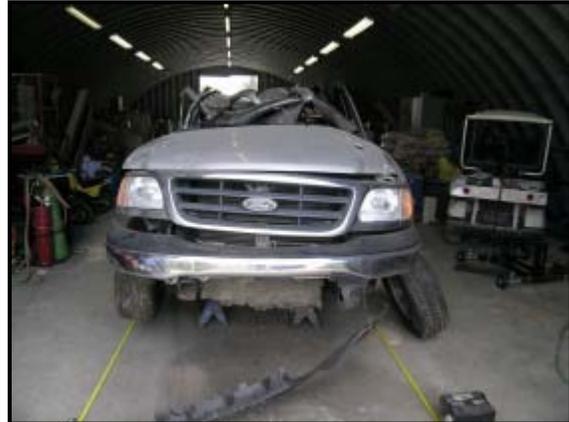
Figure 7 is a front view of the Ford. The vehicle sustained minor frontal damage as a result of the impact with the delineator post. The damage from this impact consisted of a dent to the face of the hood which measured 1 cm (0.5”) in depth and was located 33 cm (13.0”) right of the centerline. Additionally, the center grille was fractured 25 cm (10.0”) right of the centerline. The Collision Deformation Classification (CDC) for this impact was 12-FREN-1.

Figure 7: Front view of the Ford.

The front bumper was displaced upward and the lower fascia was fractured due to the contact with the ground. Examination of the forward undercarriage revealed evidence of a widely distributed ground contact pattern. Grass, dirt and debris was adhered to multiple undercarriage components. The right front fender was displaced rearward and bowed out. This damage resulted from the embankment impact as well. The CDC of the embankment impact was 00-UFDW-1.

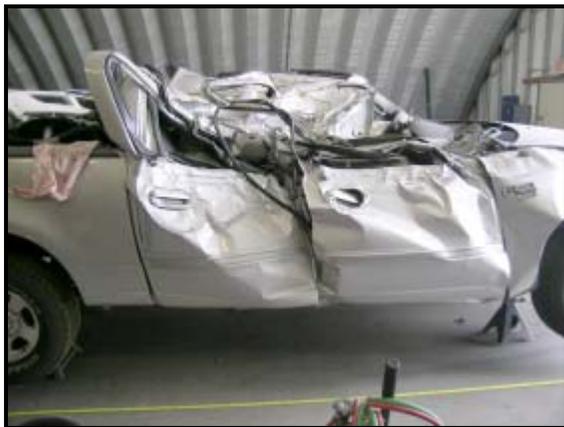
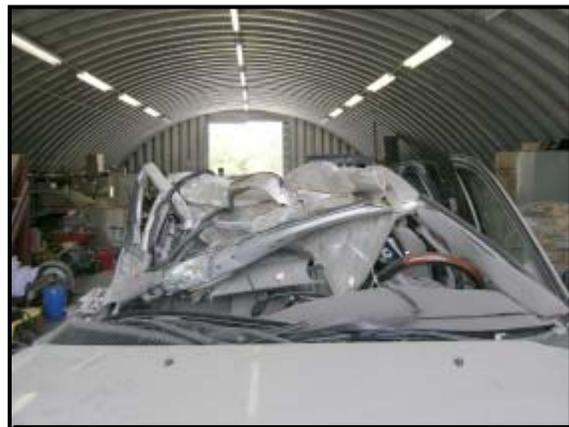
The Ford F-150 sustained severe damage to the front header and roof as a result of the impact with the overpass, **Figures 8 and 9**. The right and center aspects of the roof were crushed down to the level of the beltline. The direct contact damage to the windshield header began 8 cm (3 in) inboard of the left A-pillar and extended 122 cm (48 in) to the right A-pillar. The direct contact along the roof extended rearward to the right C-pillar and wrapped onto the right side doors due to the left roll attitude of the Ford during its engagement with the overpass. The direct contact on the right side doors extended 33 cm (13 in) below the beltline. Both right side doors were deformed rearward and were jammed shut. The CDC for the overpass impact was 12-FDGW8.

Figure 8: Right side view of the occupant compartment.

Figure 9: Front view of the header area.

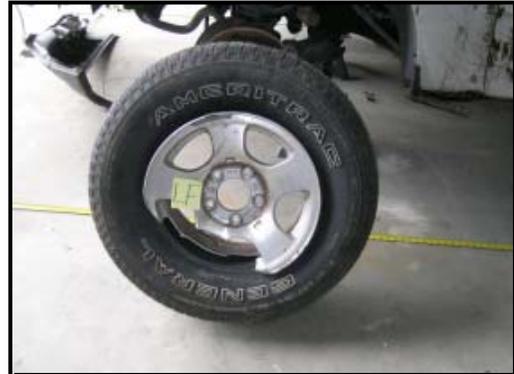
There was no change in either wheelbase dimension. Both left side tires were damaged as the vehicle fell and landed on left tires as it neared final rest. The left rear axle fractured at the wheel hub and the left rear wheel/tire separated. A 22 cm (8.7 in) section of the alloy rim fractured and was missing. The outboard surface of the rim was abraded by contact with the concrete slope at final rest. The left front tire had been removed from the vehicle prior to SCI involvement in this investigation. Examination revealed an impact related fracture of the left front wheel rim, **Figure 10**. The fracture occurred as the vehicle fell to final rest and was not a cause of the loss of control. The rim fracture measured 37 cm (14.7 in) and included one of the wheel spokes. Three additional spokes fractured at the outer circumference; however, they did not separate. There was no damage to the left front suspension components. The steering components, linkages, and pitman arm were intact as well.

Figure 10: Left front wheel/tire.

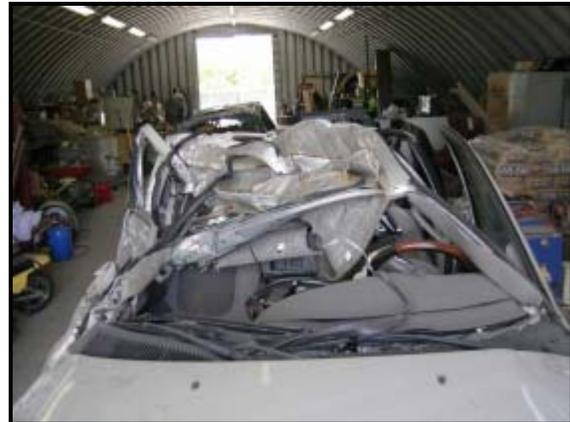
The right A- and B-pillars deformed rearward and were crushed down by the impact with the overpass. **Figure 11** is a front view of the roof deformation. The front right aspect of the roof impacted and compressed the front right seat back. The seat back was compressed an estimated 15 cm (6 in). The front right seat was in an estimated mid-track position. There were no identified contacts to the glove box door.

Figure 11: View of the deformed roof.

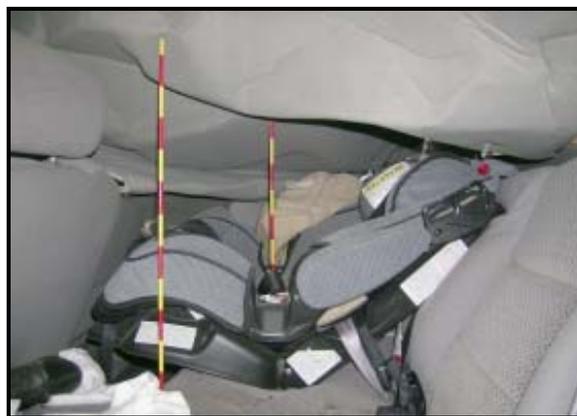
Figure 12: Left interior view of the CSS.

At the time of the inspection, the CSS was restrained by both the vehicle’s center rear lap belt and the LATCH belt. The rear seat cushion was compressed by the CSS and the lap belt and LATCH belt were tight. The side to side movement of the CSS was less than 3 cm (1 in). The top tether was not used. Due to pending civil litigation regarding this crash, the CSS was not removed from the vehicle for inspection. There was no apparent damage to the CSS shell or its components. The harness straps were adjusted to the top slots. The right strap was cut by the rescue personnel. The chest clip was in place and the buckle was operational.

Referring to Figure 12 above, the vertical distances depicted are measured to the deformed headliner. The deformed headliner was not backed up by the metal roof in this area. There was an air gap of approximately 23 cm (9 in) between the headliner and the deformed roof along the centerline of the vehicle (above the CSS).

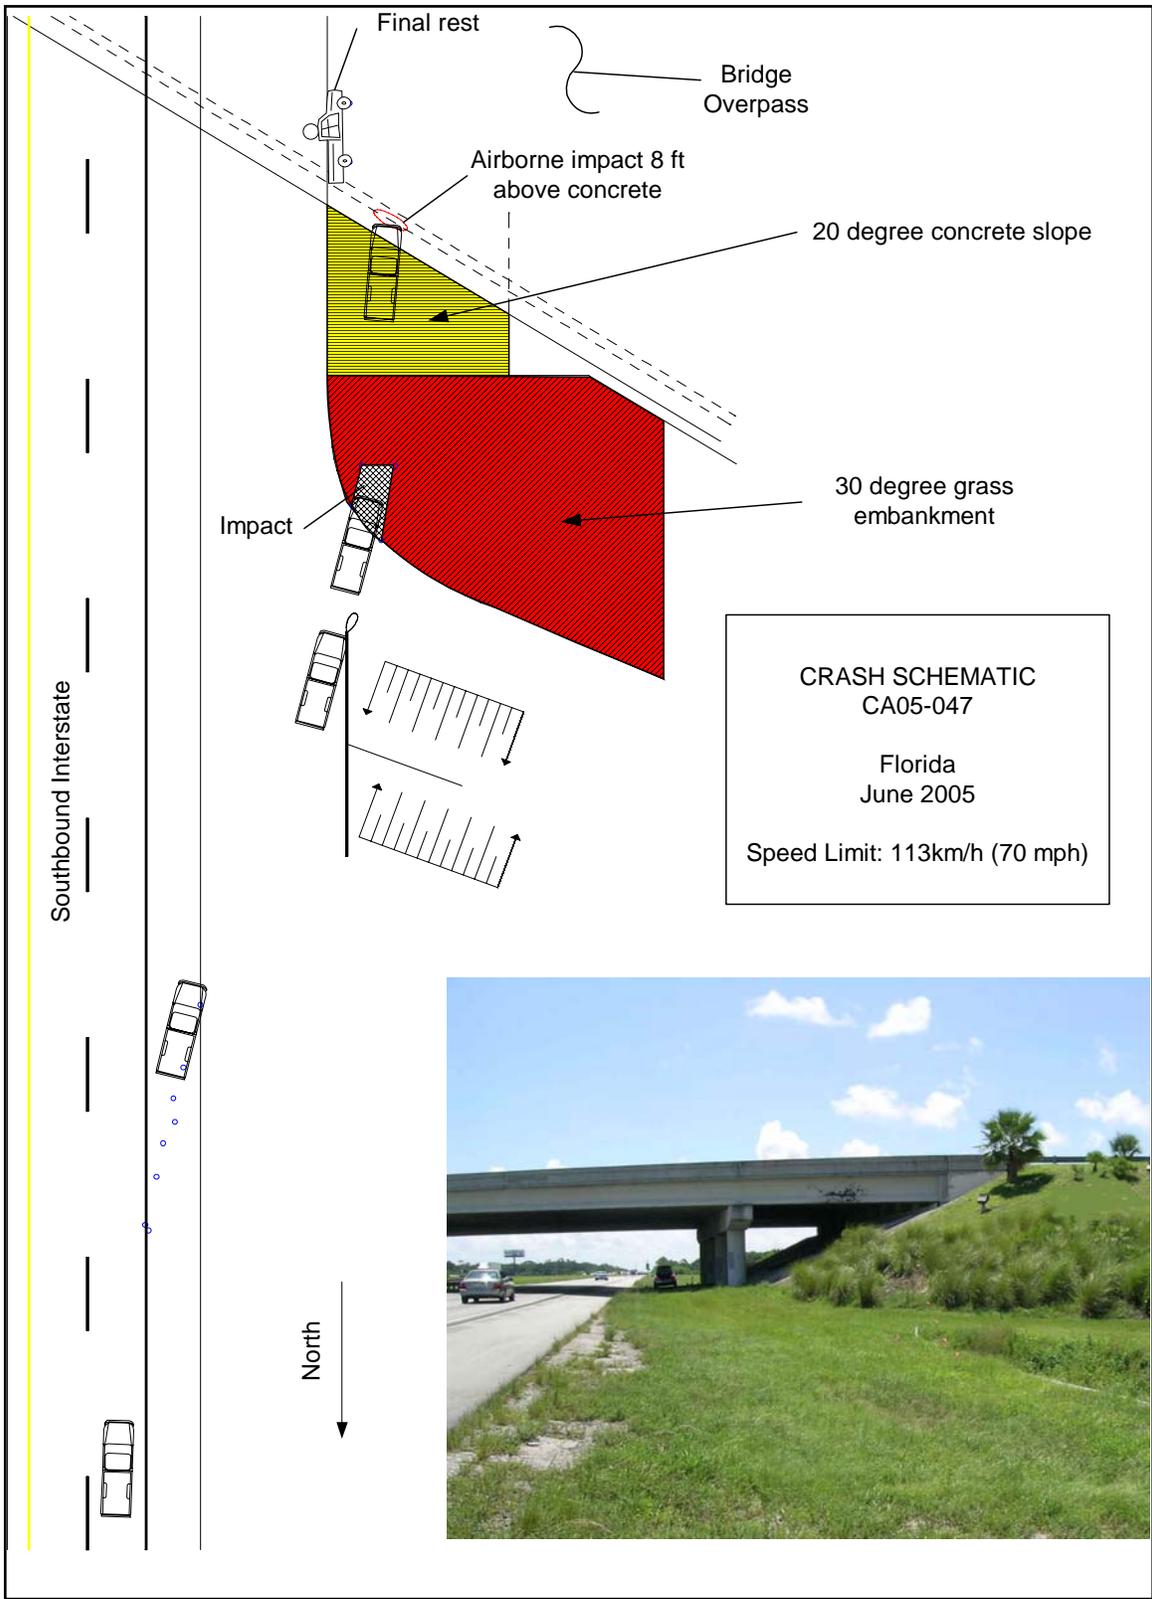
Figure 13: Crash Schematic

A schematic of the crash sequence is included at the end of this report, **Figure 13**. The restrained 28 year old male driver was operating the 2003 Ford F-150 southbound on the outboard (right) lane of the interstate at an estimated speed of 113 km/h (70 mph). For unknown reasons, the driver of the Ford relinquished directional control and allowed the vehicle to depart the right roadside. The police report indicated that the vehicle experienced an air out of the front left tire which caused the driver to lose control of the vehicle. However, a pre-crash left front tire failure was not supported by the physical evidence observed during the vehicle inspection. The damage to the left front wheel occurred as the Ford came to final rest and is discussed in further detail in the *Exterior Damage* section of this report.
