**CALSPAN ON-SITE SIDE IMPACT INFLATABLE OCCUPANT PROTECTION
INVESTIGATION**

CASE NO.: CA05-050

VEHICLE: 2004 INFINITI QX56

DATE OF CRASH: AUGUST 2005

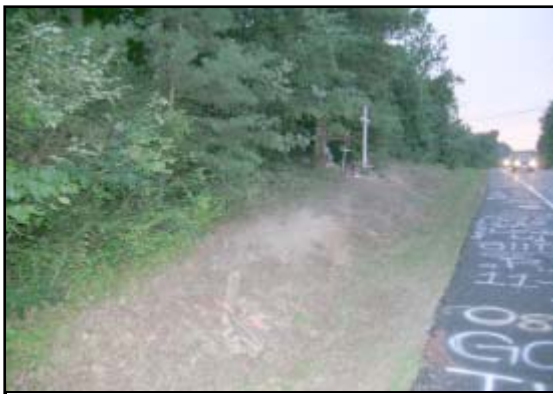
The vehicle traveled down the shallow ditch with the left front wheel, which resulted in the Infiniti to pitch down and to the left. The EDR recorded an 11-degree roll angle with a total roll rate of 130 degrees per second to the left, which triggered the deployment of the left and right canopy air bags. The center front of the Infiniti struck a wood signpost, which yielded to the impact and did not alter the vehicle's trajectory (**Figure 4**). This impact was minor and produced minimal longitudinal deceleration to the vehicle.

Figure 4. Ditch contact and first impact with the wood signpost.

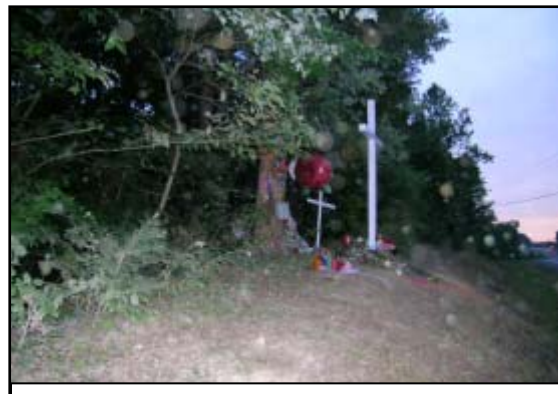
Figure 5. Tree impact at the top of the embankment.

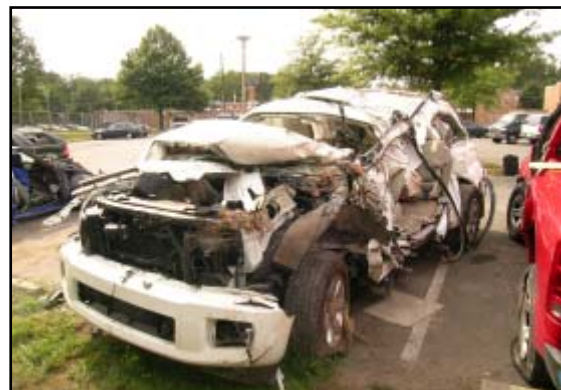
Figure 6. Overall view of the frontal and left side damage.

The Infiniti sustained moderate severity frontal damage and severe left side damage as a result of the corner impact with the tree (**Figure 6**). The damaged frontal components included the bumper fascia and beam, hood, and the left headlight assembly. The direct contact damage measured approximately 36 cm (14.0") and was located left of the vehicle centerline and extended to the front left bumper corner. The frontal damage was captured by measuring six equidistant points along the full frontal width (Field L) of 116 cm (45.5") of the bumper beam. The crush measurements were as follows: C1 = 6 cm (2.5"), C2 = 5 cm (2.0"), C3 = 5 cm (1.8"), C4 = 4 cm (1.7"), C5 = 4 cm (1.5"), C6 = 4 cm (1.6"). The CDC for the tree impact was 12-FLAE-9.

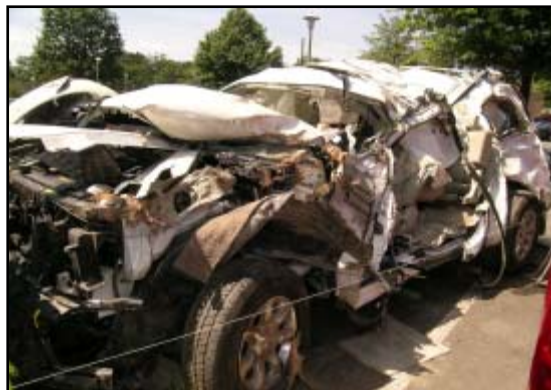
Figure 7. Overall view of the left side damage.

The left side components that were damaged in the crash included the left front fender, A-pillar, roof rail, doors, sill, and the quarter panel (**Figure 7**). Additionally, a reduction in the left side wheelbase of 8 cm (3.0") was noted. The left side crush was documented vertically and laterally along the full length of the roof side rail, which measured 196 cm (77.0") in length. The residual lateral crush was measured at six locations along the left roof side rail and were as follows: C1 = 18 cm (6.9"), C2 = 22 cm (8.5"), C3 = 38 cm (15.1"), C4 = 20 cm (7.7"), C5 = 6 cm (2.4"), C6 = 25 cm (9.8").

The vertical crush along the left roof side rail was as follows: C1 = 56 cm (22.0"), C2 = 57 cm (22.3"), C3 = 22 cm (8.8"), C4 = 31 cm (12.5"), C5 = 24 cm (9.3"), C6 = 27 cm (10.8").

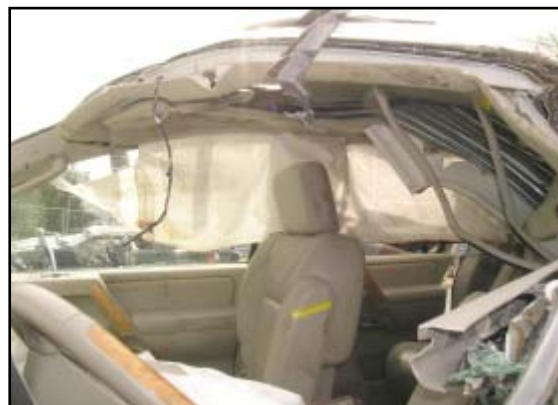
Figure 8. Deployed right side curtain air bag.

separate canopy air bag membrane for the third row. The first and second row canopy air bags deployed from the left roof side rail. The air bag membrane measured 166 cm (65.5") in length and was tethered at the A- and C-pillars. The height of the canopy air bag membrane was 43 cm (17.0") at the first row and 46 cm (18.0") at the second row. The third row canopy air bag deployed from the roof side rail. The membrane for this air bag measured 60 cm (23.5") in height and 66 cm (26.0") in length. No occupant contact points were present on the canopy air bags; however, dirt and body fluid were noted on the membrane.

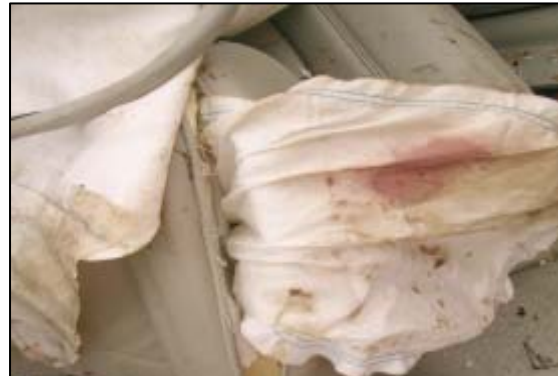
The 2004 Infiniti QX56 was equipped with seatback mounted side impact air bags for the front seating positions. As a result of the left side engagement with the tree, the left side impact air bag deployed (**Figure 9**). The air bag deployed through a 38 cm (15.0") tear seam in the seatback. The air bag membrane was of a semi-circular shape and measured 33 cm (13.0") in height and 36 cm (14.0") in width. The air bag was free of occupant contact points or damage. A large area of body fluid was noted to the upper aspect of the inboard panel of the air bag membrane. In addition, the air bag membrane contained several areas of dirt from exposure to the weather and outdoor elements.

Figure 9. Deployed left side seatback mounted side impact air bag.

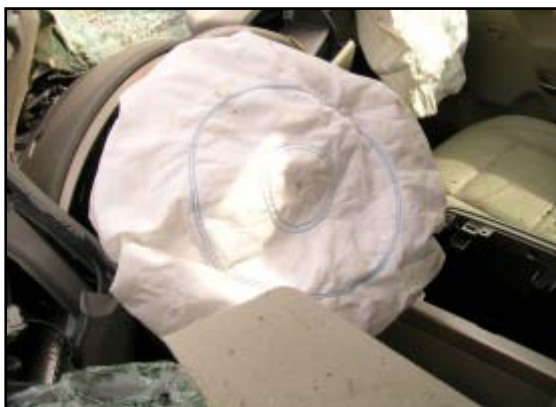
The 2004 Infiniti QX56 was equipped with a Certified Advanced 208-Compliant frontal air bag system for the driver and front right passenger. Due to the frontal crash forces, the frontal air bag system deployed. The driver's air bag was conventionally located within the steering wheel hub. Three cover flaps concealed the air bag membrane. The top cover flap measured 8 cm (3.0") in height and 16 cm (6.3") in width. Two symmetrical cover flaps were utilized on the bottom, which measured 6 cm (2.5") in height and 6 cm (2.5") in width. The air bag membrane was 43 cm (17.0") in diameter and contained two circular stitch patterns in the center for tethers. The outer stitch pattern was 23 cm (9.0") in diameter and the inner measured 9 cm (3.5") in diameter. Due to the intruding steering column, the driver loaded through the deployed air bag and deformed the steering wheel rim.

Figure 10. Deployed driver's frontal air bag.

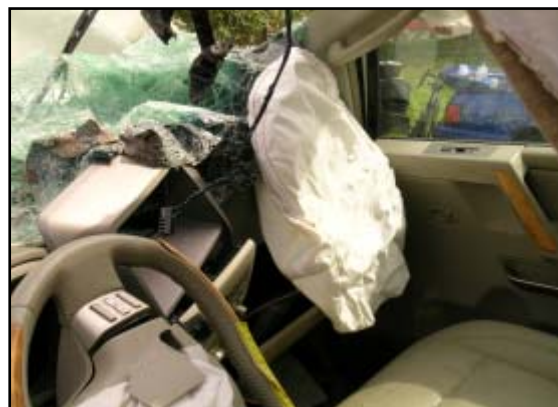
Figure 11. Deployed front right air bag.

The front right air bag was a top-mount design in the right instrument panel and was concealed by a single cover flap. The air bag membrane was 46 cm (18.0”) in height and 37 cm (14.5”) in width. No damage or contact evidence was present on the air bag membrane; however, dirt was present on the air bag.
