**CALSPAN ON-SITE CHILD SAFETY SEAT CRASH INVESTIGATION  
GRACO SNUG RIDE CHILD SAFETY SEAT  
SCI CASE NO: CA05-051**

**VEHICLE: 1998 MAZDA 626  
LOCATION: MARYLAND  
CRASH DATE: JUNE, 2005**

**CALSPAN ON-SITE CHILD SAFETY SEAT/CHILD FATALITY INVESTIGATION  
GRACO SNUG RIDE REAR FACING CHILD SAFETY SEAT**

**SCI CASE NO: CA05-51  
VEHICLE: 1998 MAZDA 626  
LOCATION: MARYLAND  
CRASH DATE: JUNE, 2005**

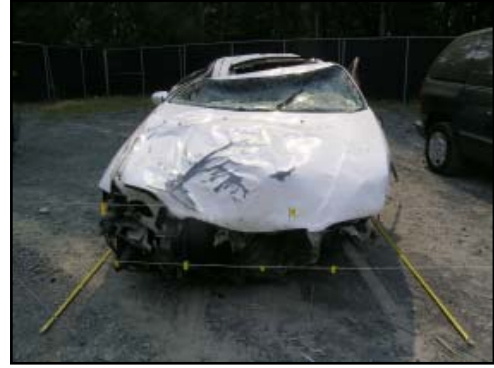
**Figures 4 through 6** are the front, left rear oblique and right side views of the Mazda 626. The vehicle's exterior damage was consistent with a frontal impact, left side impact and a two-quarter turn rollover event. The direct contact damage to the front plane extended across the full 147 cm

(58 in) end width. The impact caused the front bumper reinforcement bar and fascia to separate from the vehicle. Debris from the ground impact was observed throughout the forward undercarriage. The frontal crush was measured to the exposed front mounts and along the lower radiator support. The left bumper mount was crushed rearward 27 cm (10.7) and deformed inboard an estimated 13 cm (5 in). The crush of the right bumper mount measured 6 cm (2.2 in). The maximum crush of the lower radiator was located at its left corner and measured 14 cm (5.5 in). The Collision Deformation Classification (CDC) of the impact was 10-FDEW2.

**Figure 4: Front view of the Mazda.**

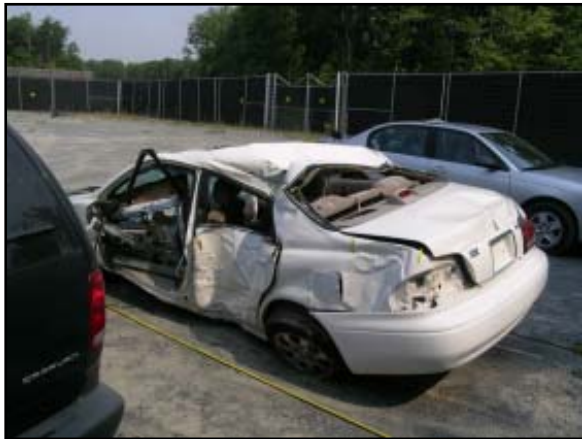
The left rear door and quarterpanel of the Mazda contacted several trees during the rollover sequence. The direct contact to the left rear door measured 51 cm (20 in). The direct damage began 89 cm (35 in) forward of the left rear axle and extended rearward. The maximum lateral crush measured 16 cm (6.2 in) at the belt line. The left rear quarterpanel exhibited direct contact damage over a 38 cm (15 in) region. The direct contact began 41 cm (16 in) aft of the left rear axle and extended to the rear corner of the left side. The maximum lateral crush was an estimated 5 cm (2 in). The CDC was 09-LZAW3.

**Figure 5: Left rear oblique view.**

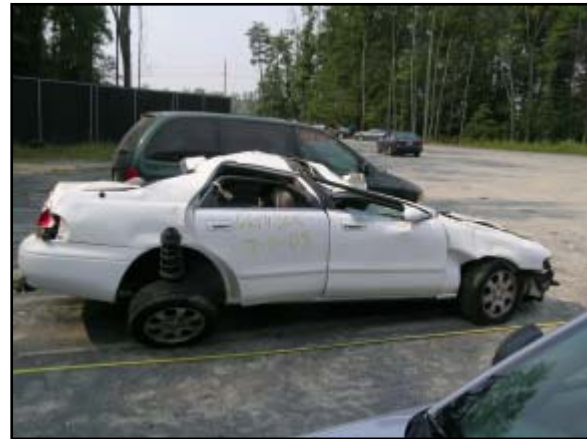
**Figure 6: Right side view.**

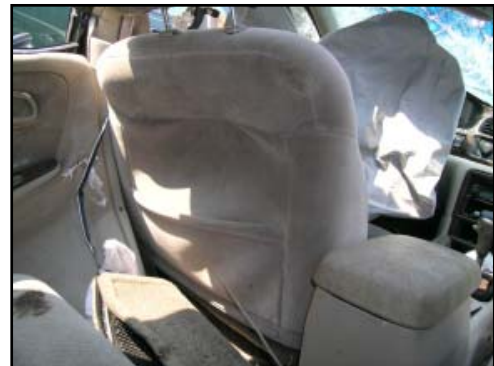
The driver seat was adjusted to a mid-track position that measured 11 cm (4.5 in) forward of full rear. The total seat track travel measured 23 cm (9 in). The seat back angle measured 18 degrees aft of vertical. The back side of the seat back was deformed 5 cm (2 in) forward by contact from the child safety seat. This deformation was located 13 cm (5 in) below the top of the seat (**Figure 7**). The horizontal distance from the rear bench seat back to the driver’s seat back measured 89 cm (35 in). The tilt steering wheel was adjusted to a center position. There was no steering wheel deformation or shear capsule displacement. There was no identified contact to the knee bolster.

**Figure 7: View of the deformed driver seat back.**

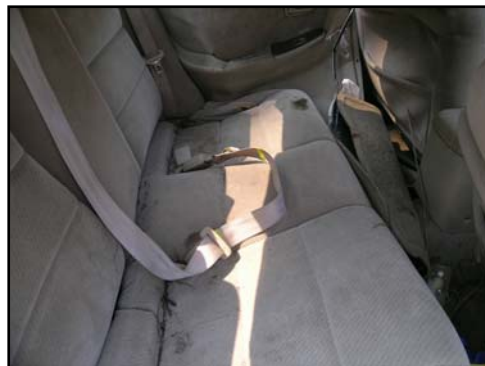
The rear center restraint was a detachable three-point belt system utilizing a sliding latch plate and a switchable ELR/ALR retractor. The rear center safety belt was used to install the rear-facing child safety seat, **Figure 8**. Its use was supported by evidence that consisted of loading/creasing of the belt system. This evidence began 16 cm (6.2 in) above the end of the webbing at the detachable buckle and extended to 48 cm (18.7 in) above

**Figure 8: View of the rear center**

the buckle. Additional loading evidence/creasing was located from 102 cm (40.2 in) to 115 cm (45.2 in) above the detachable end of the webbing. The location of the loading evidence related to the position of the webbing over the top of the CSS shell in the rear-facing orientation. The CSS base was not in use at the time of the crash. A label was present on the webbing that indicated the webbing was to be fully extended and the retractor switched to the locking mode when this safety belt was used to restrain a CSS. The CSS was removed from the vehicle by the responding police, thus the status ELR/ALR retractor at the time of the crash was not known.

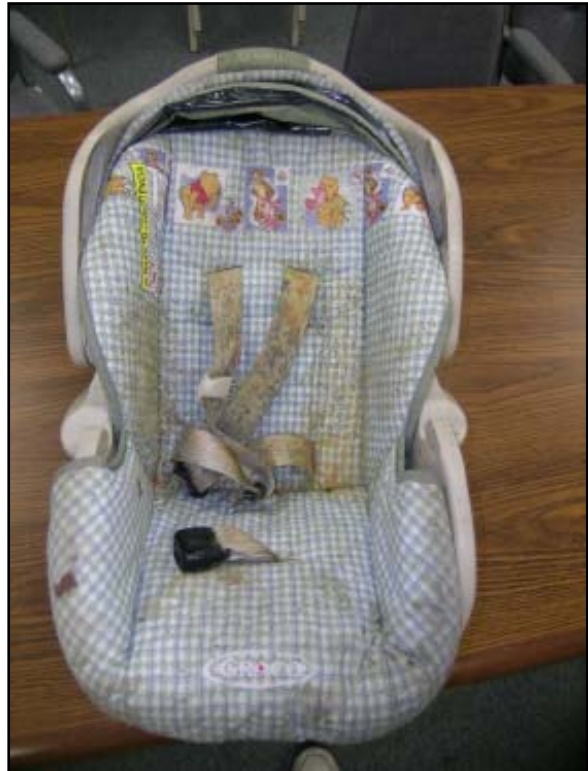
**Figure 9** is a front view of the Child Safety Seat (CSS) in use at the time of the crash. The CSS was held in police evidence and inspected at the barracks station. The seat could not be released and returned to the vehicle. The seat was heavily soiled and had molded from storage.

**Figure 9: Front view of the CSS.**

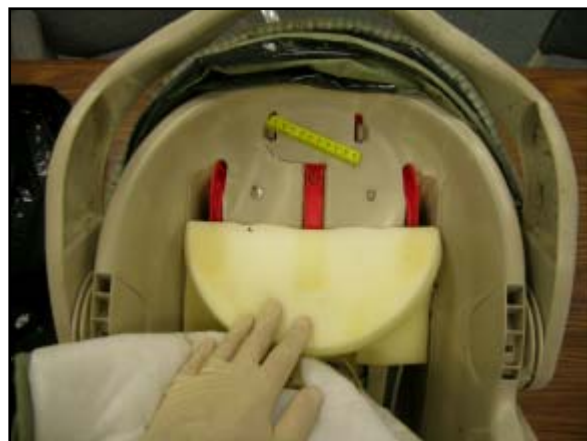
Stress marks were present on the pivoting carrying handle. The stress marks were symmetrical and were located 28 cm (11 in) from the mid-point of the handle in both directions. The upper aspect of the shell was stressed and fractured, **Figure 10**. The fracture measured 5 cm (2 in) and extended from a mold point into the center cut-out for the shell/base release handle. A second fracture measuring 18 cm (7 in) extended

**Figure 10: View of the stressed and fractured upper shell.**

The seat back loading resulted in an overload fracture of the child safety seat shell. Additionally, it was probable that the male passenger sustained his fatal injuries as a result of that loading given the close proximity of the head to the seat back contact. The lack of blood evidence within the child seat and vehicle interior was indicative of a probable closed head injury.

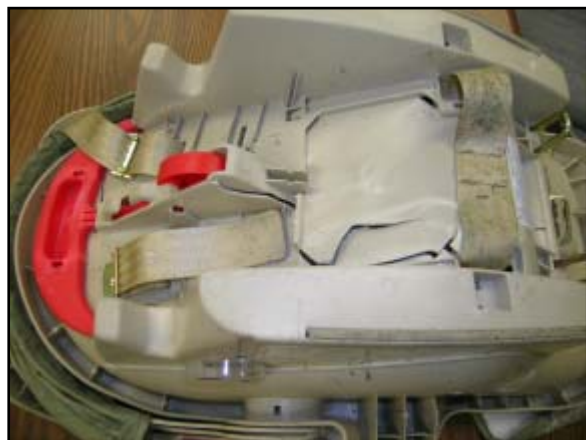
from the bottom aspect of the center cut-out to the lower left harness strap slot. Refer to **Figure 11**. The right side of the shell exhibited stress marks at the belt path, **Figure 12**.

**Figure 11:** View of the fractured shell.

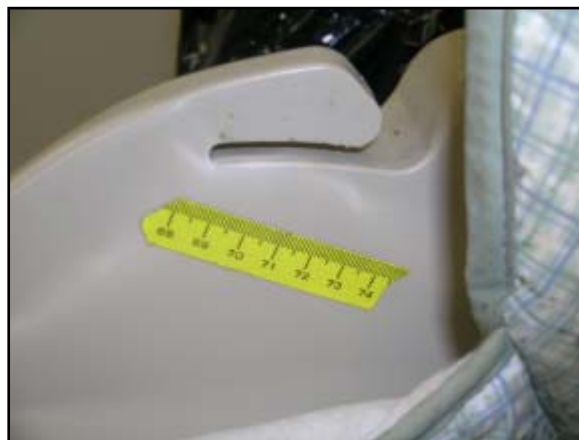
**Figure 12:** View of the stressed right belt path.
