**CALSPAN ON-SITE CERTIFIED ADVANCED-208 COMPLIANT VEHICLE
CRASH INVESTIGATION**

SCI CASE NO. – CA05-052

SUBJECT VEHICLE – 2005 GMC SIERRA

CRASH DATE – JULY 2005

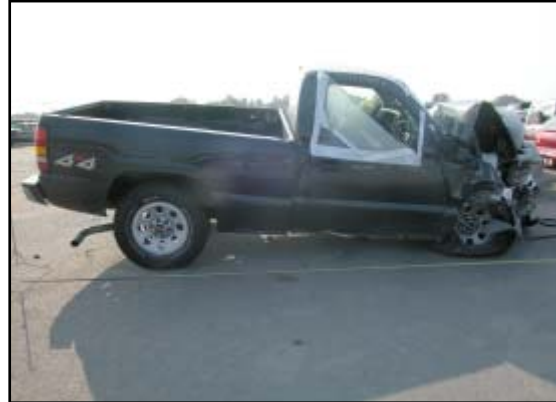
Figure 1. Subject vehicle 2005 GMC Sierra.

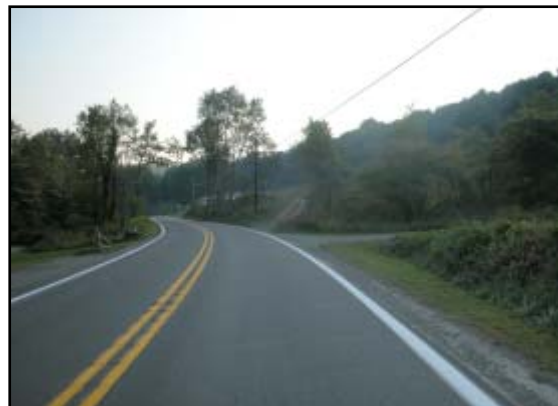
The unrestrained 19-year-old male driver of the 2005 GMC Sierra was operating the vehicle northbound (**Figure 2**) on the two-lane roadway negotiating the left curve. The EDR Non-Deployment event was determined to be the first event recorded based on the recording time. The EDR Non-Deployment data indicated that the vehicle speed was 93 km/h (58 mph) five-seconds prior to

Figure 2. Pre-crash travel direction for the GMC.

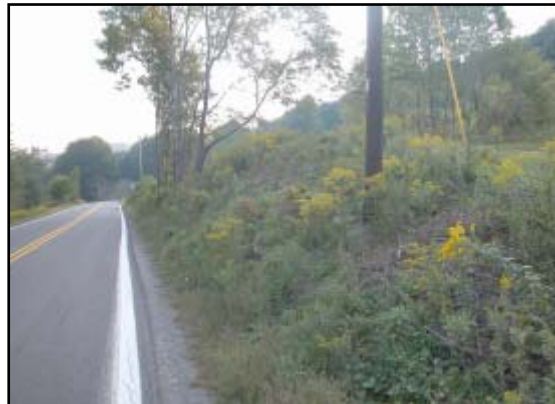
The right side at the area of the right front door of the GMC struck and overrode a tree stump on the embankment (**Figure 3**). The tree stump was located 3.4 meters (11.1 feet) from the road edge and ranged from 25-80 cm (9.8-31.5”) in diameter. The GMC sustained minor damage from this impact. The WINSMASH damage algorithm was used to calculate a delta-V for this impact. The total delta-V was 10 km/h (6.2 mph). The longitudinal and lateral components were -10 km/h (-6.2 mph) and 0 km/h, respectively. This impact resulted in the Non-Deployment recording of the EDR. The EDR maximum-recorded delta-V for this impact was -3 km/h (-1.94 mph), at 222.5 millisecond from AE.

Figure 3. Area of impact with the tree stump.

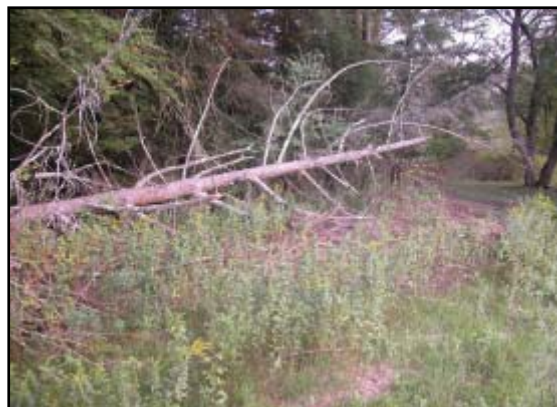
Figure 4. Impact with the hemlock tree branches.

The GMC struck several branches of a hemlock tree approximately 53.0 meters (173.9 feet) from the fawn impacts (**Figure 4**). This impact sequence was minor and did not alter the vehicle's trajectory or result in deceleration.

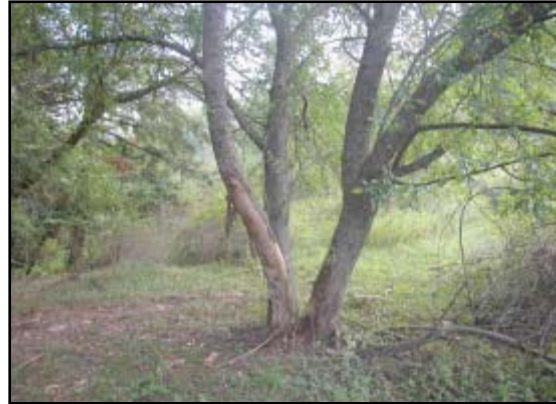
Figure 5. Point of impact with the 20 cm (7.9") diameter tree.

The GMC continued an additional 8.5 meters (27.9 feet) north where the front right aspect of the vehicle struck a 20 cm (7.9") diameter apple tree (**Figure 5**). This impact was the highest severity and resulted in the deployment of the driver's frontal impact. The EDR (Deployment file) recorded delta-V for this impact was -46.9 km/h (-29.18 mph) at 210 milliseconds from AE. The WINSMASH damage algorithm was used to calculate a delta-V for this impact. The total calculated delta-V was 39 km/h (24.2 mph) with longitudinal and lateral components of -39 km/h (-24.2 mph) and 0 km/h.

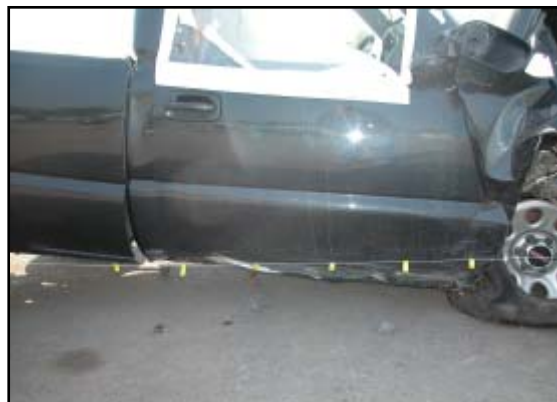
The 2005 GMC Sierra sustained minor damage from the right side impact with the tree stump (**Figure 6**). The direct contact damage began 110 cm (48.5") forward of the rear axle and extended to 122 cm (48.0") forward. The total direct damage length was 122 cm (48.0"). The maximum crush was 20 cm (6.3") and was located on the sill 159 cm (62.7") forward of the right rear axle. Although the impact produced vertical and lateral deformation, a lateral crush profile was documented to represent the damage to this location. The crush profile consisted of six equidistant points along the sill of the GMC and were as follows: C1 = 3 cm (1.2"), C2 = 7 cm (2.8"), C3 = 16 cm (6.3"), C4 = 20 cm (7.8"), C5 = 20 cm (7.8"),

Figure 6. Right side damage from the tree stump impact.

C6 = 11 cm (4.3"). The Collision Deformation Classification (CDC) for this impact was 12-RPEW-2.

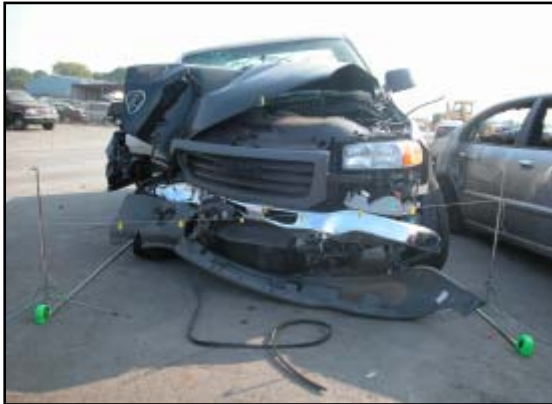
The GMC sustained moderate severity frontal damage from the impact with the apple tree (**Figures 7 and 8**). The maximum crush measured 77 cm (30.3") and was located at the front right corner of the metal bumper. The direct contact damage measured 53 cm (20.9") and began 47 cm (18.5") right of the vehicle's centerline and extended to the front right corner. A crush profile was documented of the residual damage along the front bumper using a combined direct and induced damage width of 142 cm (56.0") and was as follows: C1 = 0 cm, C2 = 0 cm, C3 = 5 cm (1.9"), C4 = 32 cm (12.6"), C5 = 70 cm (27.5"), C6 = 77 cm (30.3"). The CDC for this impact was 12-FREW-3.

Figure 7. Overall view of the frontal damage.

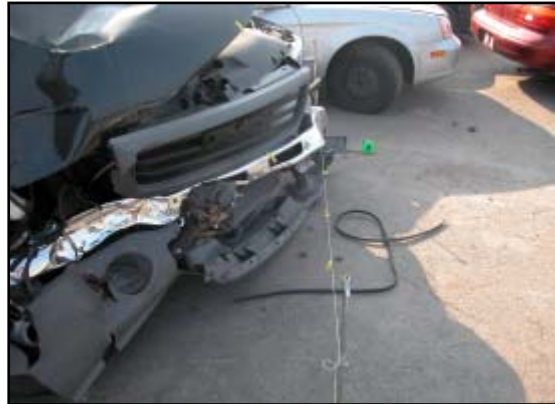
Figure 8. Lateral view of the frontal crush.

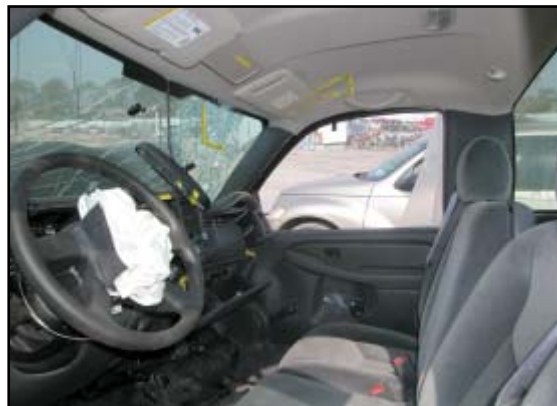
The 2005 GMC Sierra sustained moderate interior damage as a result of occupant contacts and passenger compartment intrusion. **Figure 9** is an overall view of the occupant contact points. The driver contact points consisted of his right foot deforming the gas pedal to the left. The driver loaded through the deploying air bag and compressed the steering wheel flange resulting in approximately 1 cm (0.3") of compression. This compression did not

Figure 9. Overall view of the occupant contact points.

translate further as the shear capsules were in the original mounted positions.

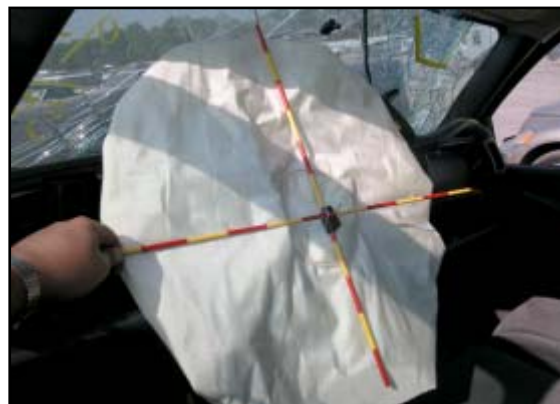
The driver's air bag was located in the center of the steering wheel hub (**Figure 10**). Two symmetrical I-configuration cover flaps concealed the air bag. Both cover flaps measured 11 cm (4.5") in height at the center tear seam and 8 cm (3.3") in width. The air bag membrane was 58 cm (23.0") in diameter in its deflated state and was vented by two vent ports that were located on the rear aspect

Figure 10. Driver's frontal air bag.

of the air bag at the 11 and 1 o'clock positions. Two wide band tethers at the 9 and 3 o'clock positions tethered the driver's air bag. Although the driver loaded through the deploying air bag, there were no occupant contact points present on the air bag membrane. Dirt transfers were present on the rear panel from post-crash handling.

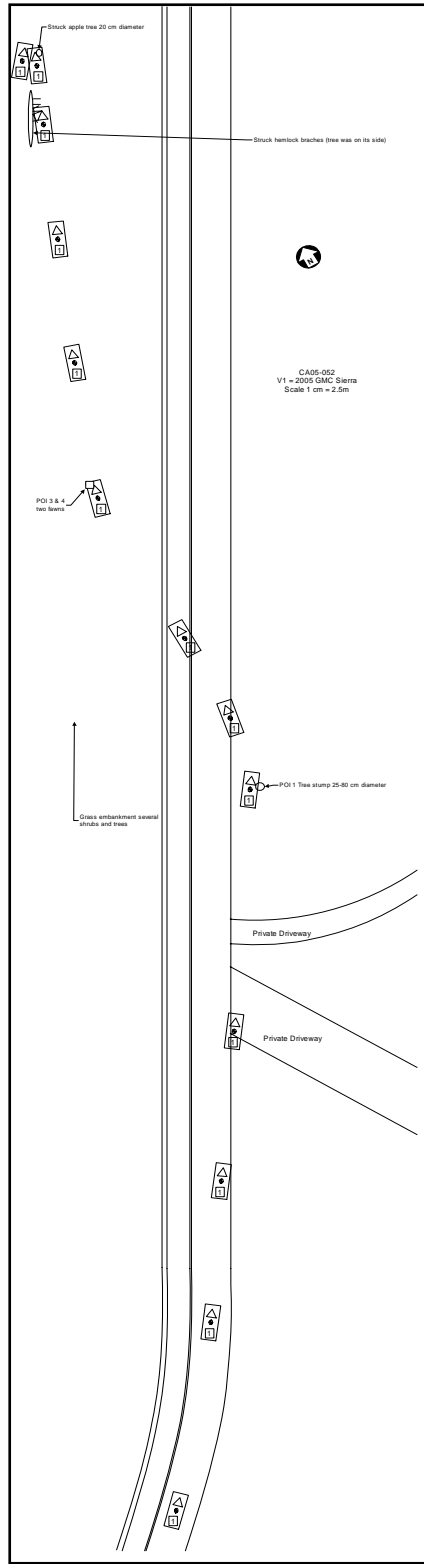
Figure 11. Scene schematic

This run-off-road crash occurred during the early morning hours of July 2005. At the time of the crash, the weather was clear and the asphalt road surface was dry. The crash occurred off the east and west roadsides of a north/south roadway. The roadway was configured with one through lane in each direction. The northbound lane curved to the left prior to the crash site, which terminated at the on-set of the first road departure location. The east roadside consisted of a grass embankment, tree stump, and utility poles. The west roadside consisted of a grass embankment with a decline, a tree line, and several shrubs. The posted speed limit for the roadway was 72 km/h (45 mph). The scene schematic is included as **Figure 11** of this report.
