CALSPAN ON-SITE CHILD SAFETY SEAT CRASH INVESTIGATION

CALSPAN CASE NO: CA05-054

VEHICLE: 2000 SATURN SL2

CRASH DATE: AUGUST 2005

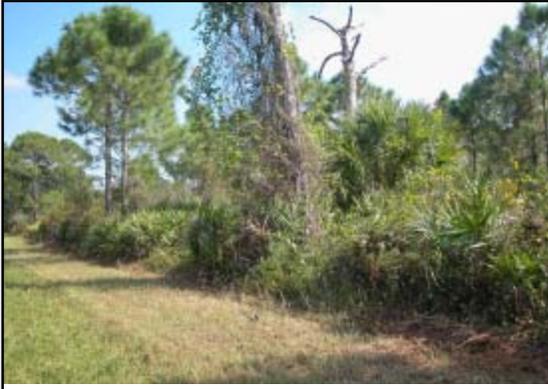
The CW rotation resulted in the left side tires rolling under the alloy wheels and thereby exposing the alloy rim bead. The alloy rims engaged the ground, which tripped the Saturn, resulting in a left-side-leading rollover (**Figure 4**).

Figure 4 -Area of rollover.

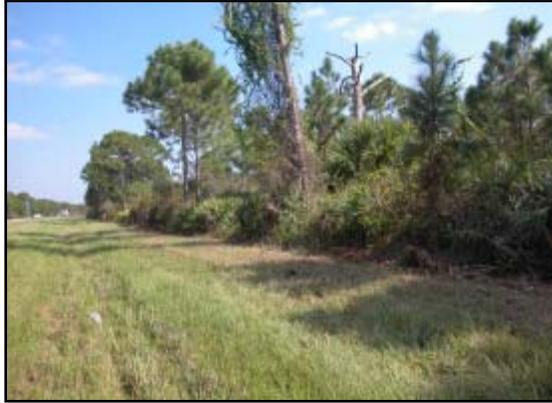
The Saturn continued on its left side approximately 5 meters (16 feet) and impacted a tree with the rear roof area (**Figure 5**). The vehicle came to rest on its left against the tree facing in a northerly direction. Due to the non-horizontal impact forces, the WinSMASH program was not used to calculate a delta-V for this impact. The EDR recorded maximum longitudinal delta-V was 0 km/h. The impact sequence did not result in the deployment of the frontal air bag system.

Figure 5. Area of roof impact with tree and

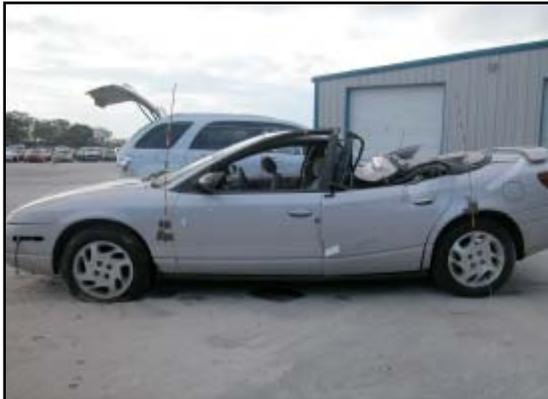
The Saturn sustained minor damage to the left side door from the rollover event. The damage consisted of a scuffmark and a fracture of the composite door panel. A crush profile was not documented for this damage. The Collision Deformation Classification (CDC) for this impact was 00-LDAO-2.

Figure 6. Left roof side rail crush profile.

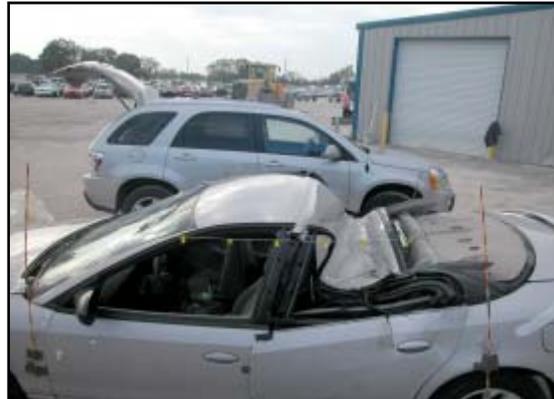
Figure 7. Overhead view of the crush to the roof area,

The 2000 Saturn SL2 sustained severe damage to the rear roof area as a result of the impact with the tree. Two crush profiles were documented at the left and right roof side rails. The direct contact damage measured 40 cm (15.7") across the left roof side rail and began 58 cm (22.8") rear of the A-pillar (**Figures 6 and 7**). The maximum crush measured 37 cm (14.6") and was located 37 cm (14.6") rear of the left A-pillar. Six equidistant crush measurements were documented at this level and were as follows: C1 = 23 cm (9.1"), C2 = 37 cm (14.6"), C3 = 26 cm (10.2"), C4 = 6 cm (2.4"), C5 = 4 cm (1.6"), C6 = 0 cm.

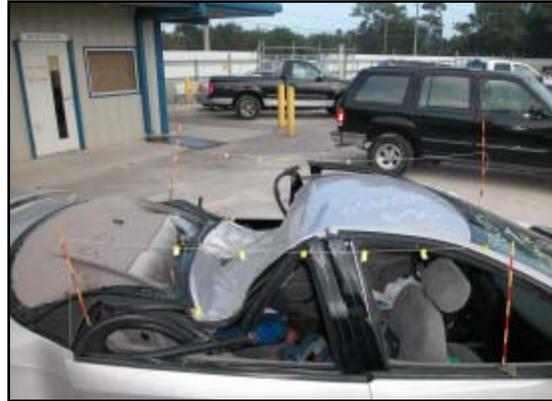
Figure 8. Right roof side rail crush.

The direct contact damage on the right roof side rail measured 15 cm (5.9) and began 77 cm (30.3") rear of the right A-pillar (**Figure 8**). The maximum crush was 31 cm (12.2") and was located at the right C-pillar. The crush profile for the right roof side rail was as follows: C1 = 21 cm (8.3"), C2 = 17 cm (6.7"), C3 = 0 cm, C4 = 0 cm, C5 = 0 cm, C6 = 0 cm. The CDC for this impact was 00-TPDN-5.

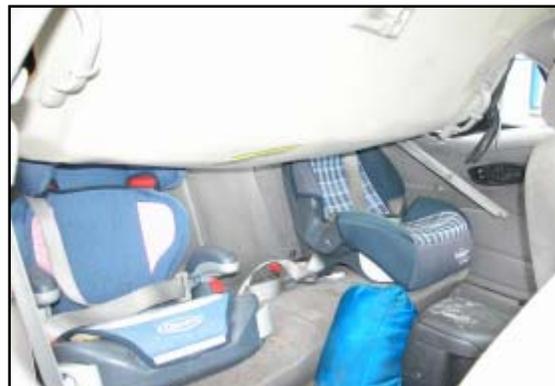
Figure 9. Child safety seats in the post-crash location.

indicative of being in the used position. The roof intrusion locked the retractors in the pre-crash location. Also noted the left rear latch plate was bent; however, it could not be determined how this occurred.

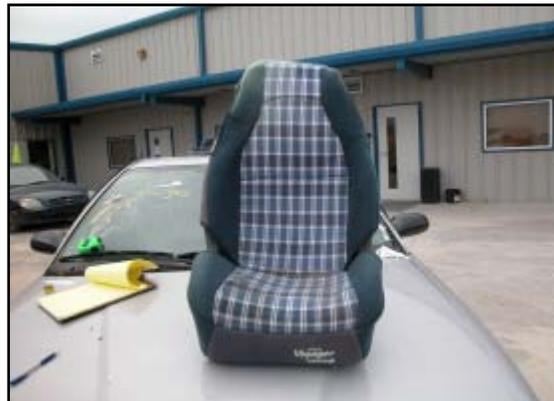
Figure 10. Belt positioning booster seat the used by the 8-year-old male.

Body fluid was found on the cloth seat cushion of the CSS. Minor stress marks were identified on the CSS that resulted from compression by the intruding roof. The marks were located on the top aspect of the seatback at the junction of the reinforcements. Additional stress marks were noted to the left and right side shoulder belt guides. No fractures of the plastic frame were present on the shell.

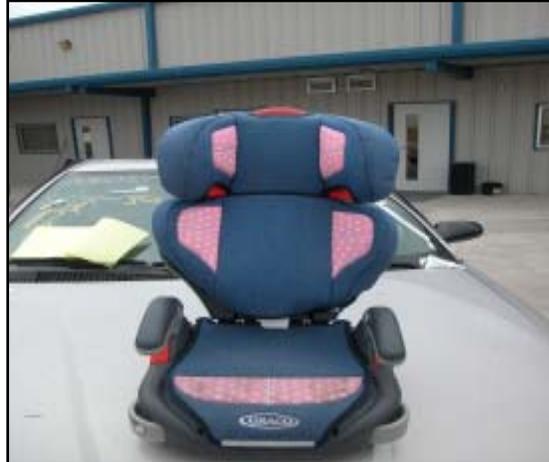
The driver stated to the SCI investigator that the 6-year-old female passenger would restrain herself with the vehicle’s lap and shoulder belt. The inspection of the CSS revealed no damage or loading evidence.

Figure 11. Belt positioning booster seat the used by the 6-year-old female.
