CALSPAN ON-SITE CHILD SAFETY SEAT CRASH INVESTIGATION
SCI CASE NO: CA05-064

VEHICLE: 2000 DODGE CARAVAN
LOCATION: NEW YORK
CRASH DATE: DECEMBER, 2005

| <p>15. <i>Supplementary Note</i> An investigation of a side impact crash involving a 2000 Dodge Caravan.</p> | | | |

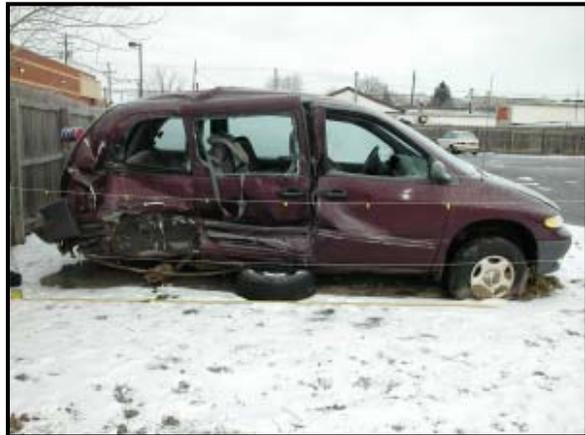
Figure 5 is an overall right side view of the Dodge Caravan. **Figure 6** is a close-up right side view of the direct damage. The right side plane of the vehicle sustained 186 cm (73.2 in) of direct contact damage that began at the right B-pillar and extended rearward to a point 44 cm (17.3 in) aft of the right rear axle. The combined width of the direct and induced damage measured 324 cm (127.5 in). The induced damage began at the right A-pillar location 43 cm (17.0 in) aft of the right front axle. The elevation of the direct contact was centered 61 cm (24 in) above the ground (consistent with the front bumper of the Ford).

Figure 5: Right side view of the Dodge.

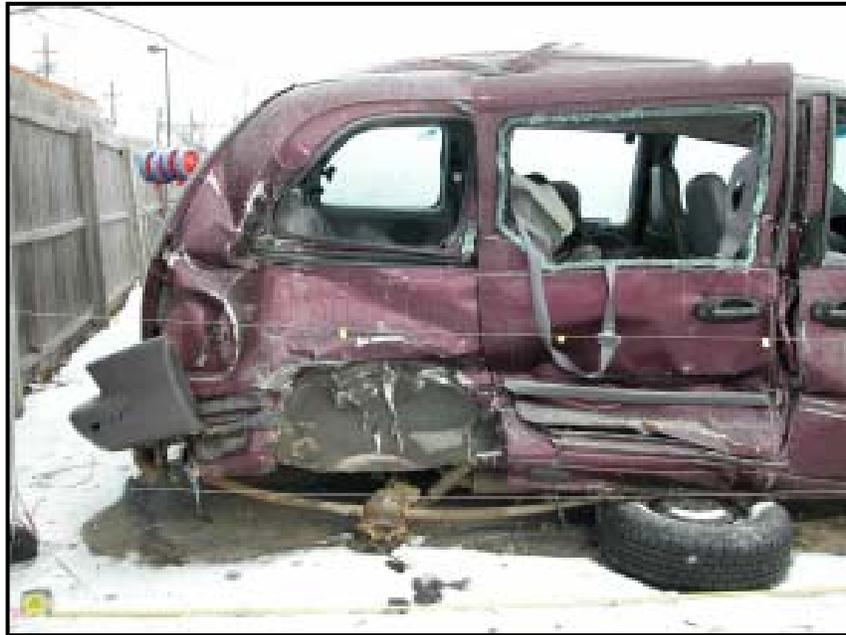
The crush profile measured at the mid door elevation was at follows: C1 = 4 cm (1.6 in), C2 = 39 cm (15.4 in), C3 = 53 cm (20.9in), C4 = 44 cm (17.3 in), C5 = 15 cm (5.9 in), C6 = 1 cm (0.4 in). The maximum crush measured 55 cm (21.6 in) at was located at the left C-pillar location. The force of the impact separated the right rear wheel and tire at the axle housing. The right side doors and rear tailgate were jammed shut. The backlight and all the right side window glazings disintegrated. The left doors were operational. There was no change in either wheelbase dimension. The Collision Deformation Classification (CDC) of the impact was 03-RZAW-3.

Figure 6: Close-up view of the direct damage.

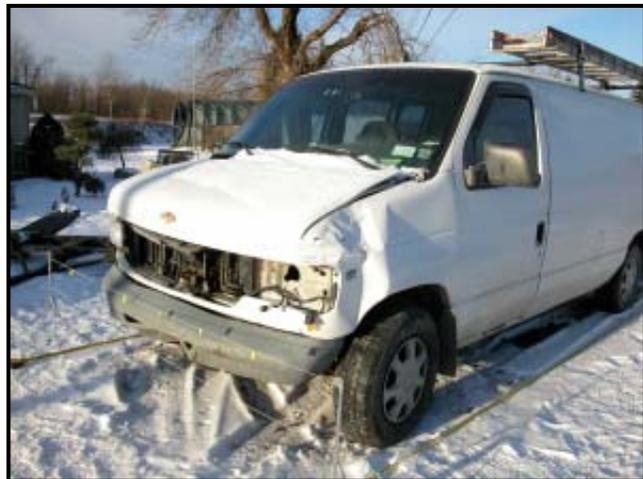
Figure 7 is a front left oblique view of the Ford. The direct contact damage to the Ford extended across the entire 175 cm (69 in) frontal end width of the vehicle. The damage was managed primarily by the vehicle's structures forward of the radiator support plane. The damaged components included: the front bumper, head lamp assemblies, center grill hood and both the left and right front fenders. The frontal structure was swayed to the right approximately 5 cm (2 in) due to lateral momentum of the Dodge. The residual crush profile measured along the front bumper was as follows: C1 = 13 cm (5.1 in), C2 = 3 cm (1.2 in), C3 = 3 cm (1.2 in), C4 = 0, C5 = 5 cm (2.0 in), C6 = 10 cm (3.9 in). There was no change in the respective wheelbase dimensions. All doors remained closed during the crash sequence and were operational post-crash. The windshield was not fractured and all the side glazing was intact. The CDC of the Ford was 12-FDEW1.

Figure 7: Oblique view of the Ford.

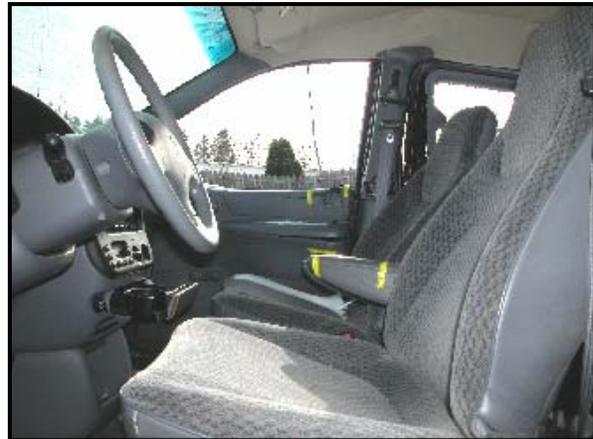
Figure 8 is a left lateral view across the front row of the Dodge. The front row of the Caravan consisted of two bucket seats with integral head restraints. The driver seat was adjusted to a rear track position that measured 6 cm (2.5 in) forward of full rear. The total seat track travel measured 23 cm (9 in). The seat back angle measured 15 degrees aft of vertical and was measured 36 cm (14 in) above the seat bight. The horizontal distance from the seat back to the center of the steering wheel rim measured 61 cm (24 in). The redesigned driver air bag located in the center of the steering wheel rim was not commanded to deploy. The tilt steering wheel was adjusted to the center position. There was no steering wheel rim deformation and there was no steering column shear capsule displacement. The driver's knee bolster did not exhibit any contact evidence.

Figure 8: Left lateral view across Row 1.

The arm rest attached to the inboard aspect of the driver seat was deflected to the right 8 cm (3 in) by contact with the driver's abdomen. The retractable cup holder located in the center console immediately below the radio was deformed to the right and could not be closed. The damage to the drink tray was attributed to contact with the driver's right knee.

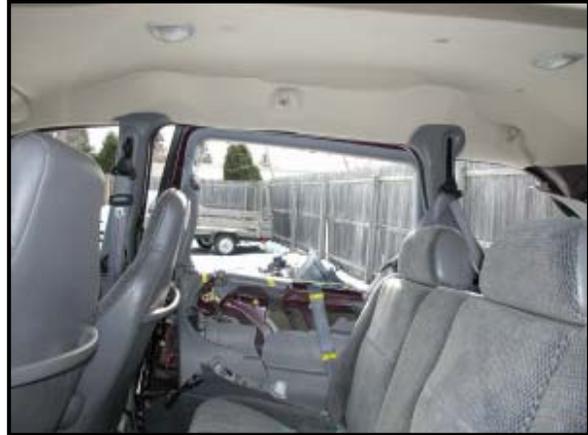
The vehicle's second row consisted of a two passenger bench seat with a folding back and adjustable head restraints, **Figure 9**. The head restraints were in the full down position. The seat back angle measured 15 degrees. The horizontal distance from the seat back of Row 2 to the seat back of Row 1 measured 67 cm (26.5 in). The interior panel of the sliding right rear door was fractured. A 17 cm (6.5 in) long region of blood transfer was noted to the top forward aspect of the right door panel at the door lock. This blood transfer was the only noted contact within the second row. There was no contact to the front seat backs.

Figure 9: Lateral view of Row 2.

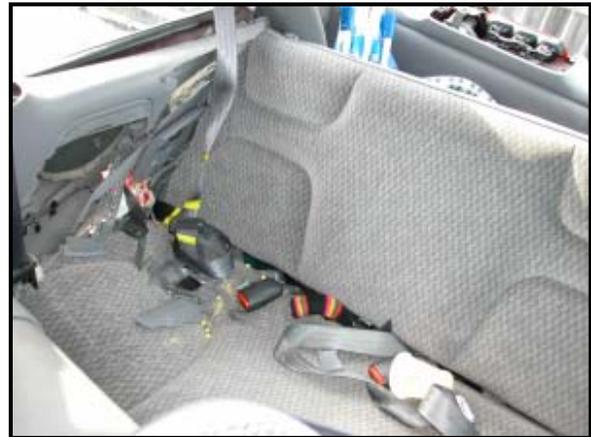
The third row of the Dodge consisted of a three passenger fixed bench seat. **Figure 10** is a view looking rearward into the seat. The seat back angle measured 28 degrees. The horizontal distance from the seat back of Row 3 to the seat back of Row 2 measured 70 cm (27.5 in). Note the right side intrusion and seat deformation. The interior side panel was deformed and fractured. The right aspect of the seat was deformed and compressed inboard 5 cm (2 in) at the seat bight. This compression resulted in the inboard movement of the safety belt anchor that in-turn introduced slack in the belt system. The slack safety belt and the centrifugal force of the post-impact resulted in the ejection of the child passenger through the right rear window opening. There were no occupant contacts identified in the third row seating area.

Figure 10: View of the Row 3 right position.

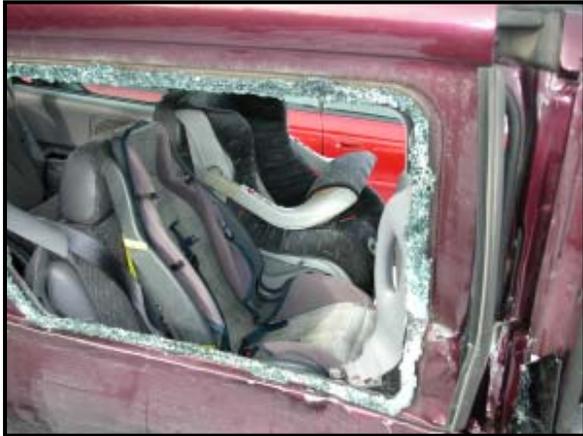
Figures 11 and 12 are views of the child safety seats reinstalled in Row 2 and Row 3 of the vehicle, respectively. The BBS in Row 3 could not be properly positioned and re-buckled due to

Figure 11: Right view across Row 2.

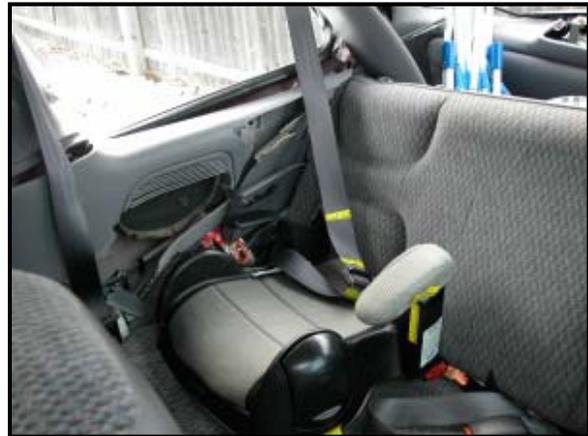
the right side deformation. The intrusion of the right side caused the floor anchor of the Row 3 right safety belt to move inboard and reduced the width between the floor anchor and belt buckle. The deformed position of the anchor introduced belt slack into the lap portion of the safety belt during the crash. The slack belt allowed the 4 year old child to be ejected out through the right rear window opening due to the lateral impact force and rotation of the vehicle.

Figure 12: View of the Row 3 right position.

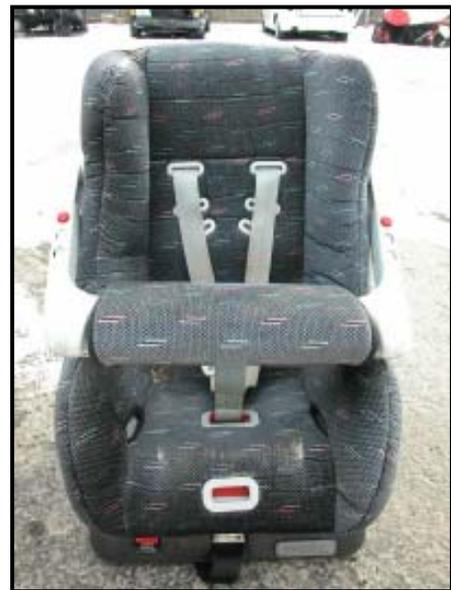
The CCSS was installed in a forward-facing mode and was restrained by the vehicle's three-point safety belt through the forward facing belt path. It was occupied by a 2 year old female with an approximate weight of 11 kg (25 lb). The base was adjusted to the forward facing mode. Inspection of the belt path identified abrasions consistent with safety belt use. The harness straps of the CCSS were adjusted to the top slots. The straps were in good condition and were not roped or twisted. There was no evidence of loading to the straps. Inspection of the shell was unremarkable for crash related evidence.

Figure 13: Evenflo Utara.

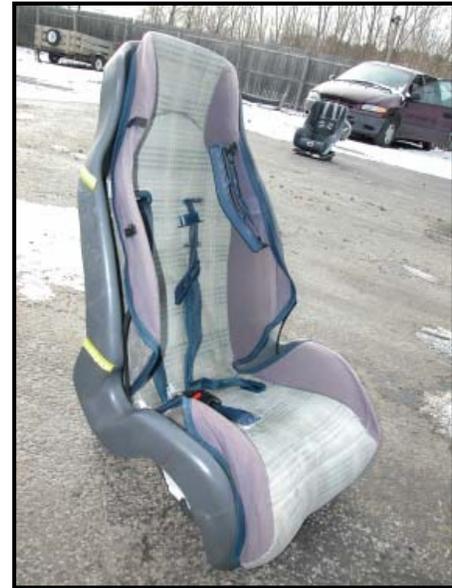
Figure 14: Dorel Booster.

The 2 year old child was restrained by the seat’s internal five-point harness at the time of the crash. The harness straps were adjusted to the top slots and were roped and twisted throughout their length. Inspection of the straps was unremarkable for crash related evidence. The belt path through the rear aspect of the shell exhibited minor abrasions from interaction with the vehicle’s safety belt. The right (outboard) aspect of the shell exhibited abrasions from contact with the intruding side door panel. Stress marks were observed on the left (inboard) side of the shell from probable contact with the right side of the adjacent Evenflo CCSS during the impact. Minor blood evidence was located on the right aspect of the shell’s base.

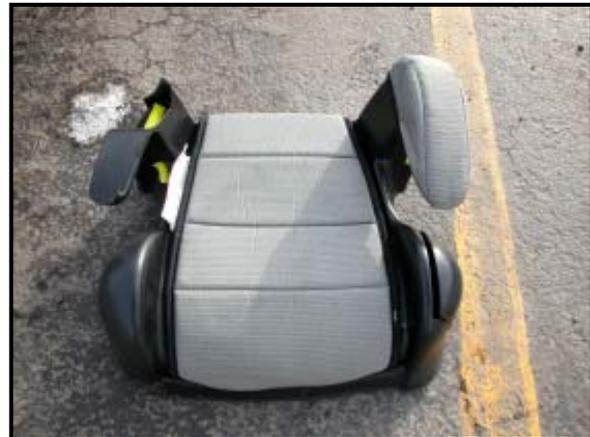
Figure 15: Cosco Highrise Backless Booster.

Examination of the seat revealed the right arm rest was fractured due to its contact with the intruding right side panel. Minor abrasions to the shell were noted within the molded cut outs for the lap belt path and to the forward aspect of the inboard side due to probable interaction with the safety belt buckle.
