ON-SITE CHILD SAFETY SEAT FATALITY INVESTIGATION

CASE NUMBER - IN-06-001

VEHICLE - 2002 DODGE NEON

CRASH DATE - December 2005

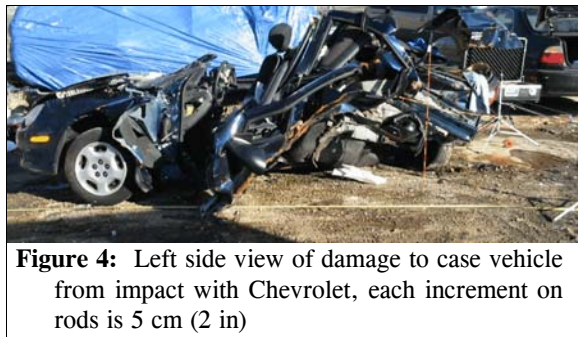
Figure 4: Left side view of damage to case vehicle from impact with Chevrolet, each increment on rods is 5 cm (2 in)

Crash: The back left of the case vehicle (**Figure 4**) was impacted by the front of the Chevrolet (**Figure 5**). The impact caused the Chevrolet's driver and front right passenger air bags to deploy. No air bags deployed in the case vehicle because the impact was to the back of the case vehicle.

Exterior Damage: The case vehicle’s contact with the Chevrolet involved the back plane. The back bumper, bumper fascia, trunk lid, left rear tire, left side tail lamp assembly, and trunk were directly damaged and crushed forward. Direct damage began at the left rear bumper corner and extended 50 centimeters (19.7 inches) to the right along the back plane. The crash deformed the back end of the case vehicle so severely that the field L was only 7 centimeters (2.8 inches) in length. Only two C-positions were used to determine the case vehicle’s crush to its back end. Residual maximum crush was measured as 145 centimeters (57.1 inches) occurring at C₁. The table below shows the cash vehicle’s back crush profile.

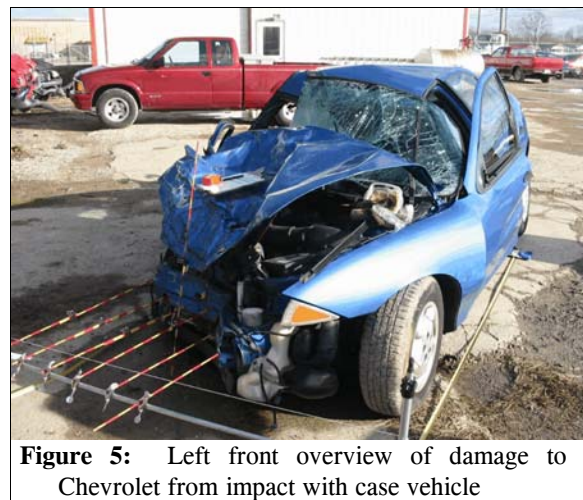
Figure 5: Left front overview of damage to Chevrolet from impact with case vehicle

Exterior Damage: The Chevrolet’s impact with the case vehicle involved it’s entire frontal plane. The front bumper, bumper fascia, radiator, hood, right fender and right front door, right turn signal and headlamp assemblies, right A-pillar, and windshield were all directly damaged and crushed rearward. Direct damage began at the right front bumper corner and extended 79 centimeters (31.1 inches) along the bumper. The Field L was determined to be 83 centimeters (32.7 inches) and the residual maximum crush was measured as 67 centimeters (26.4 inches) occurring at C₄. The table below shows the Chevrolet’s front crush profile.

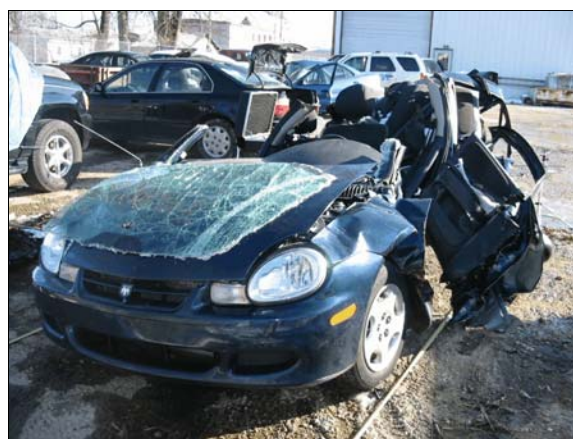
The case vehicle’s left side wheelbase was shortened 128 centimeters (50.3 inches) while the right side wheelbase was extended 8 centimeters (3.1 inches). There was induced damage to essentially the entire vehicle due to the severity of the crash. All glazing was disintegrated or cut by rescue personnel when they cut the roof off the vehicle to extricate the occupants (**Figure 6**).

Figure 6: Left front view of damage to case vehicle from impact with the Chevrolet, roof cut off by rescue personnel

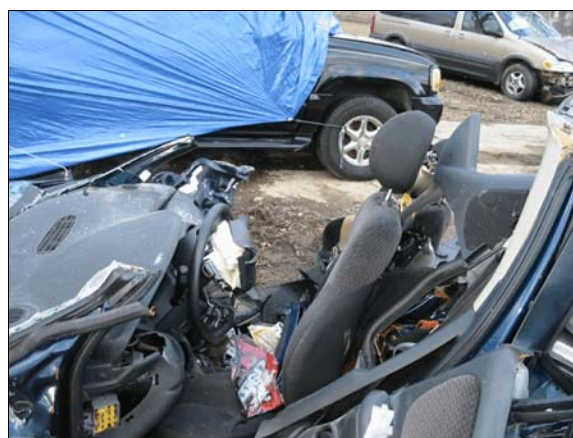
Vehicle Interior: Inspection of the case vehicle’s interior (**Figures 7 and 8 and Figure 9** below) revealed evidence of occupant contact on the interior surfaces. The steering wheel rim was completely collapsed and detached from the hub and the column was compressed and displaced upward (**Figure 10** below). This was a result of the back of the case vehicle being intruded by the Chevrolet and forcing the case vehicle’s driver forward into the steering assembly. The center instrument panel was also contacted, likely by the driver’s right knee. The case vehicle’s passenger compartment sustained numerous severe intrusions due to the severity of the crash. The primary intrusions involved the back left seat back, which intruded forward 86 centimeters (33.8 inches) while the seat cushion was forced upward 57 centimeters (22.4 inches) and forward 48 centimeters (19 inches). In addition, the left “C”-pillar intruded forward 70 centimeters (27.5 inches). Numerous other passenger compartment intrusions were identified and documented.

Figure 7: Left side view of case vehicle’s front seating row

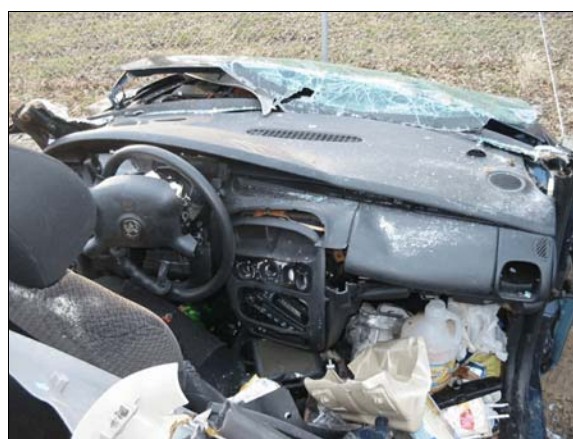
Figure 8: Overview of steering wheel and instrument panel

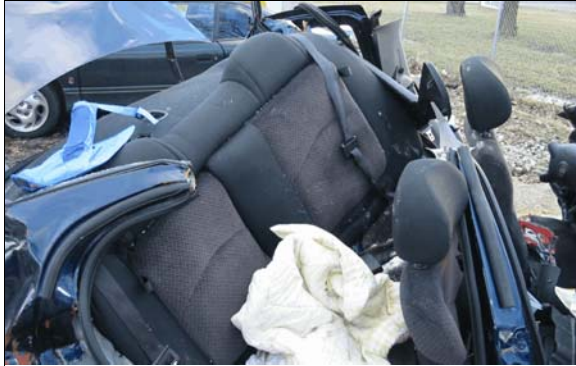
Figure 9: Overview of case vehicle's back seating row

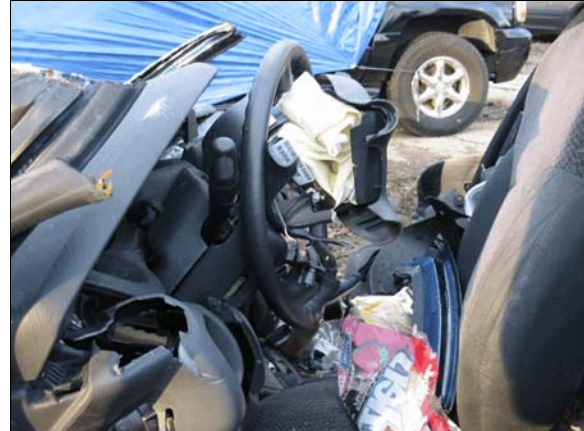
Figure 10: Left side overview of damage to case vehicle's steering wheel and steering column, air bag module torn open

The driver's air bag was located in the steering wheel hub, and the front right passenger air bag was located in the middle of the instrument panel. Neither these air bags deployed because the impact was to the back of the vehicle. However, due to the induced occupant contact to the steering wheel and instrument panel, both air bags were exposed in their modules.

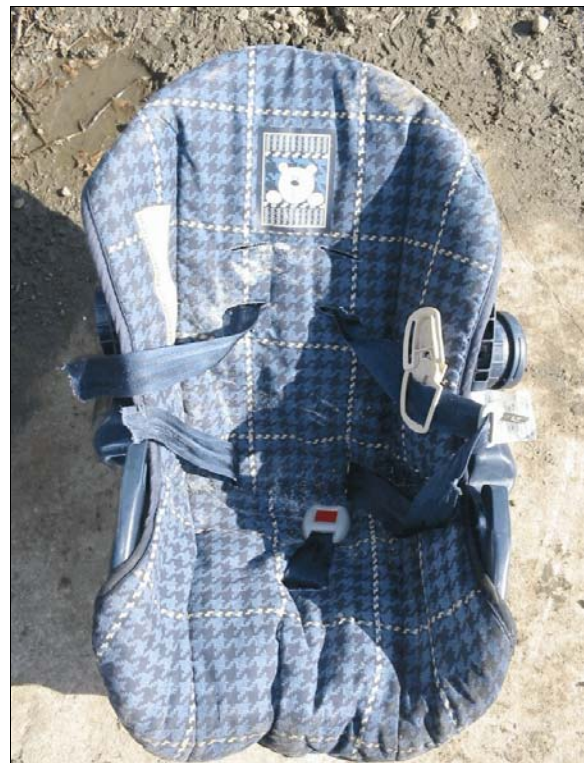
The case vehicle's back center passenger was restrained in a rear-facing infant seat with five point harness. The infant seat (**Figure 11** and **Figure 12** below) was manufactured by Graco on July 12, 2002, and was identified as model number 846MAC and model "Snug Ride". The infant seat was a two-piece design with a plastic seat that snapped into a plastic base (**Figure 13** below), which was secured by the case vehicle's safety belt. The infant seat was designed to be used with or without the base. The infant seat was lined with a thin cloth covering the back and seat cushion. Warning labels in English and Spanish warned the owner regarding proper usage, and the prohibition of placing the infant seat in the front right seating position when an air bag is present. The same label designated the infant seat's weight and height limits as: 9 kilograms (20 pounds) and 66 centimeters (26 inches) respectively. There were also informational labels with schematics showing proper usage with and without vehicle safety belts, as well as securing the infant seat using a LATCH system.

Figure 11: Case vehicle's back center passenger's infant seat, right harness strap cut by rescue personnel

The infant seat sustained large areas of stress and deformation to the entire plastic shell, as well as numerous cracks throughout the seat. Furthermore, the upper portion of the infant seat was twisted from the base in a left to right direction as a result of the crash. The carrier handle was broken off of the right side and the remainder was attached at the left side. The entire infant seat base sustained large areas of stress and was severely deformed and torn apart on its left side. In addition, there were scuff marks on the left side of the base. This was likely due to contact with the unoccupied booster seat in the left rear seating position. The damage to the infant seat indicated that it was compressed between the case vehicle's back seat, seat back and the front seat backs as the back seat, seat back was crushed forward during the crash.

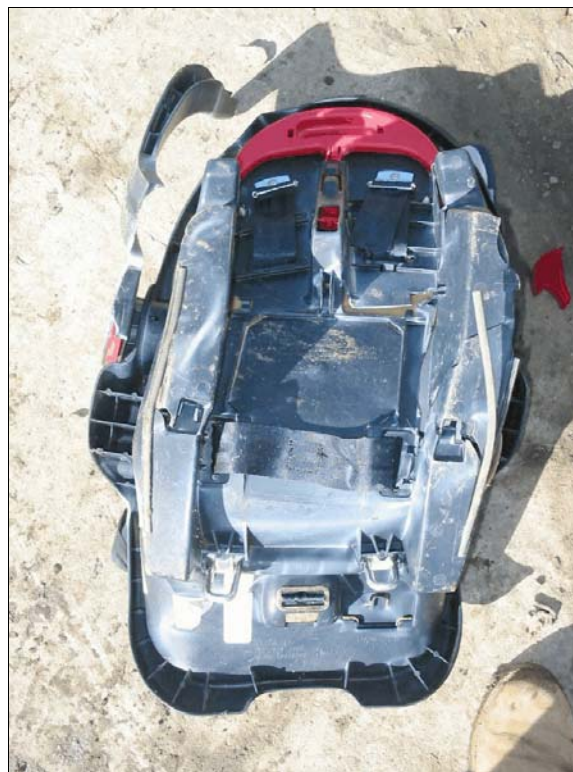
Figure 12: Back of case vehicle's back center passenger's infant seat

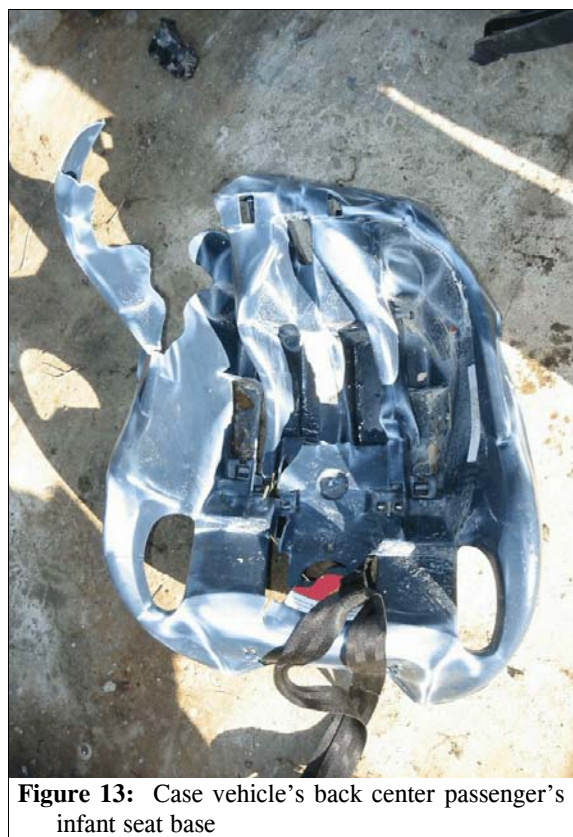
Figure 13: Case vehicle's back center passenger's infant seat base

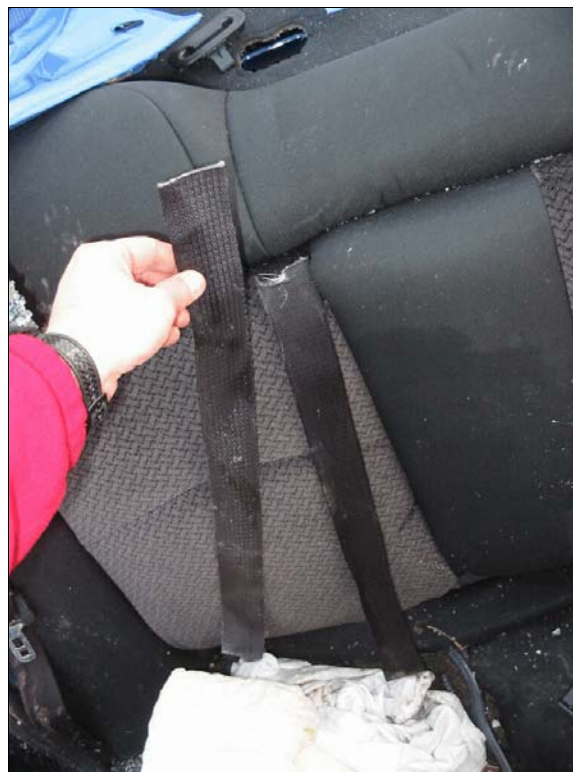
chest level. The infant seat was secured by the case vehicle's three-point, lap-and-shoulder safety belt (Figures 16 and 17). The retractor was switched to automatic locking mode and the belt pulled tightly to secure the infant seat base.

Figure 16: Case vehicle's back center safety belt cut by rescue personnel

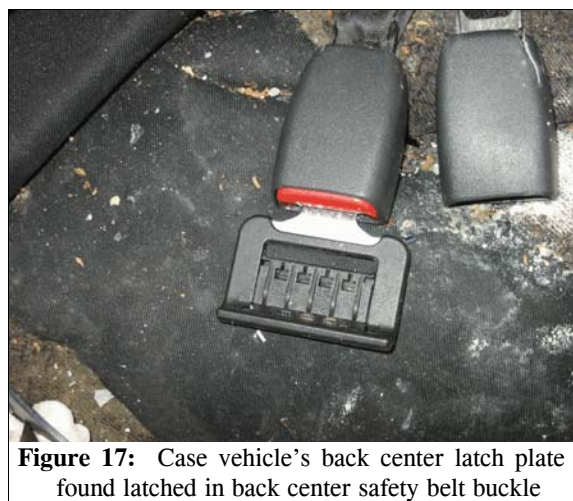
Figure 17: Case vehicle's back center latch plate found latched in back center safety belt buckle
