Rollover and Certified Advanced 208-Compliant Air Bag Investigation
Dynamic Science, Inc./Case Number: DS06001
2005 Chevrolet Trailblazer
California
August 2005

1. Report No. DS06001	2. Government Accession No.	3. Recipient Catalog No.	
4. Title and Subtitle Rollover and Certified Advanced 208-Compliant Air Bag Investigation		5. Report Date July 28, 2006

Dynamic Science, Inc.
Crash Investigation
Case Number: DS06001

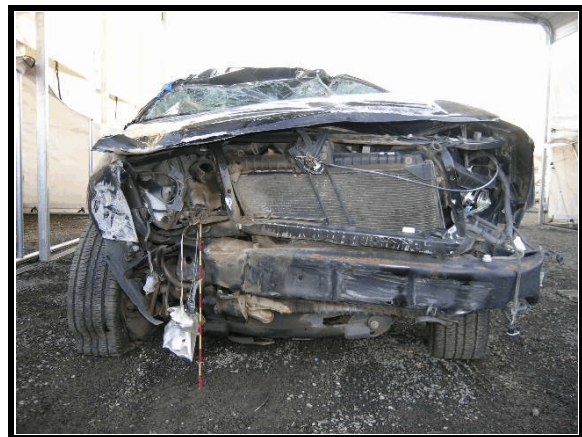
Figure 2. Front damage - 2005 Chevrolet Trailblazer

The 2005 Chevrolet Trailblazer sustained moderate front end damage as a result of the impact with the concrete traffic barrier. The Trailblazer sustained direct damage that was distributed across the front end from bumper corner to bumper corner. The location of maximum crush was at the right front bumper corner and measured 29.0 cm (11.4 in). The Collision Deformation Classification (CDC) for this impact was 01FDEW2.

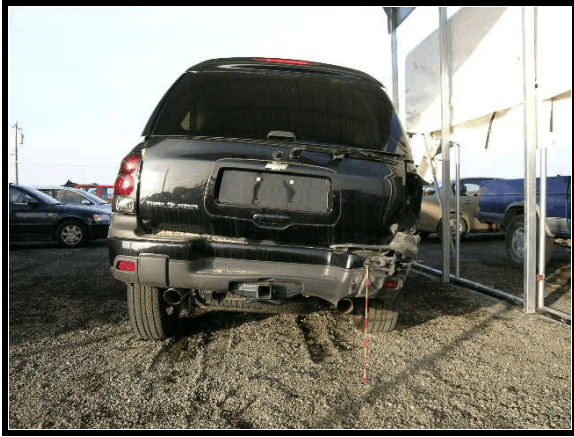
The case vehicle also sustained moderate back right damage as a result of the secondary impact with the same concrete traffic barrier. The Trailblazer sustained 44.0 cm (17.3 in) of direct damage beginning 42.0 cm (16.5 in) right of the precrash center point, extending along the back bumper to the right. The location of maximum crush was the right rear bumper corner and measured 11.0 cm (4.3 in). The CDC for this impact was 05BREW1.

Figure 4. Back right damage - 2005 Chevrolet Trailblazer

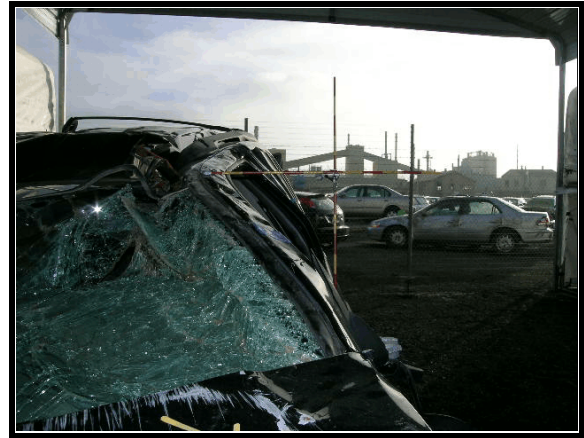
The Trailblazer sustained moderate damage as a result of the rollover event. The maximum vertical crush to the passenger compartment was 22.0 cm (8.7 in) and was located 224.0 cm (88.2 in) forward of the right rear axle, in the area of the right windshield header. The CDC for this impact was 00TDDO4.

Figure 5. Maximum lateral rollover crush

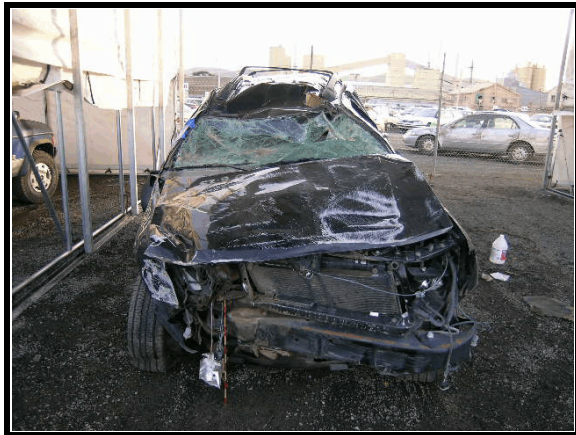
Figure 6. Rollover damage - 2005 Chevrolet Trailblazer

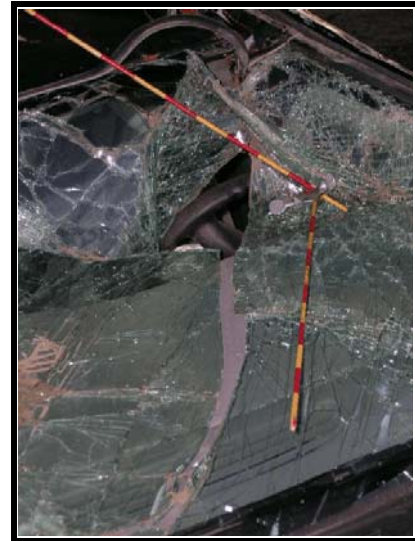
There was integrity loss to the side glazing and windshield. The right front, left front, and rearmost left side glazing disintegrated most likely during the rollover. There was a laceration beginning at the center of the base of the windshield running diagonally upward towards the upper left corner. The opening measured 70.0 cm (27.6 in) in length and was 18.0 cm (7.1 in) wide at its widest point. It is likely that this damage also occurred during the rollover event.

Figure 7. Windshield damage

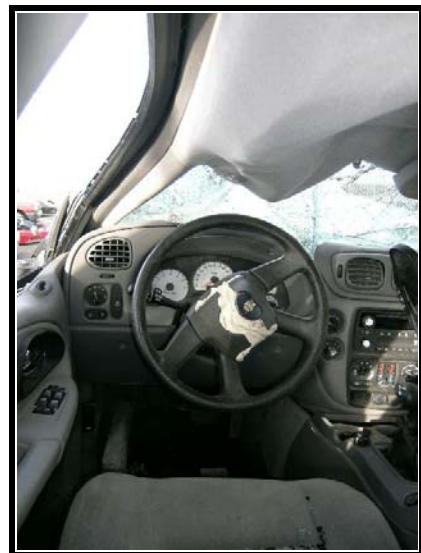
There was lateral intrusion of the A pillar into the driver's area. In the front row seating areas, there was vertical intrusion of the windshield, windshield header, left A and B pillars, right A pillar, and roof. In the second row seating area there was vertical intrusion of the roof.

Figure 8. Driver's seating area

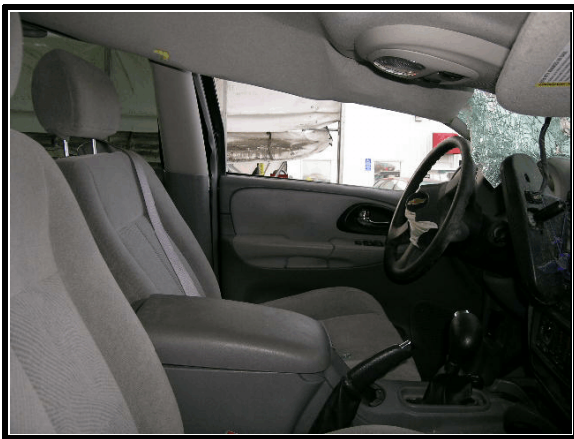
Row/Position	Intruded Component	Magnitude of Intrusion	Direction
1L	A pillar	26.0 cm(10.2 in)	Lateral
1L	Windshield header	20.0 cm (7.9 in)	Vertical
1L	Windshield	19.0 cm (7.5 in)	Vertical
1L	Roof	13.0 cm (5.1 in)	Vertical
1L	A pillar	11.0 cm (4.3 in)	Vertical
1L	B pillar	6.0 cm (2.4 in)	Vertical
1C	Windshield header	18.0 cm (7.1 in)	Vertical
1C	Windshield	16.0 cm (6.3 in)	Vertical
1C	Roof	9.0 cm (3.5 in)	Vertical
1R	Windshield header	19.0 cm (7.5 in)	Vertical
1R	Windshield	16.0 cm (6.3 in)	Vertical
1R	Roof	9.0 cm (3.5 in)	Vertical
1R	A pillar	8.0 cm (3.1 in)	Vertical
2L	Roof	9.0 cm (3.5 in)	Vertical
2M	Roof	7.0 cm (2.8 in)	Vertical
2R	Roof	7.0 cm (2.8 in)	Vertical

Figure 9. Intrusion in driver area and possible occupant injury point to the roof

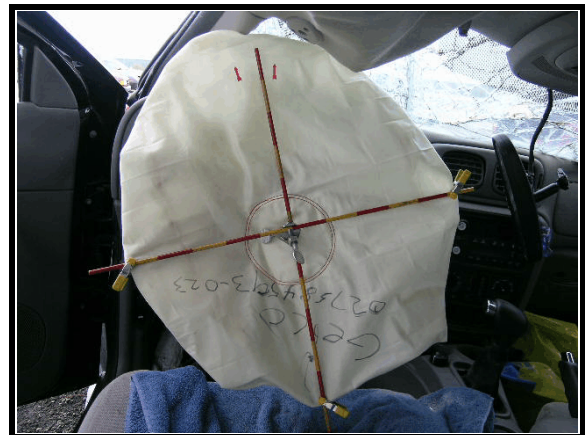
Figure 11. Driver front air bag - arrows point to top of bag

The driver's front air bag was mounted in the center of the steering wheel hub. The air bag module had a symmetrical I configuration. The left and right flaps measured 7.0 cm (4.3 in) wide at the top edge, 6.0 cm (2.4 in) wide at the bottom edge and were 12 cm (4.7 in) high. There was a semi-circular cut-out in the center of the left flap measuring 6.5 cm (2.6 in) in height. The air bag was circular in shape and measured 55.0 cm (21.7 in) high/wide in its deflated state. The maximum excursion measured 19.0 cm (7.5 in) from the module face. The

distance between the module face and the front left seat back was 75.0 cm (29.5 in). The air bag had two internal tethers. There were two circular vent ports on the back of the bag at the 11 and 1 o'clock positions. There was no damage to the air bag or air bag module cover flaps.

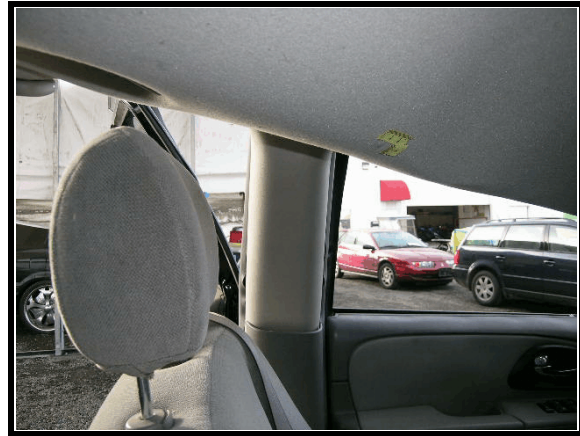
Figure 12. Possible driver contact point

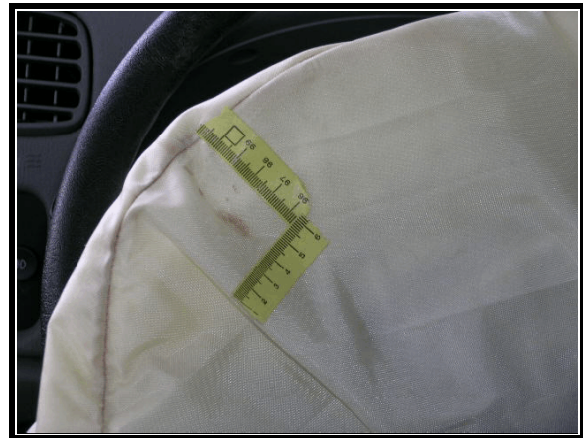
The driver's retractor pretensioner actuated during the crash and was locked in place post-impact. There was blood found on the back of the driver air bag in the 6 o'clock location, on the glove compartment door and on the front right seat cushion. All three blood transfers likely occurred post-crash, while the driver was moving around inside of the passenger compartment.

Figure 13. Blood found on back of driver air bag
