Child Safety Seat Fatality Investigation / Vehicle to Vehicle
Dynamic Science, Inc. / Case Number: DS06002
2000 Toyota Echo
California
December 2005

1. Report No. DS06002	2. Government Accession No.		3. Recipient Catalog No.	
4. Title and Subtitle Child Safety Seat Fatality Investigation			5. Report Date May 17, 2006

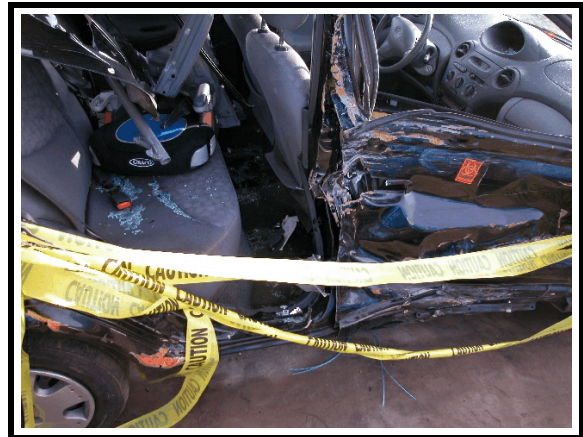
Damage Description: Moderate right side damage as a result of the impact with the Dodge Durango. The direct damage began 47.0 cm (18.5 in) rear of the front axle and extended 216.0 cm (85.0 in) rearward along the right side. Both right side doors were deformed and jammed shut. The right rear door was pried open at some point. The combined direct and induced damage began 41.0 cm (16.1 in) rear of the front axle and extended 226.0 cm (88.9 in) rearward. The right B pillar and right roof rail were deformed laterally. Both right side windows had disintegrated. The windshield was fractured from impact forces and the backlight glazing had disintegrated.

Six crush measurements were documented at the mid door level as follows: C1 = 0.0 cm (0.0 in), C2 = 0.0 cm (0.0 in), C3 = 15.0 cm (5.9 in), C4 = 25.0 cm (9.8 in), C5 = 17.0 cm (6.7 in), C6 = 0.0 cm (0.0 in). The C3 measurement was taken at a projected point.

Figure 3. Right side damage

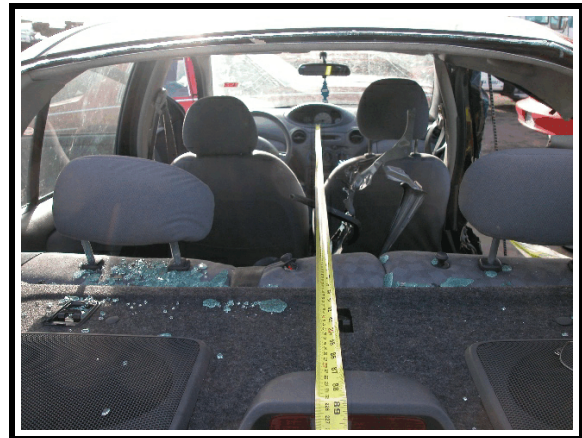
The 2000 Toyota Echo sustained moderate interior damage due to intrusion, occupant contacts and extrication efforts. The right side doors, B pillar, right roof rail, C pillar and sill sustained lateral intrusion.

Position	Intruded Component	Magnitude of Intrusion	Direction
RF	Door	30.0 cm (11.8 in)	Lateral
RF	Sill	3.0 cm (1.2 in)	Lateral
RF	B pillar	17.0 cm (6.7 in)	Lateral
RF	Roof rail	4.0 cm (1.6 in)	Lateral
RR	Door	Unknown, door removed, estimated at 17.0 cm (6.7 in)	Lateral
RR	Sill	5.0 cm (1.9 in)	Lateral
RR	Roof rail	5.0 cm (1.9 in)	Lateral
RR	C pillar	1.0 cm (0.4 in)	Lateral

Figure 4. Overview of right side intrusion

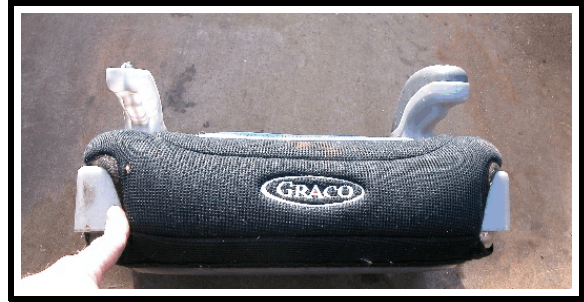
The booster seat sustained moderate damage as a result of the crash. The upper part of the right side arm rest was dislodged. The forward aspect of the seat bottom was abraded from contact to the intruding right rear door.

Figure 7. Front, Graco booster seat

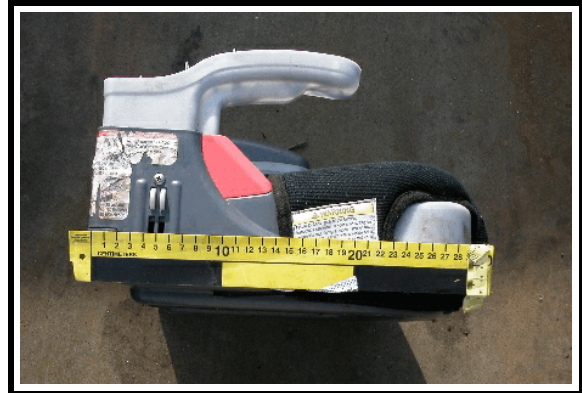
Figure 8. Right side, Graco booster seat

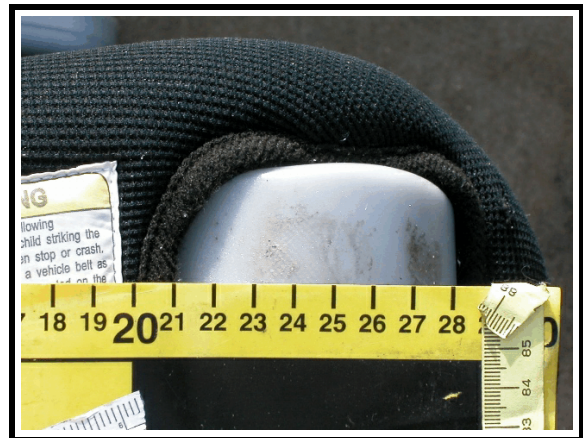
Figure 9. Close up of abrasion to seat base

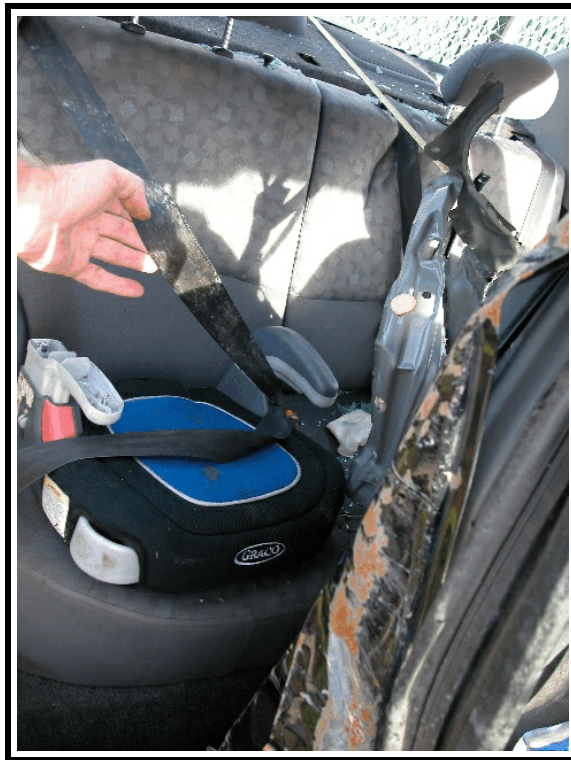
The 5-year-old female second row right occupant was seated in what is believed to be an upright posture. She was seated in a backless booster seat and was using the manual 3-point lap and shoulder belt. The second row right seat back was at a 70 degree angle, the seat bottom was at a 15 degree angle. According to police accounts, the driver was actively steering and braking. The child was pitched first to the right and then to the left. As the driver lost control of the vehicle, and the vehicle began a counterclockwise rotation, the child began pitching to the right. At impact, the child initiated a lateral and slightly forward trajectory to the right. Intrusion of the right rear door caused scuffing damage to the booster seat base and a portion of the right arm rest was broken away. The child contacted the door panel and door hardware with her right side, causing multiple contusions and abrasions to the upper arm and to the right leg. The child sustained abrasions to the right side of the neck and lower abdomen from the seat belt webbing. As the Dodge Durango intruded into the vehicle, the child's head came into contact with the rear cargo area of the Durango, causing multiple facial contusions and abrasions as well as a mandible fracture. The lateral movement of the child's head to the right during the intrusion likely caused the C1 fracture and dislocation with a complete transection of the spinal cord.

Figure 12. Booster seat belted into right rear seat position
