**CALSPAN ON-SITE CHILD AIR BAG RELATED FATALITY CRASH
INVESTIGATION**

CASE NO: CA06-002

VEHICLE: 1999 CHEVROLET CORVETTE

CRASH DATE: FEBRUARY 2006

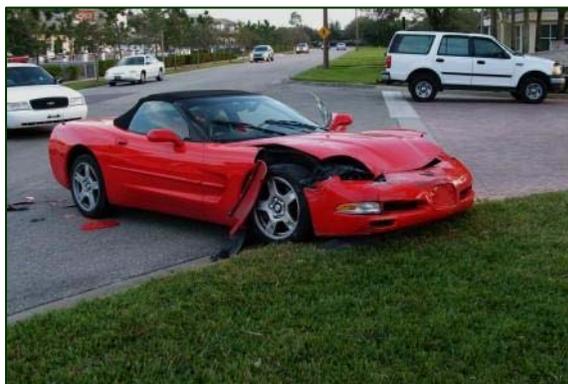
Figure 1. On-scene final rest position of the 1999 Chevrolet Corvette.

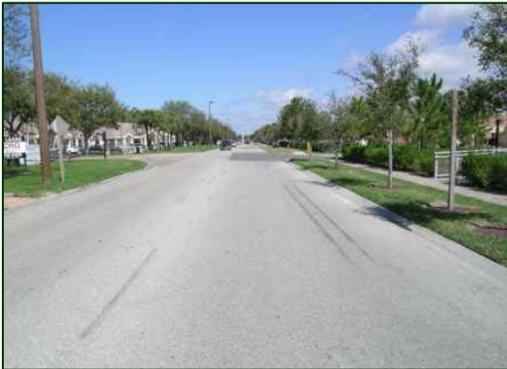
Figure 2. Northbound approach of the Corvette to the crash site.

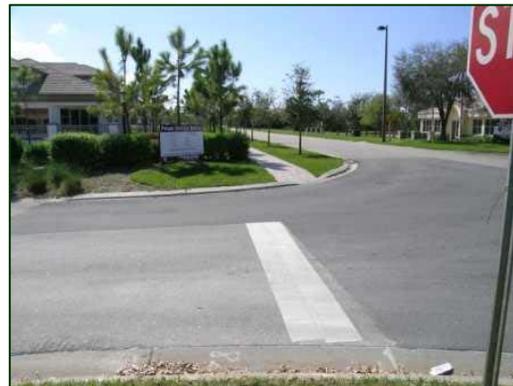
Figure 3. Toyota driver's view from the stop line of the Corvette's northbound approach to the intersection.

The roadways were straight and level with minimal crown. The southeast road edge contained a tree line, a hedgerow and a property sign that could have offered a momentary visual obstruction of approaching northbound traffic to the driver of the Toyota as he approached the intersection (**Figure 3**). These roadside objects would not interfere with a driver's line of sight of approaching northbound traffic for a vehicle stopped in the vicinity of the painted stop line. The crash schematic is included as **Figure 14** of this report.

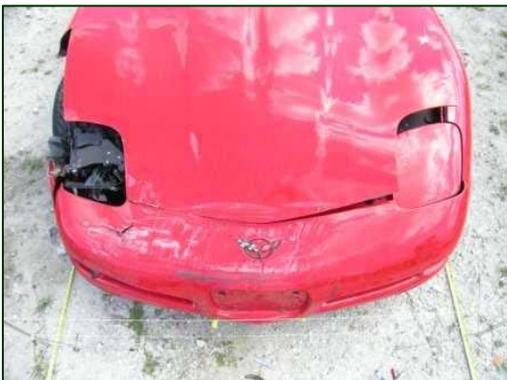
Primary - The Corvette sustained moderate severity frontal damage as a result of the initial impact with the left side of the Toyota. Maximum crush was measured at 6 cm (2.25") located at the front right corner of the bumper beam. The direct contact damage began 37 cm (14.4") left of the vehicle's centerline and extended 114 cm (45") to the

right bumper corner (**Figure 4**). The contact damage consisted of black transfers and abrasions to the bumper fascia and hood. The impact deformed the full width of the bumper system, resulting in a combined induced and direct contact damage length of 152 cm (59.75"). The residual crush (**Figure 5**) measured at the level of the bumper beam was as follows: C1 = 1 cm (0.25"), C2 = 3 cm (1"), C3 = 4 cm (1.5"), C4 = 5 cm (2"), C5 = 6 cm (2.2"), C6 = 6 cm (2.25").

Figure 4. Overhead view of the direct contact damage.

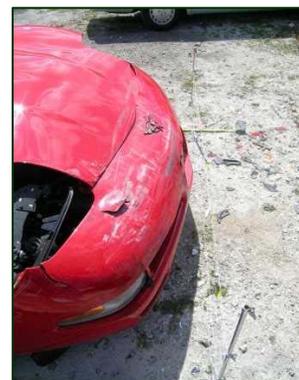
Due to the pre-crash braking by the driver of the Corvette and the ride height of the Toyota, the front bumper engaged and underrode the left side step bar of the Toyota Sequoia. This underride resulted in direct contact damage that extended 6 cm (2.5") onto the leading edge of the hood. The Collision Deformation Classification (CDC) for this crash was 02-FDEW-1

Figure 5. Lateral view of the depth of crush.

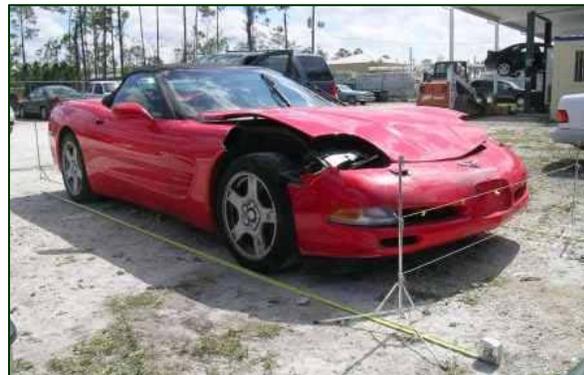
Secondary – The secondary engagement of the right front tire and fender of the Corvette by the left rear tire and quarter panel of the Toyota resulted in minor severity damage to the involved components. The composite fender fractured at the area of contact and black tire transfers were noted to the right front alloy wheel of the Corvette (**Figure 6**). There was no structural damage or measurable crush associated with this event. The CDC for this event was 03-RFEW-1.

Figure 6. Secondary damage to the right front fender and alloy wheel.

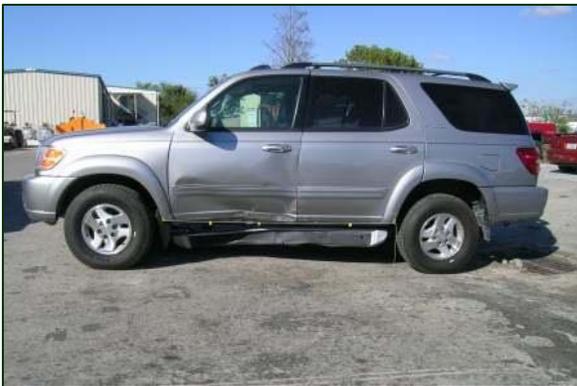
Primary - The 2003 Toyota Sequoia sustained moderate severity left side damage that was associated with the initial impact with the subject vehicle. This damage was located between the left wheelbase and involved both doors, the sill, and the left step bar (**Figure 7**). The direct contact damage began at the base of the left A-pillar and extended 207 cm (81.6”) rearward to the dogleg at the base of the left C-pillar. Maximum crush was 11 cm (4.4”) located on the sill at the mid point of the left front door. The combined direct and induced damage was isolated to this area and was the same length as the direct damage measurement. Two planes of crush measurements were documented for this damage pattern. The left sill was representative of the severity of the crash since this was direct structure to the vehicle. The second profile was documented at the face of the step bar, which yielded the greatest crush. This add-on component was supported by four hangers and was not a structural component to the Sequoia. The crush profile at the level of the sill was as follows: C1 = 0 cm, C2 = 2 cm (0.6”), C3 = 4 cm (1.4”), C4 = 8 cm (3.1), C5 = 6 cm (2.4”), C6 = 0 cm. The crush profile at the level of the step rail was as follows: C1 = 6 cm (2.5”), C2 = 14 cm (4.0”), C3 = 14 cm (5.5”), C4 = 29 cm (11.5”), C5 = 38 cm (15.0”), C6 = 38 cm (15.0”). The CDC for this impact was 11-LPLW-2.

Figure 7. Left side damage to the Toyota Sequoia.

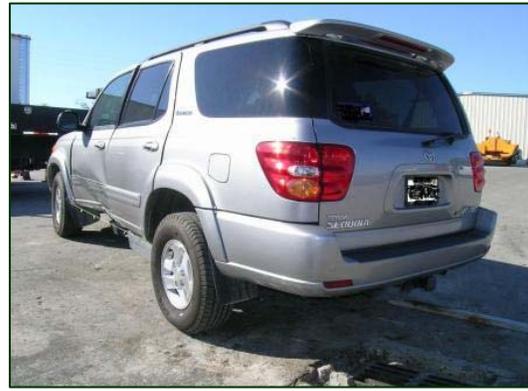
Figure 8. Secondary damage to the left rear bumper fascia.

Secondary – The left rear tire and the side surface of the rear bumper fascia of the Toyota engaged the right front fender and wheel of the Corvette as the Sequoia passed through the intersection. The left rear tire of the Sequoia sustained subtle rub marks from the contact while the lower edge of the fascia was abraded with red paint transfers (**Figure 8**). The contact on the fascia began 77 cm (30.25”) aft of the rear axle position and extended 37 cm (14.5”) to the rear corner. Due to the compliant nature of the fascia, there was no crush associated with this event. The CDC for this secondary contact was 09-LBLW-2.

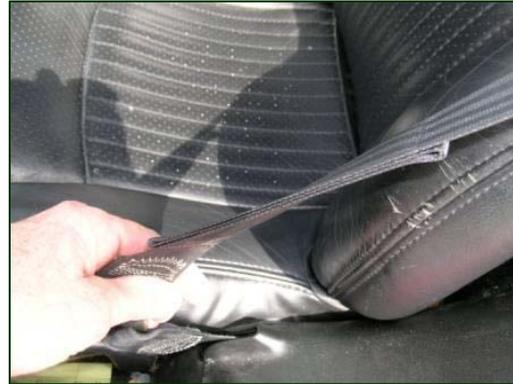
The Corvette was equipped with manual 3-point lap and shoulder safety belts for the two seating positions. Both belt systems utilized two separate belt webbings that were sewn to a common latch plate. The lap belts extended from switchable Emergency/Automatic locking retractors that were mounted to the sills of the vehicle. The shoulder belts extended from upper-B-pillar mounted Emergency Locking Retractors (ELR). Both latch plates yielded historical usage wear marks. An emergency management loop (**Figure 9**) was incorporated into the shoulder belt webbing of both belt systems. The loops consisted of a double fold that measured 16 cm (6.125”) in length and stitched at the upper and lower aspects of the loop. Both loops originated 5 cm (2”) above the latch plates. The loops did not separate in the crash.

Figure 9. Driver’s side energy management loop.

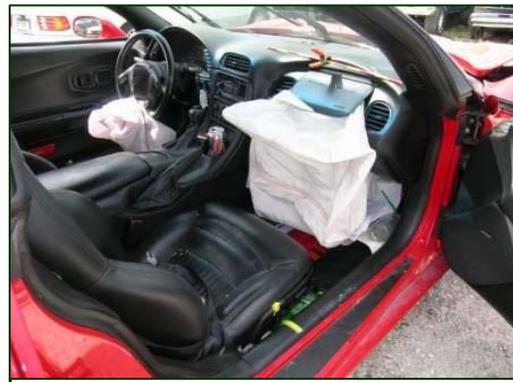
The 1999 Chevrolet Corvette was equipped with redesigned frontal air bags for the driver and right passenger positions. Both air bags deployed (**Figure 10**) as a result of the initial crash with the left side of the Toyota.

Figure 10. Deployed redesigned frontal air bags.

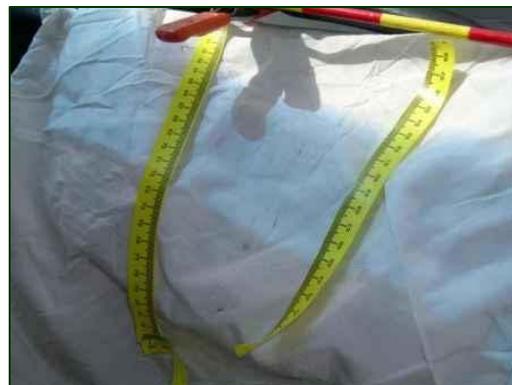
Figure 11. Red fabric and tissue transfers on the front right air bag.

The air bag membrane contained several transfers that were related to expansion against the module cover flap and the child passenger. The top right aspect of the top panel contained a black vinyl fabric transfer with a subtle red fabric transfer within the black near the perimeter of the joining face panel. This combined transfer was located 3-10 cm (1-3.75") right of the centerline and 0-15 cm (0-6") aft of the junction of the top and face panels.

A vertically oriented transfer, that appeared to be tissue, was located on the face of the air bag (**Figure 11**). This transfer began at the junction of the top panel and extended 18 cm (7.25") downward to the centerline of the bag. Located within this transfer was a red fabric transfer that extended 13-20 cm (5-8") inboard of the left side panel seam extending 10 cm (4") down from the face from the top panel.

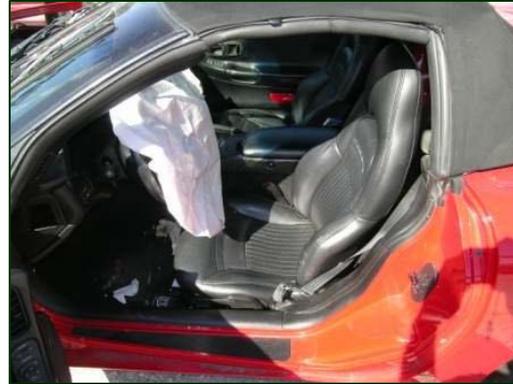
Figure 12. Lateral view of the driver’s position and the deployed front left air bag.

Immediately prior to the crash, the driver was probably bracing against the steering wheel with both hands and braking in an attempt to avoid the crash. At impact with the Toyota, the redesigned frontal air bag system deployed. The driver’s air bag deployed from the steering wheel mounted module. The unrestrained driver initiated a forward and slight lateral trajectory to her right in response to the 1 o’clock impact force. She loaded the deployed driver’s air bag (**Figure 12**), which prevented her from potential contact with the steering assembly and frontal components. The driver was not injured in the crash.

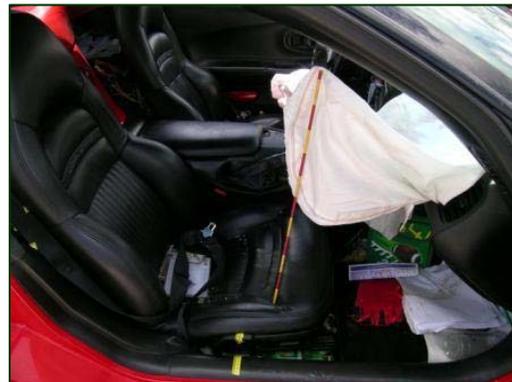
Figure 13. Lateral view of the child's trajectory and the deployment path of the front right air bag.

As the driver of the Corvette detected the Toyota Sequoia entering the intersection, she braked with sufficient force to displace the 5-year old male passenger forward. Due to the low position of the shoulder belt his upper torso and head to jackknife forward over the manual belt system. This forward movement placed his head and torso within the deployment path of the mid mount front right air bag (**Figure 13**).

At impact, the front right air bag deployed from the mid right instrument panel module. The narrow shape of the air bag membrane during the initial deployment contacted the out-of-position child passenger under the chin. This contact resulted in a full-thickness abrasion pattern that extended from ear-to-ear across the underside of the chin on the anterior neck. As the air bag began to expand vertically, the expanding membrane hyperextended the child’s neck resulting in a fracture of the odontoid with dislocation of the atlanto-axial joint. The expansion accelerated the child’s head vertically and rearward as the bag expanded against his torso. The acceleration of the head resulted in a diffuse axonal injury and a thin layer of subdural hemorrhage over the left cerebral hemisphere.
