ON-SITE CHILD SAFETY SEAT INVESTIGATION

CASE NUMBER - IN-06-003

VEHICLE - 1994 CHEVROLET CAMARO

CRASH DATE - January 2006

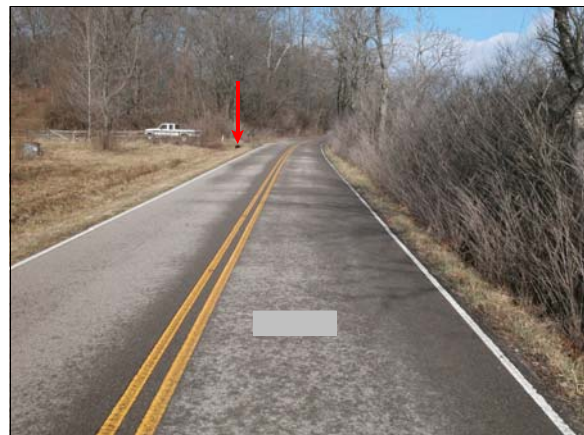
Pre-Crash: The case vehicle was traveling north in the northbound lane (**Figure 1**), and the driver was intending to continue northbound. The case vehicle departed the northbound lane and departed the west side of the roadway and entered a ditch. The driver attempted to steer right just prior to the impact. It is not known if she also applied the brakes. The crash occurred on the west roadside.

Figure 1: Approach of case vehicle northbound in northbound lane, arrow shows impacted culvert

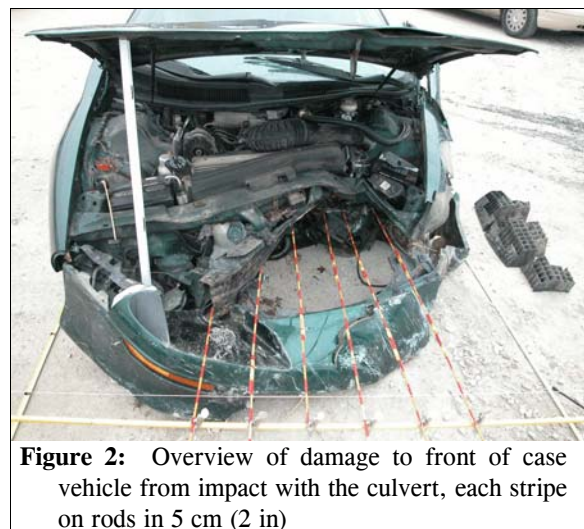
Crash: As the case vehicle entered the ditch, the front right bumper impacted a mailbox post breaking off the post. The front of the case vehicle then impacted a concrete culvert (**Figure 2** and **Figure 3** below).

Figure 2: Overview of damage to front of case vehicle from impact with the culvert, each stripe on rods in 5 cm (2 in)

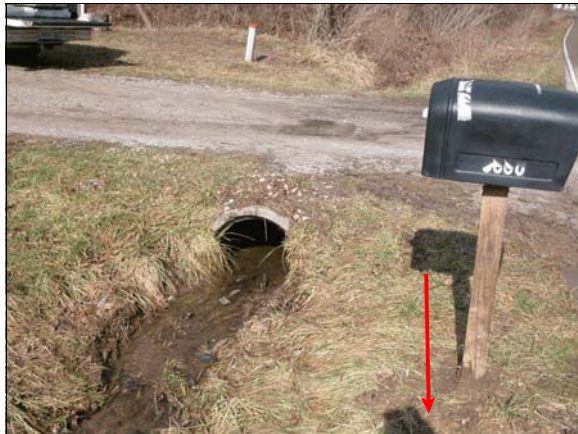
Figure 3: Overview of impacted culvert and mailbox, arrow shows location of old mailbox post

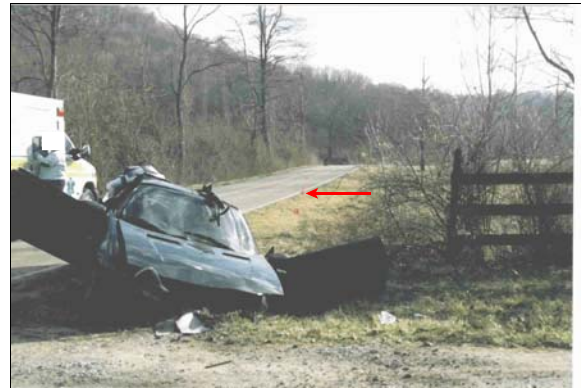
Post-Crash: The case vehicle rotated counterclockwise and came to rest partially in the ditch with the front of the vehicle against the culvert (**Figure 4** below). The case vehicle was heading northwest at final rest.

Figure 4: Police on-scene photo showing rest position of case vehicle, red flags show case vehicle's left side tire mark in grass (arrow)

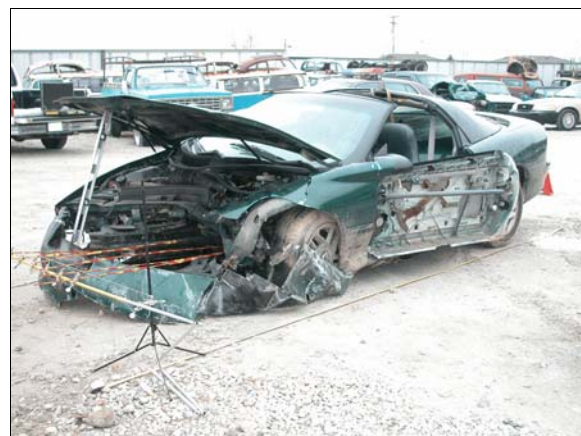
Exterior Damage: The case vehicle's impact with the mail box post involved a small area of the right portion of the front bumper. Crush measurements could not be taken for this impact due to overlapping damage from the culvert impact. The damage to the bumper fascia in this area indicated there was most likely no residual crush from the mailbox post impact. The case vehicle's impact with the culvert involved the front of the vehicle (**Figure 5**). The front bumper, left headlamp/turn signal assembly, grille and left fender were directly contacted and crushed rearward. The direct damage began at the front left

Figure 5: Front left overview of damage to case vehicle

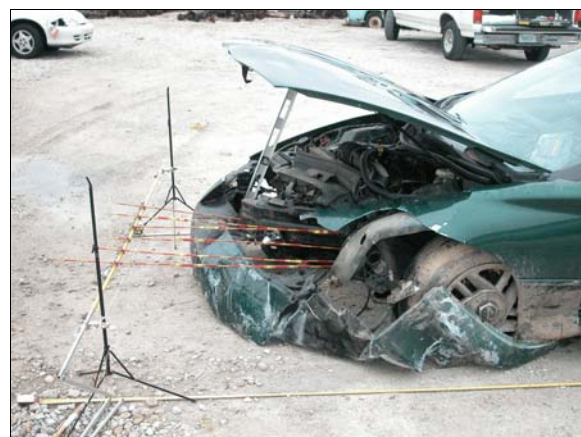
Figure 6: Left side view of crush to front of case vehicle from culvert impact, measurements were taken to the bumper bar, plastic bumper fascia was separated from the bumper bar

bumper corner and extended 127 centimeters (50 inches) across the bumper. The maximum residual crush was measured as 97 centimeters (38.2 inches) occurring at C₃ (Figure 6 above). The table below shows the case vehicle’s front crush profile.

The left side wheelbase was reduced 31 centimeters (12.2 inches) while the right side wheelbase was extended 4 centimeters (1.6 inches). Induced damage involved the left front door, left “A”-pillar, roof and the windshield.

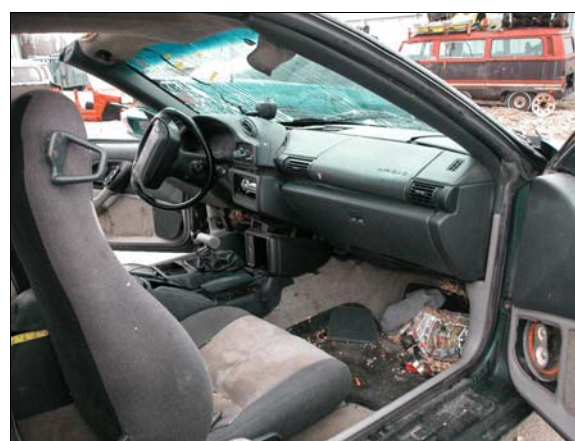
Inspection of the case vehicle’s interior (Figure 7) revealed severe deformation of the steering wheel rim (Figure 8 below) due to driver loading. The steering wheel would not rotate. Examination of the steering column shear capsules showed that the shear plate had completely separated from both shear capsules. The residual shear plate movement was measured as approximately 4 centimeters (1.8 inches). The driver’s sunvisor was knocked off and oil transfer and scuff marks were found on the windshield directly in front of and to the right of the driver’s seat. In addition, the driver’s knee bolster was dented on both sides of the steering column, and

Figure 7: Right side overview of instrument panel, windshield and steering wheel

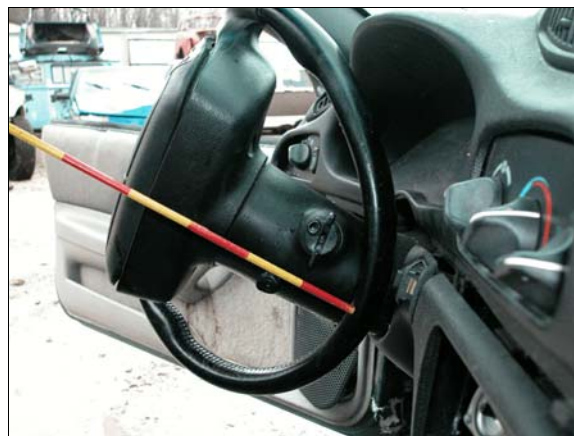
Figure 8: Right side view of deformation of steering wheel

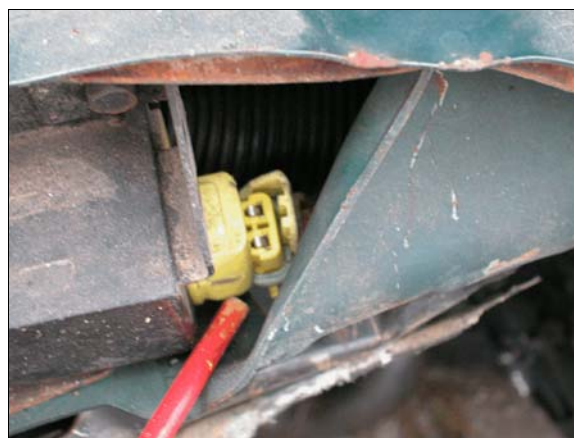
the case vehicle had been modified to some extent from factory original parts. The inspection indicated the air bag crash sensor connector had been most likely broken and disconnected during repair/alteration of the vehicle. The driver sustained serious injuries and was hospitalized.

The case vehicle was equipped with a driver and front right passenger air bag. Neither of these air bag deployed in this crash. The damage to the vehicle and the reconstruction results indicated that the crash was severe enough to require air bag deployment. There were indications the case vehicle had been modified to some extent from factory original parts. The vehicle had an after-market transmission and audio system installed, and there had been alterations to the interior. The front seats did not match, the back seat cushions and seat back were not bolted to the vehicle, and it appeared that new carpet had been installed at some point. It is not known if engine repair/replacement had also been performed on the vehicle. It is possible the air bag crash sensor had been compromised during repair/alteration of the vehicle. Examination of the front crash sensor, which was mounted on the center radiator support, revealed that the sensor plug receptacle was broken and the sensor was unplugged. The area where the sensor was located was not directly impacted and there was a minimum of induced damage to the sheet metal components surrounding the crash sensor plug (**Figure 9**). It is possible that the crash sensor was not connected at the time of the crash.

Figure 9: Front crash sensor receptacle was found broken and sensor was unplugged, plug moved to right for photo

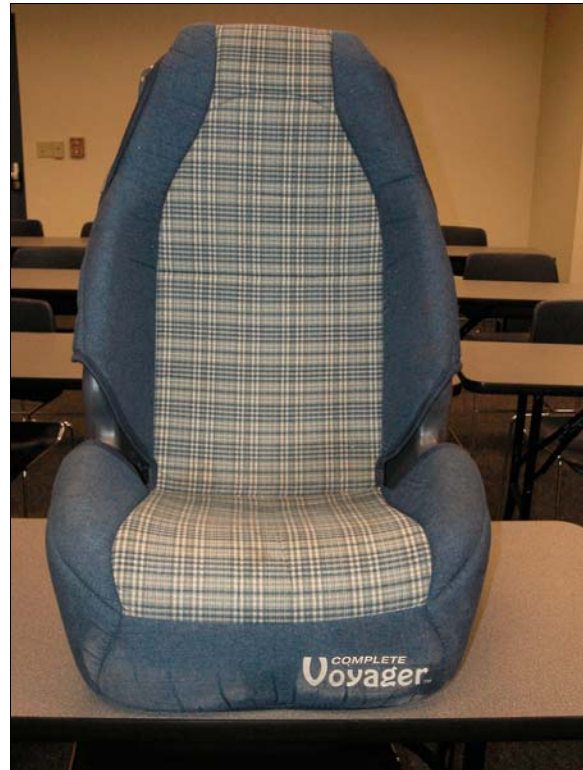
The back right passenger was seated in a Cosco Voyager high-back belt positioning booster seat (**Figure 10**). The child seat was manufactured by the Dorel Juvenile Group on September 9, 2004 and was identified by model number 22-210-WAL. It is not known at this time when the child seat was purchased or how often it was used. The child seat consisted of a plastic one-piece shell with a padded cloth cover approximately 8 millimeters thick (0.3 inch). The child seat was designed to be used with a vehicle's three-point, lap-and-shoulder safety belt system. It was equipped with lap belt guides at the back of the seat cushion and shoulder belt guides on each side of the seat back. The on-scene police photographs show the shoulder belt positioned behind the passenger's back. The police crash report indicated that the back right passenger was found restrained by only the lap belt with the shoulder belt behind him and the safety belt buckled into the buckle for the back left seat position. The buckle for the back right seat position was found by police investigators under the carpet. It appeared that at some point the carpet had been replaced in the vehicle. A slit in the carpet to accommodate the back right safety belt buckle was present; however, the buckle had not been threaded through the slit.

Figure 10: Front view of back right passenger's high back belt positioning booster seat

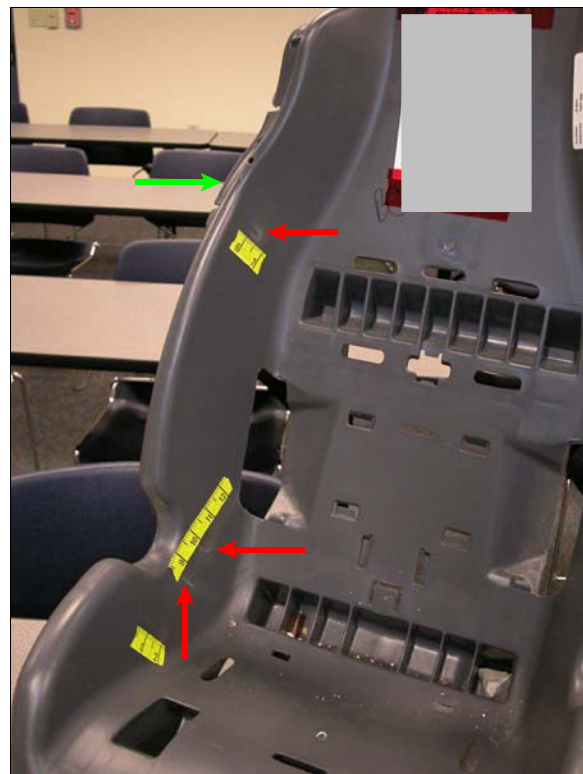
Inspection of the belt positioning booster seat revealed no apparent damage or fractures to the plastic shell. However, there were stress marks on the inside of the seat just below the right lap belt guide (**Figure 11**) that appeared to be related to loading of the seat on the lap belt during the crash. Another stress mark was observed on the seat back on the inner right side (**Figure 11** below) that appeared to be related to the shoulder belt loading the seat during the crash. The location of this stress mark was consistent with the approximate location of the shoulder belt as observed in the police on-scene photographs. It did not pass through the shoulder belt guide and was behind the child's back. No other damage

Figure 11: Red arrows show location of stress marks near belt guides, green arrow shows location of lower shoulder belt guide on right side of seat

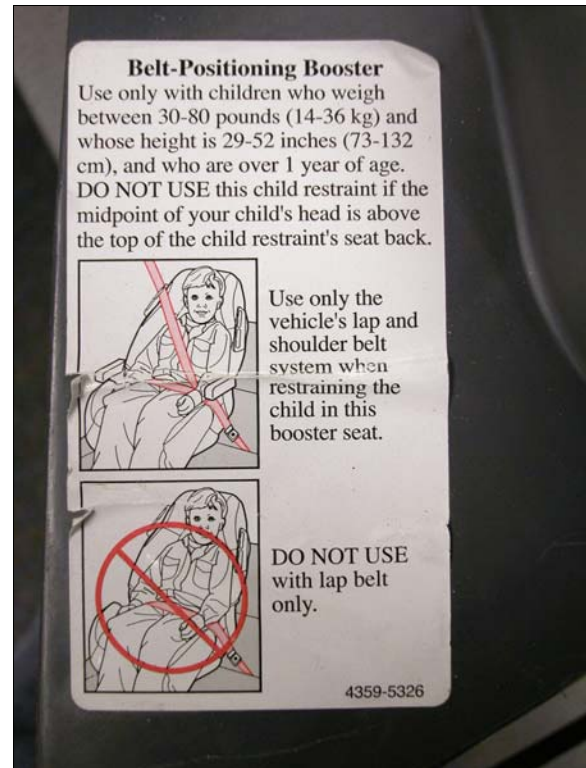
was observed to the booster seat. There was a manufacturer's warning label (**Figure 12**) affixed to the right side of the child seat giving the seat's weight, height and age limitations as follows: "use only with children who weigh between 14-36 kilograms (30-80 pounds) and whose height is 74-132 centimeters (29-52 inches), and who are over 1 year of age" The warning label also stated to not use the child seat if the midpoint of the child's head is above the top of the child seat's seat back. In addition, there was an warning with illustration that stated to use the child seat only with a vehicle's lap-and-shoulder safety belt and not to use the seat with a lap belt only.

Figure 12: Warning label on right side of belt positioning booster seat

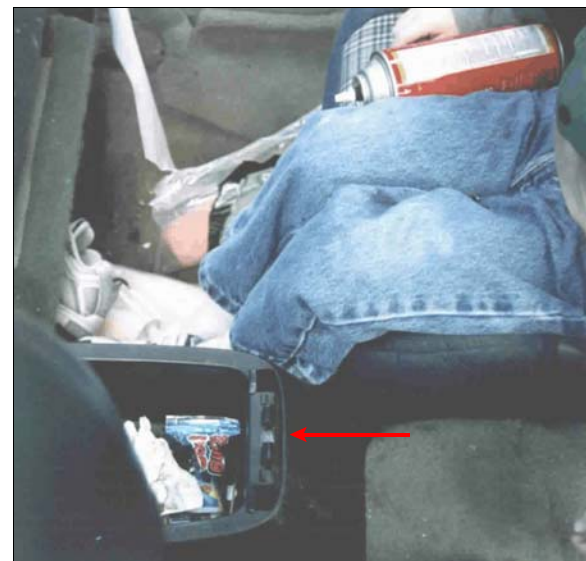
Figure 13: Police on-scene photo showing position of back right passenger relative to back of center console (arrow), passenger moved back to upright position

back of the center console (**Figure 13** above) causing a fracture and dislocation at the atlanto occipital joint, a laceration of the lower medulla oblongata, subarachnoid hemorrhage and subdural hematoma. This contact also produced a police-reported “C”-shaped abrasion on the left side of his head consistent with contact to the back corner of the center console. The back right passenger remained in his child safety seat as the case vehicle rotated counterclockwise and came to final rest. He was found at final rest leaned over to the left and his head and upper torso were resting on the back left seat cushion.

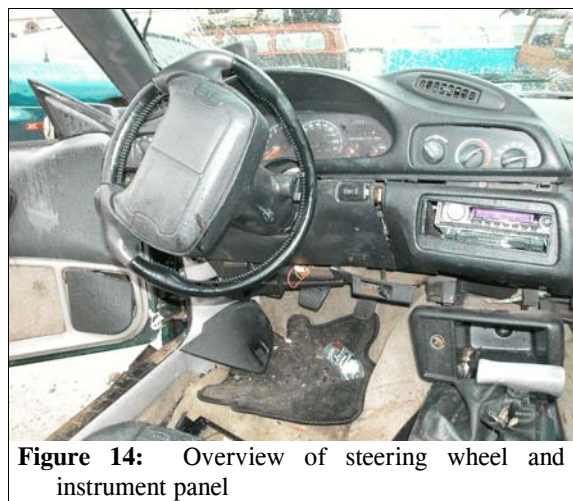
Figure 14: Overview of steering wheel and instrument panel

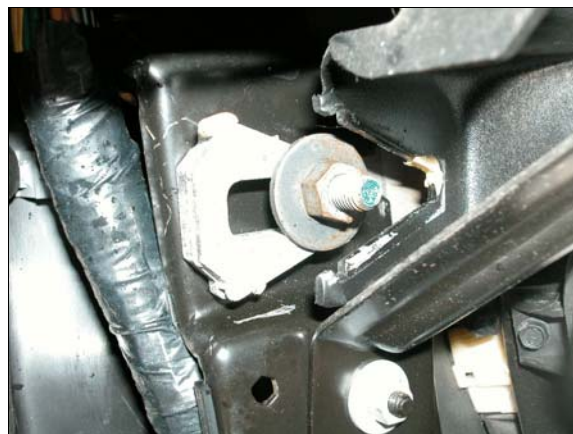
Figure 15: Separation of case vehicle’s right shear capsule and shear plate due to steering column loading by driver, left seat capsule also separated
