**CALSPAN ON-SITE SIDE IMPACT INFLATABLE OCCUPANT PROTECTION  
VEHICLE CRASH INVESTIGATION**

**CASE NO: CA06-007**

**VEHICLE: 2005 VOLKSWAGEN PASSAT**

**CRASH DATE: APRIL 2006**

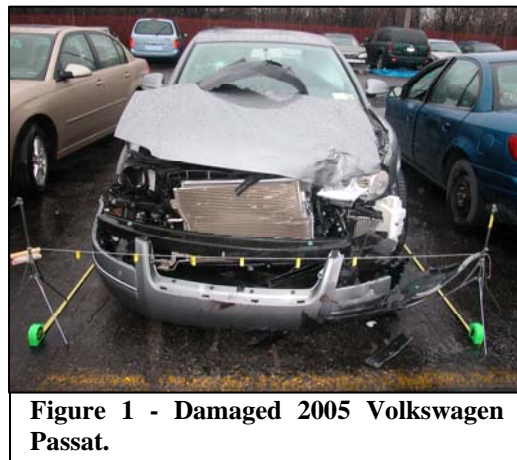
This on-site investigation focused on the performance of the seat back mounted side impact air bag and the Inflatable Curtain (IC) air bag system that deployed in a 2005 Volkswagen Passat (**Figure 1**). The Passat was equipped with dual stage frontal air bags for the driver and front right passenger positions, front seatback mounted side impact air bags, and IC air bags at the four outboard positions of the vehicle. The 33-year-old male driver occupied the vehicle and was restrained by the manual 3-point lap and shoulder restraint. The Passat was involved in an

**Figure 1 - Damaged 2005 Volkswagen Passat.**

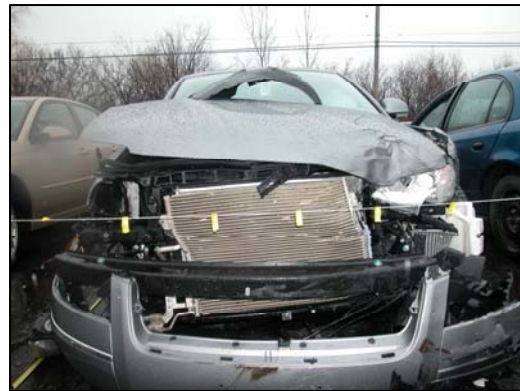
The 2005 Volkswagen Passat sustained moderate frontal damage (**Figure 4**) as a result of the impact with the right side of the 2000 Ford Taurus. The direct contact damage began 4 cm (1.5”) right of the vehicle’s centerline and extended 58 (22.8”) cm to the left front corner of the upper radiator support. Direct contact damage on the hood began 8 cm (3.0”) left of the vehicle’s centerline and extended 66 cm (26”) to the left. The vehicle’s Principal Direction of Force (PDOF) was 330 degrees. Due to the 11 o’clock direction of force, both front bumper energy-absorbing devices (EAD) shifted to the right. The right EAD displaced laterally 17 cm (6.5”) and the left 22 cm (8.5”). The left EAD separated from the frame rail. The maximum crush was located 34 cm (13.4”) left of the vehicle’s centerline and measured 9 cm (3.5”) in depth. The combined direct and induced damage measured 115 cm (45.5”), began at the left outermost point of the radiator support and terminated at the right outermost point of the same component. The Collision Deformation Classification (CDC) for the impact with the Taurus was 11-FDEW-1. Six equidistant crush measurements were documented along the upper radiator support and were as follows: C1 = 5 cm (2.0”), C2 = 9 cm (3.5”), C3 = 2 cm (0.8”), C4 = 4 cm (1.5”), C5 = 2 cm (0.8”), C6 = 1 cm (0.3”).

**Figure 3 - Frontal damage on 2005 Volkswagen Passat.**

A second crush profile was documented at the level of the bumper beam of the Passat. The bumper beam was partially detached due to the separation of the left EAD; therefore, the crush profile was not a true representation of the crush and not used to generate a delta-V. The direct contact damage on the bumper beam began 22 cm (8.5”) right of the vehicle’s centerline and extended 99 cm (39”) to the left front bumper corner. Due to bumper beam shifting to the right, the maximum crush was located at the right front bumper corner and measured 21 cm (8.3”) in depth. The combined direct and induced

damage measured 127 cm (50"). Six crush measurements were documented at the bumper level and were as follows: C1 = 0 cm, C2 = 0 cm, C3 = 1 cm (0.3"), C4 = 4 cm (1.5"), C5 = 10 cm (3.8"), C6 = 22 cm (8.5").

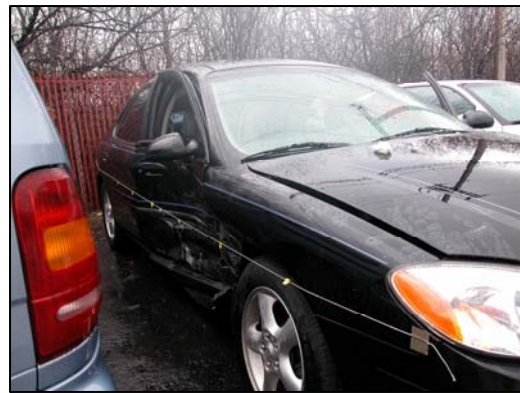
The 2000 Ford Taurus sustained moderate severity right side damage (**Figure 5**) as a result of the impact with the frontal aspect of the 2005 Volkswagen Passat. The direct contact damage began 130 cm (51.2") forward of the right rear axle and measured 105 cm (41.3) in length. The maximum crush was located 217 cm (85.4") forward of the right rear axle and measured 21 cm (8.3") in depth. The combined direct and induced damage began 72 cm (28.3") forward of the right rear axle and measured 217 cm (85.4) in length. The PDOF for the Taurus was 290 degrees. The CDC for the impact with the Passat was 02-RYEW-2. Six equidistant measurements were documented at the mid-door level and were as follows: C1 = 0 cm, C2 = 3 cm (1.2"), C3 = 19 cm (7.5"), C4 = 17 cm (6.7"), C5 = 3 cm (1.2"), C6 = 0 cm.

**Figure 5 - Right side damage 2000 Ford Taurus.**

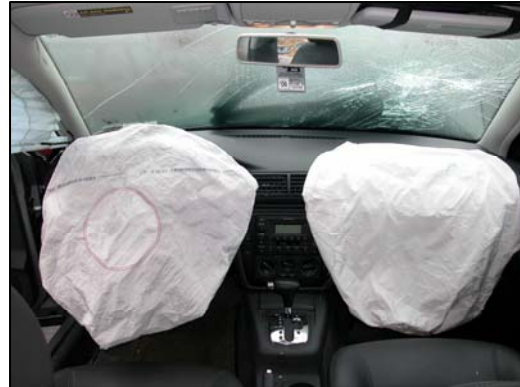
The 2005 Volkswagen Passat was equipped with redesigned frontal air bags for the driver and front right passenger positions (**Figure 6**). The driver's air bag was housed in the center of steering wheel hub and deployed through H-configuration module cover flaps. The symmetrical flaps were 17 cm (6.6") in width and 7 cm (2.8") in height. The driver's air bag measured 58 cm (22.8") in diameter in its deflated state. The air bag was internally vented and was tethered by four straps fixed in the 12, 3, 6, and 9 o'clock positions to a circular stitch pattern on the air bag that measured 18 cm (7") in diameter. Vinyl striations were present around the entire perimeter of the air bag from expansion against the module assembly.

**Figure 6 - Frontal air bag deployment - 2005 Volkswagen Passat.**

The front right passenger air bag deployed from a mid-mount module with a rectangular cover flap that was hinged at the forward aspect. The module cover flap measured 34 cm (13.3") in width and 20 cm (8") in height. The deployed front right passenger's air bag measured 46 cm (18") in width and 79 cm (31") in height in its deflated state. The air bag was internally vented and tethered. The cover flap was tethered by two straps 8 cm (3") in length and 4 cm (1.5") in width. The cover flap contacted and fractured the windshield. Damage was present on the flap at the bottom left corner and also 16 cm (6.3") inboard of the bottom left corner along the lower edge. Vinyl striations were present around the outer edge of the air bag with a heavy vinyl distribution on the underside of the bag.

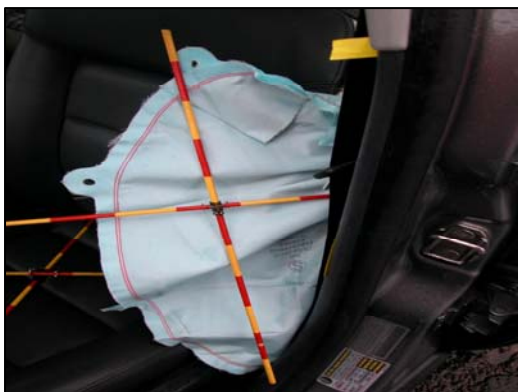
The driver's side impact air bag and left IC deployed as a result of the frontal impact with the 2000 Ford Taurus. The driver's side air bag deployed from the outboard aspect of the driver's seatback (**Figure 7**). The tear seam began at the top aspect of the seat back and descended vertically 53 cm (21") down the seatback. The vinyl fabric tear seam measured 51 cm (20") in height and 15 cm (5.8") in width. The underlying plastic flap beneath the vinyl fabric on the outboard plane of the seatback measured 22 cm (8.6") in height and 7 cm (2.8") in width. The driver's side impact air bag was semi-circular in shape and measured 58 cm (23") in height and 27 cm (10.5") in width. There was no occupant contact evidence on the side impact air bag. As the side impact air bag deployed, it contacted and fractured the plastic cover panel trim housing the B-pillar (**Figure 8**). The crack was linear in nature and was approximately 10 cm (4") rear of the panel's leading edge. The crack began 3 cm (1.2") below the beltline and extended 34 cm (13.5") downward. There was discernable contact evidence on the side impact air bag.

**Figure 7 - Deployed side impact seat bag - 2005 Volkswagen Passat.**

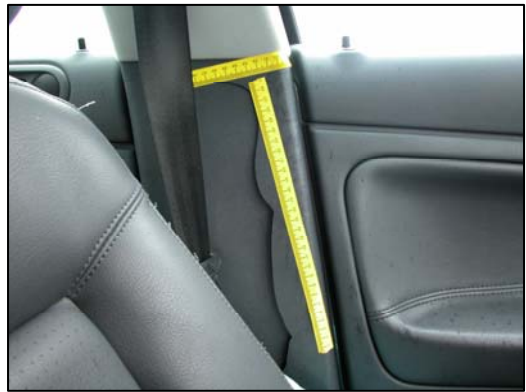
**Figure 8 - Fractured plastic trim - 2005 Volkswagen Passat.**

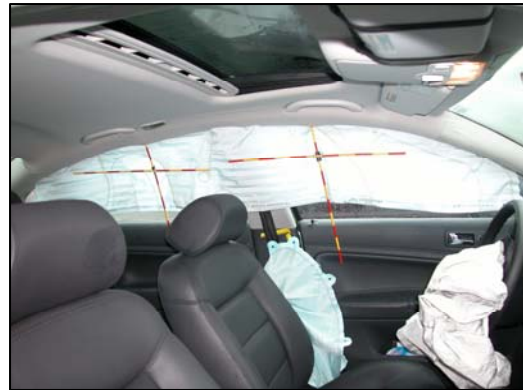
The left side IC deployed downward from the left roof side rail. The IC was rectangular at the C-pillar aspect and trapezoidal to the contour of the A-pillar at the forward aspect. The separation of the headliner measured 183 cm (72") between the left A-pillar and C-pillar. The left IC measured 184 cm in length and 32 cm (12.5") in height. Two 1.3 cm (0.5") diameter rope tethers secured the air bag. The front tether was 10 cm (4") in length and was affixed to the A-pillar, secured to the bottom aspect of the air bag. The rear tether was 18 cm (7") in length and was located 10 cm (4") below the roof side rail and 12 cm (4.7") above the beltline at the C-pillar. There was no occupant contact evidence on the IC. **Figure 9** illustrates the IC in its deflated state.

**Figure 9 – Deployed IC 2005 Volkswagen Passat.**

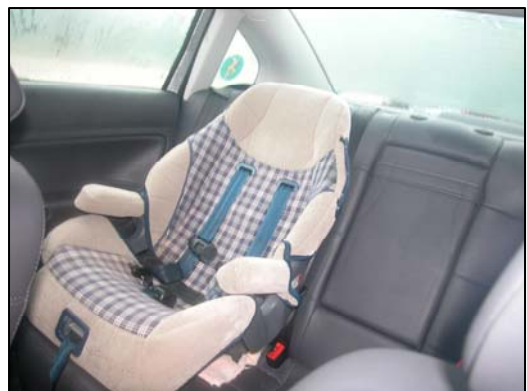
An unoccupied Cosco Eddie Bauer Dorel Juvenile Group forward-facing CSS was installed in the right rear seating position of the Passat (**Figure 10**). The Model Number was 22-859-HML HB4rA and the Date of Manufacture was 11/21/02. The CSS was designed for forward-facing use only. The CSS can be used for children weighing 10 kg (22 lb) to 18 kg (40 lb) utilizing the internal harness, and for children up to 132 cm (52") in height and between 14 kg (30 lb) and 36 kg (80 lb) as a belt positioning booster seat.

The CSS was installed using the lower anchor hooks of the Lower Anchors and Tethers for Children (LATCH) system, but not utilizing the top tether. A bath towel was placed under the leather seat for frictional purposes. The integral 5-point harness straps were routed through the top slots and a retainer clip was positioned 18 cm (7") below the same. The harness excursion was 67 cm (26.5") for the right strap and 53 cm (21") for the left. Lateral excursion of the CSS was 3 cm (1.2") to each side with no forward travel. The unused top tether was tucked between the child seat's internal seat cushion and its outer shell.

**Figure 10 - Forward-facing Child Safety Seat.**

The seat was also equipped with OEM armrests. The CSS was not damaged during the crash events.

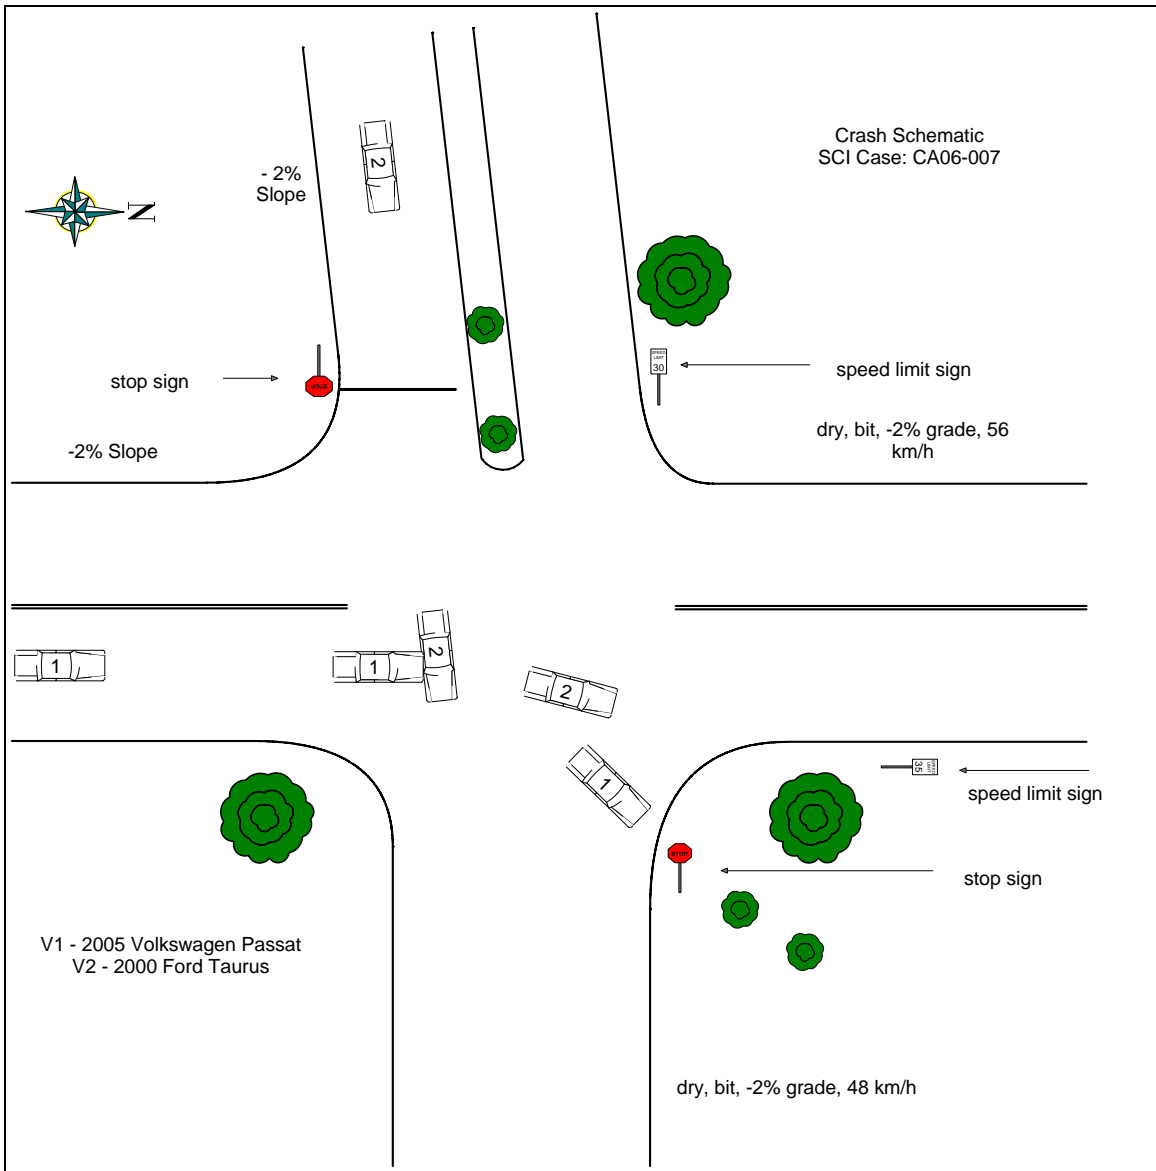
**Figure 11 – Scene Schematic**

This two-vehicle crash occurred at the northeast quadrant of a four-leg intersection during daylight conditions. At the time of the crash, the weather was clear and the asphalt roadway was dry. The north/south roadway was configured with two travel lanes, one in each direction, and was separated by a double yellow painted centerline. The northbound and southbound lanes were 6.5 meters (21.3') and 6 meters (19.7') in width, respectively. The east leg of the east/west roadway consisted of a two-lane unmarked asphalt roadway that was 9.4 m (30.8') in width. The west leg consisted of a two-lane asphalt roadway separated by center grassy median enclosed by mountable concrete curbs. The west leg of the roadway was offset of the intersection at an angle of -15 degrees. Each lane was 6 m (19.7') in width and the center median was 2.2 m (7.2') wide. The east/west roadway was controlled by stop signs and the posted speed limit was 48 km/h (30 mph). The posted speed limit for the north/south roadway was 56 km/h (35 mph). The roadside environment consisted of residential properties and natural growth. The scene schematic is included as **Figure 11** at the end of this narrative report.
