CALSPAN ON-SITE CHILD SAFETY SEAT CRASH INVESTIGATION

CALSPAN CASE NO: CA06-009

VEHICLE: 2005 CHEVROLET COBALT

CRASH DATE: MARCH 2006

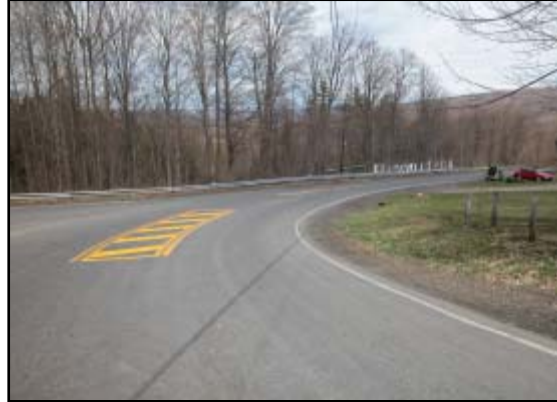
The 20-year-old female driver was operating the vehicle eastbound to southbound while negotiating the right curve through the intersection (**Figure 2**). As she began to travel in a southerly direction, the driver relinquished directional control of the Cobalt and departed the right side of the road in a tacking mode (**Figure 3**). The Chevrolet traveled 5.2 meters (17 feet) off-road traversing a lawn area to the point of impact.

Figure 2. Pre-crash travel for the Cobalt.

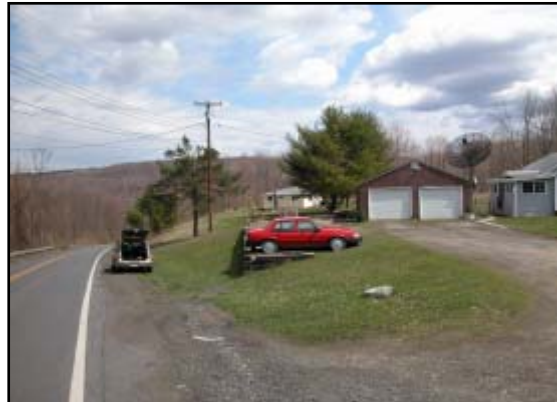
Figure 3. Right roadside departure.

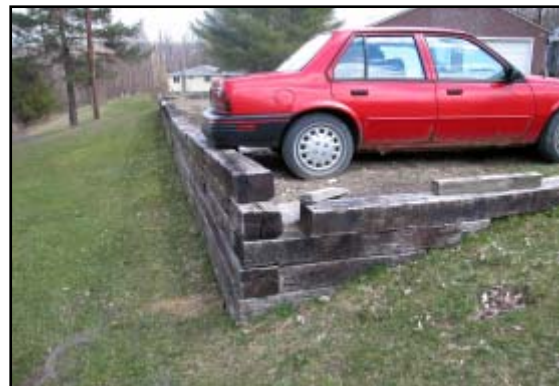
The front center area of the Cobalt struck the exposed corner of the wood retainer wall, which arrested the vehicle's trajectory (**Figure 4**). The vehicle came to final rest against the wood retainer wall facing a southerly direction. The resultant direction

Figure 4. Area of impact with the wood retainer wall,

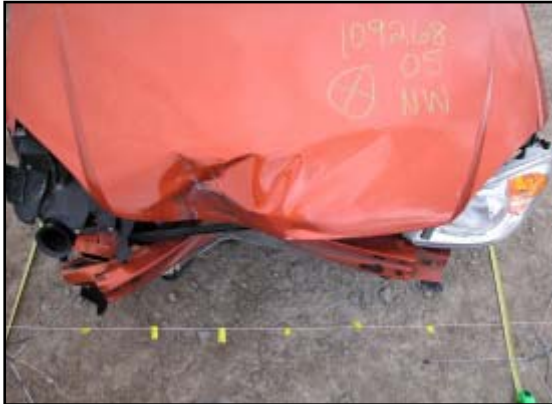
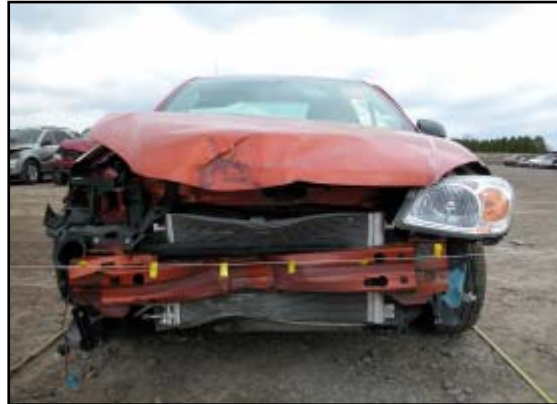
The 2005 Chevrolet Cobalt sustained moderate severity frontal damage as a result of the impact with the wood retainer wall (**Figures 5 and 6**). Maximum crush was 36 cm (14.2”), located 14 cm (5.5”) inboard of the right end of the bumper beam. The direct

Figure 5. Overhead view of the frontal damage.

Figure 6. Frontal view of the crush to the Cobalt.

contact damage began 5 cm (2”) right of the vehicle’s centerline and extended 28 cm (11”) to the right end of the bumper beam. The residual crush was measured along the full width of the deformed bumper beam (Field L) of 86 cm (34”). Six equidistant crush measurements were documented at this level and were as follows: C1 = 4 cm (1.6”), C2 = 18 cm (7.1”), C3 = 28 cm (11”), C4 = 36 cm (14.2”), C5 = 17 cm (6.7”), C6 = 0 cm. Damaged components included the hood, front bumper fascia and reinforcement beam, grille, and radiator. The Collision Deformation Classification (CDC) for this impact was 12-FCEN-2.

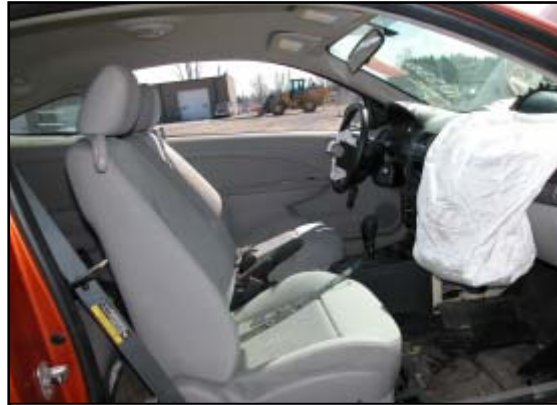
The interior of the Chevrolet sustained minor interior damage that was attributed to the frontal air bag deployment. Both air bags deployed as designed from the respective modules. The minor severity crash did not produce intrusion to the passenger compartment.

The corners of the front right air bag cover flap contacted and fractured the windshield glazing at two locations. There was no damage attributed from occupant contact points. **Figure 7** is an overall view of the interior.

Figure 7. Overall of the interior first row.

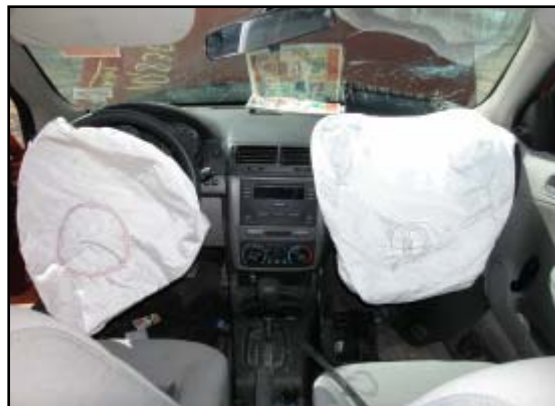
The Chevrolet was equipped with dual-stage frontal air bags for the driver and front right passenger positions. The system deployed as a result of the impact sequence with the wood retainer wall (**Figure 8**).

The driver's air bag was contained within the four-spoke steering wheel rim and concealed by two I-configuration cover flaps. Both flaps were 9 cm (3.5") wide and 11 cm (4.5") in height at the horizontal tear seam. The air bag membrane measured 53 cm (21") in diameter in its deflated stated and was tethered by two internal tethers at the 12/6 o'clock positions. Two vent ports that were located on the backside of the bag at the 11 and 1 o'clock sectors vented the bag into the passenger compartment. The maximum rearward excursion of this bag at the tether locations was 33 cm (13"). There was no damage or evidence of driver contact on the deployed air bag.

Figure 8. Deployed frontal air bag system.

The front right passenger air bag was a top-mount design, incorporated into the right instrument panel. A single cover flap concealed the bag which measured 32 cm (12.6") wide at the horizontal tear seam and 23 cm (9") in depth. There was no damage or contact evidence to the cover flap. The air bag measured 43 cm (17") in width and 66 cm

(26") in height. A single tether strap at the mid point tethered the air bag membrane. Two ports vented the front right air bag at the 11 and 1 o'clock positions on the side panels. The maximum rearward excursion of this bag at the midpoint measured 43 cm (17"). No occupant contact evidence or damage was noted to the front right air bag.

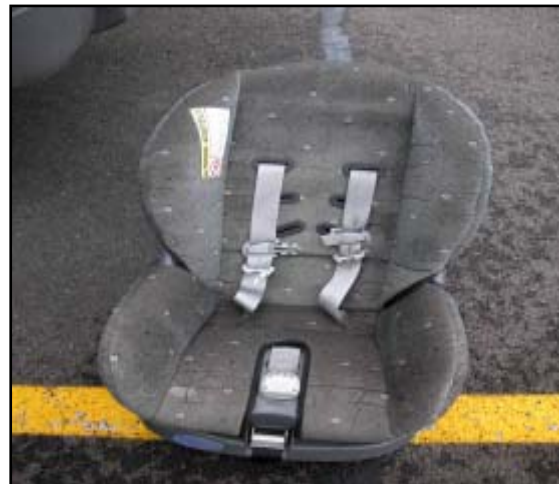
The 15-month-old male was restrained in the rear right position of the Cobalt. He was seated in a Graco Comfort Sport convertible child safety seat (**Figure 9**) and was restrained by the integrated five-point harness system. The safety seat model number was 8433F0F and was manufactured on 05/19/05. The child seat was placarded with a label that advised against usage after year 2011. The following was also placarded on the safety seat:

Figure 9. Graco child safety seat.

stated to the SCI investigator that she installed the child safety seat by routing the vehicle’s lap and shoulder belt through the rear belt path. The LATCH system was not utilized for this installation. She pulled out the webbing to engage the ALR to ensure the safety belt was locked in place. The driver stated that the child safety seat was installed tightly with minimal movement at the belt path. However, she did not apply weight on the safety seat in order to spool in additional webbing for a tighter installation. The inspection of the child safety seat revealed no damage or loading marks.

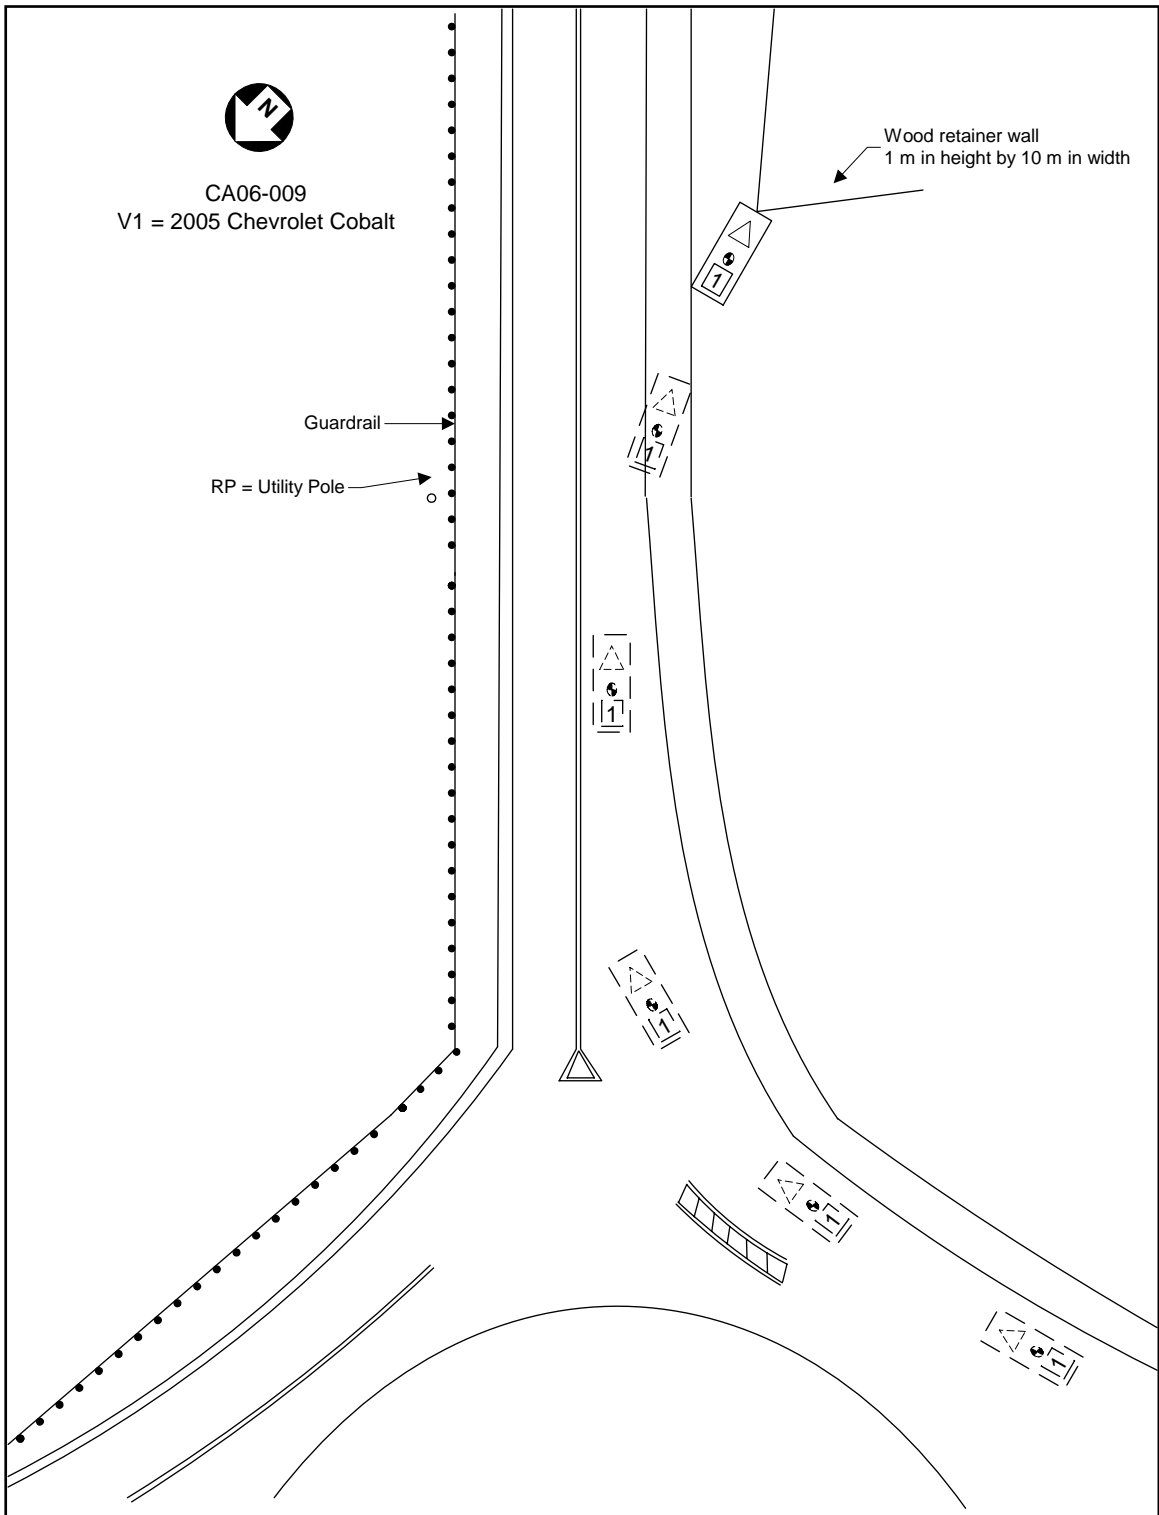
Figure 10: Scene Schematic

This run-off road crash occurred on the roadside of a two-lane north/south road in a rural, residential area. The travel lanes were 3 meters (9.8 feet) in width and delineated by double yellow centerlines. A negative grade of 2 percent was present for the southbound travel direction. White fog lines bordered the travel lanes. A 2.1-meter (6.9 feet) gravel shoulder extended beyond the east fog line. The southbound lane curved right at the area of the crash. Located immediately north of the crash site was a three-leg intersection that was not controlled for southbound travel. The east roadside consisted of a grass embankment and a wood retainer wall. The retainer wall was 1.1 meters (3.6 feet) in height was constructed of railroad ties and was built into a hillside around the perimeter of a parking area. There was no posted speed limit within the vicinity of the crash site; therefore, the speed limit defaults to the state limit of 89 km/h (55 mph). The scene schematic is included as **Figure 10** of this report.
