**CALSPAN ON-SITE CHILD SAFETY SEAT
VEHICLE CRASH INVESTIGATION**

CASE NO: CA06-010

VEHICLE: 1989 CHEVROLET BLAZER

CRASH DATE: MAY 2006

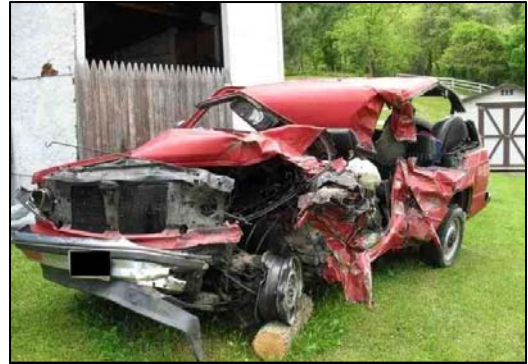
This investigation focused on the performance of a rear-facing infant Child Safety Seat (CSS) that was placed in the rear right position of a 1989 Chevrolet Blazer. The Blazer (**Figure 1**) was occupied by an unrestrained 47-year-old female driver, an unrestrained 2-year-old male seated in the rear left position, and a 9-month-old female who was restrained in an infant CSS in the rear right seating position of the vehicle. The Blazer was involved in a head-on crash with a 1996 Ford F-350 straight truck after crossing the centerline of the roadway and entering the F-350's travel lane. The Blazer sustained severe front and left side damage as the result of the impact. The

Figure 1 - Damaged 1989 Chevrolet Blazer

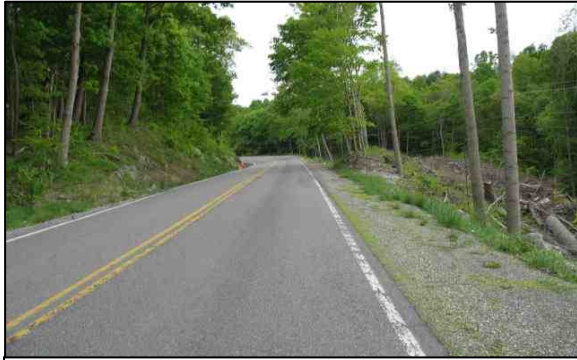
Figure 2 - Northbound approach of 1996 Ford F-350

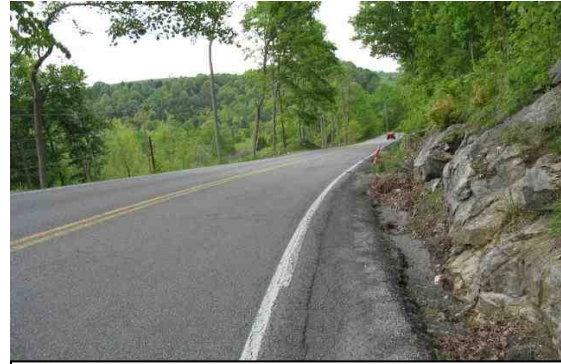
(**Figure 3**) was straight at the point of impact, but had just diverged from a sharp right curve 8 m (26.2') prior to the point of impact. The roadway was bordered by gravel and natural growth. The west roadside was 2.5 m (6.4') in width before declining steeply down a hillside. A 1 m (3.3') wide ditch was present on the east roadside before ascending up a steep hillside. The posted speed limit was 64 km/h (40 mph). The scene schematic is included as **Figure 15** of this narrative report.

Figure 3 - Southbound approach of 1989 Chevrolet Blazer.

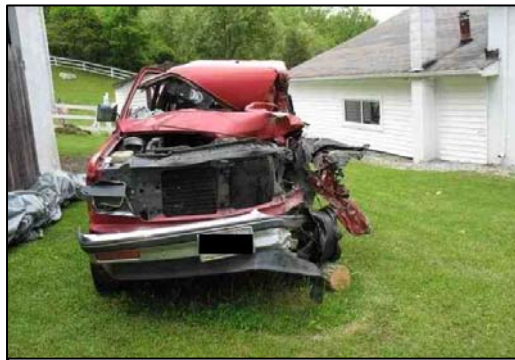
The 1989 Chevrolet Blazer sustained severe frontal and left side damage due to the off-set frontal impact with the front and left side, including the cargo box, of the 1996 Ford F-350 Super-Duty straight truck (**Figure 4**). The direct contact damage began 27 cm (10.7") left of the vehicle's centerline and extended 48 cm (18.9") to the left front bumper corner. A width of 19 cm (7.5") of the chrome bumper at the left front corner was separated and discarded prior to the SCI investigation. The separation was outboard of the frame rail and the crush profile was not altered due to this separation. The position of the left corner was estimated resulting in a Field L measurement of 144 cm (56.7"). The maximum crush was located at the front left bumper corner and measured 55 cm (20.5) in depth. The direction of force for the Blazer was 12 o'clock. The Collision Deformation Classification (CDC) was 12-FLEW-3. Six equidistant crush measurements were documented along the bumper beam and were as follows: C1 = 55 cm (20.5"), C2 = 18 cm (5.9"), C3 = 10 cm (2.8"), C4 = 5 cm (0.8"), C5 = 1 cm, C6 = 0 cm. The C1 measurement was estimated due to the separated front bumper.

Figure 2 - Damaged frontal plane - 1989 Chevrolet Blazer.

The greatest extent of the crush was located outside the frame rail, which allowed engagement onto the left side structure. The Blazer's front left wheel was damaged due to contact with the front left wheel of the F-350. This engagement fractured the tie-rod, tore the sidewall and tread

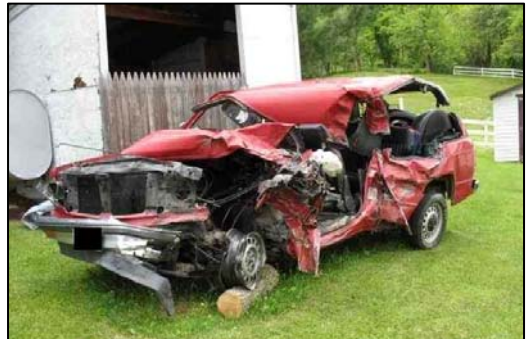
As the vehicles continued to engage, the Blazer's left front wheel yielded allowing the F-350 to partially ramp up the front end of the Blazer and contact the left side, left A-pillar, and the roof (**Figure 5**). The direct contact damage down the left side of the Blazer extended from the front left bumper corner 323 cm (127.2") rearward, before terminating 112 cm (44.1") forward of the left rear bumper corner. The front left fender was peeled rearward and laterally 46 cm (18") outboard of the vehicle's baseline. The left side sustained crush from the F-350 along the mid-door level. The maximum crush on the left side was located 20 cm (8") rear of the B-pillar and was 34 cm (13.5") in depth. The left A-pillar was deformed laterally 42 cm (16.5") into the passenger compartment and the roof was deformed 44 cm (17.5") vertically from contacting the front bumper and cargo box of the F-350. The Blazer's hood protruded through the windshield and into the passenger compartment reaching a maximum encroachment of 11 cm (4.5") located 21 cm (8.3") inboard of the lower left aspect of the windshield. The right aspect of the Blazer's hood shifted from its original position 69 cm (27") to the left. Direct contact damage was present on the vehicle's cowl beginning at its left most aspect and extending to the right 20 cm (8"). The front left door of the vehicle was removed by the emergency personnel and was not available for an inspection.

Figure 3 - Damaged left side of 1989 Chevrolet Blazer.

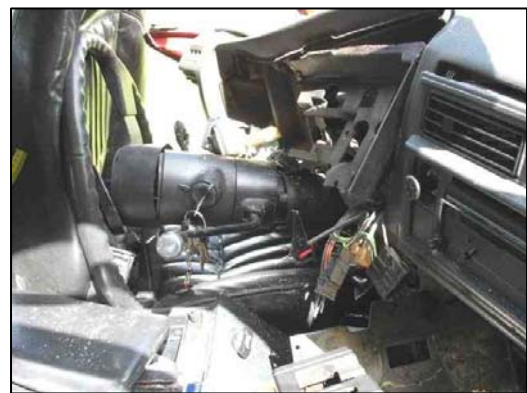
The 1989 Chevrolet Blazer sustained severe interior damage as a result of passenger compartment intrusion (**Figure 6**). The static intrusions were altered due to the extrication measures performed by the emergency personnel. All three left side and the right side A- and C- pillars were mechanically cut. The instrument panel was displaced forward and several components were manually detached post-crash, presumably by rescue efforts. The steering column intruded into the passenger compartment 20 cm (8"). The spokes and mounting flange of the wheel assembly were deformed from occupant loading. The column compressed from the shear capsules and the steering assembly collapsed.

Figure 6 - Front left seating area of 1989 Chevrolet Blazer.

The fractured lower instrument panel was the result of passenger compartment intrusion and in all probability direct contact of the driver's lower extremities. The bottom of the left sun visor sustained a fabric tear located 13 cm (5") inboard of the far left aspect and 20 cm (7.9"), inboard of the far right aspect. It was possible that this component was contacted by the driver; however, considering the level of intrusion, it was more likely due to an intruding component. The roof intruded both longitudinally and vertically into all three frontal sectors and the windshield header

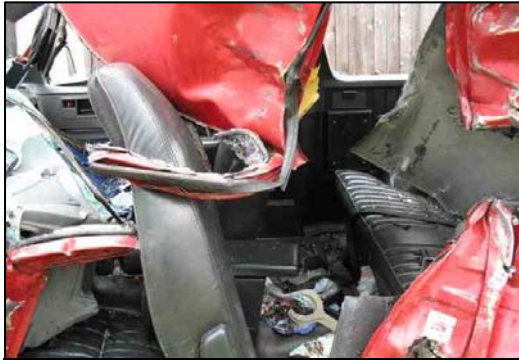
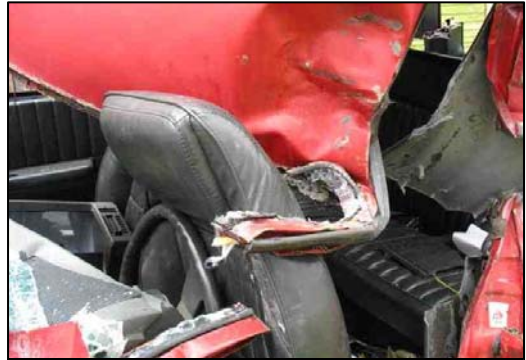
Figure 7 - Left A-pillar in relation to seat back.

Figure 8 - Left A-pillar in relation to seat back.

intruded vertically into the front left and center sectors. The floor pan and toe pan intruded moderately into front left sector and the left A-pillar intruded laterally 25 cm (9.8”). Despite an absence of distinct physical evidence at the vehicle inspection, witnesses recall the driver as being pinned between the intruded roof and the front left seat back. It is likely that the driver contacted the left instrument panel, and the front bumper and potentially the cargo box of the F-350. The post-crash position of the left aspect of the roof was found to be rear of the driver’s seat at the time of the SCI inspection. Due to the height of the seat back in relation to the roof (**Figures 7 and 8**), emergency personnel probably manually lifted the roof and adjusted the seat back forward after removing the driver to allow access to the rear left occupant.

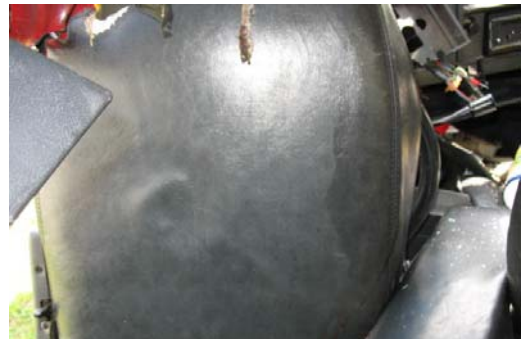
The back aspect of the front left seat back contained direct contact evidence and body fluid transfers from the 2-year-old child seated in the rear left position. A scuff was present on the lower left aspect of the seat back that measured 5 cm (2”) in length. A linear blood transfer located 3 cm (1.2”) inboard of the right aspect of the seatback was present beginning at the bottom aspect and ascending vertically 18 cm (7.3”) (**Figure 9**). Pooled blood was present on the second row floor in the center and left seating positions. The plastic panel housing of the left B-pillar sustained two linear cracks 6 cm (2.5”) in length and an underlying scuff mark. The left side B-pillar and side panel intruded laterally into the second row left seating position.

Figure 9 – Loading and body fluids on seat back.

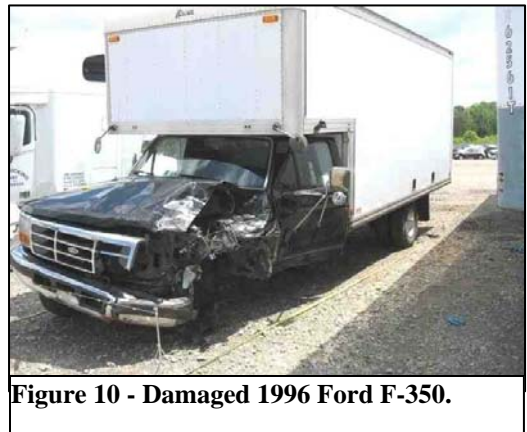
The 1996 Ford F-350 sustained moderate damage as a result of the offset frontal impact with the 1989 Chevrolet Blazer (**Figure 10**). The direct contact damage across the vehicle's bumper beam began 16 cm (6.3") left of the vehicle's centerline and extended 64 cm (25") to the left front bumper corner. The direct contact damage across the vehicle's hood began at the hood's left corner and extended 62 cm (24.5") to the right. The direct and induced damage extended the full width of the bumper beam and measured 170 cm (67"). The crush profile was projected

slightly due to the altered state of the vehicle. The crush profile stands were set from the rear axle forward 555 cm (218.5") to include the original wheelbase and front overhang. The maximum crush was located at the front left bumper corner and was 31 cm (12.2") in depth. The front left wheel was fractured from the axle and was not present during the SCI inspection. Due to the offset manner in which this impact occurred, subsequent direct contact damage extended 153 cm (60.2") down the left side of the cab aspect of the F-350. Red paint transfers from the Blazer accompanied the direct damage on the left side of the F-350. The direction of force for the F-350 was 12 o'clock. Six equidistant crush measurements were documented along bumper beam and were as follows: C1 = 31 cm (12.2"), C2 = 5 cm (2"), C3 = 2 cm (0.8"), C4 = 0 cm C5 = 0 cm, C6 = 0 cm. The CDC for the impact with the Blazer was 12-FYEW-2.

Figure 10 - Damaged 1996 Ford F-350.

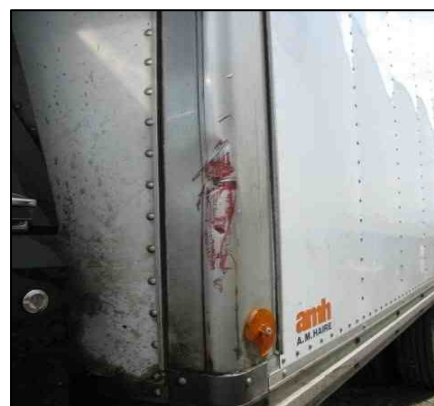
As the engagement between the two vehicles continued, the F-350 partially climbed the front end and contacted the Blazer's A-pillar, windshield, and roof before separating. The cargo box (**Figure 11**), which protruded 25 cm (10") outboard of the vehicle's bodyline contacted the Blazer's roof. The ground clearance for the cargo box was 66 cm (26") in height. The direct contact damage on the cargo box measured 5 cm (2") in width across the horizontal plane; the direct contact damage on the cargo box began 18 cm (7") above the bottom aspect and was 46 cm (18") in height. A wide-body mirror was present outboard the vehicle's cab and protruded laterally 40 cm (15.5"). A red paint transfer was present along the horizontal mirror brace,

Figure 11 - Damaged cargo box on Ford F-350.

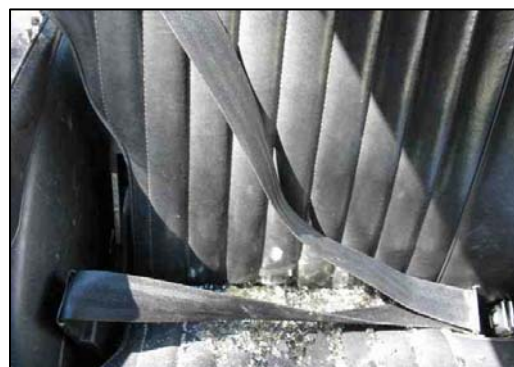
The rear seat was equipped with manual 3-point lap and shoulder belts for the outboard positions. Each was configured with continuous loop webbing, a locking latch plate, and an ELR. The rear right belt was found in the engaged position at the time of the SCI inspection. The rear right safety belt was used to improperly install a rear-facing CSS. The belt’s latch plate was still buckled at the time of the SCI inspection (**Figure 12**); however, the shoulder portion of the belt was cut by witnesses 34 cm (13.5”) below to the retractor housing was cut as the child was removed from the vehicle following the crash. The CSS was found in the cargo bay of the Blazer during the SCI inspection. Rippling and cupping of the lap belt was present and the webbing was twisted one rotation. The belt was stretched in various locations and loading evidence was present on the lap belt portion of the belt system. The loading evidence was located 23 cm (9.1) from the position of the buckled latch plate and again 51 cm (20.1”) forward thereof. The evidence was consistent with the length of the front aspect of the CSS, which is 36 cm (14”) in width. No loading marks were present on the rear right D-ring. Due to glass and fluid

Figure 12 - Rear right lap and shoulder restraint.

absorption material strewn into the back seating area, it was difficult to isolate corroborative physical evidence on the seat cushion. Considering the upside-down position of the CSS post-crash, it is probable that the restraint was loose. As the CSS engaged the loosely installed belt system, the top aspect of the CSS engaged the belt system allowing the bottom aspect to move in a forward trajectory against the low frictional vinyl surface of the seat cushion and submerge the belt-system. As the CSS was disengaging from the belt system, it tracked forward while the child was suspended in an upside-down position, and became wedged in-between the rear seat cushion and the front right seat back.

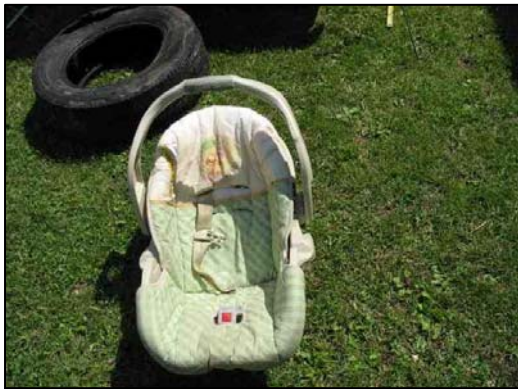
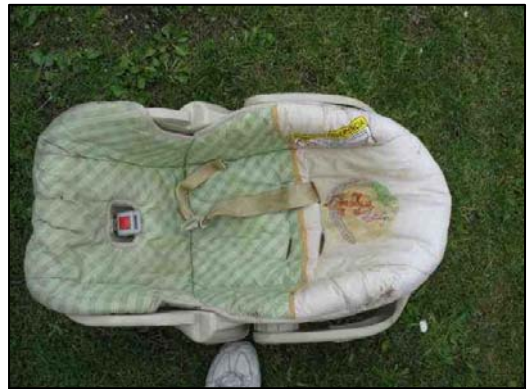
A rear-facing infant CSS was installed in the rear right seating position of the Chevrolet Blazer. The model number was 7454WNN and the date of manufacture was March 22, 2003. The infant seat was configured with a three-point harness system and a two-piece locking harness retainer clip. The CSS was designed for rear-facing only, and for children weighing 9 kg (20 lb) or less and whose height was 66 cm (26”) or less. The child’s weight was 10 (22 lb) and her height was 74 cm (29”), both of which exceeded the designated parameters of the CSS. The CSS is illustrated in **Figures 13 and 14**.

Figure 13 - Frontal view of rear-facing CSS.

Figure 14 - Lateral view of rear-facing CSS.

The CSS was removed from the vehicle and found in the cargo area of the vehicle during the SCI inspection. The CSS was installed without the detachable base and the integrated harness straps had been cut by a passerby who removed the child prior to the arrival of emergency personnel. The left strap was routed through the top harness slots and the retainer clip was positioned 27 cm (10.5”) from the top harness slot and 18 cm (7.3) above the cut point. The remainder of the harness was not contained within the vehicle.
