Certified Advanced 208-Compliant Air Bag Investigation/Vehicle to Objects
Dynamic Science, Inc./Case Number: DS06011
2006 Chevrolet Cobalt
Nevada
March 2006

1. Report No. DS06011		2. Government Accession No.		3. Recipient Catalog No.	
4. Title and Subtitle Certified Advanced 208-Compliant Air Bag Investigation				5. Report Date July 28, 2006

Background

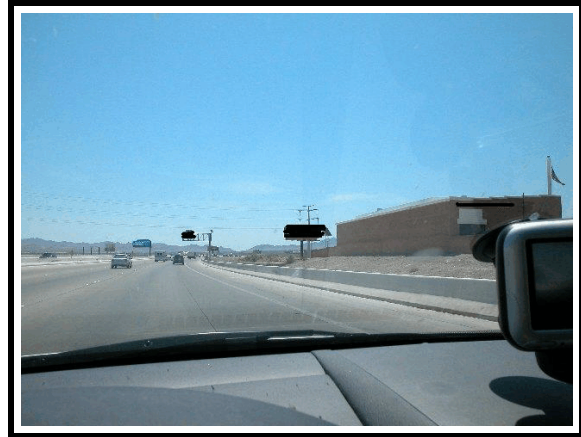
Figure 3. Approach of case vehicle to area of impact (south)

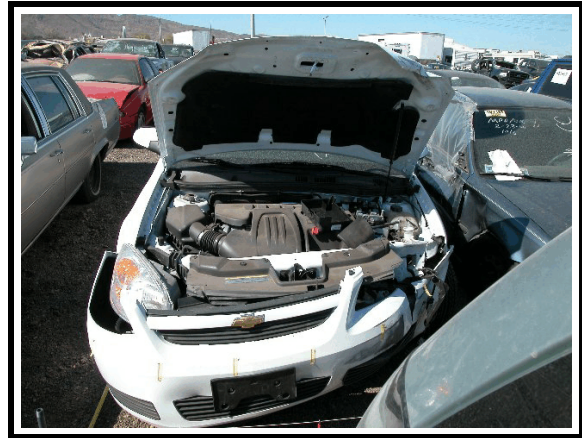
The 2006 Chevrolet Cobalt sustained moderate front end damage as a result of the first impact with the concrete barrier. The case vehicle sustained 30.0 cm (11.8 in) of direct damage along the front bumper, beginning at the left front bumper corner, extending to the right. The left wheelbase was shortened by 2.0 cm (0.8 in). Six crush measurements were documented along the front bumper as follows: C1=36.0 cm (14.1 in), C2=34.0 cm (13.4 in), C3=20.0 cm (7.9 in), C4=18.0 cm (7.1 in), C5=14.0 cm (5.5 in), C6=22.0 cm (8.6 in).

Figure 4. Front - 2006 Chevrolet Cobalt

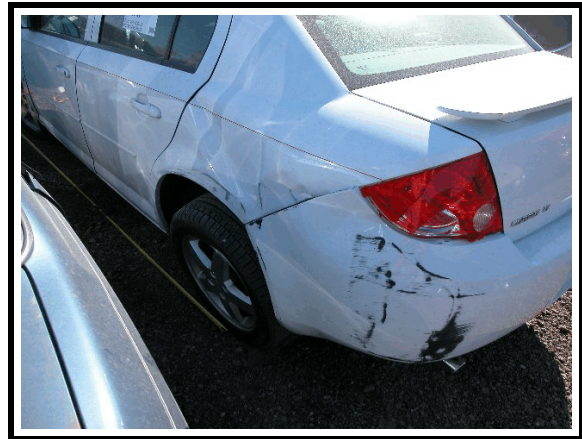
The case vehicle sustained moderate left side damage as a result of the secondary impact with the concrete barrier. The case vehicle sustained 108.0 cm (42.5 in) of direct damage along the left side beginning at the left rear bumper corner, extending forward along the left side of the vehicle. The bottom of the left rear tire was angled inward as a result of the impact. Four crush measurements were documented along the left side as follows: C1=10.0 cm (3.9 in), C2=8.0 cm (3.1 in), C3=4.0 cm (1.6 in), C4=4.0 cm (1.6 in).

Figure 5. Left rear damage - 2006 Chevrolet Cobalt

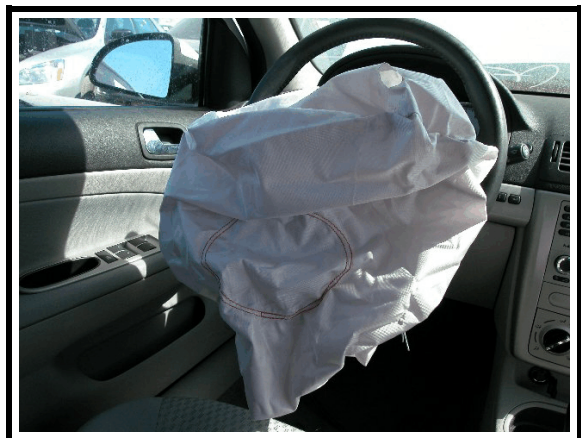
Figure 6. Driver's deployed air bag

The driver's air bag deployed from the center of the steering wheel hub through symmetrical I-configuration cover flaps. Each flap measured 7.0 cm (2.8 in) wide and 11.0 cm (4.3 in) high, with a semi-circular cutout located in the center of the flaps. The deployed driver air bag measured 45.0 cm (17.7 in) in diameter in its deflated state. The air bag had no tethers. There were two circular vent ports that were located at the 11 and 1 o'clock positions on the rear of the air bag. There was no damage or occupant contact visible on either the cover flaps or air bag.

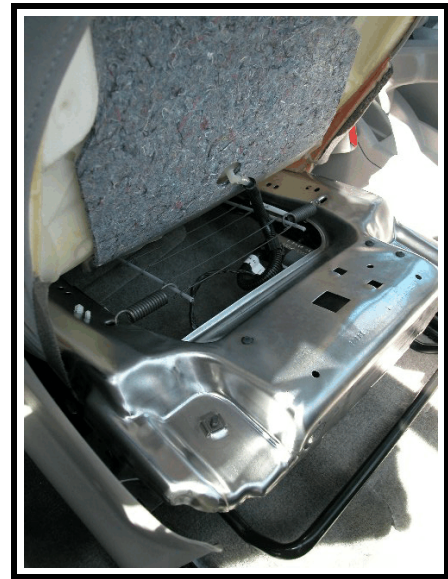
The front right passenger air bag was a top instrument mount. The air bag did not deploy.

Figure 7. Occupant sensors -
Front right seat

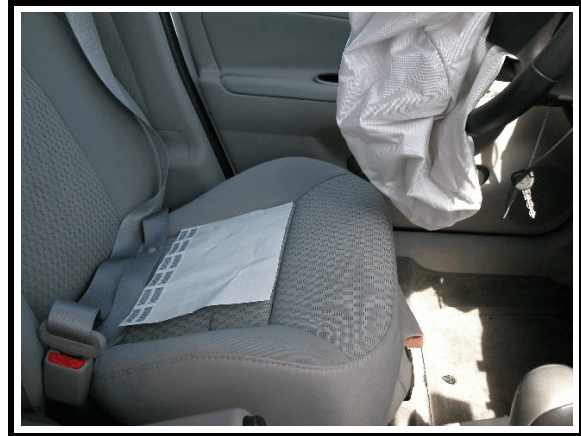
The driver's B pillar seat belt pretensioner actuated during the collision and was locked in place post-crash. The front right seat belt retractor also actuated and was locked in the stowed position.

Figure 8. Driver’s seat belt (Retractor pretensioner actuated)

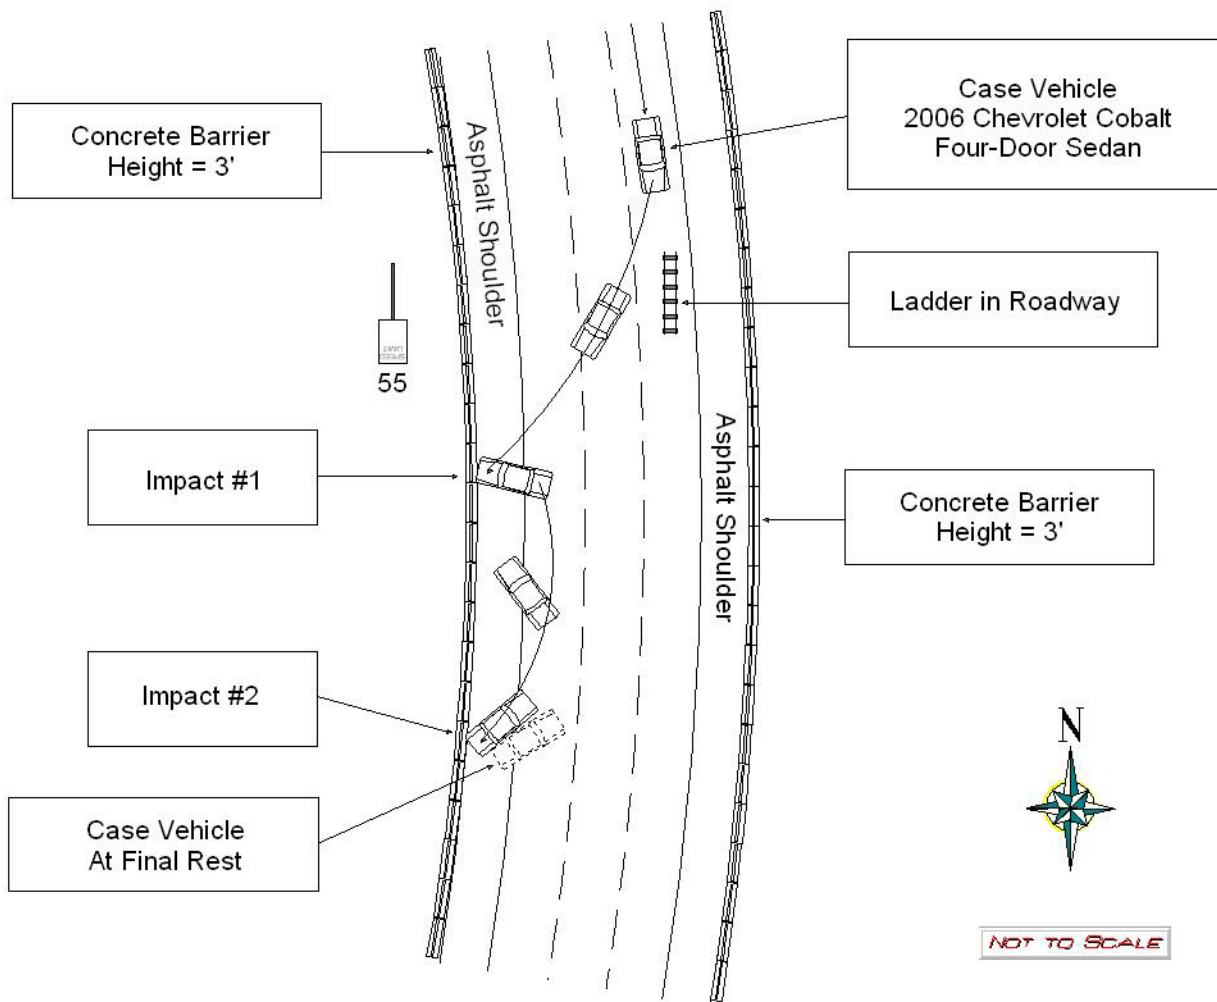
Attachment 1. Scene Diagram

When the driver steered right, she lost control of the vehicle and the Cobalt began a clockwise rotation. As the vehicle continued its rotation, it crossed over the other two southbound lanes and the front of the vehicle (11FYEE2) struck the right side concrete barrier, resulting in the deployment of the driver's front air bag. The barrier equivalent routine of the WinSmash program computed a total delta V of 32.0 km/h (19.9 mph). The longitudinal and lateral components were -30.1 km/h (-18.7 mph) and 10.9 km/h (6.8 mph), respectively. The vehicle continued its rotation and struck the barrier a second time with its left rear (09LBEW2). The vehicle came to rest in the right lane, facing northeast.
