ON-SITE CHILD SAFETY SEAT INVESTIGATION

CASE NUMBER - IN-06-012

VEHICLE - 1999 OLDSMOBILE ALERO GX

CRASH DATE - May 2006

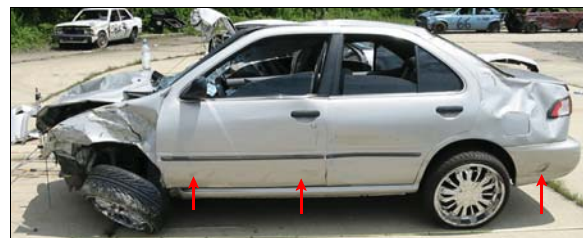
Figure 2: Damage to left side of Nissan from sideswiping right side of Chevrolet, arrows show tire marks from Chevrolet's left front wheel, damage on upper quarter panel is from rollover

the case vehicle; however, it appeared that the damage began at the front of the left fender. The direct damage then extended down the Nissan’s entire left side. There was also rubber transfer on the left side of the Nissan from contact with the Chevrolet’s left front wheel during the sideswipe.

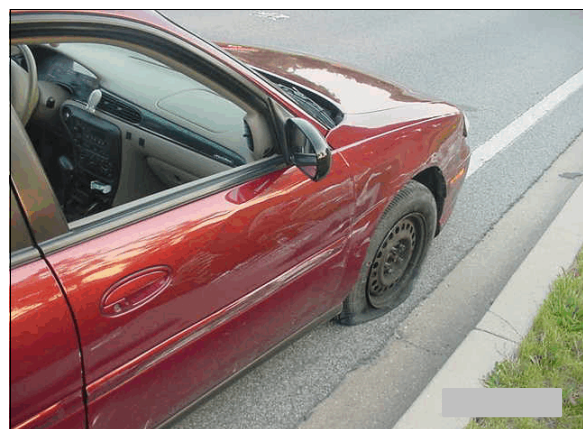
Figure 3: Police photo showing sideswipe damage to right side of Chevrolet from impact with left side of Nissan

Exterior Damage: The Chevrolet's sideswipe impact with the Nissan involved the right front door, right fender and right corner of the front bumper. The direct damage began at the back of the right front door and extended to the front right bumper corner. The right front wheel was also involved and was flat. The Chevrolet's other sideswipe impact involved the front left bumper corner and the left fender. The direct damage began at the front left bumper corner and extended rearward to the front of the left front wheelhouse. The Chevrolet was under repair at the time of this contractor's investigation and was not inspected. Therefore, no damage measurements were obtained.

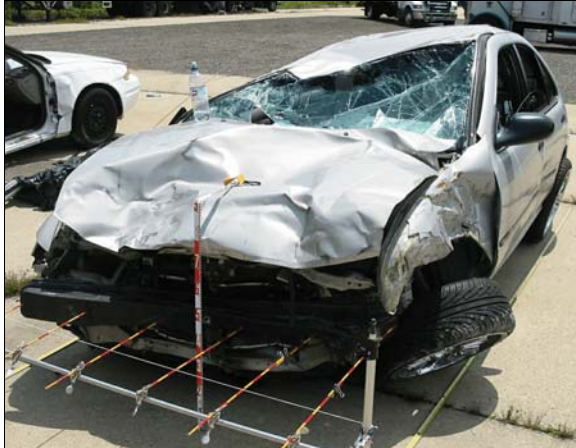
Figure 4: Damage to front of Nissan from impact with back of case vehicle, increments on vertical scale are tenths of meter, each increment on rods is 5 cm (2 in)

The Nissan’s impact with the back of the case vehicle involved the front end. The Nissan’s front bumper, left fender, grille and hood were directly contacted and crushed rearward. The direct damage began at the front left bumper corner and extended 128 centimeters (50.4 inches) across the front end. The Nissan’s maximum residual crush was determined to be 63 centimeters (24.8 inches) occurring at C₁. The table below shows the Nissan’s crush profile.

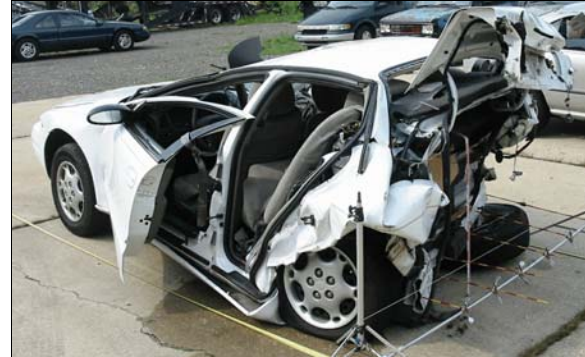
Figure 5: Damage to back of case vehicle from impact with front of Nissan, baseline set 100 cm (39.4 in) short of overall length due to insufficient length of measurement rods to capture totality of crush

Exterior Damage: The case vehicle’s impact with the Nissan involved the back end. The case vehicle’s back bumper, both quarter panels and the trunk lid were directly damaged and extensively crushed forward. The direct damage began at the back right bumper corner and extended 145 centimeters (57.1 inches) across the bumper. Crush measurements were taken at the back bumper bar. The maximum residual crush was determined to be 134 centimeters (52.8 inches) occurring at C₆. The table below shows the case vehicle’s back crush profile.

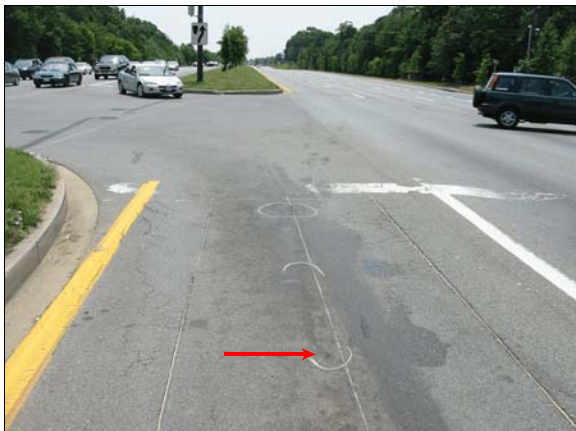
Figure 6: Point of impact in southwestbound left turn lane, arrow shows gouge marks in pavement from crash

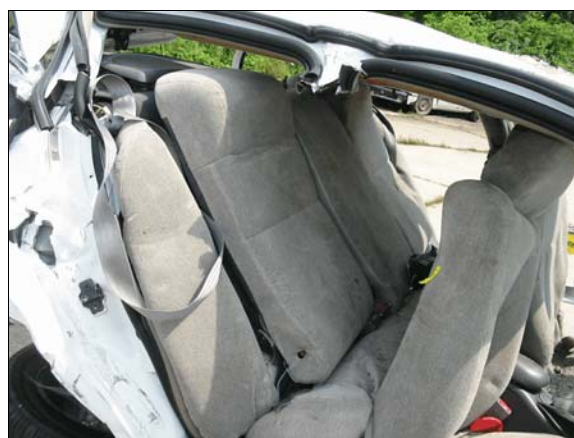
Vehicle Interior: Inspection of the case vehicle's interior revealed occupant contact evidence on the roof over the front and back seating rows, on the backs of the front seats, on the back seating row seat backs, on the right sunvisor and on the right windshield. The case vehicle sustained numerous passenger compartment intrusions. The most severe intrusions occurred to the back seat (**Figure 10**). The back seat, seat back intruded longitudinally 65 centimeters (25.6 inches) into the back left occupant space, 74 centimeters (29.1 inches) into the back center occupant space and 82 centimeters (32.3 inches) into the back right occupant space. Lastly, there was no deformation of the steering wheel and no compression of the energy absorbing steering column.

Figure 10: Intrusion of case vehicle's back seat, view from passenger side

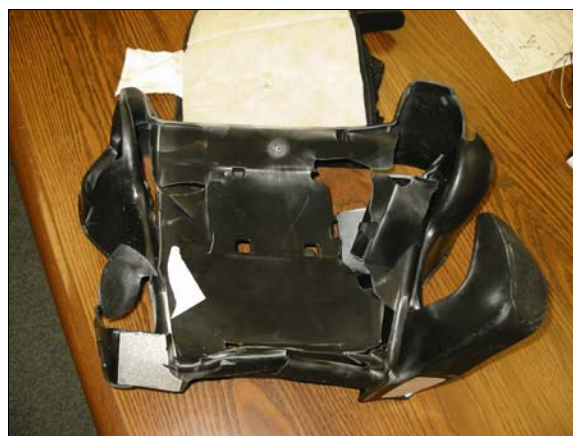
Inspection of the back right passenger's booster seat revealed severe damage to the entirety of the booster seat (**Figure 11**). The damage to the booster seat indicated it had been severely compressed between the front right seat back and the intruding back right passenger's seat back causing numerous breaks in the plastic throughout the seat.

Figure 11: Case vehicle's back right passenger's booster seat

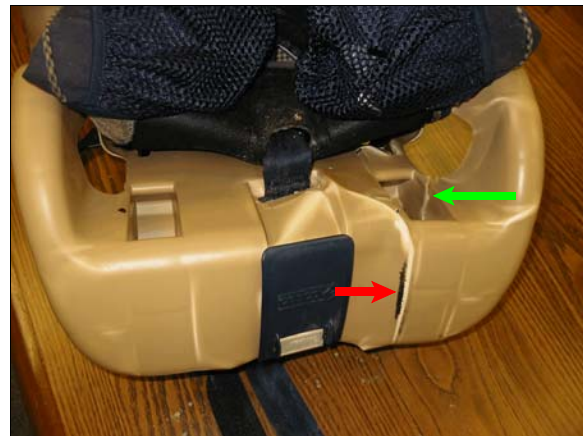
Inspection of the back center passenger's child safety seat revealed that the front and bottom of the seat cushion and the lower right side had been bent causing stress marks in the plastic. There was a fabric transfer from the child seat cover on the front left portion of the seat cushion (**Figure 14**) indicating the child seat had been forced into the driver's seat back during the crash. The lower left side of the child seat also had been heavily deformed, and the lower left portion of the seat cushion had been deformed to the extent that the plastic had broken (**Figure 14**). On the back of the child seat, the recline adjuster was broken. The damage to the child safety seat indicated that the seat was compressed between the front seat backs and the intruding back center passenger's seat back during the crash.

Figure 14: Damage to back center passenger's child safety seat, red arrow show fabric transfer on front of seat cushion, green arrow shows fractures in plastic

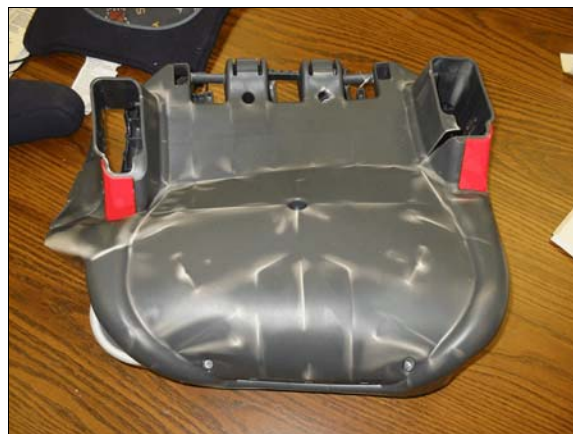
Figure 15: Deformation to case vehicle's back left passenger's booster seat

Inspection of the back left passenger's booster seat revealed extensive bending and stress marks to the entirety of the booster seat (**Figure 15**). In addition, the base of the seat was partially separated from the seat cushion. The damage to the booster seat indicated it had been compressed between the driver's seat back and the intruding back left passenger's seat back during the crash.

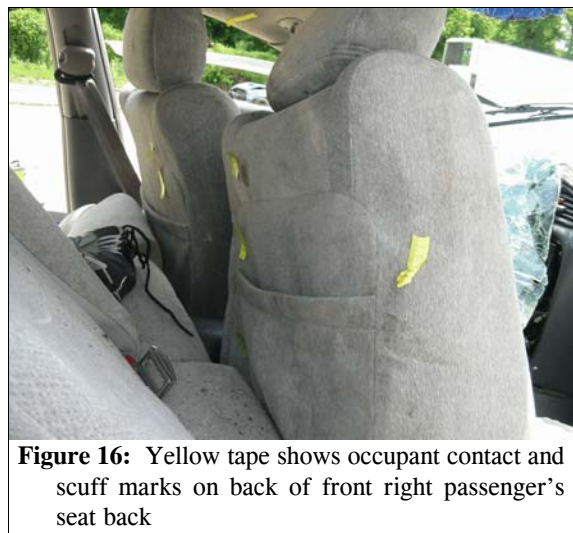
Figure 16: Yellow tape shows occupant contact and scuff marks on back of front right passenger's seat back

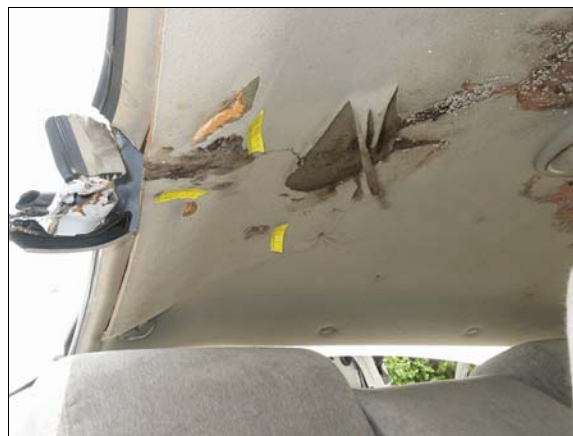
Figure 17: Blood stains and possible occupant contact on roof above back right seat position

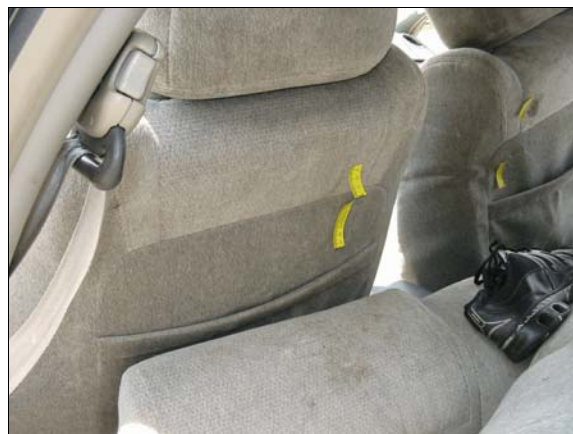
Figure 18: Occupant contact marks on driver's seat back

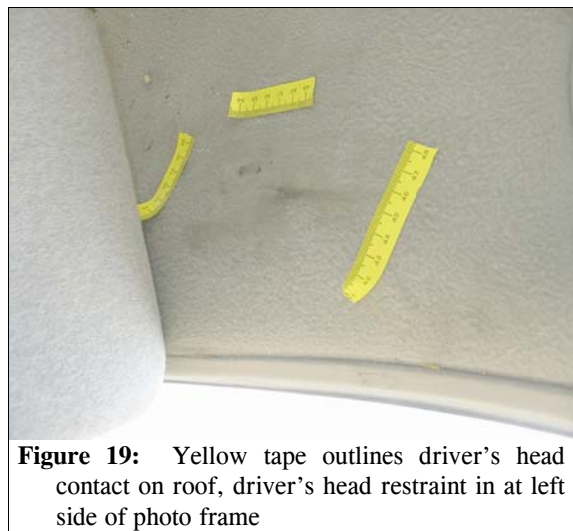
Figure 19: Yellow tape outlines driver’s head contact on roof, driver’s head restraint in at left side of photo frame
