## ON-SITE CERTIFIED ADVANCED 208-COMPLIANT VEHICLE INVESTIGATION

CASE NUMBER - IN-06-013

LOCATION - NORTH CAROLINA

VEHICLE - 2005 MERCURY MARINER

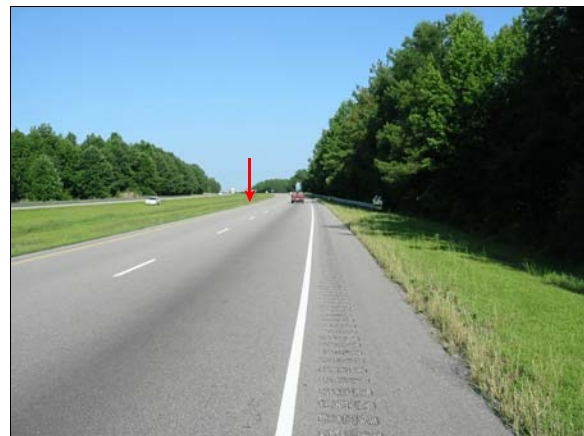
**Figure 1:** Overview of case vehicle's eastbound approach roadway, arrow shows area of onset of case vehicle's yaw mark furrows in median

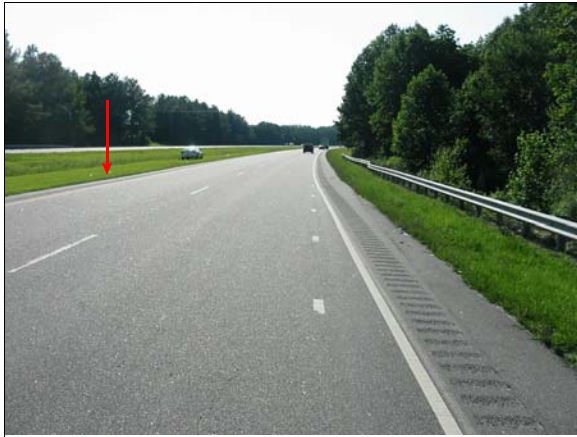
**Figure 2:** Approach of Saturn westbound in outside lane and overview of impact area in foreground, arrow shows area where case vehicle entered westbound lanes

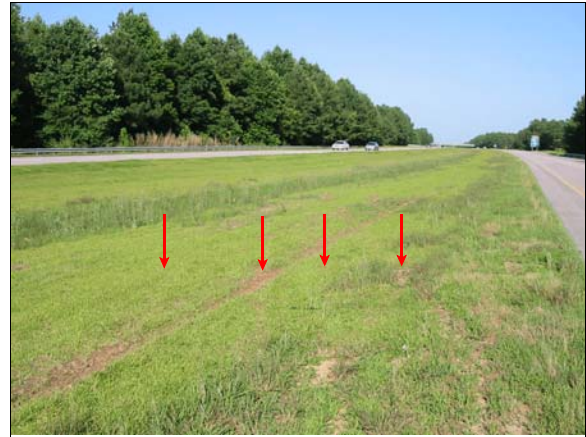
**Figure 3:** Case vehicle's yaw mark furrows in median, arrows show yaw marks, marks are from left to right: left front, right front, left rear and right rear

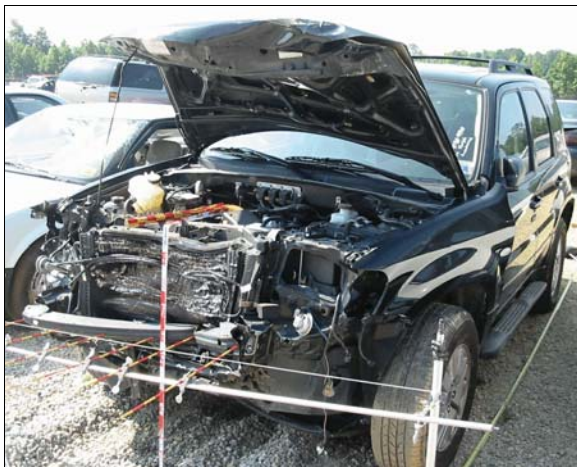
**Figure 4:** Damage to front of case vehicle from impact with the Saturn, increments on vertical scale in tenths of meter

**Crash:** The case vehicle's front left (**Figure 4**) impacted the Saturn's front right (**Figure 5**) causing the case vehicle's driver and front right passenger air bags to deploy. The crash also caused the Saturn's driver and front right passenger air bags to deploy.

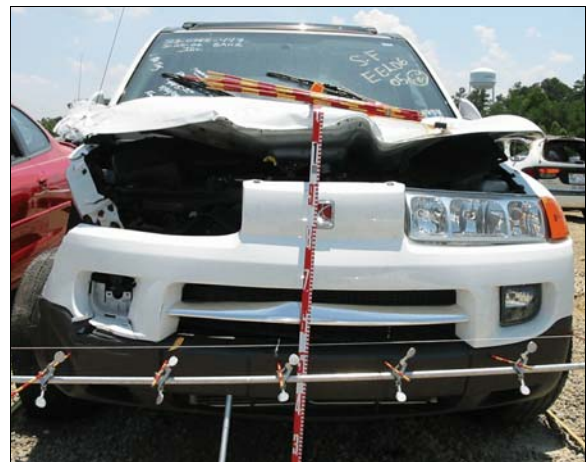
**Figure 5:** Damage to Saturn's front right corner from impact with case vehicle, deformations at middle of hood are not crash related, hood was pried open

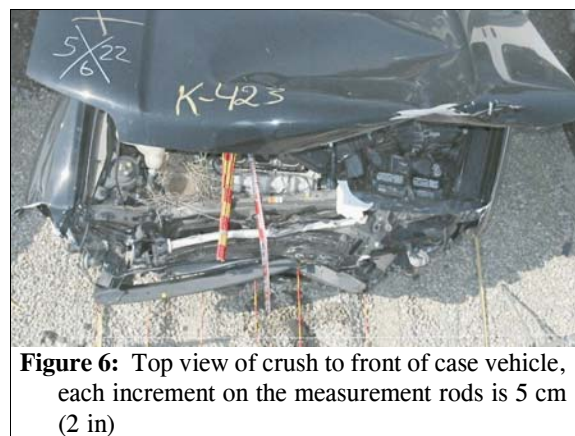
**Exterior Damage:** The case vehicle’s impact with the Saturn involved the front end. The front bumper, grill, and hood were directly damaged and crushed rearward and to the right. The direct damage began at the front left bumper bar corner and extended 104 centimeters (40.9 inches) across the front end. The bumper fascia and grille were missing. Crush measurements were taken at the bumper bar, and the maximum residual crush was measured as 24 centimeters (9.5 inches) occurring at C<sub>2</sub> (**Figure 6**). The table below shows the case vehicle’s front crush profile.

**Figure 6:** Top view of crush to front of case vehicle, each increment on the measurement rods is 5 cm (2 in)

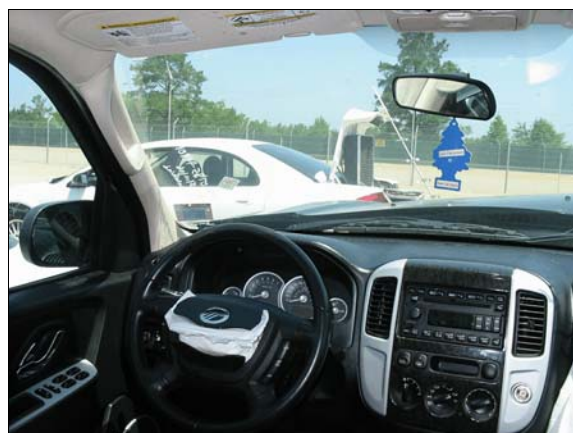
**Vehicle Interior:** Inspection of the case vehicle’s interior (Figures 7 and 8) revealed a possible make-up scuff at the top of the driver’s air bag and a possible skin transfer on the upper right quadrant of the front right air bag. There was no other evidence of occupant contact to any of the vehicle’s interior surfaces or components. There were no passenger compartment intrusions and no evidence of deformation of the steering wheel or energy absorbing steering column.

Figure 7: Case vehicle’s steering wheel, instrument panel and windshield

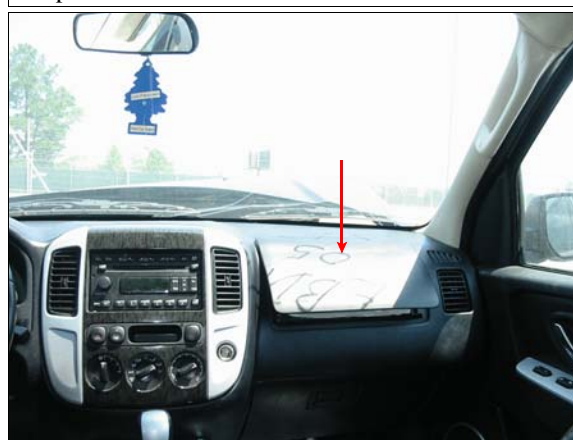
Figure 8: Case vehicle’s center and right instrument panel, arrow shows front right passenger air bag module cover flap

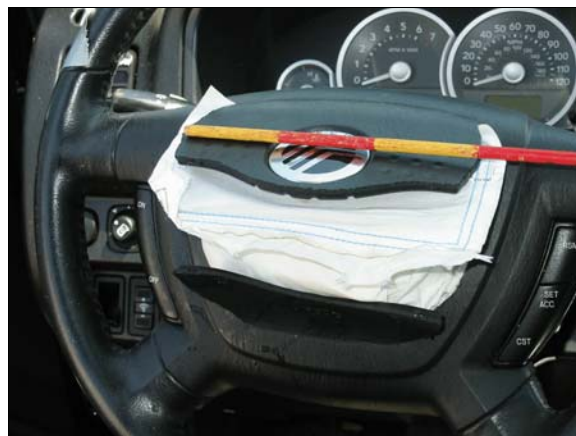
The case vehicle's driver air bag was located in the steering wheel hub. The air bag module was constructed with "H"-configuration cover flaps (Figure 9) constructed of pliable vinyl. The upper cover flap was constructed with the manufacturer's logo in the middle, which created a rounded contour at the horizontal tear seat. This contour fit into a rounded cut-out in the lower cover flap. The upper cover flap's overall dimensions were 15 centimeters (5.9 inches) in width and 9 centimeters (3.5 inches) in height. The lower cover flap's dimension's were 15 centimeters (5.9 inches) in width and 3 centimeters (1.2 inches) in height at the middle and 5 centimeters (2 inches) in height on each side. An inspection of the air bag module cover flaps and the air bag fabric revealed that the cover flaps opened at the designated tear points. There was no evidence of damage during the deployment to the air bag module cover flaps or the air bag fabric. The deployed driver's air bag (Figure 10) was round with a diameter of approximately 54 centimeters (21.3 inches). The air bag was designed with two tether straps, each approximately 10 centimeters (3.9 inches) in width and had two vent ports, each 3 centimeters (1.2 inches) in diameter, located at the 3 and 9 o'clock positions. The distance between the mid-center of the driver's seat back, as positioned at the vehicle inspection (seat track in middle position, seat back slightly reclined), and the air bag at approximate full excursion was 35 centimeters (13.8 inches). Inspection of the driver's air bag revealed a possible make-up scuff on the top right quadrant of the air bag. In addition, there were a few dark scuffs, possibly related to deployment, and an area of discoloration on the left portion of the air bag that appeared to be a liquid stain.

**Figure 9:** Case vehicle's driver air bag module cover flaps

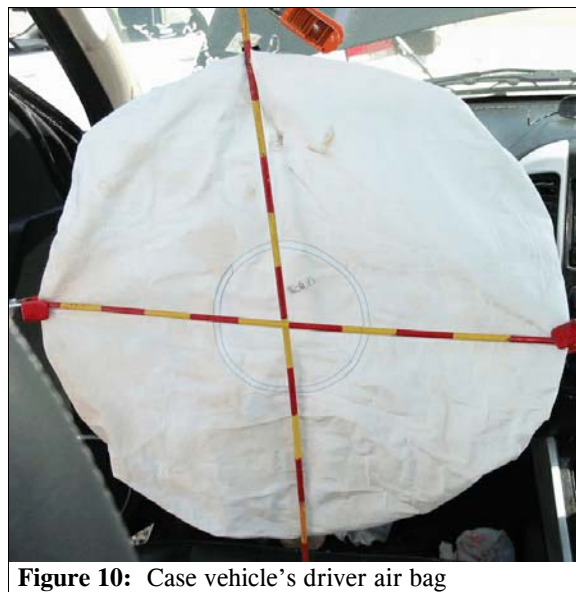
**Figure 10:** Case vehicle's driver air bag

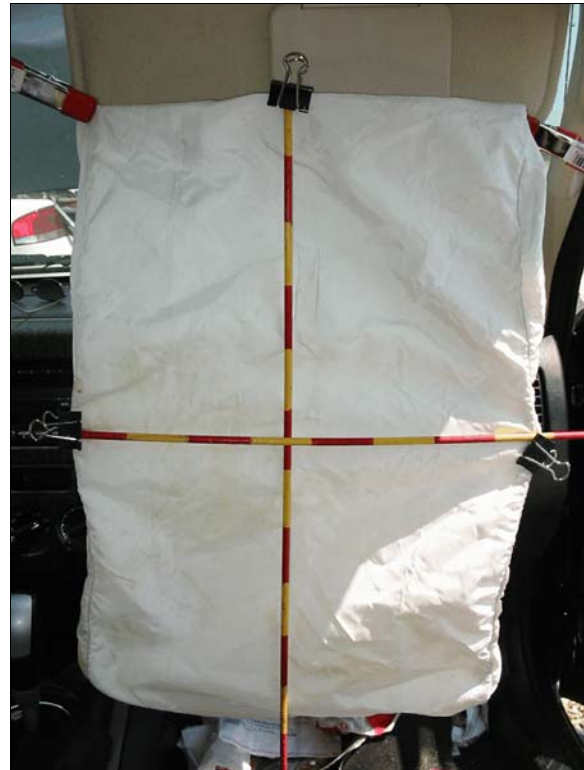
The front right passenger air bag was located in the middle of the right instrument panel (Figure 8 above). The air bag module was constructed with a single rectangular-shaped cover flap. The cover flap's overall dimensions were 33 centimeters (13 inches) in width and 22 centimeters (8.7 inches) in height. An inspection of the cover flap and the air bag fabric revealed that the cover flap opened at the designated tear points. There was no evidence of damage during the deployment to the air bag module cover flap or the air bag fabric. The deployed front right air bag (Figure 11) was rectangular and was approximately 60 centimeters (23.6 inches) in height and approximately 39 centimeters (15.4 inches) in width. The air bag was designed without tether straps and had two vent ports, each 6 centimeters (2.4 inches) in diameter, located at the 9:30 and 2:30 o'clock positions. The distance between the mid-center of the front right passenger's seat back, as positioned at the vehicle inspection (seat track between rear-most and middle position, seat back slightly reclined), and the air bag at approximate full excursion was 43 centimeters (16.9 inches). Inspection of the air bag revealed a possible skin transfer on the right upper quadrant. There were also numerous dark scuffs, possibly related to the deployment, as well as an area of discoloration on the left portion of the air bag that appeared to be liquid stains.

Figure 11: Case vehicle's front right passenger air bag

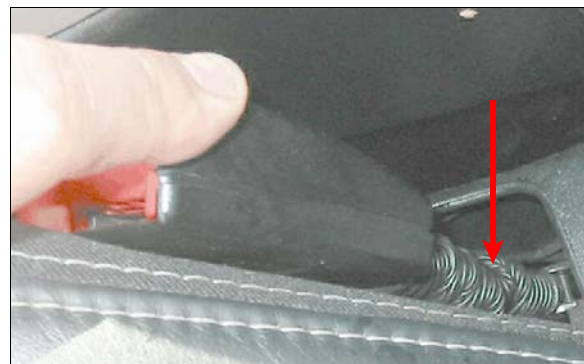
Figure 12: Case vehicle driver's safety belt buckle stalk, arrow shows retracted buckle stalk due to activation of the pretensioner

The evidence indicates the case vehicle's driver was restrained by her manual, three-point, lap-and-shoulder, safety belt system. The driver's buckle-mounted pretensioner actuated in the crash (Figure 12).

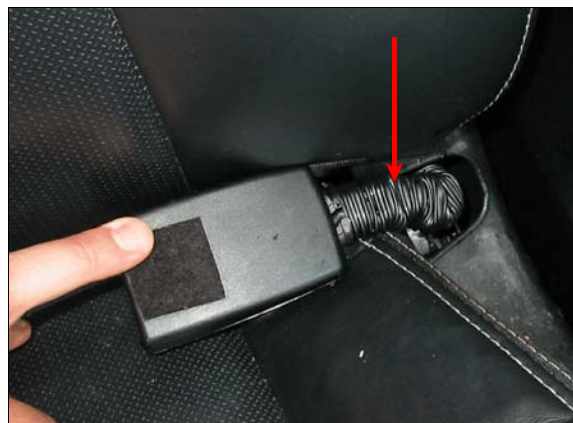
The evidence indicates the case vehicle's front right passenger was restrained by her manual, three-point, lap-and-shoulder, safety belt system. The passenger's buckle-mounted pretensioner actuated in the crash (**Figure 13**).

**Figure 13:** Case vehicle's front right passenger safety belt buckle, arrow shows retracted buckle stalk due to activation of pretensioner

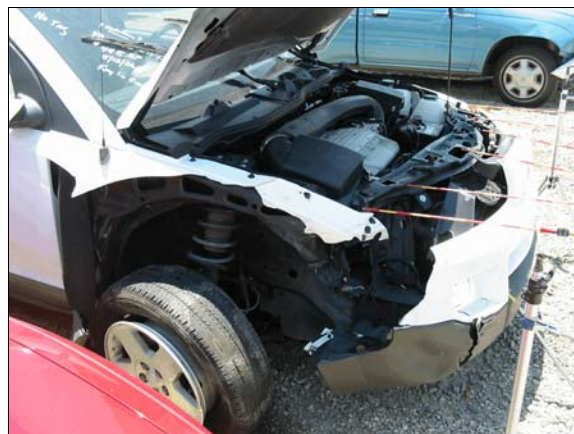
**Exterior Damage:** The Saturn’s impact with the case vehicle involved the front right corner of the vehicle. The right portion of the front bumper fascia, right headlamp/turn signal assembly, fog lamp, grille, hood and right fender were directly contacted and crushed rearward. In addition, the plastic right fender was broken. Due to the length of the front bumper bar, it was minimally engaged. The primary engagement occurred to the right front wheel (**Figure 14**), which was crushed rearward 13 centimeters (5.1 inches). The direct damage began at the front right bumper corner and extended 29 centimeters (11.4 inches) across the front bumper. Crush measurements were taken at the bumper level and the radiator frame level. The maximum residual crush at the bumper level was measured as 2 centimeters (0.8 inches) occurring at C<sub>1</sub>. The maximum residual crush at the radiator frame level was measured as 9 centimeters (3.5 inches), also occurring at C<sub>1</sub>. The table below shows the case vehicle’s crush at the bumper level. The above bumper crush was not averaged with the bumper crush because the extent of the above bumper crush did not meet the crush averaging requirement.

**Figure 14:** Right side view of damage to Saturn’s front bumper, right fender and right front wheel due to impact with front of case vehicle

The Saturn’s right side wheelbase was reduced 13 centimeters (5.1 inches). The left side wheelbase was reduced 2 centimeters (0.8 inch). Induced damage involved the bumper, grille and hood.

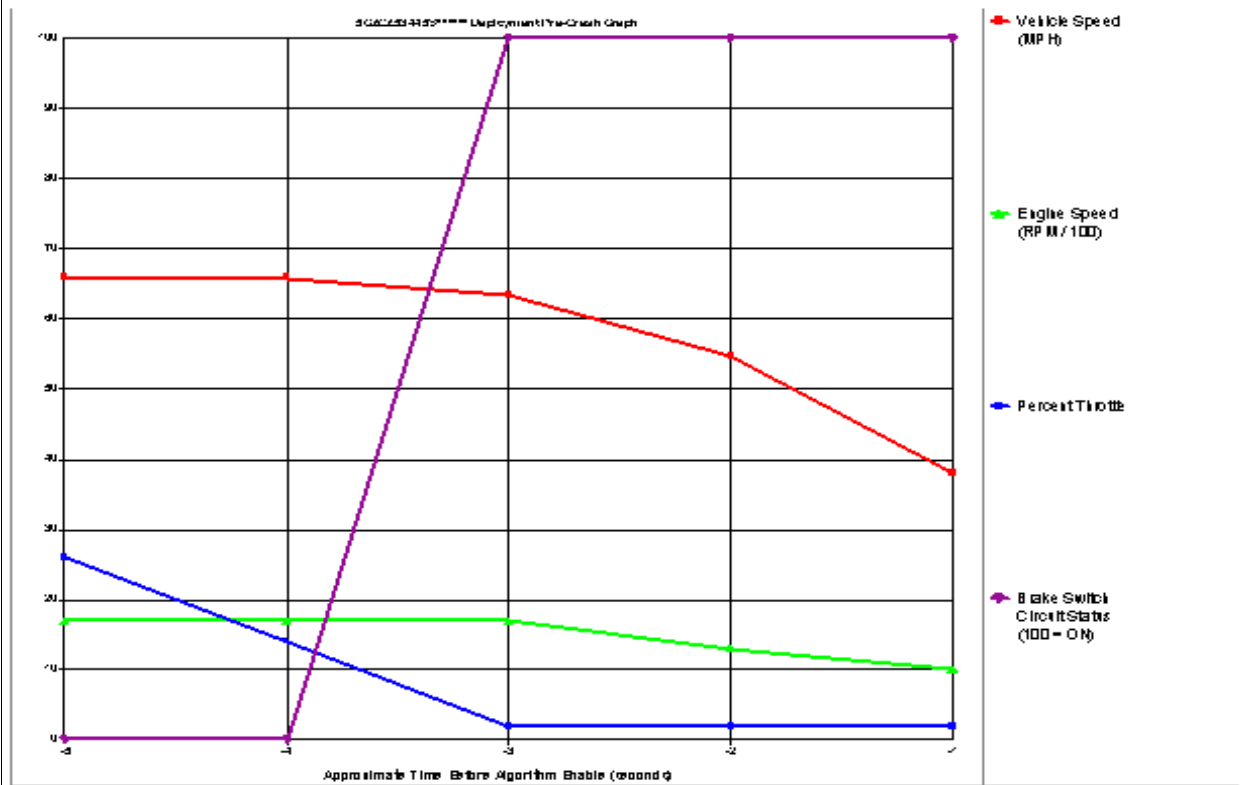
The pre-crash data indicates the Saturn was traveling 106 km.p.h. (66 m.p.h.) and accelerating at 26% throttle 5 seconds prior to AE. The brake switch is recorded on at 3 seconds prior to AE and remains on to one second prior to AE, at which point the case vehicle's speed is recorded as 61 km.p.h. (38 m.p.h.). The speed recorded during braking can vary and is not precise. It can fluctuate under braking because it is determined from the Saturn's speed sensor.

Figure 17: Saturn's System Status at Deployment report and pre-crash data

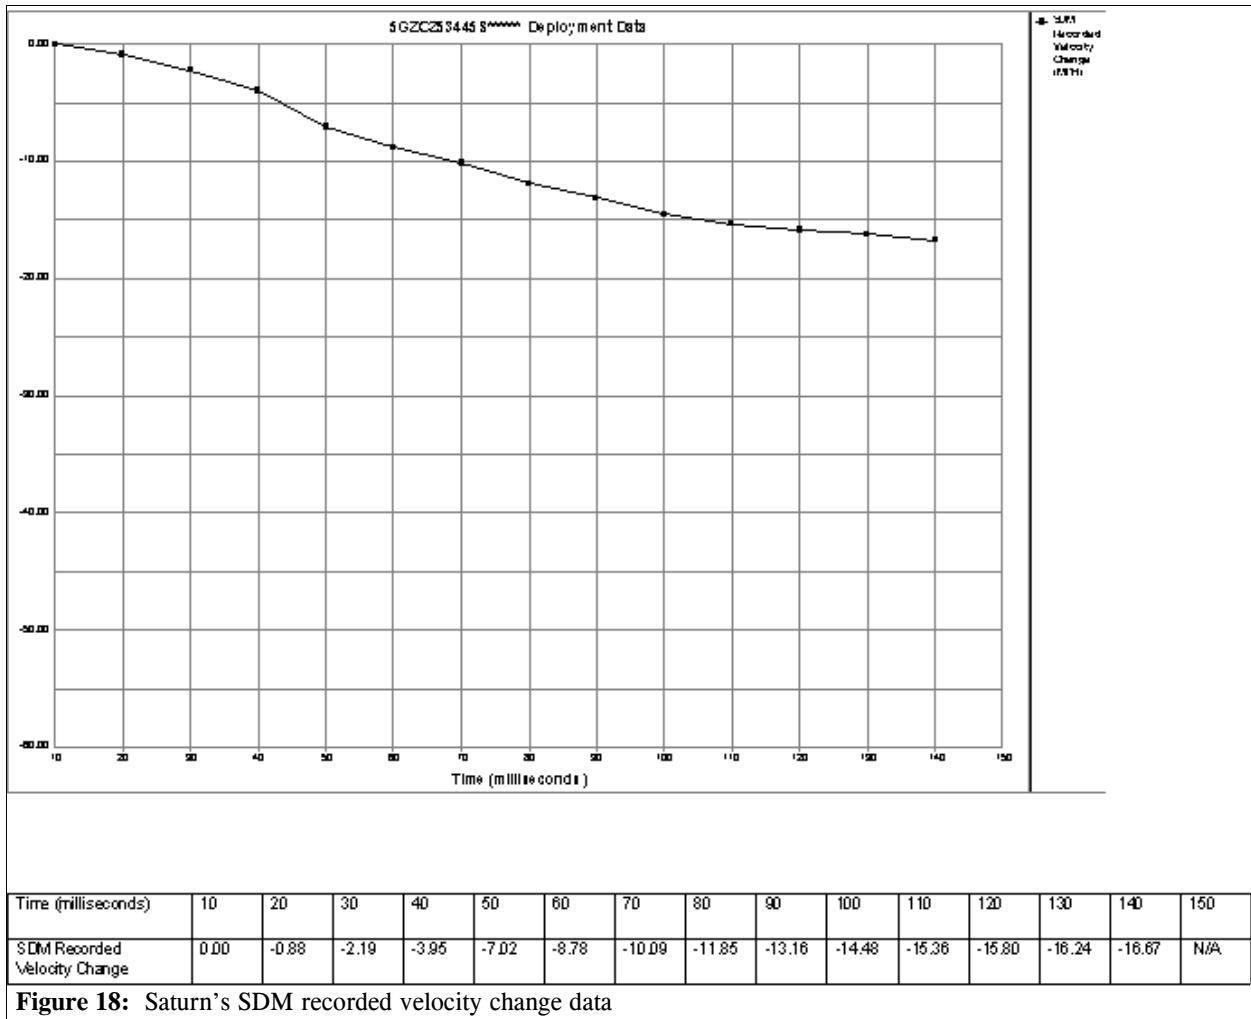
**Crash Data Recording:** The Saturn's EDR recorded a deployment event and a non-deployment event. The non-deployment event was recorded 168 ignition cycles prior to the deployment event and was therefore not related to this crash. The EDR reports for the deployment event are presented at the end of this report (**Figures 15-18**). The system status report shows the SIR warning lamp was recorded as off, and the driver's seat belt switch circuit was recorded as buckled. The maximum SDM recorded longitudinal velocity change was -27.29 km.p.h. (-16.96 m.p.h.) occurring 137.5 milliseconds after algorithm enable (AE). In addition, the system status report shows that the first and second stage deployment criteria for the driver's and front right passenger's air bags were met respectively at 37.5 and 47.5 milliseconds after AE. The data indicated the deployment command was issued between approximately 40 and 50 milliseconds after AE.

Figure 18: Saturn's SDM recorded velocity change data
