Child Safety Seat Investigation / Vehicle to Vehicle
Dynamic Science, Inc. / Case Number: DS06013
2006 Ford Mustang
California
June 2006

| 4. Title and Subtitle Child Safety Seat Investigation | | 5. Report Date August 28, 2006 | |

**Dynamic Science, Inc.
Crash Investigation
Case Number: DS06013**

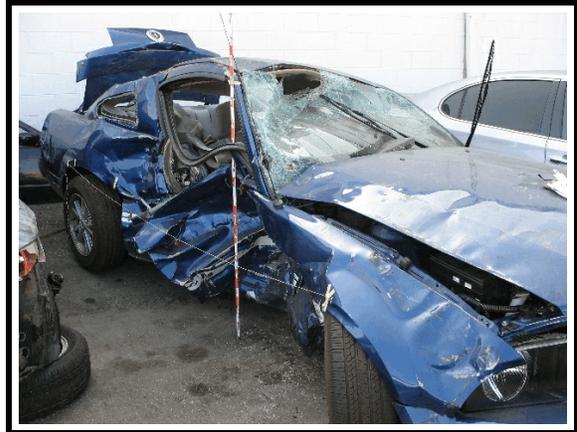
Figure 1. Damaged 2006 Ford Mustang

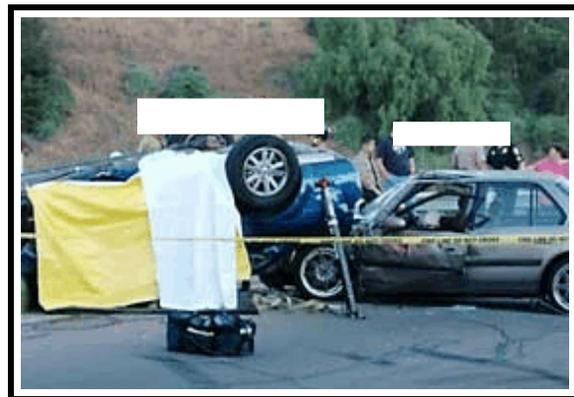
Figure 5. Final rest (news photo)

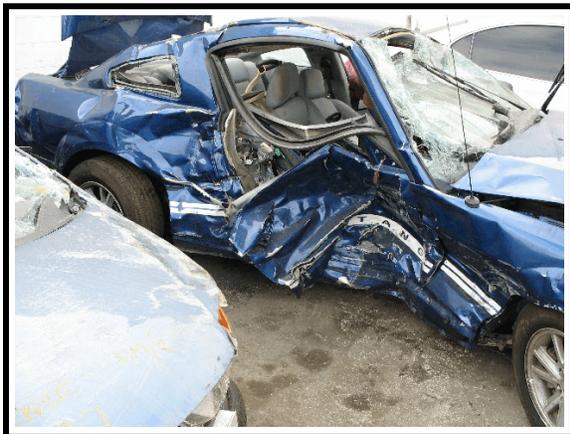
The 2006 Ford Mustang sustained severe right side damage as a result of the impact with the Honda Accord (see Figure 6). The direct damage began 59.0 cm (23.2 in) forward of the rear axle and extended 188.0 cm (74.0 in) forward along the right side plane. The maximum lateral crush was located at the C4 location. The right side door was deformed and jammed shut. The combined direct and induced damage began 12.0 cm (4.7 in) rearward of the rear axle and extended 263.0 cm (103.5 in) forward along the right side plane. The right A and B pillars were deformed laterally. The roof had induced buckling damage. The side glass on the right side was disintegrated. The windshield was fractured. The right wheel base was shortened by 27.0 cm (10.6 in). Six crush measurements were documented at the mid door level as follows: C1 = 0 cm (0 in), C2 = 13.5 cm (5.3 in), C3 = 40.0 cm (15.7 in), C4 = 68.0 cm (26.8 in), C5 = 40.0 cm (15.7 in), C6 = 0 cm (0 in).

Figure 6. Right side, 2006 Ford Mustang

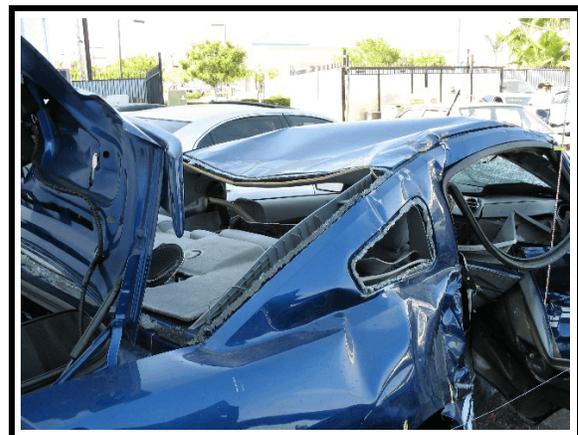
The Mustang also sustained moderate damage to the hood, roof and deck lid from the rollover event (see Figure 7). The direct damage measured 410.0 cm (161.4 in) longitudinally and 125.0 cm (49.2 in) laterally. The maximum crush was along the backlight header and rear roof areas.

Figure 7. Right side roof area

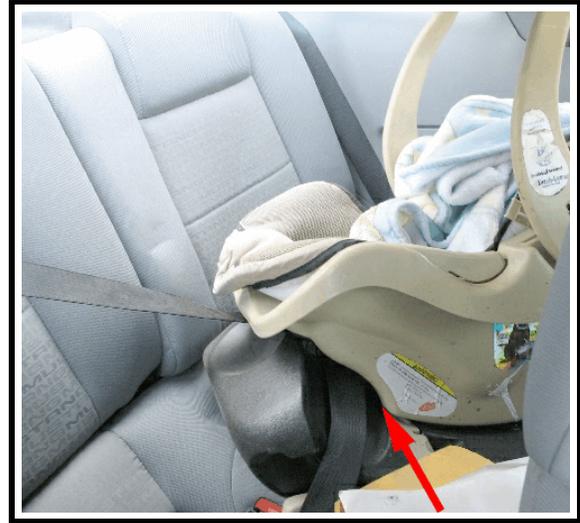
The rear right safety belt was used to anchor a rear facing infant safety seat (see Figure 8). At the time of the vehicle inspection, the latch had been unfastened but the webbing was still trapped between the infant seat and the base.

Figure 8. Seat belt webbing routing

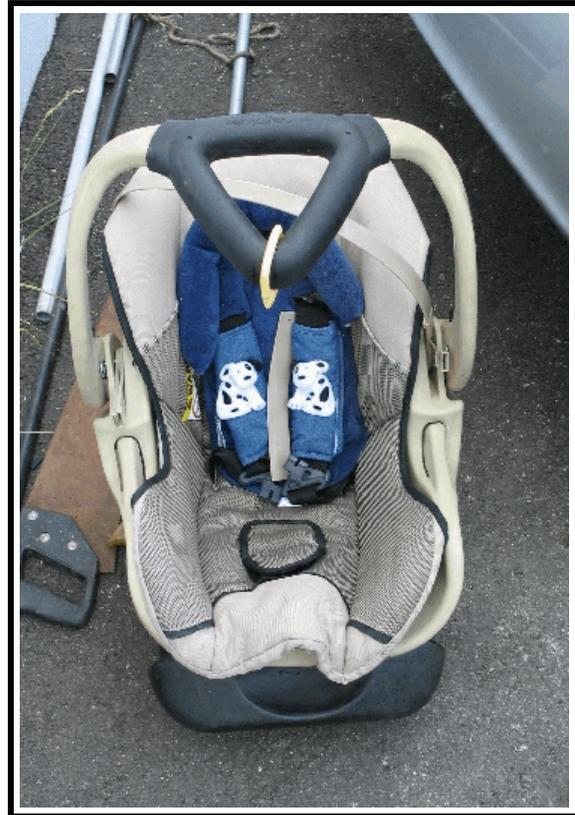
A BabyTrend Latch-Loc rear facing infant safety seat was positioned in the rear right seat of the Ford Mustang (see Figure 9). The model number was 6001 and the date of manufacture was July 20, 2004. The infant seat was configured with a five-point safety harness. The seat is designed to be used with or without the stay-in-vehicle base. The seat was being used with the stay-in-vehicle base. The seat is designed to be used rear facing. The manufacturer recommends the use of the child seat for infants who weigh between 2.2 - 10 kg (5-22 lbs) and whose height is 72.4 cm (28.5 in) or less. The child in this crash was within the weight recommendations (4 kg/9 lbs). His height is not known.

Figure 9. BabyTrend Latch-Loc infant safety seat

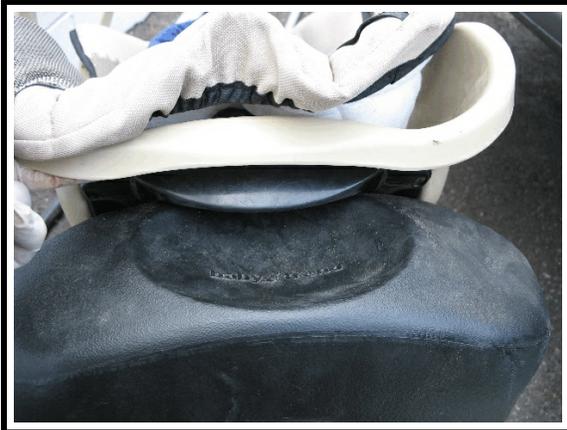
Figure 10. Base release lever

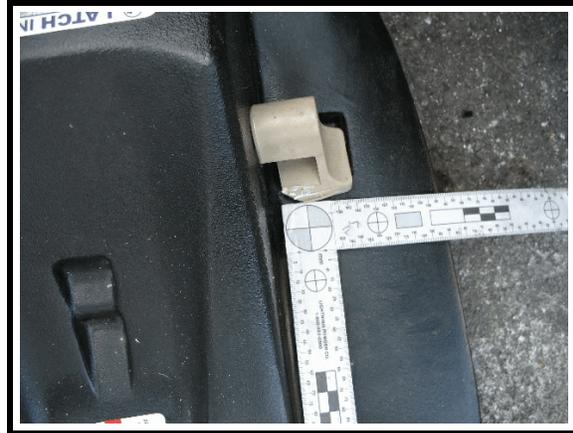
The child seat was damaged during the crash due to lateral loading. The seat base to child seat attachment point on the left side of the seat (on the right side as installed in the vehicle) was deformed (see Figures 10-13). The base release lever moved but would not release the base. This prevented the child seat from being removed from the child seat base. Since the seat belt was routed between the child seat and the base, this prevented the child seat from being removed from the vehicle. Rescue personnel were able to unbuckle the vehicle safety belt, but the sliding latch could not pass between the child seat and the base. The child seat and base were removed from the vehicle by this investigator by cutting the vehicle safety belt.

Figure 11. Damage to base attachment

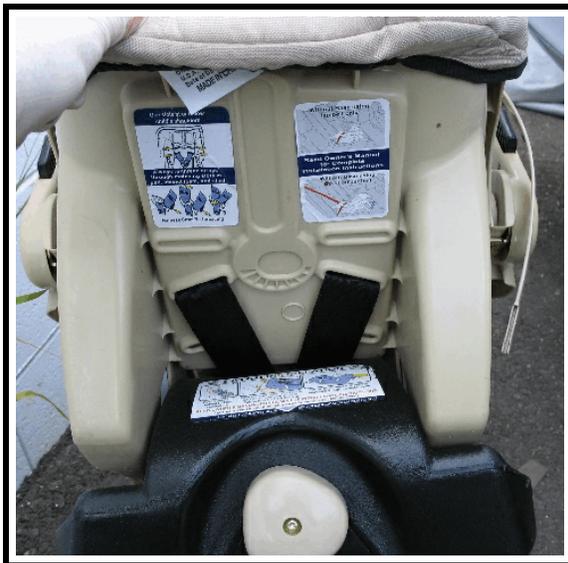
Figure 12. Misalignment of seat and base

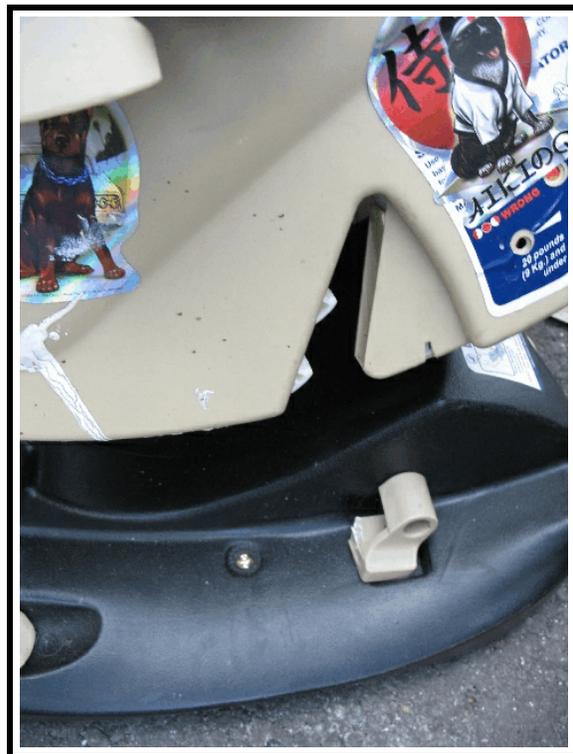
Figure 13. Child seat and base attachment point

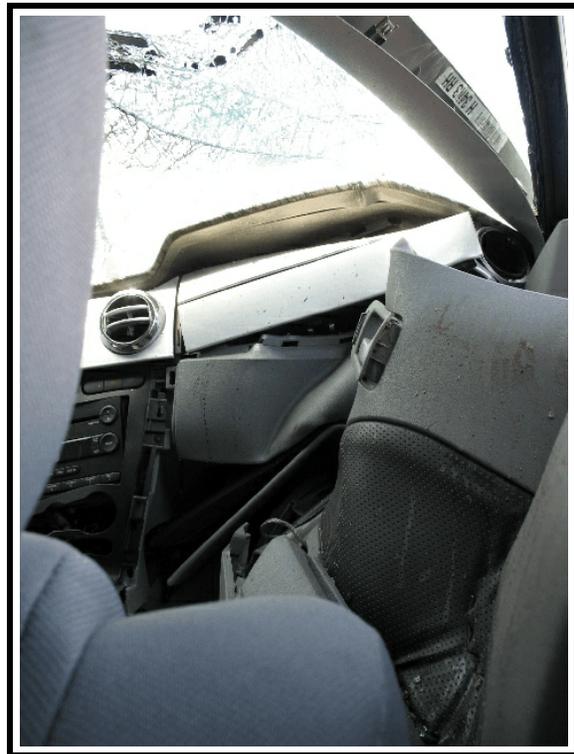
The 2006 Ford Mustang sustained moderate interior damage as a result of passenger compartment intrusion and occupant contacts. The right door, A pillar, B pillar sustained lateral intrusion. The front right seat was compressed 24.0 cm (9.4 in), as measured to the outside edge.

Figure 16. Front right seat position, shows lateral door intrusion
