**CALSPAN ON-SITE DRIVER AIR BAG RELATED FATALITY  
INVESTIGATION**

**SCI CASE NO.: CA06-014**

**VEHICLE: 1997 LINCOLN CONTINENTAL**

**CRASH DATE: MAY 2006**

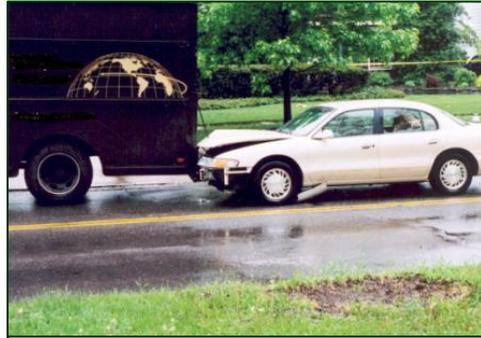
**Figure 1. On-scene of the front-to-rear crash.**

The Lincoln continued forward and struck the same back left area of the step van with the deformed frontal area of the Continental. This secondary impact/contact was overlapping and did not alter the initial crush profile to the Lincoln. A second CDC of 12-FZEW-1 was assigned to reflect this secondary engagement. This event was supported by the on-scene images of the crash and depicted in **Figure 1**.

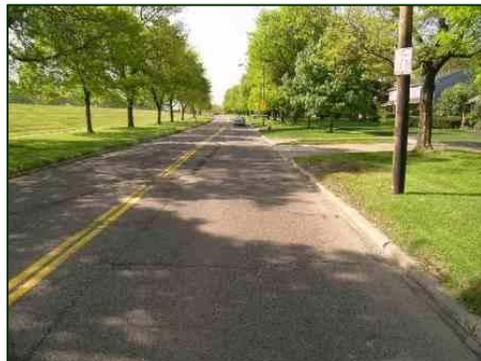
The crash occurred on a two-lane roadway in a residential (**Figure 2**) area during daylight hours. At the time of the crash, the conditions were overcast and the asphalt road surface was wet due to a light rainfall. The temperature was police reported at 11 degrees C (52 degrees F). The roadway consisted of two 4 m (13') wide travel lanes delineated by double yellow centerlines and bordered by 10 cm (4") barrier curbs. Residential

**Figure 2. Westbound view of the crash site.**

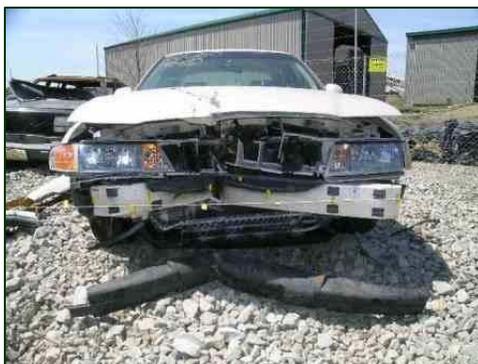
The frontal area of the Lincoln sustained moderate severity damage as a result of the engagement against the back of the struck step van. Although the bumper fascia separated and was run over by the Lincoln, the impact related direct contact damage on the fascia began 6 cm (2.5”) left of center and extended 76 cm (30”) to the right bumper corner. Maximum crush was measured at 37 cm (14.6”) located on the front bumper beam 13 cm (5”) right of center. The impact fractured and separated the fascia and energy absorbing foam from the bumper, deformed the bumper beam to a V-shape, fractured the grill and gouged the fiberglass hood (**Figure 3**). The crush profile was documented at the level of the bumper beam using a combined induced and damage length of 130 cm (51.25”). The crush profile (**Figure 4**) was as follows: C1 = 0 cm, C2 = 5 cm (2”), C3 = 10 cm (4”), C4 = 34 cm (13.5”), C5 = 19 cm (7.4”), C6 = 10 cm (3.75”). The Collision Deformation Classification (CDC) for this impact was 12-FZEW-2.

**Figure 3. Frontal damage to the Lincoln Continental.**

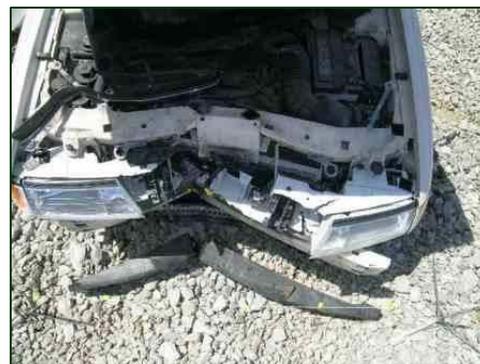
**Figure 4. Overhead view documenting the extent of frontal crush.**

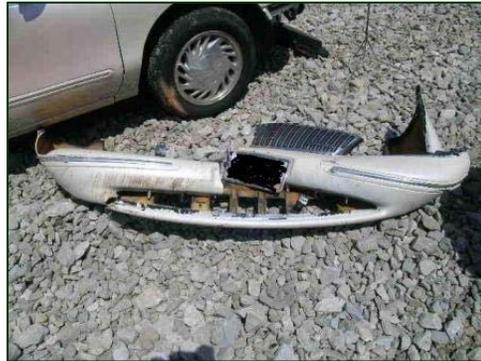
The bumper fascia separated and fell onto the road surface and was subsequently run over by the undercarriage and the front tires of the Continental. The fascia was abraded full width from contact with the road surface (**Figure 5**).

**Figure 5. Separated bumper fascia.**

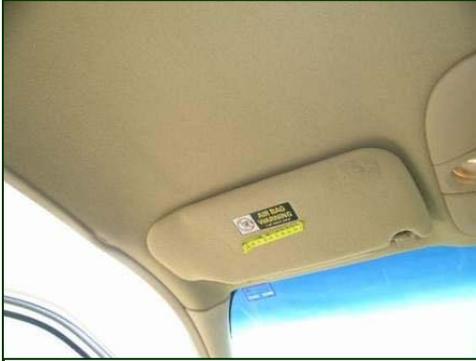
The driver was within the path of the deploying and expanding front left air bag. There was no damage or contact evidence to the air bag membrane. The steering assembly was free of damage and compression. The expanding air bag displaced the driver vertically into the left sun visor (**Figure 6**). The visor remained in its stowed position, engaged into the inboard locking tab. The driver's head impacted the exposed surface of the visor. There was no damage visible to this side (**Figure 7**). His loading fractured the integrated vanity mirror (**Figure 9**) which was only visible by pivoting the visor and opening the plastic cover that concealed the mirror. There was no other damage to the top side of the visor (**Figure 8**).

Figure 6. Impacted left sun visor.

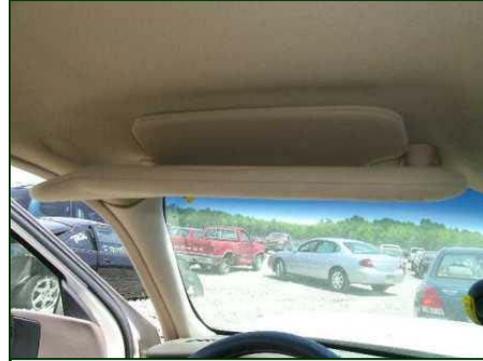
Figure 7. Edge view of the non-distorted visor.

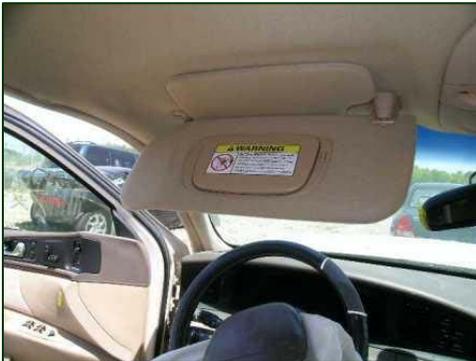
Figure 8. Top side of the visor; vanity mirror not damaged.

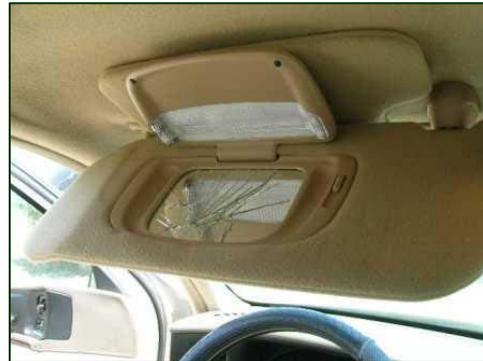
Figure 9. Fractured vanity mirror.

exposed face of the visor; however, the integrated vanity mirror glass was fractured. The driver sustained an abrasion of the forehead from the visor contact. As he compressed the visor against the headliner, the mirror fractured. The visor/roof contact resulted in a 10x10 cm subgaleal hematoma.

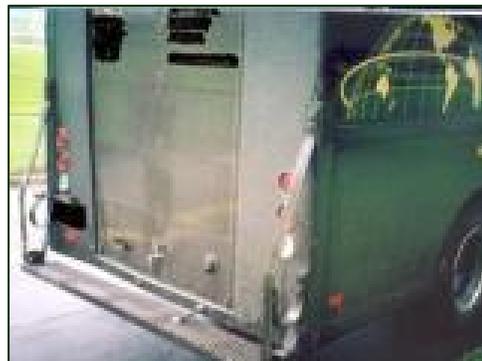
The rear bumper of the step van sustained minor severity damage as a result of the crash (**Figure 9**). This was based on the on-scene images of the vehicle that were provided to the SCI team. The left aspect of the bumper was minimally crushed and a mounting bracket was separated above the level of the bumper. Additionally, the back wall and the floor area of the cargo box were crushed forward, estimated at 5 cm (2"). The step van was towed from the scene for a police required safety inspection. The minor severity damage to the rear of the vehicle did not require towing.

Figure 10. Damage to the rear of the struck step van.

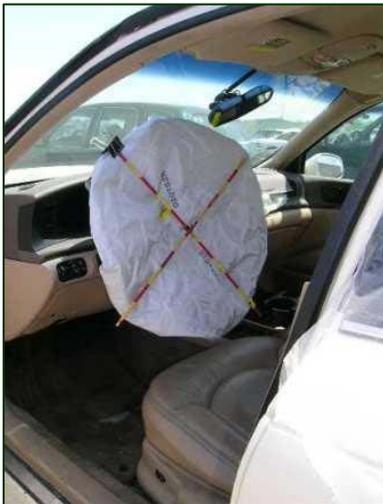
The driver's air bag deployed from the module as designed (**Figure 11**). The air bag membrane measured 61 cm (24") in diameter in its deflated state and was tethered internally by two straps at the 12 and 6 o'clock positions. The tethers were sewn to the face of the air bag with a 17 cm (6.75") stitch pattern. The air bag was vented by two 2 cm (0.6") diameter ports located on the back side of the bag at the 11 and 1 o'clock positions. The ports were centered 6 cm (2.5") forward of the peripheral seam. The following nomenclature was stamped on the face of the air bag:

**Figure 11. Deployed driver's air bag.**

The driver initiated a forward trajectory into the path of the expanding driver's air bag. The air bag expanded against the underside of the driver's chin which hyperextended the neck resulting in fractures of C3/C4 with a laceration and contusion of the spinal cord.

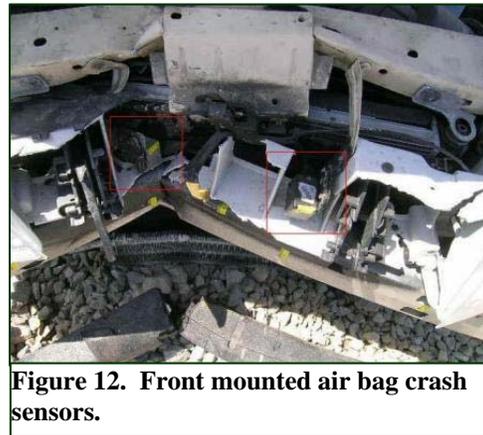
The 1997 Lincoln Continental was equipped with first generation frontal air bags for the driver and front right passenger positions. This system consisted of a steering wheel mounted driver air bag module, a front right passenger air bag module that was incorporated into the top and mid right instrument panel, a transmission tunnel (interior) Restraints Control Module (RCM), and two electro-mechanical crash sensors that were mounted on brackets attached to the forward aspect of the upper radiator support. The left sensor was not directly involved in this crash; however, the right sensor was rotated to the left by direct contact during the crash. The sensor cover was not crushed or deformed.

**Figure 12. Front mounted air bag crash sensors.**

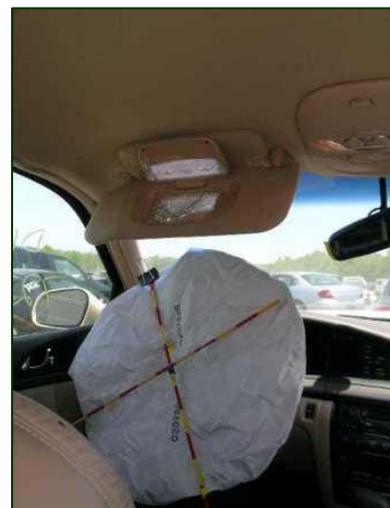
The expansion of the air bag displaced the driver vertically into the sun visor (**Figure 13**). His contact with the visor did not produce contact evidence to the

**Figure 13. Driver's vertical displacement into the sun visor.**

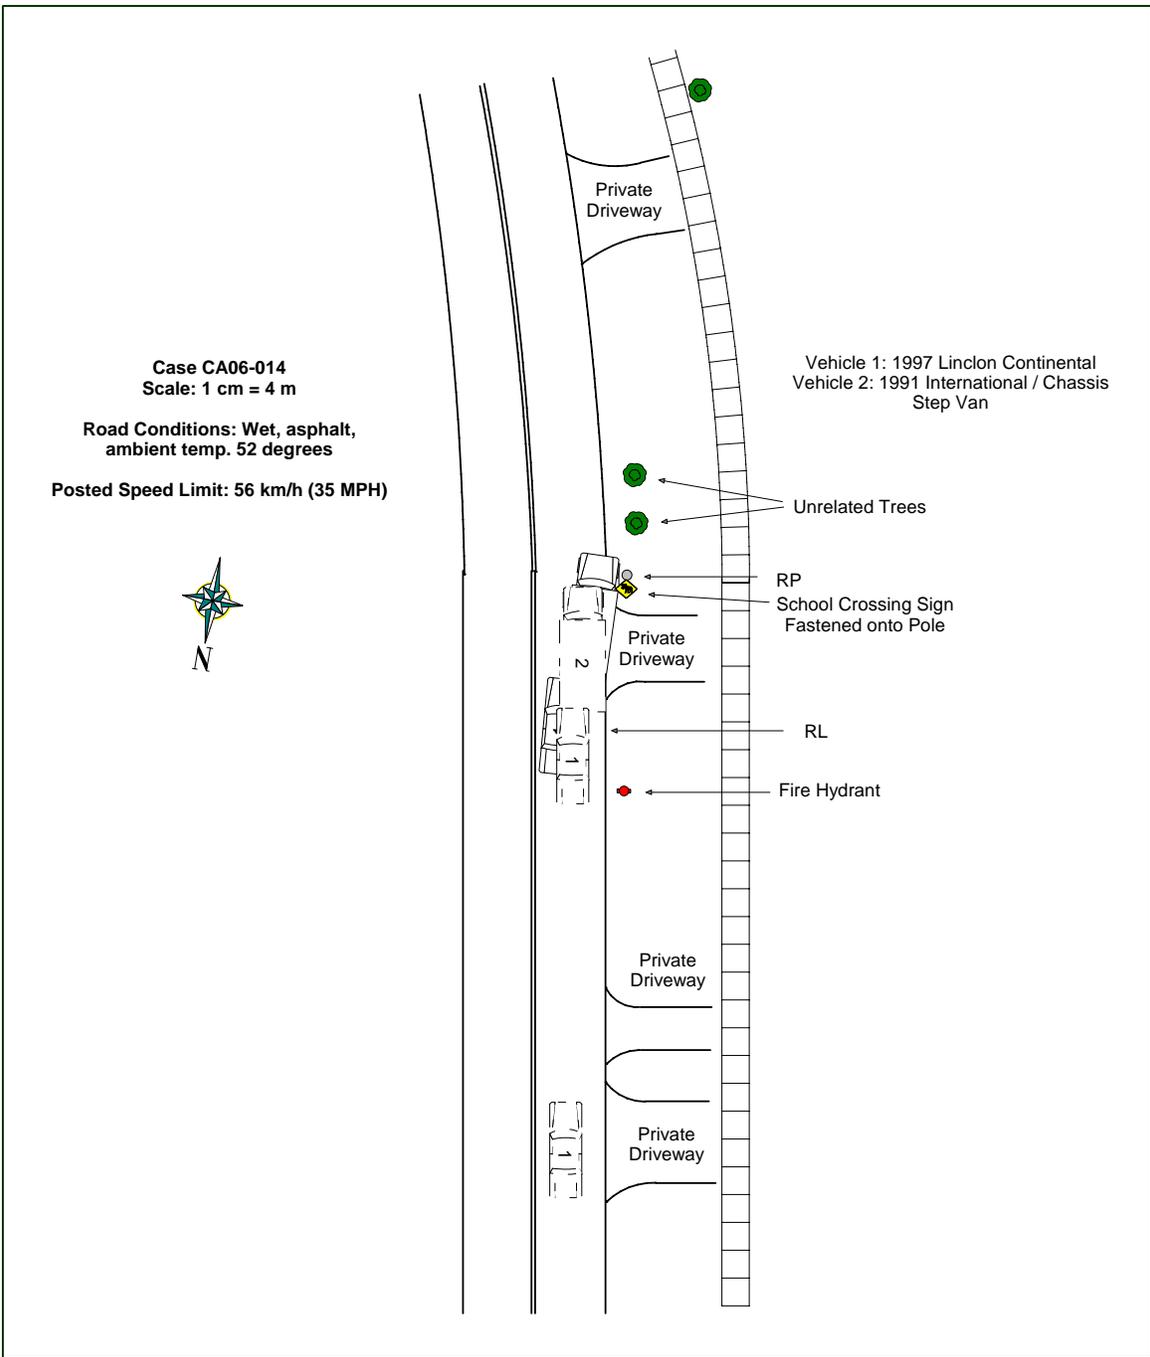
**Figure 14. Crash Schematic.**
