## ON-SITE OTHER INFLATABLE OCCUPANT PROTECTION INVESTIGATION

CASE NUMBER - IN-06-014

VEHICLE - 2006 MAZDA 5

CRASH DATE - June 2006

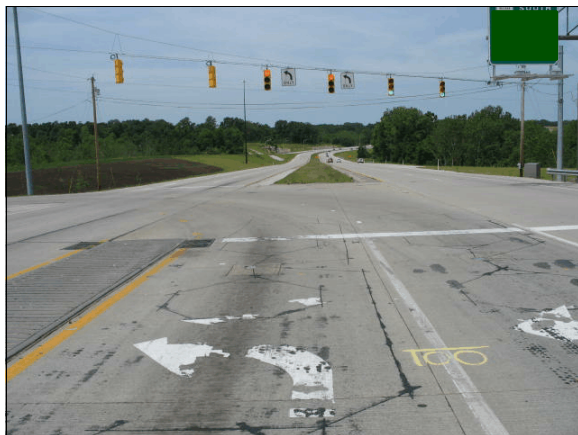
**Figure 1:** Approach of case vehicle westbound in inside left turn lane, number shows feet to impact

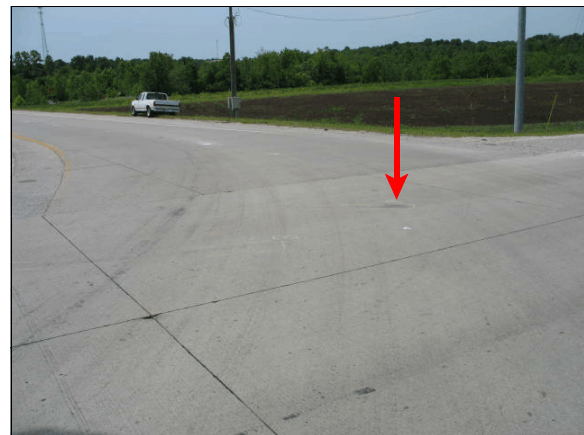
**Figure 2:** Approach of case vehicle to impact turning left onto the entrance ramp, red arrow shows impact scrub from case vehicle's right rear tire

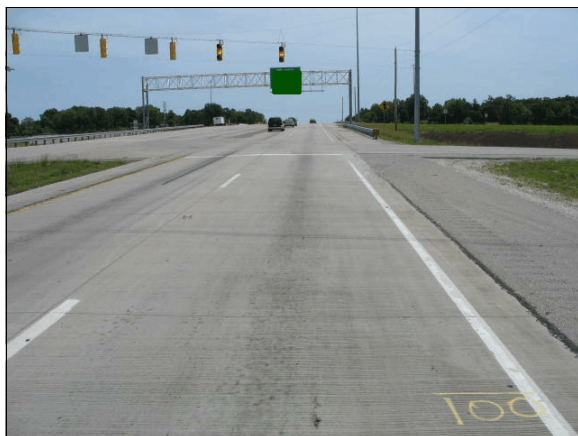
**Figure 3:** Approach of Ford to intersection, number on pavement shows feet to impact

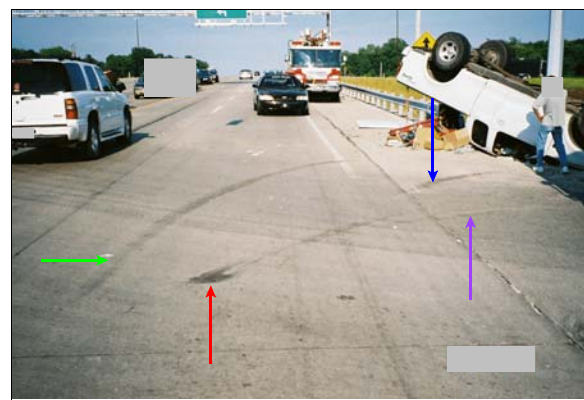
**Figure 4:** View east to point of impact and final rest of Ford, red arrow shows impact scrub from case vehicle's right rear tire, purple arrow shows case vehicle's left rear tire mark, green arrow shows Ford's left rear yaw mark, blue arrow shows Ford's left front yaw mark

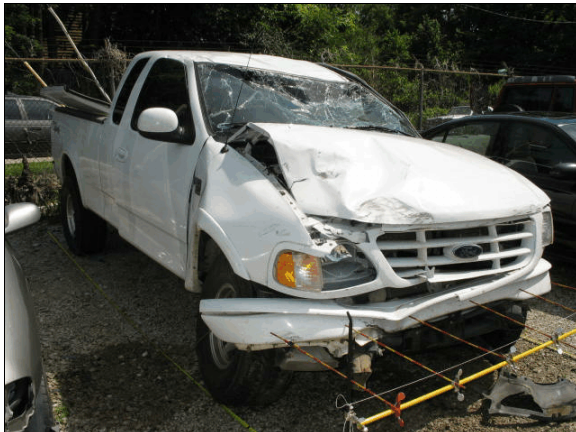
**Figure 5:** Right front view of damage to front of Ford from impact with the right side of the case vehicle and rollover damage to roof and hood.

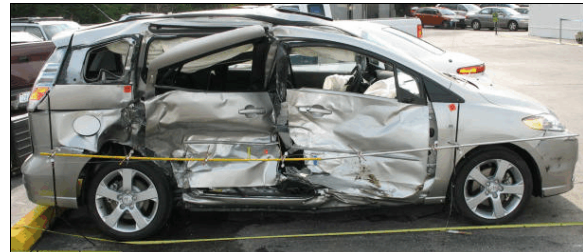
**Figure 6:** Damage to case vehicle's right side due to impact with front of Ford, right side doors placed back on vehicle in approximate crushed position

**Exterior Damage:** The case vehicle's initial impact with the Ford involved both the right side doors and the right quarter panel. The direct damage extended vertically from the sill to the right roof side rail. The direct damage began 58 centimeters (22.8 inches) rear of the right front axle and extended 240 centimeters (94.5 inches) rearward along the right side of the vehicle. Both right side doors, the sill and the quarter panel were crushed into the passenger compartment. The impact separated the right "B" pillar at the sill. The "B"-pillar was crushed inward nearly to the center of the case vehicle (**Figure 9**). Both right side doors had been cut off the vehicle by rescue personnel. They were positioned back on the vehicle as near as possible to their original crushed position. However, the precise crushed location of the doors could not be established due to the deformation of the structures. The crush measurements were then taken at the mid-door level. Adjustments to the crush values were made based on the extent of crush to the right B-pillar, measurements from an exemplar vehicle and judgement. Based on this process, the maximum residual crush was determined to be

approximately 65 centimeters (25.6 inches) occurring at C<sub>4</sub>. A second set of crush measurements was also taken at the sill level. The maximum residual crush at this level was determined to be 7 centimeters (2.8 inches) occurring at C<sub>5</sub>. The table below shows the average of the case vehicle's mid-door and sill level crush measurements.

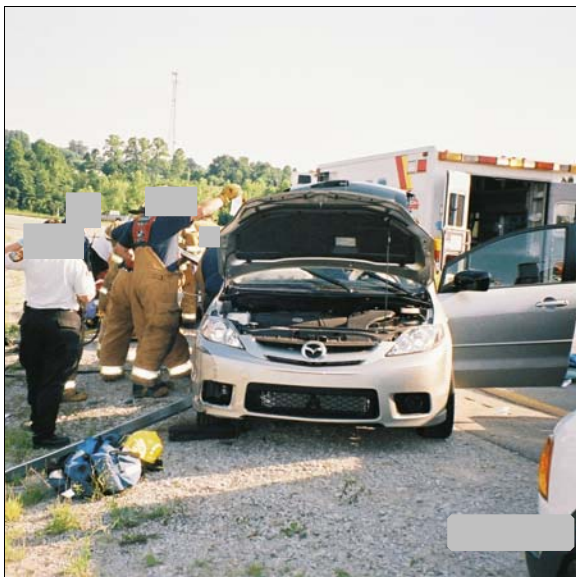
**Figure 7:** Police photo showing case vehicle's rest position on east shoulder of entrance ramp, view is to southwest

**Post-Crash:** As a result of the impact, the case vehicle rotated clockwise a total of approximately 195 degrees, traveled southeast and came to final rest on the east shoulder of the entrance ramp heading northeast (**Figure 7**). The Ford rotated clockwise a total of approximately 135 degrees and came to final rest on its top on the southeast corner of the intersection just off the shoulder

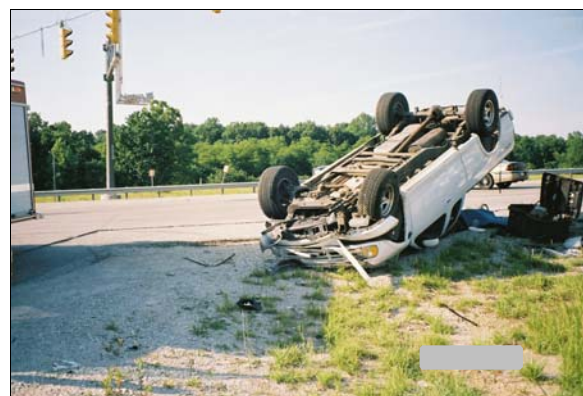
**Figure 8:** Police photo showing Ford's rest position, on southeast corner of intersection, photo taken from east shoulder of entrance ramp looking northwest

heading southwest (**Figure 8**).

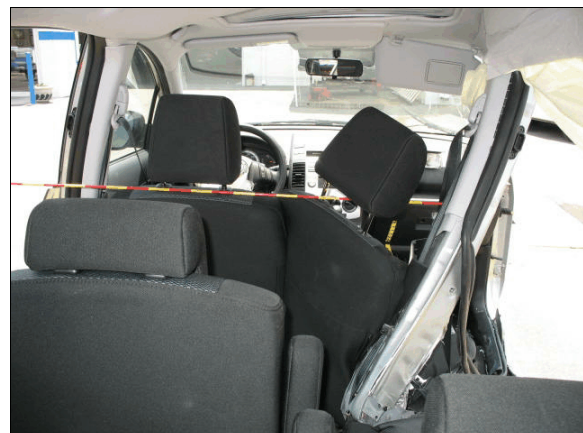
The investigation revealed that the case vehicle's right side curtain air bag did not fully deploy in this crash due to case vehicle damage. The right "B"-pillar separated from the sill during the impact and the lower portion of the pillar was crushed into the passenger compartment approximately 65 centimeters (25.6 inches). As a result, the "B"-pillar was angled into the passenger compartment approximately 25 degrees. This resulted in the right side curtain air bag becoming impinged between the top of the "B"-pillar and what appeared to be styrofoam material under the headliner. In addition, an approximate 30 centimeter (11.8 inches) section of the air bag adjacent to the right C-pillar was found folded over with the bottom edge still under the headliner.

**Figure 9:** Overview of right "B"-pillar intrusion

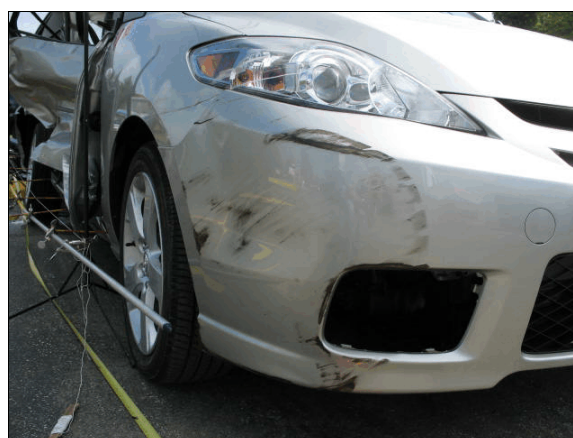
The case vehicle's second impact with the Ford involved the front portion of the right fender, front bumper corner and the headlamp/turn signal assembly (**Figure 10**). The fender and bumper fascia and the headlamp/turn signal assembly lens were directly damaged and the fender was slightly crushed. There was extensive black rubber transfer on the fender and bumper fascia indicating that this portion of the vehicle had impacted the Ford's right front tire. The direct damage began 15 centimeters (5.9 inches) forward of the right front axle and extended 56 centimeters (22 inches) along the fender and right side of the bumper fascia. The residual maximum crush was measured as 1 centimeter (0.4 inch) occurring at C<sub>2</sub> and C<sub>3</sub>. The table below shows the case vehicle's right fender crush measurements

**Figure 10:** Damage to right front corner of case vehicle due to secondary impact with V2's right front wheel

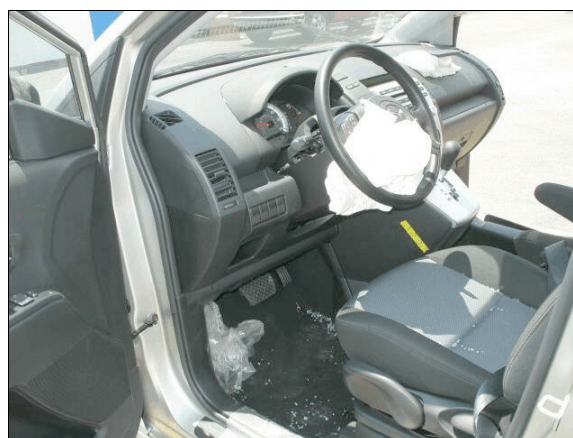
**Figure 11:** Overview of steering wheel and instrument panel, yellow tape shows occupant contact mark on center console

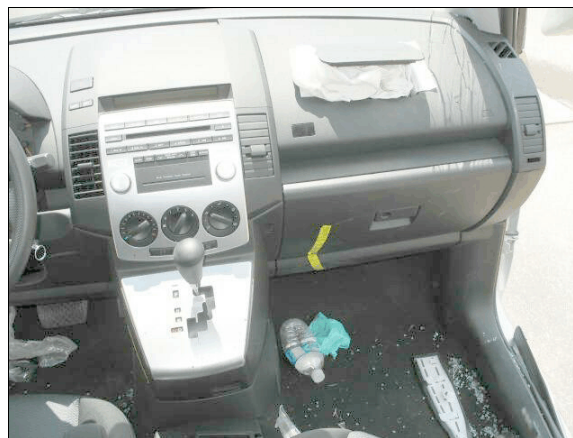
**Figure 12:** Overview of center and front right instrument panel, yellow tape shows occupant contact mark on glove box door and lower instrument panel

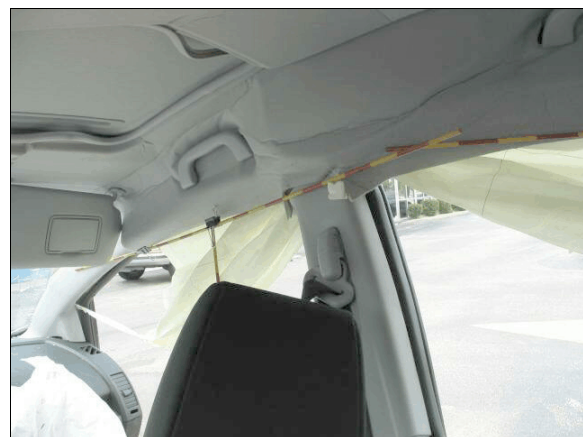
The right side curtain air bag was located along the right roof side rail under the headliner. The air bag was approximately rectangular in shape and extended along the front, second and third seat rows. It was designed to provide protection to an occupant's head during a side impact. The evidence indicated that the side curtain air bag did not fully deploy during the crash (Figure 14). Upon inspection, the air bag was found bunched-up and impinged behind the headliner at the top of the right "B"-pillar (Figure 15). The damage to the case vehicle indicated the air bag was blocked from full deployment at the top of the right "B"-pillar due to the extensive crush of the pillar. The right "B"-pillar separated from the sill during the impact and the lower portion of the pillar was crushed into the passenger compartment approximately 65 centimeters (25.6 inches). As a result, the "B"-pillar was angled inward into the passenger compartment approximately 25 degrees. Examination of the non-deployed portion of the side curtain air bag at the upper "B"-pillar indicated the displacement of the pillar resulted in the air bag becoming impinged between the top of the "B"-pillar and what appeared to be styrofoam material under the headliner. In addition, an approximate 30 centimeter section of the air bag adjacent to the right C-pillar (Figure 16

Figure 14: Overview of right side curtain air bag, it did not break out of the headliner at the "B"-pillar, each increment on rods is 5 cm (2 in)

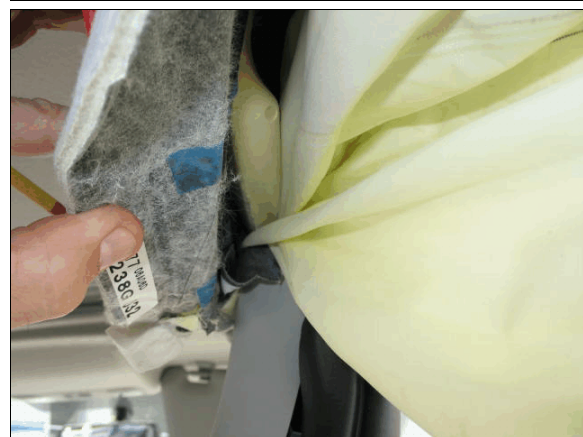
Figure 15: Close view of air bag bunched up behind headliner at right "B"-pillar, view is from back of "B"-pillar

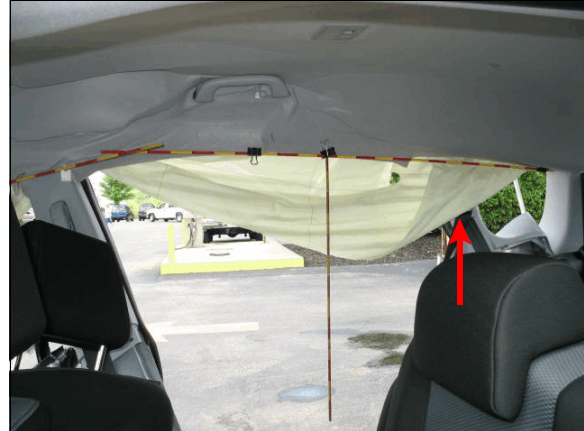
below) was found folded over with bottom edge still under the headliner. Following documentation of the air bag in its “as-found” condition, the air bag was fully unfolded and inspected (**Figures 17 and 18** below). The inspection revealed no damage to the air bag due to the deployment. However, the bottom outside surface of the air bag adjacent to the second seat row had numerous small cuts in it due to interaction with glass fragments from the right rear door window glazing during the crash. The area was approximately 30 centimeters (11.8 inches) in length and 10 centimeters (3.9 inches) in height. In addition, an area of probable occupant contact was observed on the side curtain air bag adjacent to the front right seat position (**Figure 17**), and the second seat right passenger position (**Figure 18**). The side curtain air bag was approximately 203 centimeters (79.9 inches) in length and 33 centimeters (13 inches) in height. The air bag was designed with irregularly shaped inflatable chambers adjacent to each seat position. The air bag was anchored to the right “A”-pillar by a cloth cord approximately 45 centimeters (17.7 inches) in length and 1.5 centimeters (0.6 inches) in width. There was no anchor cord at the back of the air bag. The air bag was designed without tethers or vent ports.

**Figure 16:** Overview of side curtain air bag adjacent to second seat right position, air bag did not break out of headliner at “B”-pillar and did not completely unfold at “C”-pillar (arrow)

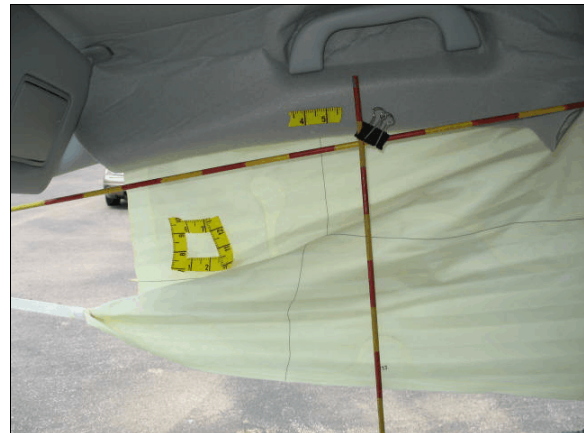
**Figure 17:** Right side curtain air bag adjacent to front right seat position, yellow tape on air bag shows location of possible skin transfer from front right occupant

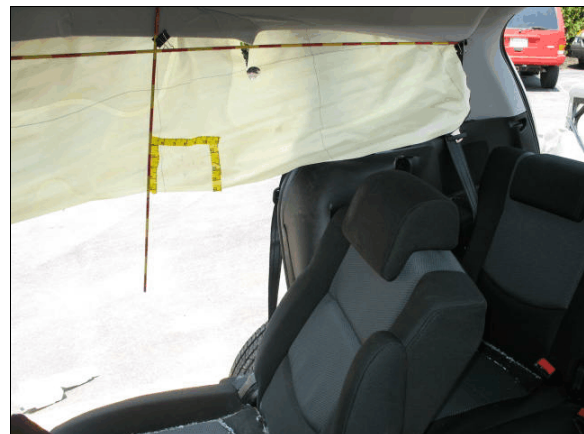
**Figure 18:** Overview of right side curtain air bag adjacent to second seat right passenger, yellow tape shows location of possible occupant contact mark

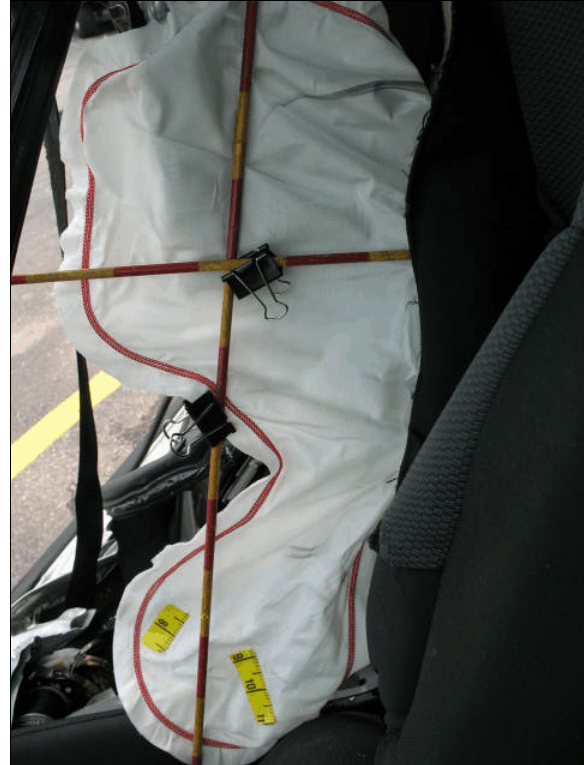
The front right passenger’s seat back-mounted side impact air bag was located in the outboard side of the front right seat back (**Figure 19** below). The deployed air bag was approximately kidney-shaped. It was designed to provide protection to the hip and thorax area during a side impact. The air bag was approximately 53 centimeters (20.9 inches) in height. The upper portion of the air bag was approximately 25 centimeters (9.8 inches) in width while the bottom portion was approximately 15 centimeters (5.9 inches) in width. The air bag was designed without tethers or vent ports. There was no module flap on the side of the seat back. The air bag deployed through a tear-seam in the side of the seat back. There was no evidence of

damage to the air bag due to deployment. However, the intrusion of the door produced a black scuff and a 1 centimeter (0.4 inch) cut in the fabric on the outside bottom portion of the air bag. A scuff and fabric transfer were observed on the inside bottom portion of the air bag in addition to a small black scuff. A long narrow black scuff was also observed on the inside top portion of the air bag.

**Figure 19:** Inside surface of front right passenger's side impact air bag

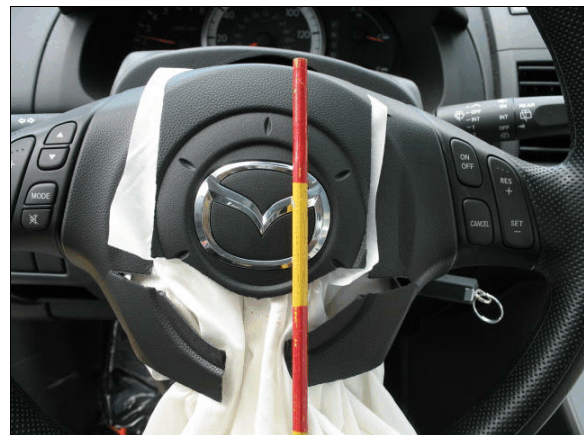
The case vehicle's driver air bag was located in the steering wheel hub. The air bag module cover consisted of three asymmetrical flaps made of pliable vinyl positioned within an overall approximate hexagonal shape. The top flap was essentially a rectangle, except that the bottom was semicircular-shaped so as to accommodate the manufacturer's logo. The overall dimensions of the top flap were approximately 9 centimeters (3.5 inches) in width and 11 centimeters (4.3 inches) in height. The overall dimensions of each of the two bottom flaps were approximately 7 centimeters (2.8 inches) in width, approximately 3 centimeters (1.2 inches) in height at the inside tear seam and 4 centimeters (1.6 inches) in height at their outer edge. The distance between the mid-center of the driver's seat back as positioned at the time of the vehicle inspection [i.e., distance from seat back to air bag module was 55 centimeters (21.7 inches), seat back slightly reclined] and the front surface of the air bag fabric at approximate full excursion was 29 centimeters (11.4 inches). An inspection of the air bag module cover flaps and the air bag fabric revealed that the cover flaps opened at the designated tear points (**Figure 20**). There was no

**Figure 20:** Case vehicle driver's air bag module flaps

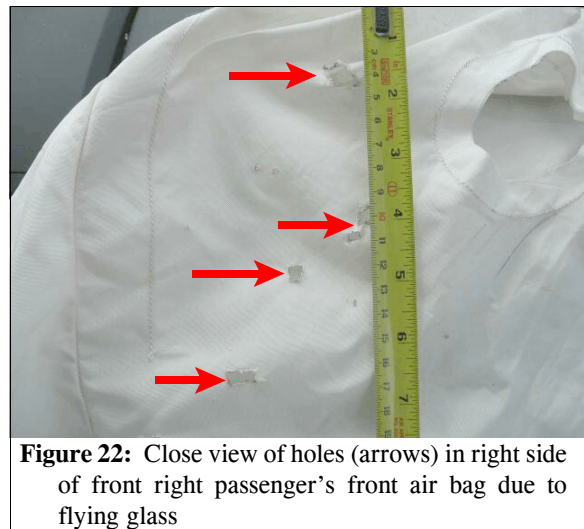
**Figure 22:** Close view of holes (arrows) in right side of front right passenger's front air bag due to flying glass

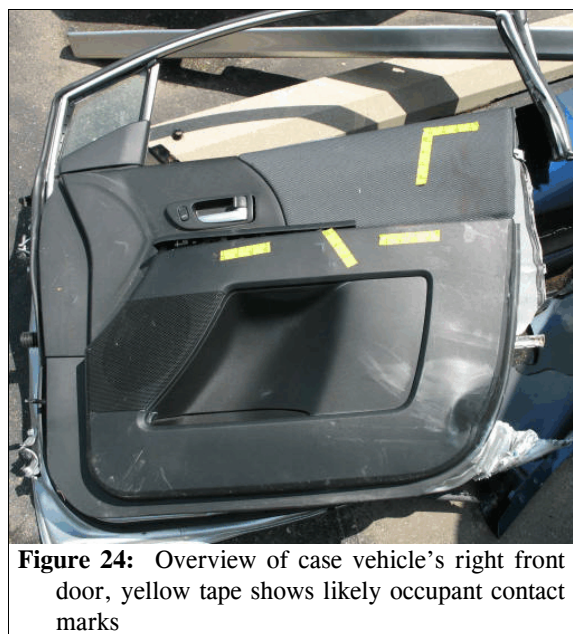
**Figure 24:** Overview of case vehicle’s right front door, yellow tape shows likely occupant contact marks

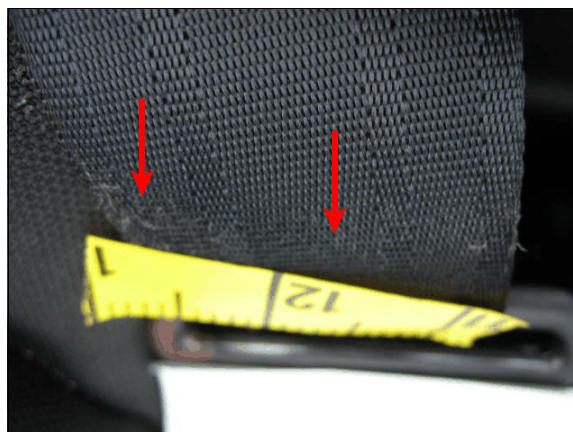
The second seat right passenger was restrained by his manual, three-point, lap-and-shoulder safety belt system. A load mark was found on the safety belt in a location consistent with usage of the safety belt during the crash. The safety belt had pulled on the latch plate belt guide during the crash forming an abrasion on the belt (**Figure 26**).

**Figure 26:** Abrasion in fabric of second row right safety belt from latch plate belt guide

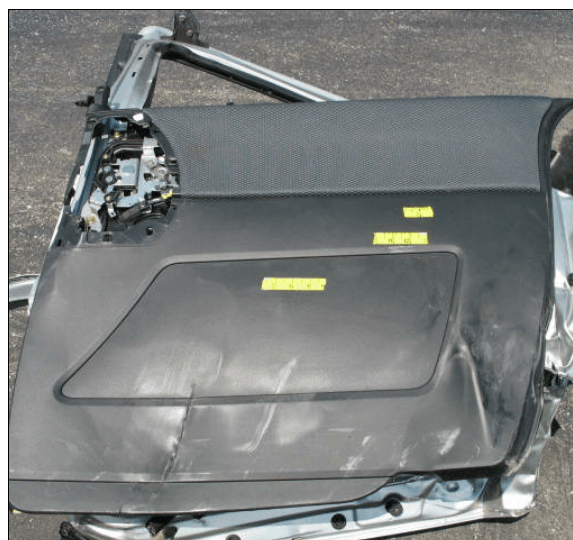
**Figure 27:** Overview of right rear door, yellow tape shows likely occupant contact marks

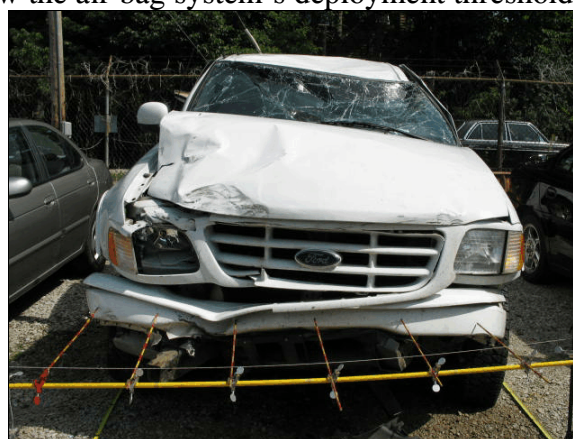
**Exterior Damage:** The Ford's initial impact with the case vehicle's right side involved the front end of the vehicle (**Figure 28**). The front bumper, grille, hood and right headlamp/turn signal were directly contacted and crushed rearward and to the right. The direct damage began at the right bumper corner and extended 155 centimeters along the bumper, hood and grille. Crush measurements were taken at the bumper level. The maximum residual crush was measured as 54 centimeters (21.3 inches) occurring at C<sub>6</sub>. The table below shows the Ford's front bumper crush.

**Figure 28:** Damage to front of Ford from impact with the right side of the case vehicle and damage to the roof from the rollover

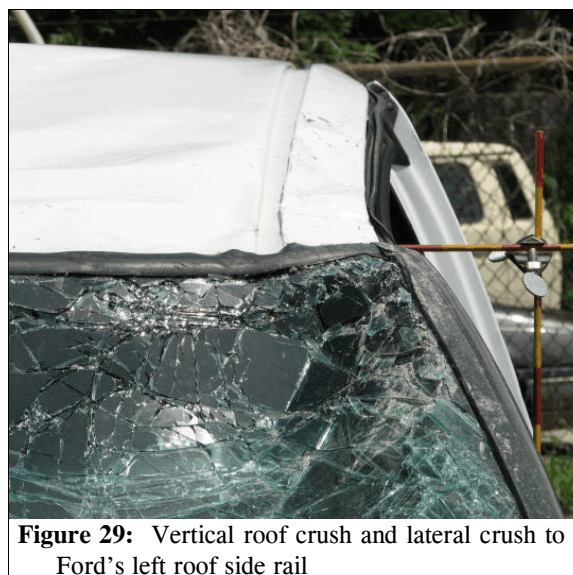
The Ford's secondary impact with the case vehicle's right fender involved the Ford's right fender and right front tire. There was minor damage to the Ford's fender and scuffing to the tire, but no residual crush. The rollover involved the left side, roof and top of the hood. The front portion of the roof, both "A"-pillars and the windshield header were crushed downward. The maximum vertical crush occurred to the roof adjacent to the left roof side rail just behind the left

**Figure 29:** Vertical roof crush and lateral crush to Ford’s left roof side rail
