ON-SITE CERTIFIED ADVANCED 208-COMPLIANT VEHICLE INVESTIGATION

CASE NUMBER - IN-06-015

VEHICLE - 2006 CHEVROLET COBALT

CRASH DATE - May 2006

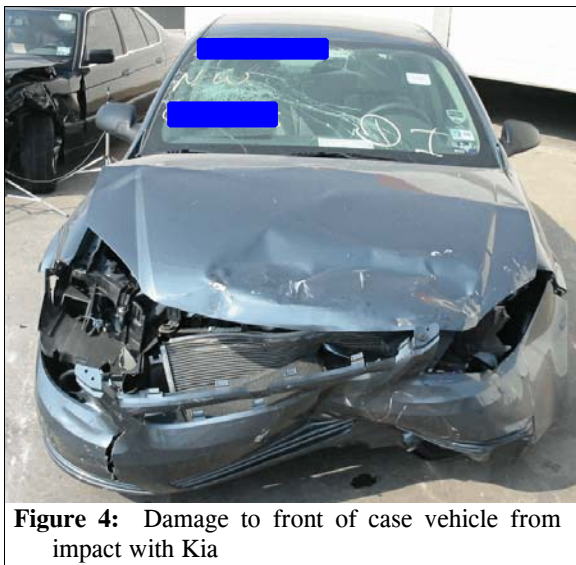
Figure 4: Damage to front of case vehicle from impact with Kia

Crash: The front of the case vehicle (**Figure 4**) impacted the Kia's right fender, right front wheel and right front bumper corner (**Figure 5**) causing a stage 1 deployment of the case vehicle's driver and front right passenger air bags. In addition, both the case vehicle's driver and front right passenger safety belt pretensioners actuated.

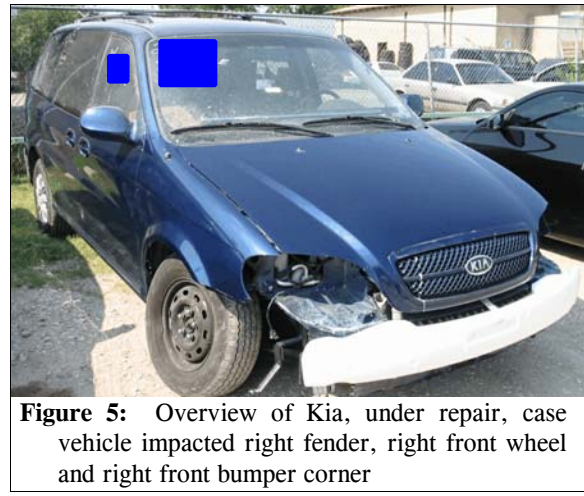
Figure 5: Overview of Kia, under repair, case vehicle impacted right fender, right front wheel and right front bumper corner

Exterior Damage: The Kia's impact with the case vehicle involved the right front wheel, right fender and right corner of the front bumper. The fender had been repaired and the front bumper fascia had been removed. The right front wheel was observed to be tilted inward and the rim dented. As a result, no crush measurements could be taken of the damage to the Kia.

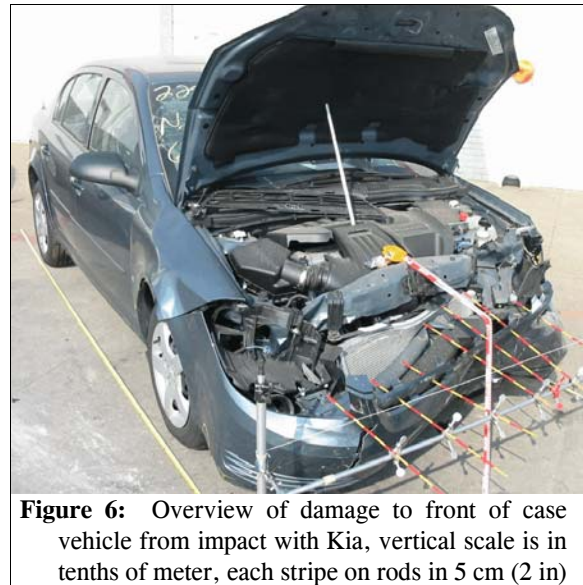
Exterior Damage: The case vehicle's impact with the Kia involved the front end. The front bumper, grille, hood and front of the left fender were directly contacted and crushed rearward and slightly to the right (**Figure 6**). The direct damage began at the left corner of the front bumper fascia and extended across the full width of the front bumper. The bumper fascia had sprung back, away from the underlying bumper bar, so crush measurements were taken at the bumper bar. The direct damage began at the front left bumper corner and extended 120 centimeters (47.2 inches) across the bumper. The maximum residual crush was measured as 43.0 centimeters (16.9 inches) occurring 9 centimeters (3.5 inches) right of C₂ (**Figure 7** below). The table below shows the case vehicle's front crush profile.

Figure 6: Overview of damage to front of case vehicle from impact with Kia, vertical scale is in tenths of meter, each stripe on rods in 5 cm (2 in)

The case vehicle’s left side wheelbase was shortened 0.8 centimeters (1.2 inches) and the right side wheelbase was shortened 3.0 centimeters (1.2 inches). Induced damage involved both fenders and the hood.

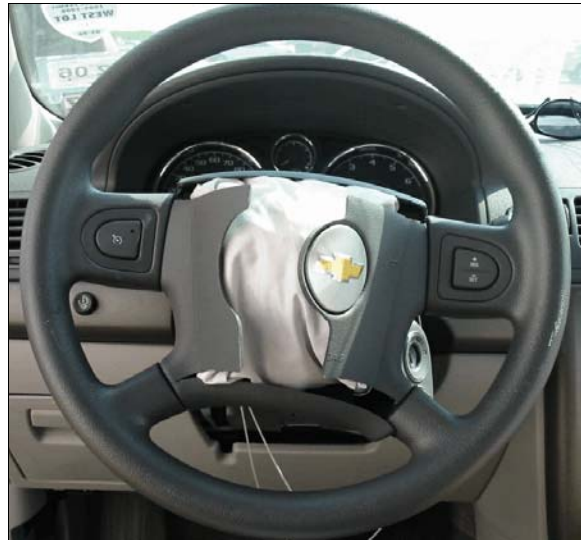
The case vehicle's driver air bag was located in the steering wheel hub. The module cover consisted of symmetrical "I" configuration cover flaps made of thick, pliable vinyl. Each cover flap was 8.5 centimeters (3.3 inches) in width at the top seam, 7 centimeters (2.8 inches) in width at the bottom seam and 11.5 centimeters (4.5 inches) in height along the center seam. There was a semi-circular cut-out in the center of the left cover flap to accommodate the manufacturer's logo on the right cover flap. The distance between the mid-center of the driver's seat back, as positioned at the time of the vehicle inspection (i.e., seat track between middle and full-rear position, seat back slightly reclined) and the front surface of the air bag's fabric at approximate full excursion was 27 centimeters (10.6 inches). An inspection of the air bag module cover flaps and the air bag fabric revealed that the cover flaps opened at the designated tear points (**Figure 8**). There was no evidence of damage during the deployment to the air bag module cover flaps or the air bag fabric. The deployed driver's air bag (**Figure 9**) was round with a diameter of approximately 50 centimeters (19.7 inches). The air bag was designed with two tethers, each approximately 13 centimeters (5.1 inches) in width and had two vent ports (**Figure 10**), each approximately 3 centimeters (1.2 inches) in diameter, located at the 11 and 1 o'clock positions. Inspection of the air bag revealed no evidence of occupant contact. There were a few dark transfers on the air bag that appeared to be grease.

Figure 8: Case vehicle's driver air bag module cover flaps

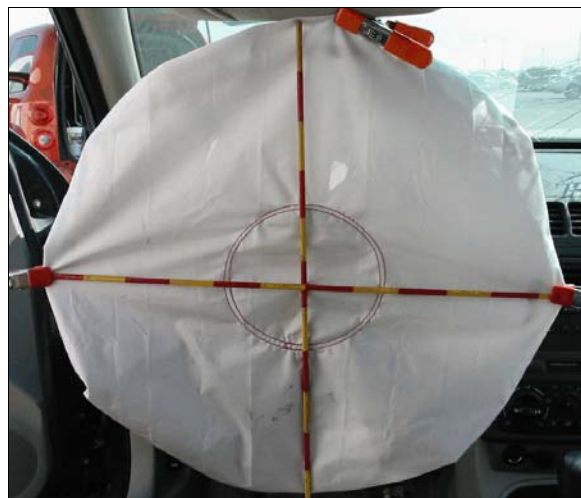
Figure 9: Case vehicle's driver air bag

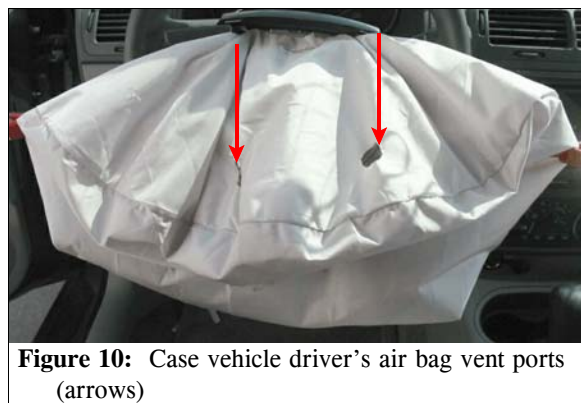
Figure 10: Case vehicle driver's air bag vent ports (arrows)

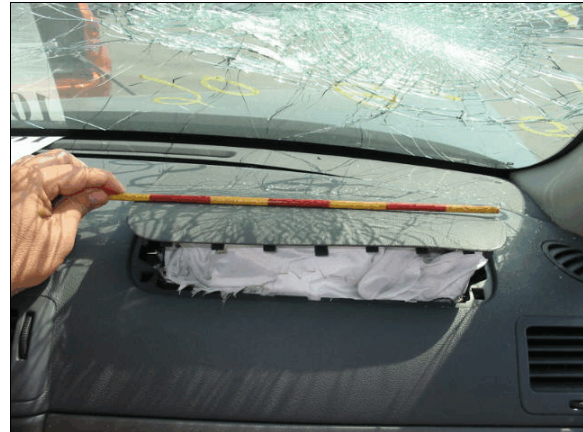
The front right passenger air bag was located in the top of the right instrument panel (Figure 11). The module cover consisted of a single, approximately trapezoidal-shaped cover flap. The cover flap was 32 centimeters (12.6 inches) in width. The left side of the flap was 23 centimeters (9 inches) in height and the right side was 16 centimeters (6.3 inches) in height. An inspection of the module cover flap and the air bag fabric revealed that the cover flap opened at the designated tear points (Figure 11). There was no evidence of damage during the deployment to the air bag module cover flap or the air bag fabric. The deployed front right passenger's air bag (Figure 12) was rectangular in shape with a height of approximately 60 centimeters (23.6 inches) and a width of 43 centimeters (16.9 inches). The air bag was designed with two tethers, each approximately 12 centimeters (4.7 inches) in width and had two vent ports, each approximately 5 centimeters (2 inches) in diameter, located at the 3 and 9 o'clock positions. Inspection of the air bag revealed no evidence of occupant contact.

Figure 11: Case vehicle's front right passenger air bag module cover flap

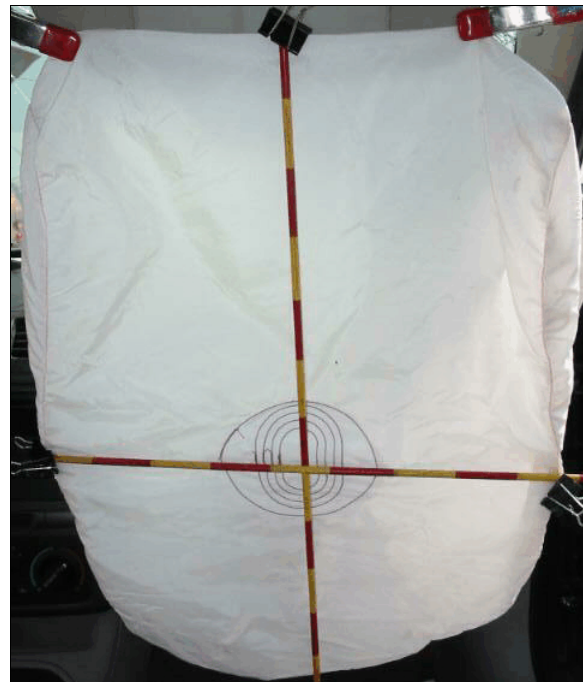
Figure 12: Overview of case vehicle's front right passenger air bag

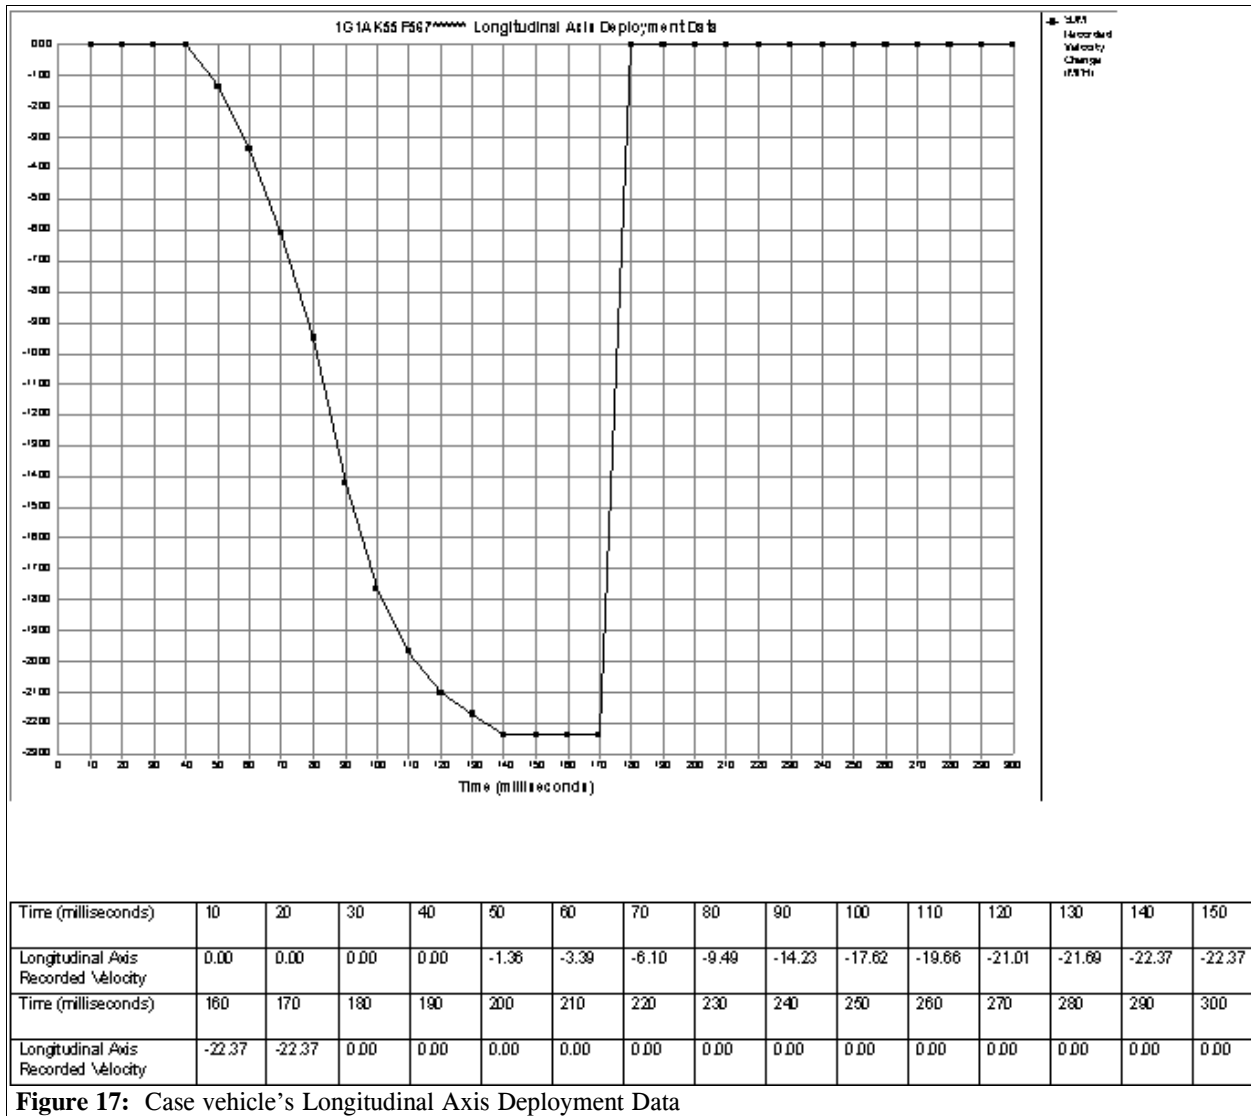
The interpretation of the Longitudinal Axis Deployment Data graph shows that the first stage deployment command was issued at the approximate 80 millisecond sample point. A second stage deployment was not required and disposal of the second stage was commanded. The maximum recorded longitudinal and lateral Delta Vs were respectively: -36 km.p.h. (-22.37 m.p.h.) and 8.72 km.p.h. (5.42 m.p.h.), and the reported estimated principal direction of force was 345 degrees. Lastly, the data indicated that the deployment event recording was complete.
