Side Curtain Air Bag Investigation/Vehicle to Objects
Dynamic Science, Inc./Case Number: DS06016
2006 Chevrolet Cobalt SS Supercharged Coupe
Colorado
June 2006

1. Report No. DS06016	2. Government Accession No.	3. Recipient Catalog No.	
4. Title and Subtitle Side Curtain Air Bag Investigation		5. Report Date September 20, 2006

This on-site investigation focused on the side curtain air bag system in a 2006 Chevrolet Cobalt. This single vehicle crash occurred in June 2006 at 2320 hours in an urban area of Colorado. The crash occurred on a three lane, two way roadway. The case vehicle was a 2006 Chevrolet Cobalt SS Supercharged two-door coupe being driven by an unrestrained 16-year-old male. There were no other occupants in the vehicle.

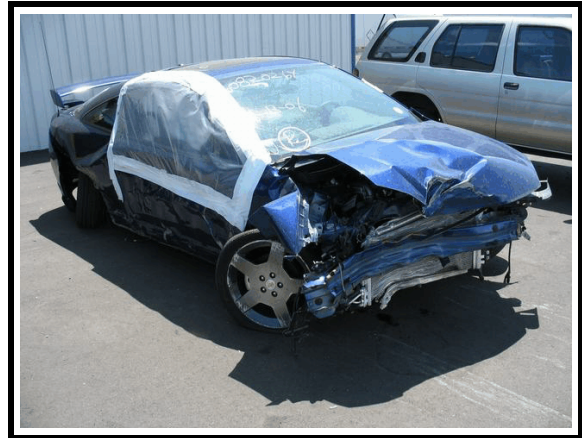
Figure 1. Front/Right - 2006 Chevrolet Cobalt

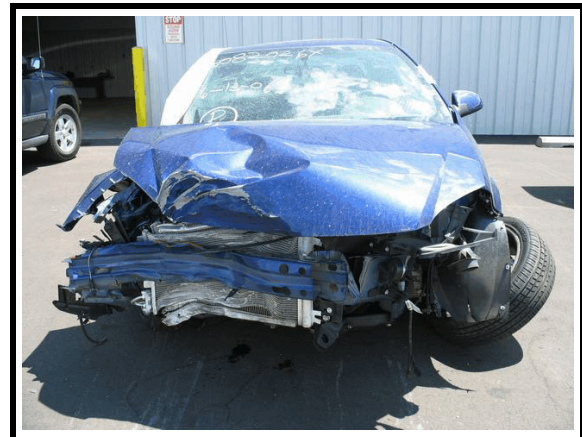
Figure 2. Front - 2006 Chevrolet Cobalt

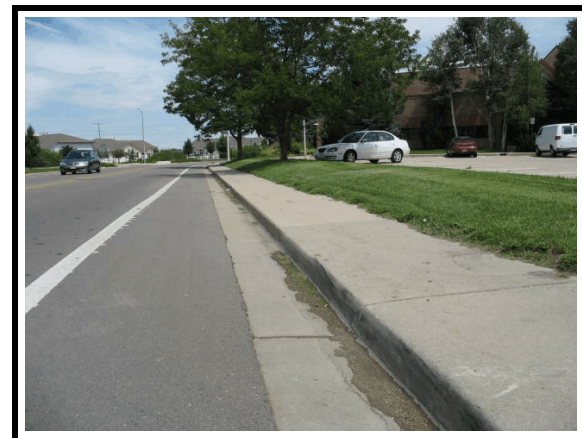
Figure 5. Probable roadway departure point (tire scuffs on curb)

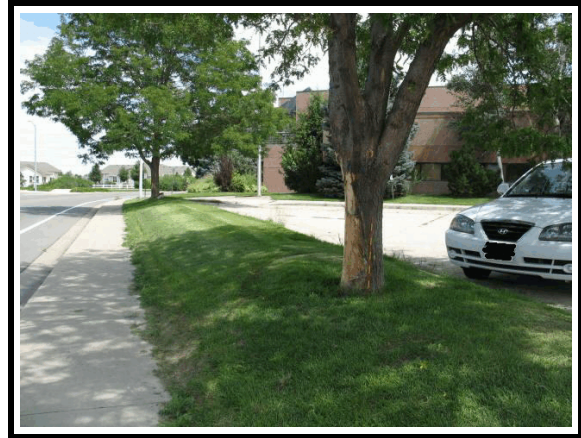
Figure 6. First struck tree (east)

This crash event resulted in the deployment of the Cobalt's driver and passenger front air bags, the deployment of the right side curtain and the actuation of the front row seat belt pretensioners. The right side damage from this impact resembled a sideswipe type impact, but as the Cobalt swiped past the tree, its right rear tire snagged on the tree, sending the vehicle into a clockwise rotation.

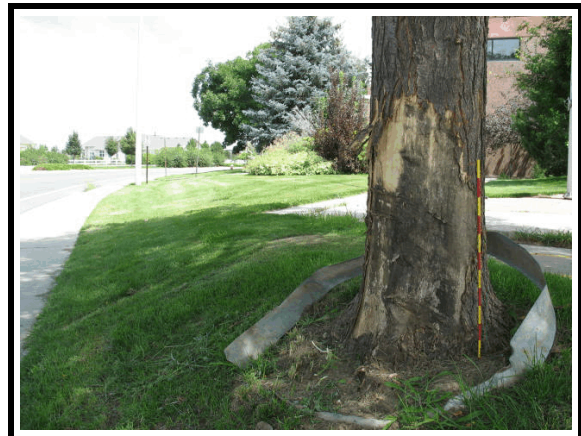
Figure 8. Second struck tree

The Cobalt continued east while in a yaw, traveled approximately 22.1 m (72.5 ft) and the front of the Cobalt impacted a second tree (10FZEW3), with a trunk diameter of 0.5 m (1.3 ft). The case vehicle was nearly at a 90 degree angle to the tree at impact. The barrier equivalent routine of the WinSmash program computed a total delta V of 25.0 km/h (15.5 mph). The longitudinal and lateral components were -8.6 km/h (-5.3 mph) and 23.5 km/h (14.6 mph), respectively. After striking the second tree, the vehicle was redirected back onto the roadway, crossed all of the travel lanes while still in a yaw, and the left front tire impacted the curb on the north side of the street (09LFWN1), damaging the tire and axle. The Cobalt traveled over the north curb, slid through some low bushes and came to final rest on the north sidewalk, facing southwest.

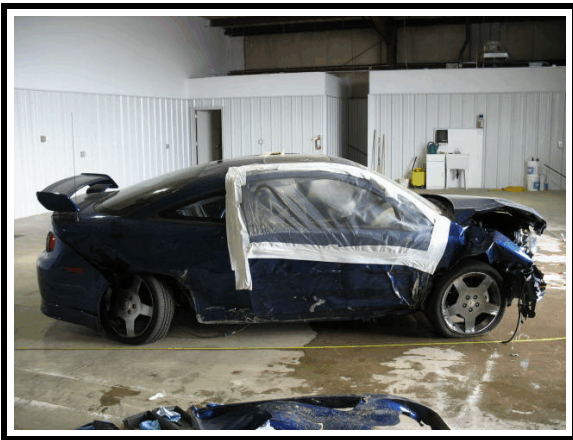
The 2006 Chevrolet Cobalt sustained moderate right side damage as a result of the impact with the first tree. The case vehicle sustained 248.0 cm (97.6 in) of direct damage along the right side, beginning 20.0 cm (7.9 in) forward of the right rear axle, extending forward. Since there were no undamaged axles on this vehicle post-crash, a damaged axle had to be used to document the location of the direct damage for this crash event.

The Collision Deformation Classification (CDC) for this impact was 01RYEW2. The EDR reported estimated principle direction of force was 20 degrees.

Figure 14. Right side damage

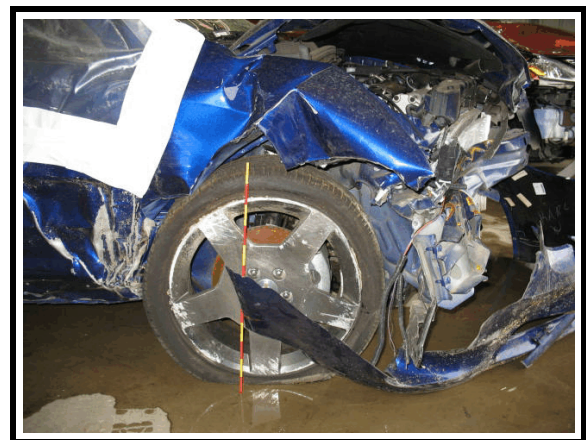
The right front tire was restricted and torn, although this damage may have occurred during the second crash event. The right rear tire was also restricted, holed and the rim was deformed. Both right side tires had moved rearward from the crash events, and the right wheelbase was shortened by 6.0 cm (2.4 in). The location of the maximum lateral crush for this impact was 25.0 cm (9.8 in) forward of the post-crash right rear axle and measured 4.0 cm (1.6 in).

Figure 15. Right front damage

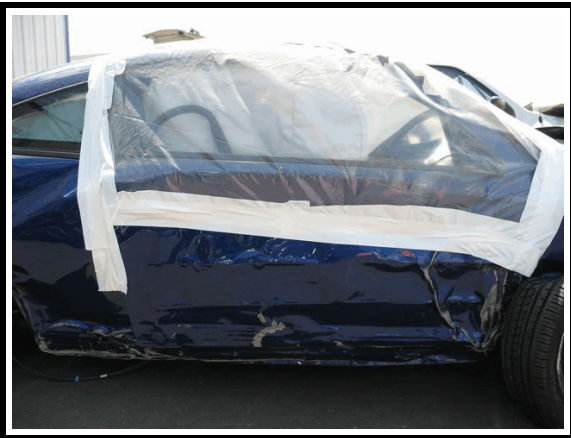
Figure 16. Right side tree impact damage

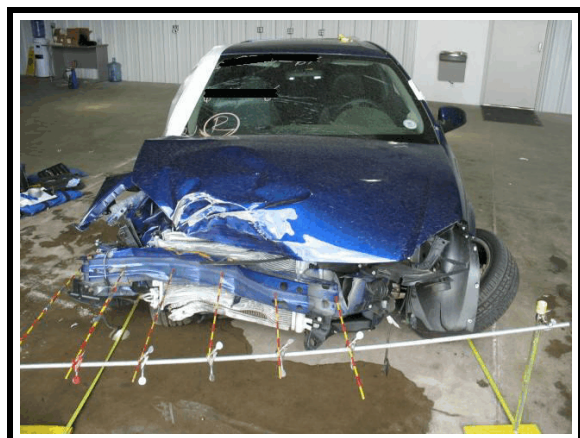
The case vehicle sustained 84.0 cm (33.1 in) of direct damage along the front bumper beginning 14.0 cm (5.5 in) left of the pre-crash centerpoint, extending to the right. The right front tire was restricted, the tire was torn, and the rim was damaged. The right wheelbase was shortened by 6.0 cm (2.4 in). The left wheelbase was lengthened by 5.0 cm (2.0 in). The bumper had shifted to the right from the impact forces. The right frame rail had shifted more than 10.0 cm (4.0 in) to the right but the left frame rail did not shift enough to increment the CDC. The bumper cover and energy absorbing styrofoam were no longer attached and were found inside the Cobalt's passenger compartment.

Additional freespace was subtracted from the crush profile to account for the width of the cover and foam. Due to the extent of the front bumper damage, an exemplar vehicle was located and measured so that the appropriate freespace could be subtracted from the front crush profile. Six crush measurements were documented along the front bumper backing bar as follows: C1=0.0 cm (0.0 in), C2=16.0 cm (6.3 in), C3=43.0 cm (16.9 in), C4=52.0 cm (20.5 in), C5=50.0 cm (19.7 in), C6=43.0 cm (16.9 in). The bumper backing bar had a width of 114.0 cm (44.9 in). The original undeformed front end width was 140.0 cm (55.1 in). The location of maximum crush was at C4.

The CDC for this impact was 10FZEW3. The EDR reported estimated principle direction of force for this crash event was 255 degrees.

Figure 17. Front crush profile

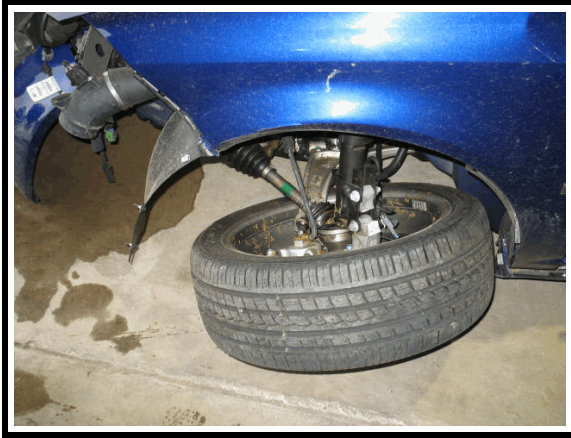
The Cobalt sustained moderate damage to the left front tire as a result of the impact with the north curb. The tire broke off the front axle and the rim was scuffed. At the scene inspection, small pieces of the north curb were missing. The CDC for this impact was 09LFWN1.

Figure 18. LF tire/axle damage

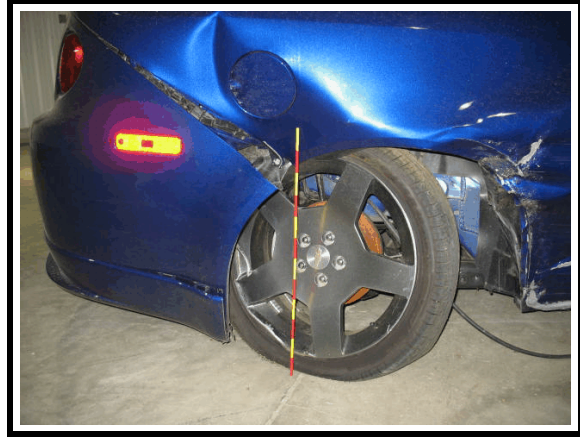
Figure 19. Damage to RR tire

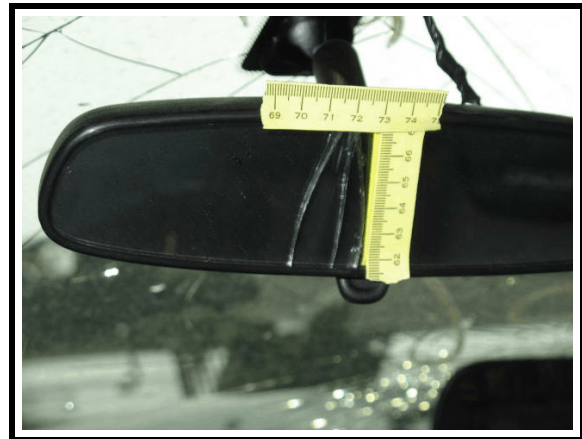
The windshield was cracked by impact forces and by the cover flap of the deploying front passenger air bag. The rearview mirror was cracked, possibly due to occupant contact. There was a scuff to the lower section of the center console, near the driver's foot controls that may have been due to contact from the driver's right ankle. There was a faint scuff to the top of the left A pillar, possibly due to contact from the driver's left wrist and/or hand. The glove compartment door was partially open and could not be closed.

Figure 20. Damage to rearview mirror

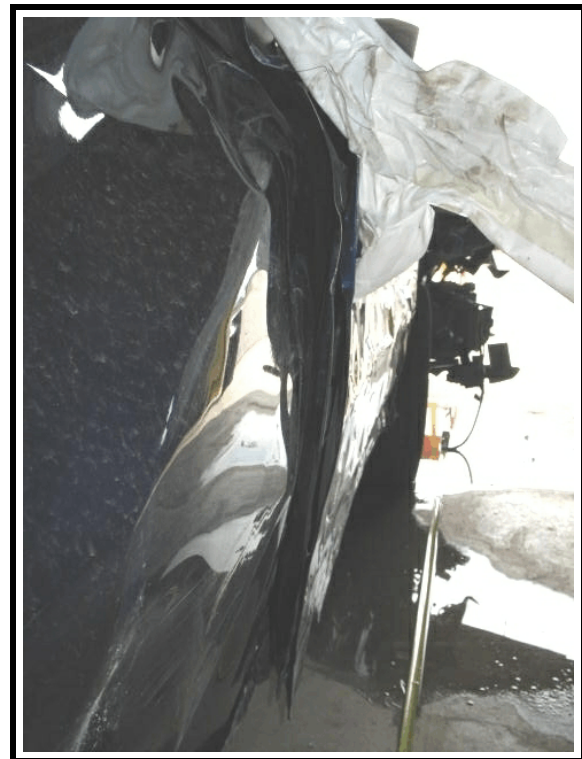
There was integrity loss to the passenger compartment. The right front window glazing shattered, leaving an opening that measured 106.0 cm (41.7 in) wide by 34.0 cm (13.4 in) high. The right front door was jammed shut and was slightly displaced, although the door latch/striker and hinges remained intact. At the latch/striker area, there was a 2.0 cm (0.8 in) gap between the damaged right front door panel and the door panel's pre-crash location. The widest gap was at the bottom of the right front door panel and measured 5.0 cm (2.0 in) in width. The left front door remained closed and operational.

Figure 21. RF door damage (no integrity loss)

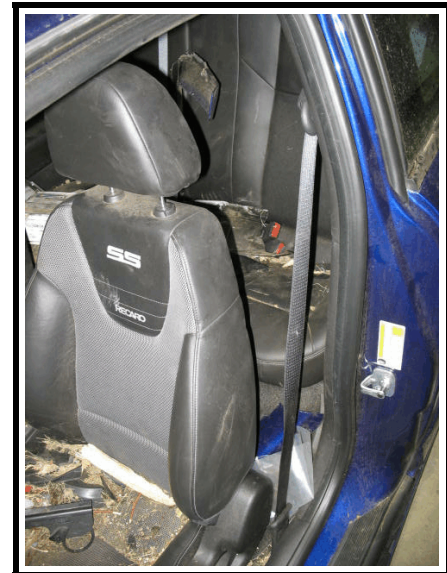
The driver and right front seat belt retractor pretensioners actuated during the first crash event and were locked in the stowed position post-crash. A piece of the left front plastic seat belt positioning device that had been attached to the bottom of the head restraint broke off when the pretensioner activated. The seat belt was not in use at the time of the crash.

Figure 22. Driver's seat belt - not in use (pretensioner actuated)

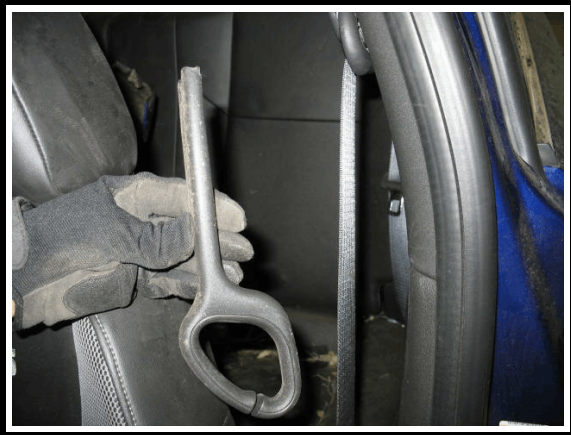
head restraints. The driver's seat belt positioning device broke off when the left front belt pretensioner actuated. The second row was configured as a fabric covered 60/40 bench seat with folding backs. The two outboard second row seating positions were equipped with adjustable head restraints that were not damaged. All three second row outboard seating positions were equipped with the lower anchor points and top tether anchors that are part of this vehicle's Lower Anchors and Tethers for Children (LATCH) system. The top tether anchors were located on the hat shelf behind the second row seat backs.

Figure 23. Damaged left front seat belt positioning device (belt not worn during crash)

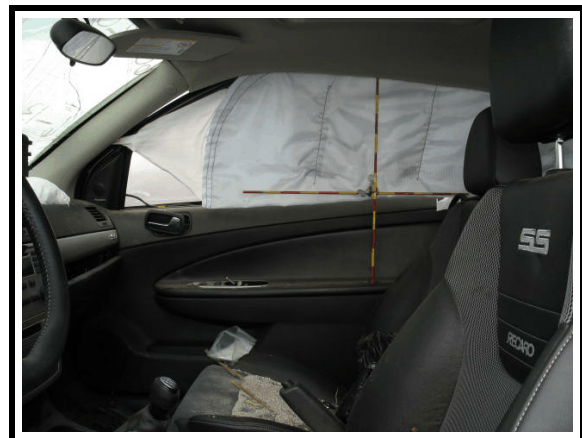
The Cobalt was also equipped with left and right side curtain air bags. The right side curtain deployed and extended from the A pillar to the C pillar. There was a small coverage gap present at the right A-pillar. The gap consisted of a triangular shaped area measuring 26.0 cm (10.2 in) in height at the forward aspect of the bag, 28.0 cm (11.0 in) in width along the belt line and 18.0 cm (7.1 in) in length along the A-pillar. The curtain was fairly rectangular in shape and in its deflated state, measured 173.0 cm (68.1 in) in length. The height of the front section of the curtain measured 38.0 cm (15.0 in) and the back

Figure 27. Right side curtain and gap distance at the right A pillar

section measured 26.0 cm (10.2 in). The air bag had one external tether, located at the front of the bag at the A pillar. There were no vent ports. The side curtain deployed from the right roof side rail and had no visible signs of occupant contact or damage. There were black deployment streaks found on the inner curtain material near the lower portion of the bag, in the front and center sections.

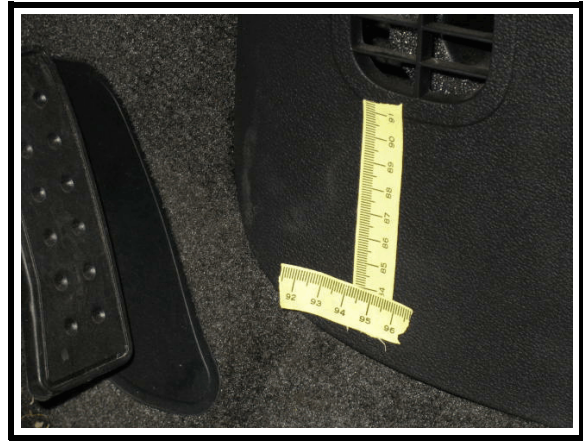
The driver's body pitched to the right, and his right ankle may have scuffed the lower corner of the center console cover. The case vehicle continued traveling east while in a yaw and the front of the Cobalt struck the second tree. The case vehicle was nearly at a 90 degree angle to the tree at impact. The male driver initiated a lateral trajectory towards the 9 o'clock direction of force.

Figure 30. Scuff to left side of center console (possible occupant contact)
