ON-SITE CERTIFIED ADVANCED 208-COMPLIANT VEHICLE INVESTIGATION

CASE NUMBER - IN-06-017

VEHICLE - 2006 CHEVROLET COBALT

CRASH DATE - June 2006

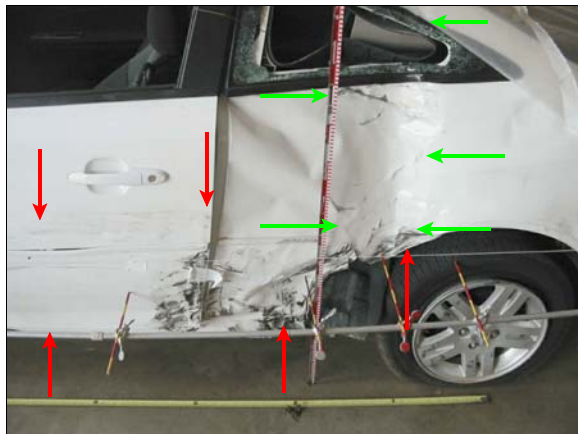
Crash: As the case vehicle changed lanes to the left in front of the Mercury, the case vehicle's left side (**Figure 2**) was impacted by the front right of the Mercury (event 1). The case vehicle entered the gore (**Figure 3**) and its front right corner (**Figures 4 and 5**) impacted the bluff end of a steel guard rail (event 2, **Figure 6** below) causing a first stage deployment of the driver and front right passenger air bags. As the impact progressed, the guardrail snagged the right front wheel (**Figure 7** below) and the case vehicle rapidly rotated clockwise. The front of the case vehicle (**Figures 4 and 5**) then impacted the back of the guardrail and guardrail post (event 3). The case vehicle continued to rotate clockwise and the left quarter panel (**Figure 2**) impacted an exit ramp sign post breaking it off its base (event 4). The left front door (**Figure 8** below) then impacted one of the guardrail posts as the case vehicle continued to rotate.

Figure 2: Sideswipe damage from impact with Mercury (red arrows) and damage from exit ramp sign post impact (green arrows)

Exterior Damage: The case vehicle's impact with the Mercury (event 1) involved the left quarter panel, left rear wheel and left front door. This was a sideswiping impact and the sheet metal in front of the left rear wheel house was crushed inward and displaced forward indicating a rear to front force direction. The sideswipe scraping continued forward onto the left front door. The direct damage began 31 centimeters (12.2 inches) rear of the left rear axle and extended forward 211 centimeters (83.1 inches). There was also an overlapping narrow vertical damage pattern just in front of the left rear wheel due to the impact with the exit ramp sign post (event 4) that extended to the "C"-pillar. In addition, there was an overlapping narrow vertical damage pattern near the middle of the left front door due to the impact with the guardrail post (event 5). The crush resulting from each of these impacts could not be effectively separated; therefore, a single set of crush measurements were taken to capture the totality of the damage to the left side. The crush measurements were taken at the mid-door level. The maximum residual crush was measured as 13 centimeters (5.1 inches) occurring at C₃. The table below shows the crush measurements for the totality of the left side impacts.

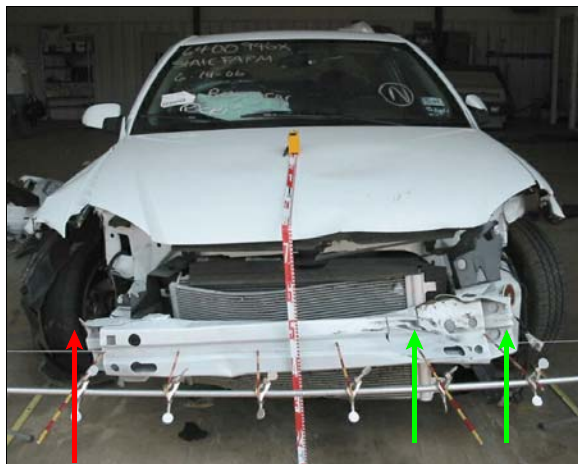
Figure 4: Damage to front of case vehicle from impact with guardrail, red arrow shows damage from end of guardrail, green arrows show damage from secondary guardrail impact

The damage from the impact with the bluff end of the guardrail (event 2) involved the front right corner of the bumper fascia. The guardrail passed by the right corner of the bumper bar, and the right unibody frame member and engaged the right front wheel and crushed it rearward approximately 20 centimeters (7.9 inches). There was no crush to the front bumper bar as a result of this impact.

The front impact with the back of the guardrail (event 3) involved approximately 80% of the front bumper, with the majority of the direct damage occurring at the left portion of the front bumper. Crush measurements were taken at the front bumper bar. The maximum residual crush

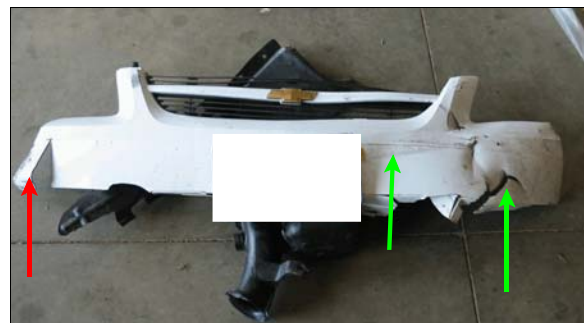
Figure 5: Damage to case vehicle's front bumper fascia, red arrow shows damage from end of guardrail, green arrows show damage from secondary guardrail impact

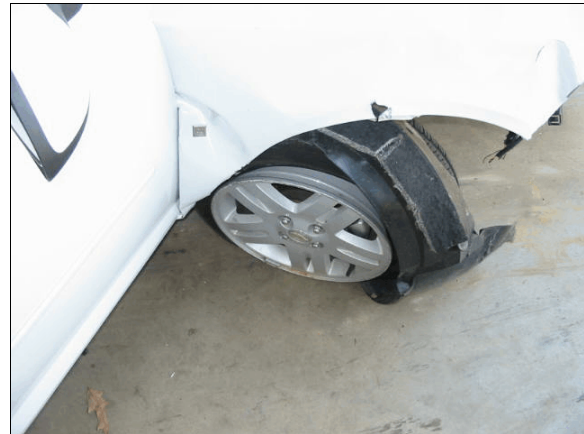
Figure 7: Displacement of right front wheel from snagging guardrail

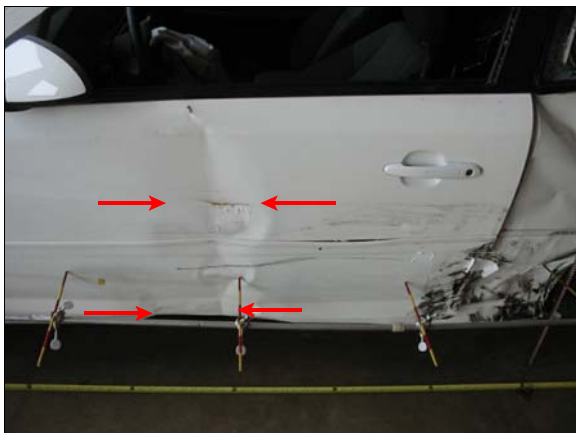
Figure 8: Guard rail post direct damage (arrows) to case vehicle's left front door and sideswipe damage from impact with Mercury

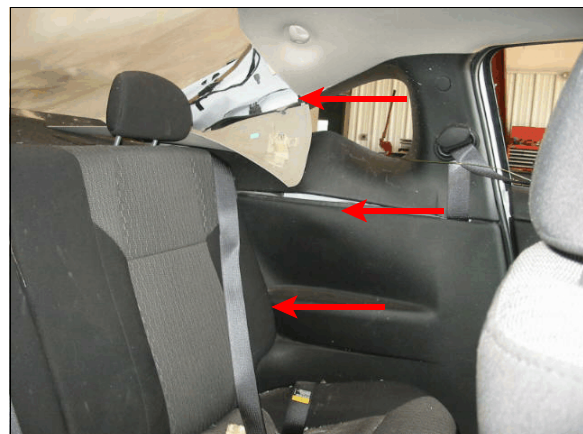
Figure 12: Overview of case vehicle's back left seat position, arrows show intrusion

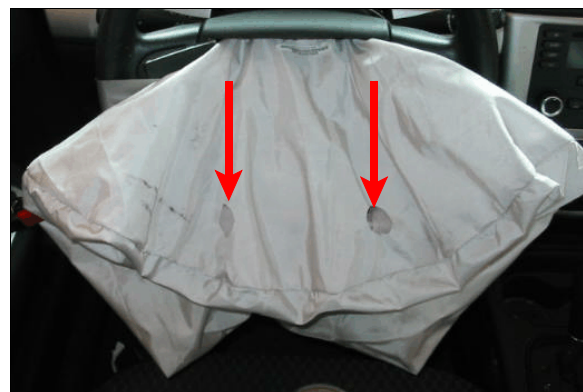
Figure 16: Arrows show case vehicle driver's air bag vent ports

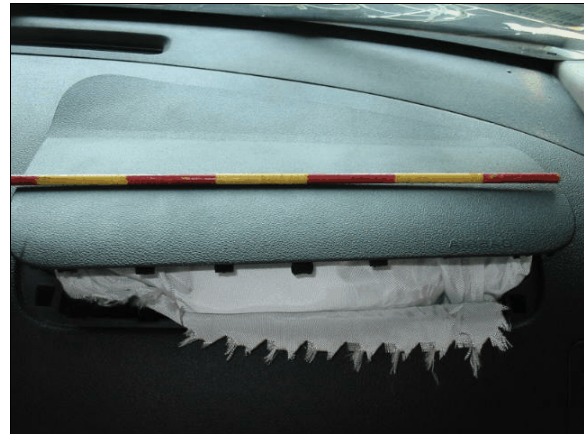
The front right passenger air bag was located in the top of the instrument panel (**Figure 17** below). The air bag module cover consisted of a single approximate trapezoidal-shaped cover flap constructed of slightly pliable vinyl. Its left side was approximately 22.5 centimeters (8.9 inches) in height, the right side was approximately 16.5 centimeters (6.5 inches) in height and the flap was approximately 37 centimeters (14.6 inches) in length. An inspection of the cover flap and the air bag fabric revealed that the cover flap opened at the designated tear points (**Figure 17** below).

Figure 17: Case vehicle's front right passenger air bag module cover flap

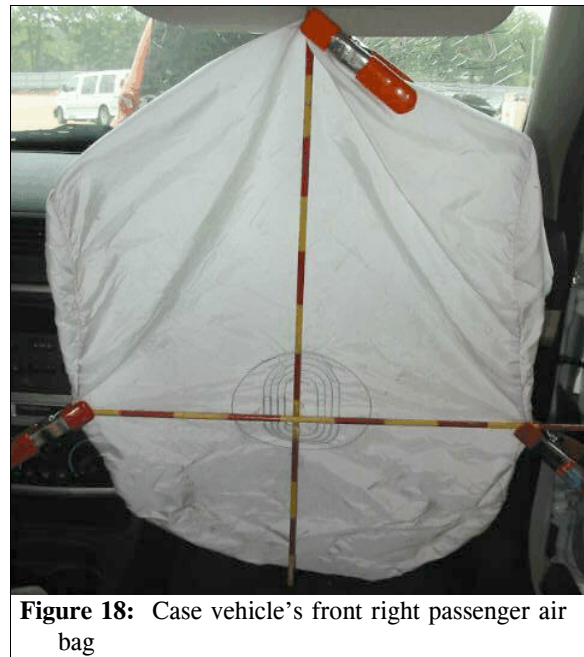
There was no evidence of damage during the deployment to the air bag cover flap or the air bag fabric. The deployed front right passenger's air bag (**Figure 18**) was rectangular in shape and was approximately 63 centimeters (24.8 inches) in height and approximately 44 centimeters (17.3 inches) in width. The air bag was designed with two tethers, each approximately 12 centimeters (4.7 inches) in width and had two vent ports, each approximately 5 centimeters (2 inches) in diameter, located at the 2:30 and 9:30 o'clock positions. There was no evidence of occupant contact to the air bag. The module cover flap contacted and cracked the windshield during the deployment.

Figure 18: Case vehicle's front right passenger air bag

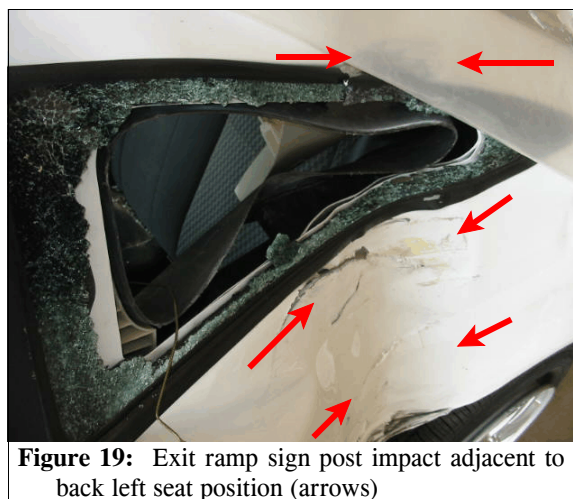
the back left glazing and tempered glass fragments impacted the left side of her face causing several small lacerations. In addition, the left side of her head impacted the left “C”-pillar causing a closed head injury without loss of consciousness, and the left side of her body impacted the side panel. The subsequent left front door impact with the guardrail post, just prior to the case vehicle coming to rest, caused her to again move left and the left side of her body most likely contacted the side panel and her head most likely contacted the “C”-pillar again. The back left passenger remained restrained in her seat following the crash. The driver reported that the passenger was removed from the vehicle by medical personnel.

Figure 19: Exit ramp sign post impact adjacent to back left seat position (arrows)
