Certified Advanced 208 Compliant Air Bag Investigation / Vehicle to Vehicle
Dynamic Science, Inc. / Case Number: DS06018
2005 Ford Focus
California
July 2006

1. Report No. DS06018	2. Government Accession No.	3. Recipient Catalog No.	
4. Title and Subtitle Certified Advanced 208 Compliant Air Bag Investigation		5. Report Date November 22, 2006

Dynamic Science, Inc.
Crash Investigation
Case Number: DS06018

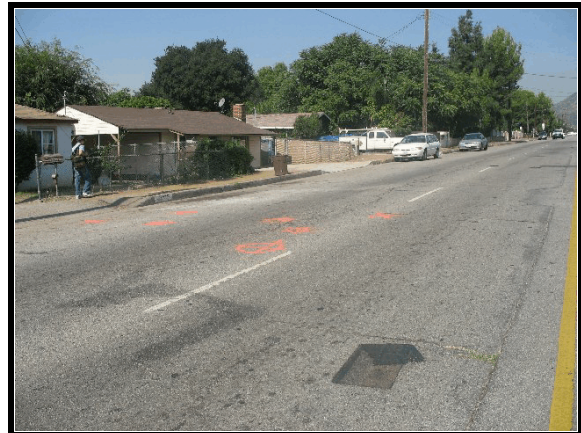
Figure 5. Area of impact and final rest

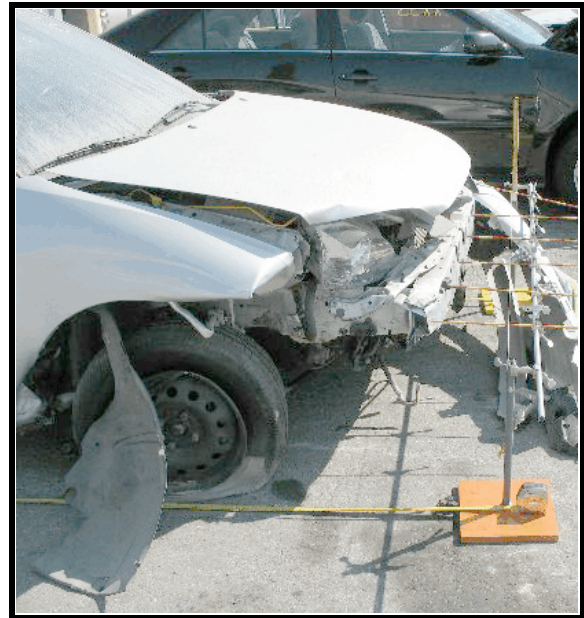
The 2005 Ford Focus sustained moderate front end damage as a result of the impact with the Honda Civic. The direct damage began 20.0 cm (7.9 in) right of the bumper centerline and extended 48.0 cm (18.9 in) laterally to the right. The bumper fascia was torn away from the bumper backing bar. Both right side doors were jammed shut. There was remote buckling at the right roof area and at the right sill between the two right side doors. The front right rim was dented and the front right tire was flat. The wheelbase was shortened by 2.0 cm (0.8 in) on the right side, and elongated 1.0 cm (0.4 in) on the left side. There were spider web fractures to the windshield from contact with the mirror and its support. Six crush measurements were documented at the bumper level as follows: C1=3.0 cm (1.2 in), C2=2.0 cm (0.8 in), C3=3.0 cm (1.2 in), C4=4.0 cm (1.6 in), C5=5.0 cm (2.0 in), C6=10.0 cm (3.9 in). Maximum crush was located at C6 and measured 10.0 cm (3.9 in). The Collision Deformation Classification (CDC) for the impact with the Honda was 01FZEW1.

Figure 6. Right side, right wheel damage

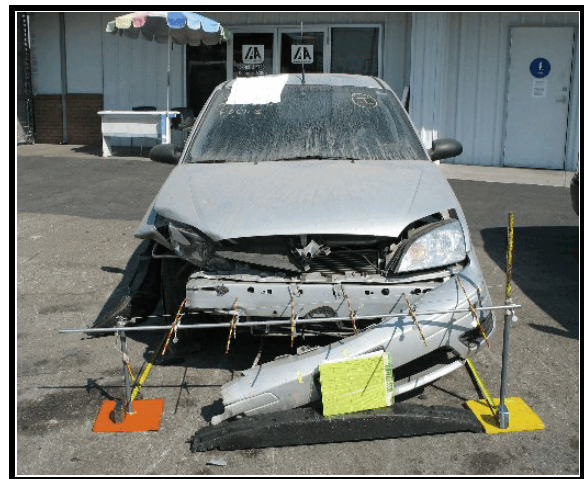
Figure 7. Front, 2005 Ford Focus

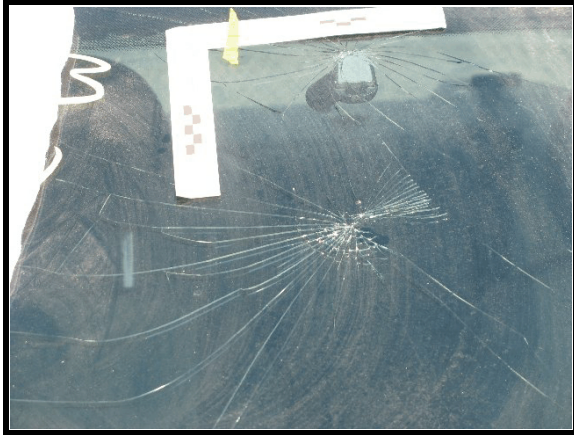
The 2005 Ford Focus sustained minor interior damage due to occupant contact. The windshield was fractured at two points along the line formed by the mirror and its supporting hardware. The mirror was likely contacted by the driver's right hand. The driver's left knee contacted the left lower instrument panel, causing the fuse door to be dislodged. There was 0.3 cm (0.1 in) of steering column shear capsule movement due to occupant loading. The panel above the steering column was missing.

Figure 8. Damage to windshield from mirror

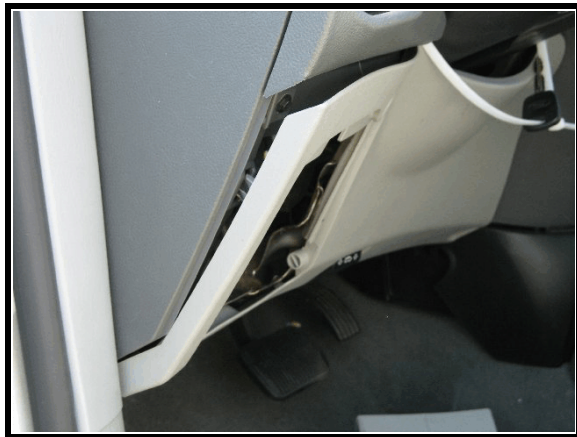
Figure 10. Left lower instrument panel

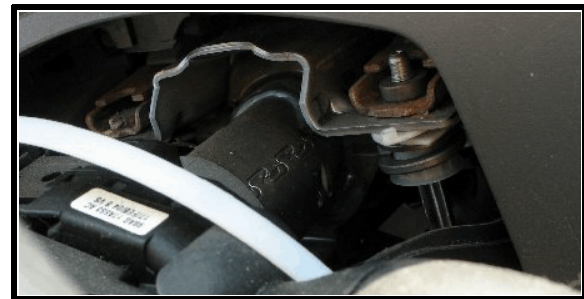
Figure 11. Shear capsule

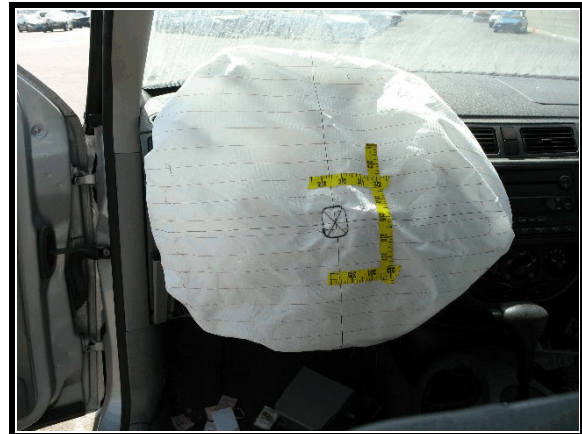
The driver’s air bag deployed from the center of the steering wheel hub through H-configuration module cover flaps. The top flap measured 18.0 cm (7.1 in) wide by 5.0 cm (2.0 in) high at its highest point. The bottom flap measured 18.0 cm (7.1 in) wide and 12.0 cm (4.7 in) vertically along the seams. The deployed driver’s air bag measured 56.0 cm (22.0 in) in diameter in its deflated state. There was a single internal tether. There were three half circle vent ports at the 9 o’clock position on the back of the air bag and two half circle vent ports at the 3 o’clock position. There were 22 horizontal lines across the face of the air bag. There was a blue fabric transfer near the center of the air bag which was a result of driver contact with the air bag.. The transfer was 6.0 cm (2.4 in) wide and 10.0 cm (3.9 in) high. The contact began 1.5 cm (0.6 in) laterally from the vertical center line and 3.0 cm (1.2 in) vertically from the horizontal center line. The contact was likely from the seat belt webbing across the driver’s torso. There were two small scuffs found on the air bag, one in the right upper quadrant and one in the left lower quadrant. These possibly came from contact with the driver.

Figure 13. Driver’s air bag

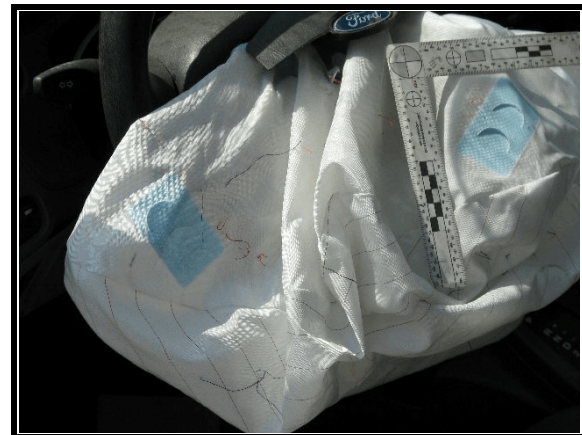
Figure 14. Vent ports, top module cover, driver’s air bag

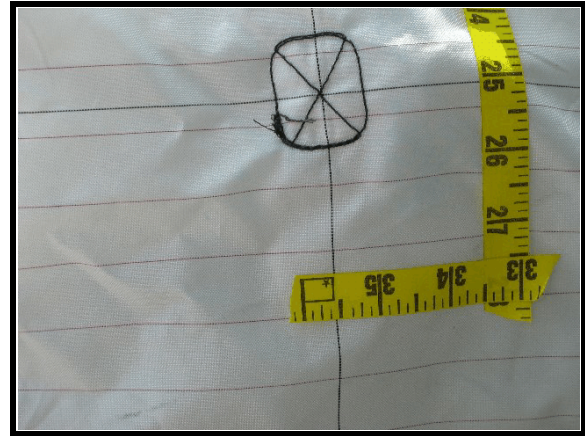
Figure 15. Close up of fabric transfer to driver's air bag
