CALSPAN ON-SITE ROLLOVER CRASH INVESTIGATION

CALSPAN CASE NO.: CA06-020

VEHICLE: 2005 FORD FREESTAR

CRASH DATE: JULY 2006

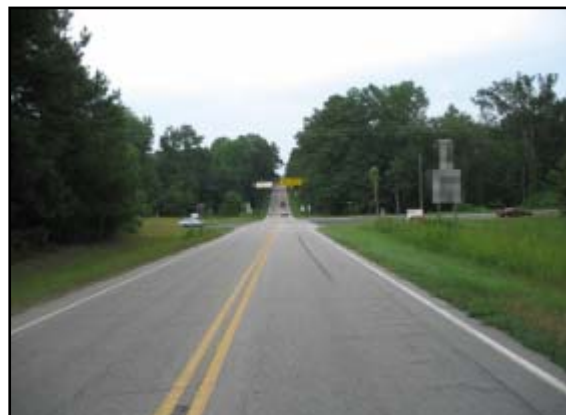
The crash occurred on the south roadside of an east/west roadway during night time hours. The 26-year-old female driver of the Ford was operating the vehicle eastbound (**Figure 2**) approaching the intersection at police reported speed of 113 km/h (70 mph). The driver allowed the Freestar to drift off the right road side and enter the south roadside at a shallow angle of approximately five degrees. As the vehicle entered the roadside, it began a clockwise rotation. The Ford reached a rotation angle of approximately 75 degrees as it traveled down the shallow embankment.

Figure 2. Ford's pre-crash eastbound travel.

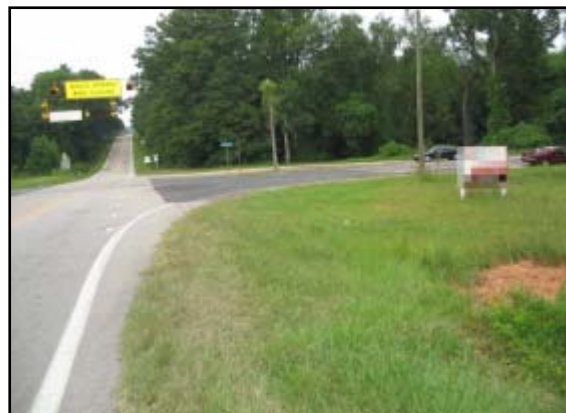
The front bumper and undercarriage of the Ford contacted the ground as it reached the transition point of the embankment and the level aspect of the ground (**Figure 3**). This impact was evidenced by a gouge that was located 4.8 meters (15.7 feet) south of the south road edge and 25 meters (82 feet) west of the intersection. The ground impact resulted in moderate non-horizontal damage to the frontal undercarriage area. The ground contact in conjunction with the lateral forces resulted in disengagement of the right front drive axle. This impact resulted in the

Figure 3. Area of ground contact with front undercarriage and trip.

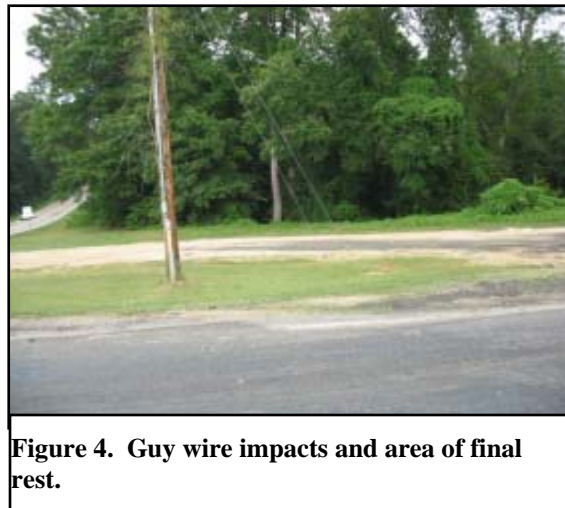
As the Ford traversed the north/south bound travel lanes and departed the east roadside the vehicle was returning to its wheels completing the eight quarter-turns. The rollover sequenced was interrupted as the left front door area of the vehicle impacted and disengaged a guy wire that was located 6 meters (19.7 feet) west of the west road edge and 18 meters (59 feet) south of the south road edge. The Ford traveled an additional 2.6 meters (8.5 feet) and impacted a second guy wire with the left rear door area. The second guy wire arrested the roll of the Ford and it came to final rest against the guy wire. **Figure 4** depicts the area of final rest for the Freestar.

Figure 4. Guy wire impacts and area of final rest.

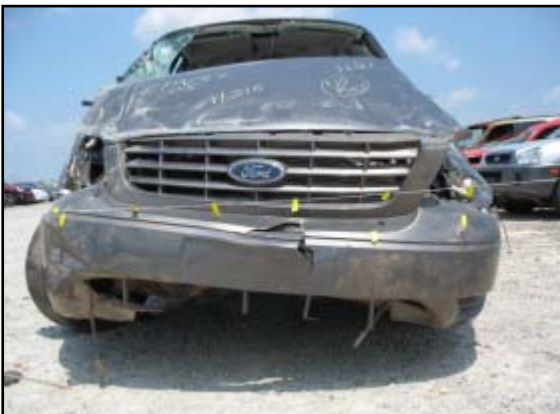
The Ford sustained moderate damage to all four planes as a result of the eight quarter-turn rollover event and impacts to the two guy wires. The first impact in this crash sequence involved the front bumper and frontal undercarriage contacting the ground. This impact resulted in vertical and longitudinal displacement of the front bumper system and disengagement of the right drive axle. **Figures 5 and 6** depict the front and undercarriage damage. The direct contact damage measured 104 cm (41.0") and began 36 cm (14.0") left of the centerline and extended to the right. The crush was measured across the full frontal width of the bumper beam of 122 cm (48.0"), using six equidistant crush measurements. The crush was as follows: C1 = 4 cm (1.6"), C2 = 0 cm, C3 = 3 cm (1.2"), C4 = 1 cm (0.4"), C5 = 4 cm (1.6"), C6 = 2 cm (0.8"). The Collision Deformation Classification (CDC) for this impact was 00-UFDW-2.

Figure 5. Frontal damage.

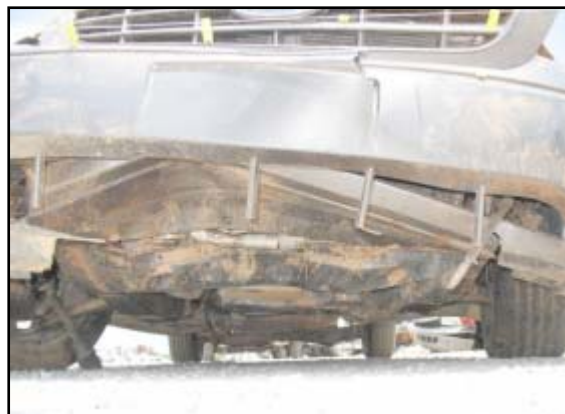
Figure 6. Undercarriage damage.

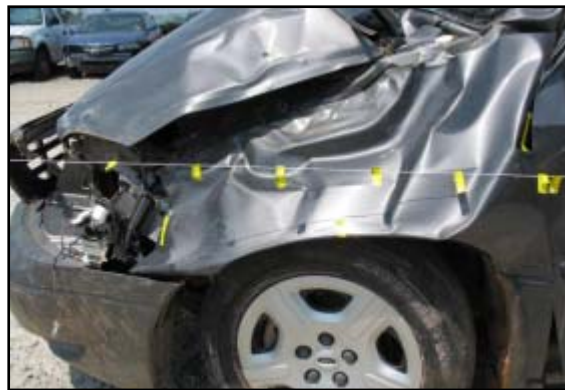
The rollover event resulted in damage to all four planes. Crush was evident on the front fenders and the right rear roof area. The resultant crush to the fenders was both vertical and lateral in scope and was documented at six equidistant points on the fenders. The direct contact damage on the left fender measured 80 cm (31.5") which began at the forward edge and extended 38 cm (15.0") rear of the left front axle. The left fender crush (**Figure 7**) profile was as follows: C1 = 0 cm, C2 = 0 cm, C3 = 8 cm (3.0"), C4 = 11 cm (4.5"), C5 = 14 cm (5.5"), C6 = 17 cm (6.7").

Figure 7. Left fender damage from rollover event.

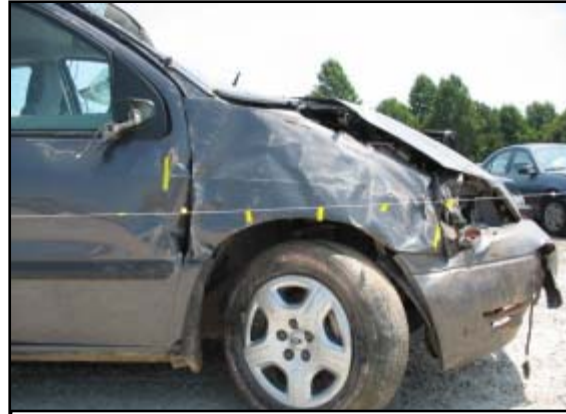
The direct contact damage on the right fender measured 102 cm (40.0") and began at the leading edge and terminated on the forward aspect of the right front door. The crush to this component (**Figure 8**) was as follows: C1 = 0 cm, C2 = 1 cm (0.4"), C3 = 3 cm (1.3"), C4 = 5 cm (2.0"), C5 = 12 cm (4.7"), C6 = 38 cm (5.9").

Figure 8. Right fender damage.

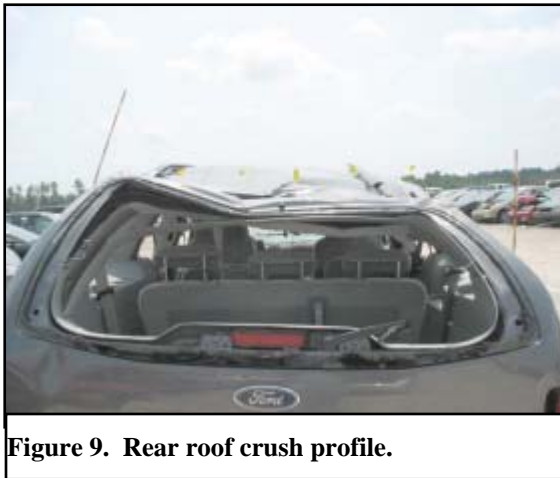
The rear right roof area sustained vertical and lateral crush as a result of contact with the ground during the rollover event. The direct contact damage measured 122 cm (48.0") and extended from the left D-pillar to the right D-pillar. A crush profile was documented along the full width of the rear roof which was 122 cm (48.0") (**Figure 9**). The six crush measurements were as follows: C1 = 0 cm, C2 = 0 cm, C3 = 10 cm (4.0"), C4 = 10 cm (3.8"), C5 = 9 cm (3.6"), C6 = 9 cm (3.5").

Figure 9. Rear roof crush profile.

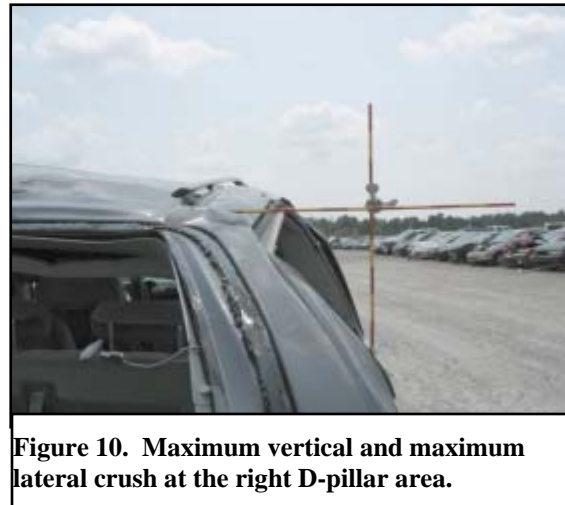
Figure 10. Maximum vertical and maximum lateral crush at the right D-pillar area.

The greatest extent of crush occurred within the right rear D-pillar area which resulted in maximum lateral crush of 30 cm (12.0") and maximum vertical crush of 9 cm (3.5") (**Figure 10**).

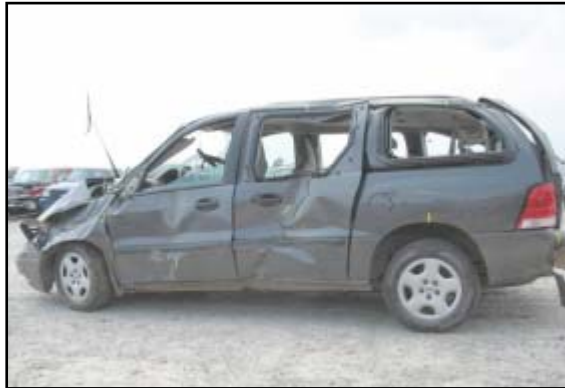
The left front door sustained minor damage from the yielding impact with the first guy wire. This impact did not disintegrate the partially opened left front glazing; however, the deformation jammed the left front door in the closed position. The direct contact damage measured 36 cm (16.0") and was contained within the center of the left front door. A crush profile was used to capture the deformation and was as follows: C1 = 3 cm (1.2"), C2 = 5 cm (1.9"), C3 = 7 cm (2.8"), C4 = 8 cm (3.1"), C5 = 6 cm (2.4"), C6 = 4 cm (1.6"). The CDC for this impact was 09-LPAN-2.

The left rear sliding door impacted a second guy wire resulting in minor damage to this component. The direct contact damage extended vertically from the sill to the left roof rail and was biased to the rear of the vehicle consistent with the angle of the guy wire. This impact disintegrated the tempered glazing and jammed the left rear door in a closed position. The direct contact damage measured 13 cm (5.0") and was located diagonally from top to bottom on the center of the door. The crush for this impact was follows: C1 = 3 cm (1.2"), C2 = 8 cm (3.1"), C3 = 11 cm (4.3"), C4 = 15 cm (5.9"), C5 = 10 cm (3.9"), C6 = 5 cm (1.9"). The CDC for this impact was 09-LPAN-2.

Figure 11. Left front and left rear door damage from the guy wire impacts.
