Rollover Investigation / Vehicle to Vehicle
Dynamic Science, Inc. / Case Number: DS06022
2006 Toyota 4Runner
California
September 2006

1. Report No. DS06022	2. Government Accession No.		3. Recipient Catalog No.	
4. Title and Subtitle Rollover Investigation		5. Report Date November 28, 2006

Dynamic Science, Inc.
Crash Investigation
Case Number: DS06022

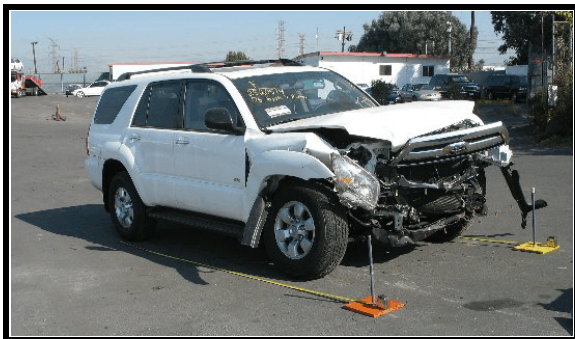
Figure 4. Front right, 2006 Toyota 4Runner

The 2006 Toyota 4Runner sustained moderate frontal damage as a result of the impact with the Audi. The direct contact began at the front right bumper corner and extended 65.0 cm (25.6 in) laterally along the bumper fascia. Measurements were taken to the end of the bumper mounting bracket and to the end of the frame. The two crush measurements at the frame level were as follows: C1 = 2.0 cm (0.8 in) and C2 = 18.0 cm (7.1 in). Both bumper mounting brackets were shifted to the left, with the right bracket shifted 45.0 cm (17.7 in). The right frame end was shifted to the left 28.0 cm (11.0 in). The left frame end remained in place. Six crush measurements were taken along the radiator support as follows: C1= 0 cm (0 in), C2 = 0 cm (0 in), C3 = 3.0 cm (1.2 in), C4 = 11.0 cm (4.3in), C5 = 17.0 cm (6.7 in), C6 = 32.0 cm (12.6 in). The Collision Deformation Classification (CDC) for the impact with the Audi was 01FZEW2.

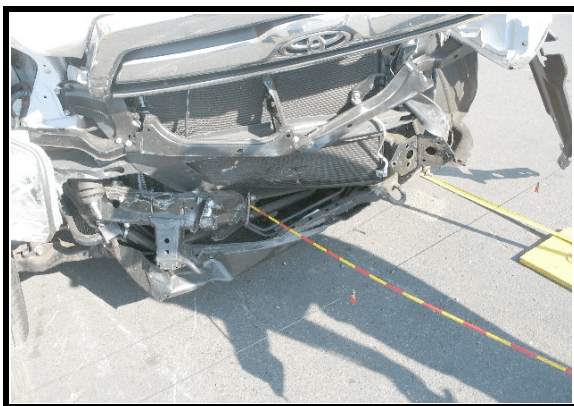
Figure 7. Close up of frame ends and mounting brackets

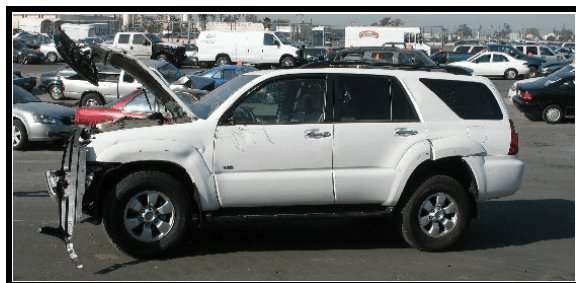
The 4Runner sustained minor left side damage as a result of the quarter turn rollover. The direct damage began 83.0 cm (32.7 in) rear of the rear axle and extended 408.0 cm (161 in) forward along the left side plane. The left mirror was knocked off. The CDC for the rollover was 00LDAO2.

Figure 6. Left side rollover damage, 2006 Toyota 4Runner

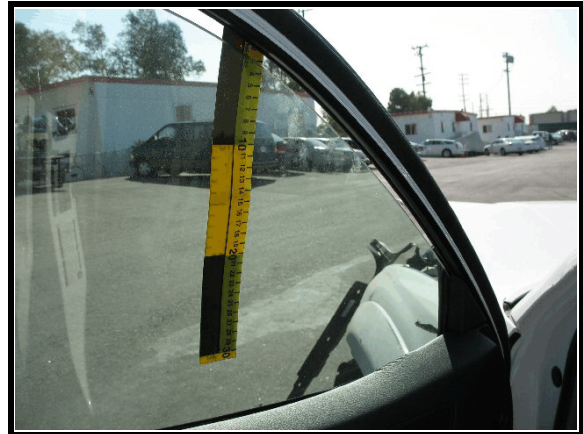
The 2006 Toyota 4Runner did not sustain any significant impact related damage. Hand print smudges were found on the driver's side window. The fuse panel cover near the left knee bolster was dislodged. There were abrasions to the right side of the center console from an unknown source. All the doors remained closed and operational. There was no intrusion nor any integrity loss.

Figure 8. Smudges to driver's side window

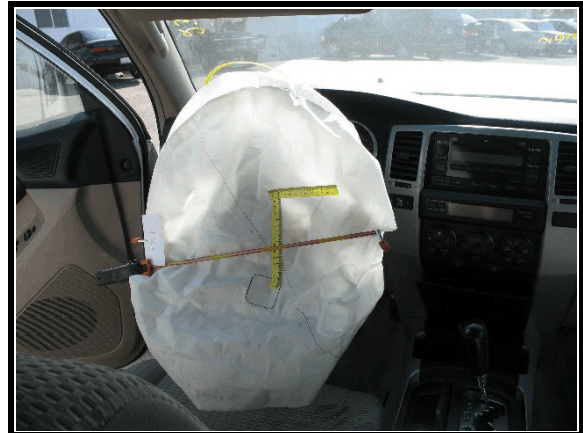
The driver's air bag and safety belt pretensioner deployed as a result of the longitudinal deceleration of the 4Runner during the impact with the Audi.

The driver's air bag deployed from the center of the steering wheel hub through asymmetrical H-configuration module cover flaps. The top flap measured 13.0 cm (5.1 in) wide by 11.0 cm (4.3 in) high. The bottom flap measured 13.0 cm (5.1 in) by 9.0 cm (3.5 in). The deployed driver's air bag measured 50.0 cm (19.7 in) in diameter in its deflated state. The air bag was tethered by a single internal strap. Two circular vent ports were located at the 11 and 1 o'clock aspects on the rear of the air bag. A brown make-up smudge/transfer was present on the air bag face. The transfer was located 5.0 cm (2.0 in) below the horizontal center line and measured 16.0 cm (6.3 in) wide and 10.0 cm (3.9 in) high.

Figure 9. Driver's air bag (top of air bag to left of image)

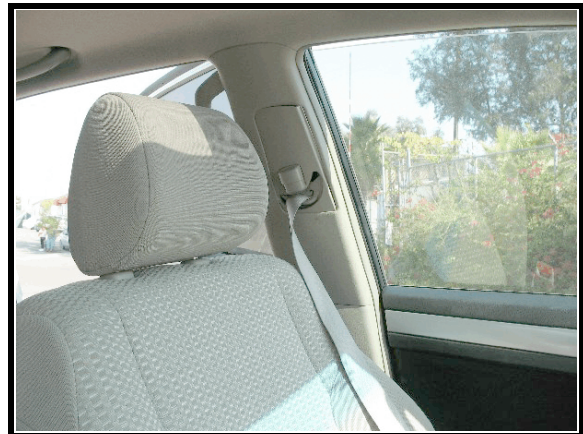
The 2006 Toyota 4Runner was configured with manual 3-point lap and shoulder belts for each seating position. Both front seat safety belts were equipped with retractor pretensioners and adjustable D rings that were in the full-down position. The driver's safety belt was configured with a sliding latch plate and an Emergency Locking Retractor (ELR). The remaining safety belts were configured with sliding latch plates and switchable ELR/Automatic Locking Retractors (ALR).

Figure 10. Driver's safety belt D ring

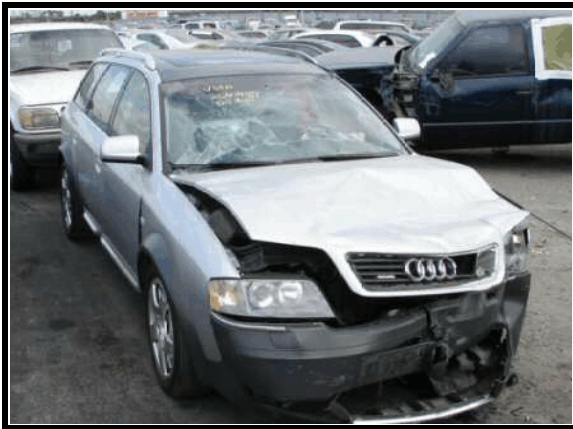
Description:	2004 Audi Allroad	
VIN:	WA1YD64B74Nxxxxxxx	
Odometer:	34,184 km (21,242 miles)	
Engine:	2.7 liter, 6 cylinder	
Reported Defects:	None noted	
Cargo:	None	
Damage Description:	Moderate front end damage. Vehicle towed from scene. Declared total loss by insurance company.	
CDC:	12FYEW1	
Delta V:	Total	20.0 km/h (12.4 mph)
	Longitudinal	-19.7 km/h (-12.2 mph)
	Latitudinal	3.5 km/h (2.2 mph)
	Energy	16,376 joules (12,078 ft lbs)

Figure 11. 2004 Audi Allroad

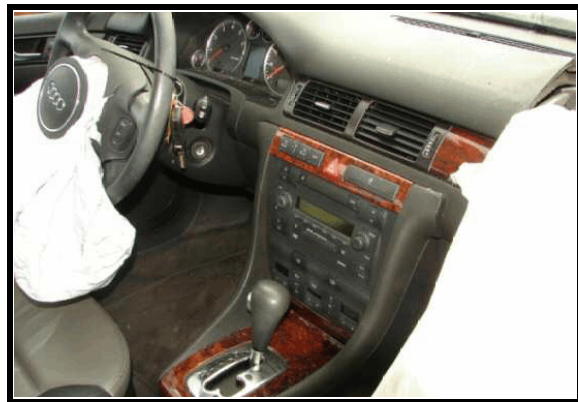
Figure 12. Driver's and front right passenger's air bag, Audi Allroad

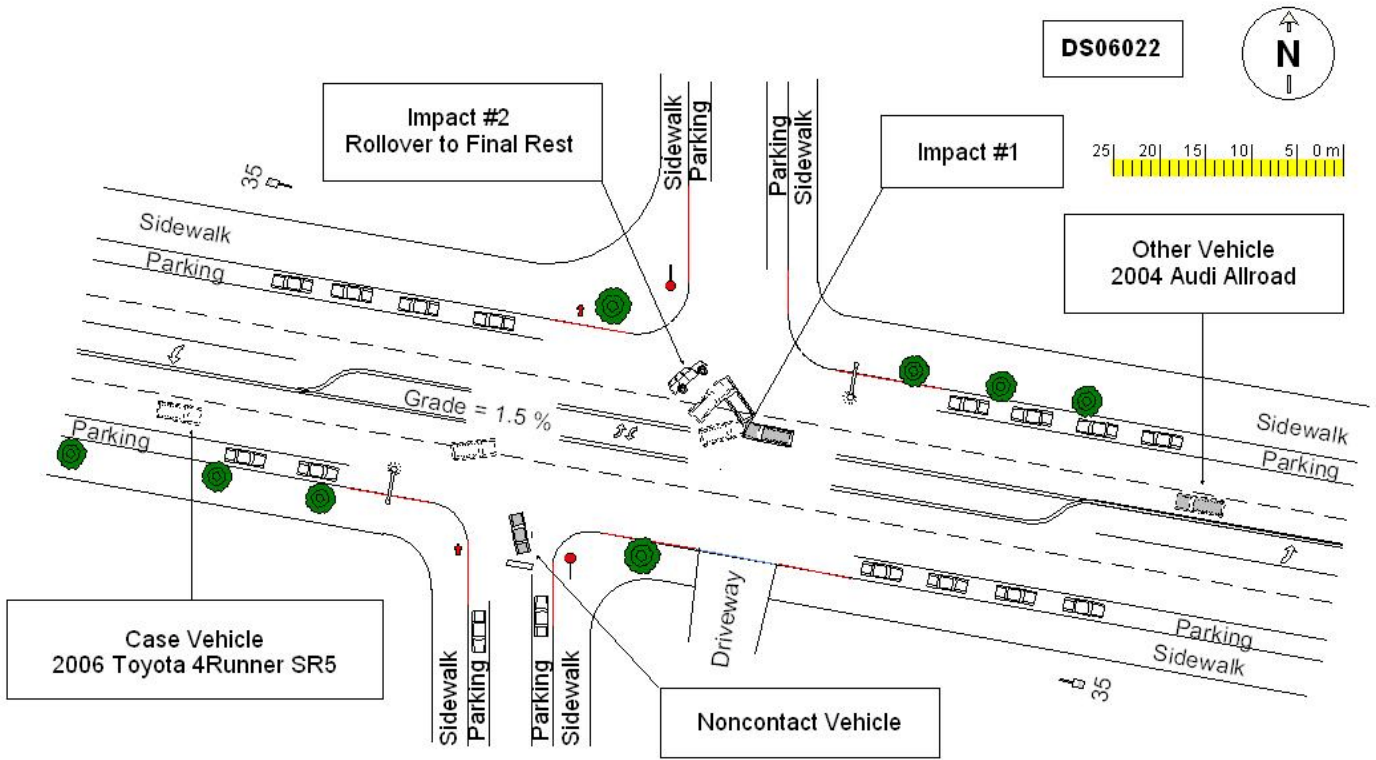
Attachment 1. Scene Diagram

As the 4Runner approached the first T intersection, the driver reportedly observed a car in the roadway which may have been crossing or turning from an intersecting street. The driver attempted to steer left. It is not clear if there was any control loss. The 4Runner crossed the two-way left-turn lane and entered the westbound travel lane. After the initial front to front impact, the 4Runner was redirected in a counterclockwise rotation and tripped. The stability features would not have had any effect. The 4Runner rotated approximately 80 degrees before tripping. The 4Runner began a left side leading rollover along its longitudinal axis and completed one quarter turn before coming to rest on its left side.
