ON-SITE CERTIFIED ADVANCED 208-COMPLIANT VEHICLE INVESTIGATION

CASE NUMBER - IN-06-022

VEHICLE - 2006 FORD F150

CRASH DATE - June 2006

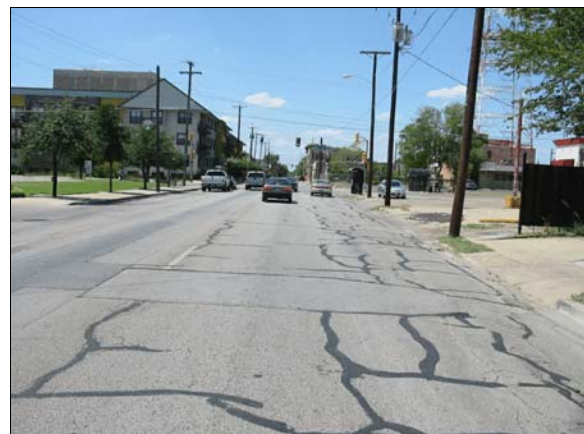
Figure 1: Approach of case vehicle to intersection, northwestbound in center right through lane

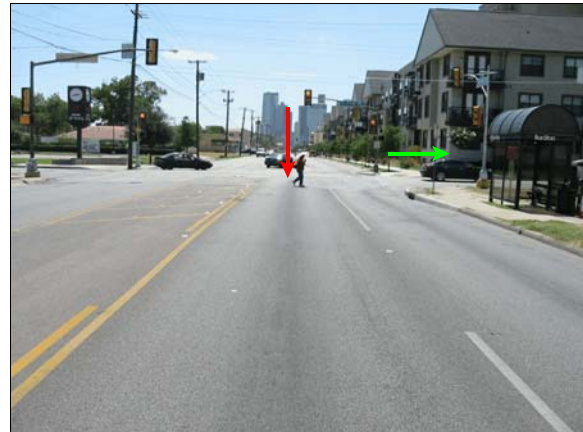
Figure 2: Approach of Chevrolet to intersection, southwestbound in inside through lane, red arrow shows area of first impact, green arrow shows struck corner of building

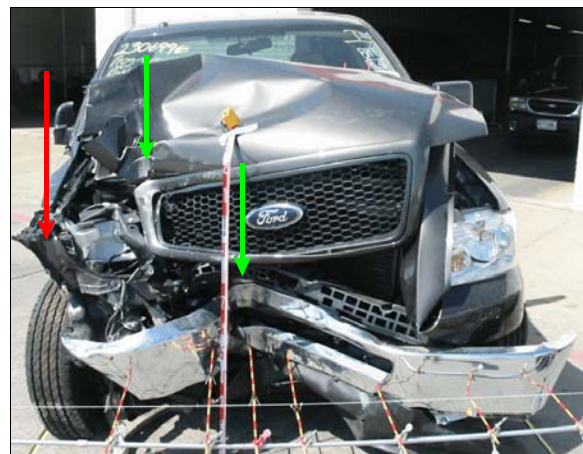
Figure 3: Damage to front of case vehicle from impact with the Chevrolet as well as the traffic signal pole (red arrow) and building (green arrows)

Exterior Damage: The case vehicle sustained three impacts through the front plane as follows: The impact with the Chevrolet (event 1) involved approximately the right third of the front end. The front bumper, grille and hood were directly damaged and crushed rearward and the front bumper was shifted to the left. The case vehicle's front impact with the traffic signal pole (event 3) involved the right fender and right front wheel. The fender and wheel were directly damaged and crushed rearward and the wheel was broken off its axle. The case vehicle's impact with the corner of the building (event 4) involved the front bumper, grille and hood. The impact produced a "V"-shaped deformation to the case vehicle's front bumper and crushed the grille and hood.

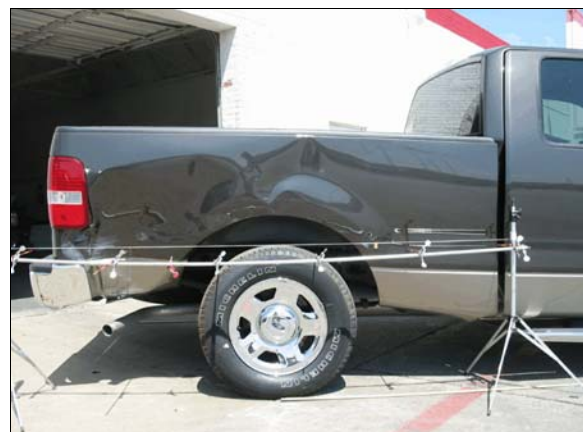
Figure 4: Damage to right side of case vehicle's truck bed from sideslap impact with left side of Chevrolet

The case vehicle's second impact with the Chevrolet (event 2) involved the right side of the truck bed. The direct damage began 46 centimeters (18.1 inches) forward of the right rear axle and extended 158 centimeters (62.2 inches) along the side of the truck bed. The residual maximum crush was measured as 10 centimeters (3.9 inches) occurring at C₂. The table below shows the case vehicle's right side crush profile.

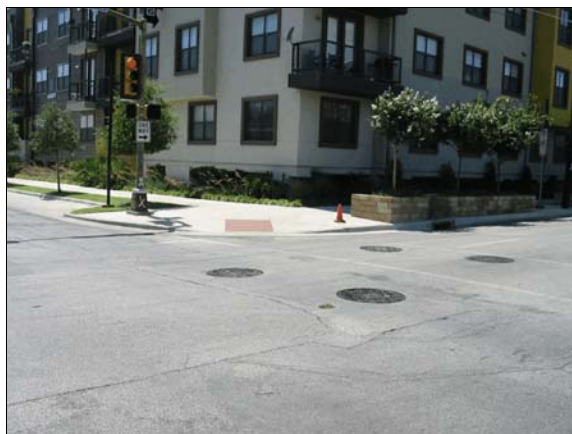
Figure 5: Approach of case vehicle to impact with traffic signal pole (orange cone shows location of pole) and corner of building

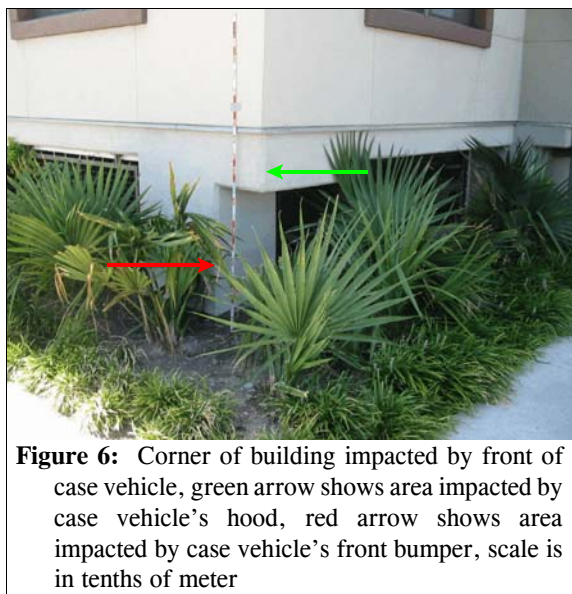
Figure 6: Corner of building impacted by front of case vehicle, green arrow shows area impacted by case vehicle's hood, red arrow shows area impacted by case vehicle's front bumper, scale is in tenths of meter

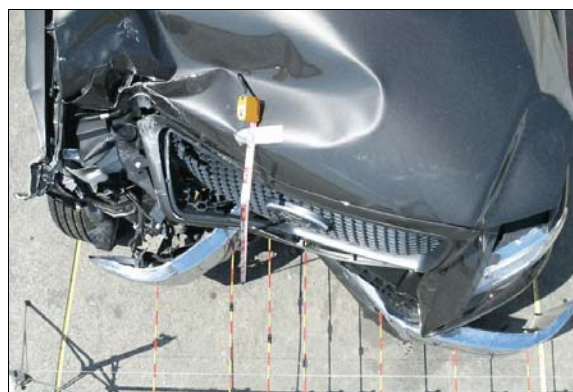
These impacts produced overlapping damage that could not be separated for the purpose of documenting individual crush profiles for each impact, so the totality of the damage to the front of the case vehicle was measured using one set of crush measurements. The direct damage began at the front right bumper corner and extended 116 centimeters (45.7 inches) across the front end. The residual maximum crush was measured as 60 centimeters (23.6 inches) occurring 34 centimeters (13.4 inches) left of C₅ (**Figure 7**). The shape of the damage in this area indicated that it was due to the impact with the corner of the building. The table below shows the totality of the case vehicle's front crush due to these overlapping impacts.

Figure 7: Top view of crush to front of case vehicle, baseline was set 10 cm (4 inches) beyond the vehicle's overall length to clear the displaced left bumper corner, each increment on rods is 5 cm (2 in)

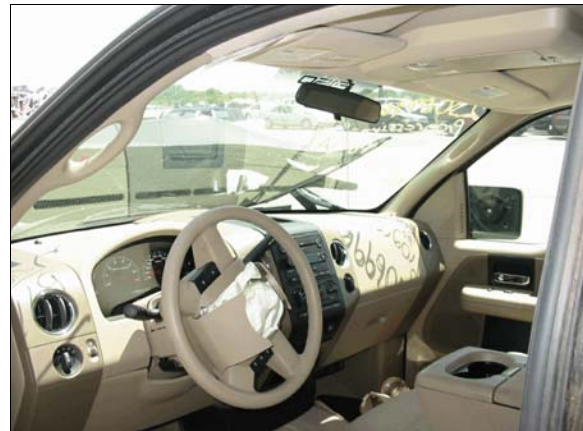
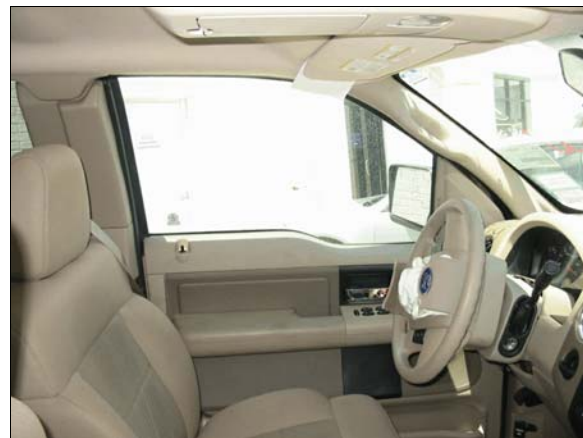
Vehicle Interior: Inspection of the case vehicle’s interior (**Figures 8 and 9**) revealed no evidence of occupant contact to any of the interior surfaces or components. The vehicle sustained no passenger compartment intrusion. Finally, there appeared to be no compression of the energy absorbing steering column, but the column housing was displaced. There was no deformation of the steering wheel (**Figure 10** below).

Figure 8: Overview of case vehicle’s steering wheel, instrument panel and windshield

Figure 9: Overview of case vehicle driver’s seating area and steering assembly

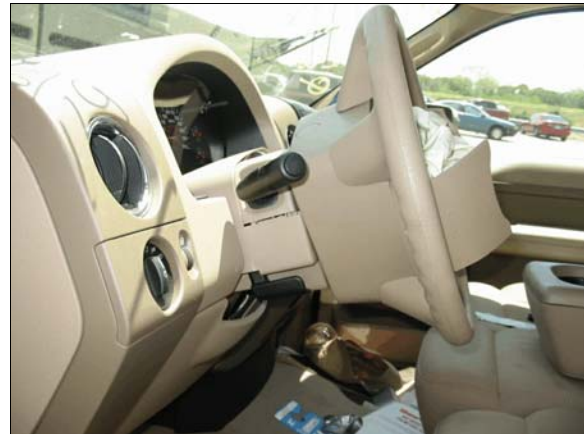
Figure 10: Left side view of case vehicle's steering assembly showing displacement of column cover

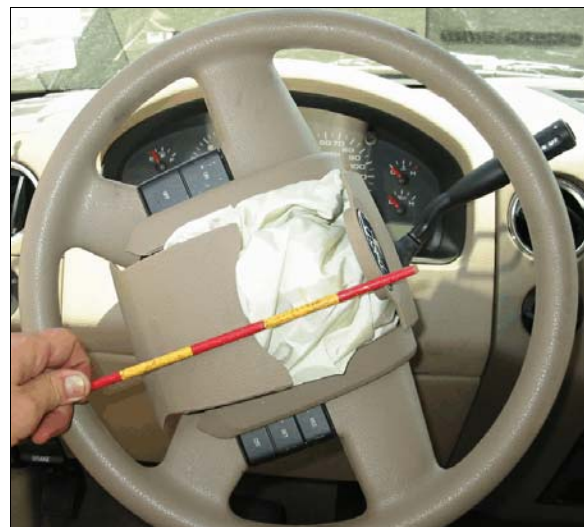
The case vehicle's driver air bag was located in the steering wheel hub. The air bag module cover consisted of approximate "H"-configuration cover flaps made of thick vinyl. There was a semi-oval contour at the horizontal tear seam in the center of the upper cover flap to accommodate the manufacturer's logo. A corresponding semi-oval cut-out was present at the horizontal tear seam on the lower cover flap. The upper cover flap was 11 centimeters (4.3 inches) in width and 6 centimeters (2.4 inches) in height. The lower cover flap was 11 centimeters in width (4.3 inches) and 12 centimeters (4.7 inches) in height. An inspection of the air bag module cover flaps and the air bag fabric revealed that the cover flaps opened at the designated tear points (**Figure 11**). There was no evidence of damage during the

Figure 11: Case vehicle driver's air bag module cover flaps

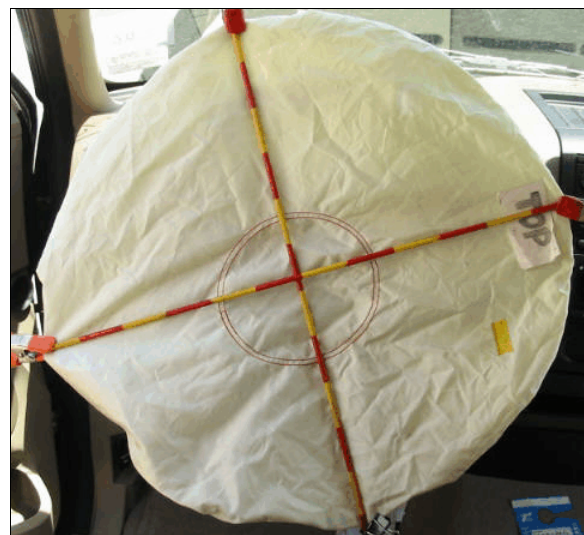
Figure 12: Case vehicle driver's air bag

deployment to the air bag or the air bag module cover flaps. The deployed driver's air bag (**Figure 12** above) was round with a diameter of approximately 61 centimeters (24 inches). The air bag was designed with two tethers, each approximately 14 centimeters (5.5 inches) in width and had two vent ports, each approximately 2.5 centimeters (1 inch) in diameter, located at the 11 and 1 o'clock positions. The distance between the mid-center of the driver's seat back, as positioned as the time of the vehicle inspection (i.e., seat at the rear-most track position, seat back slightly reclined), and the front surface of the air bag's fabric at approximate full excursion was 38 centimeters (15 inches). An inspection of the air bag revealed a few light yellow/orange spots on the upper right quadrant of unknown origin. Otherwise, the air bag was remarkable.

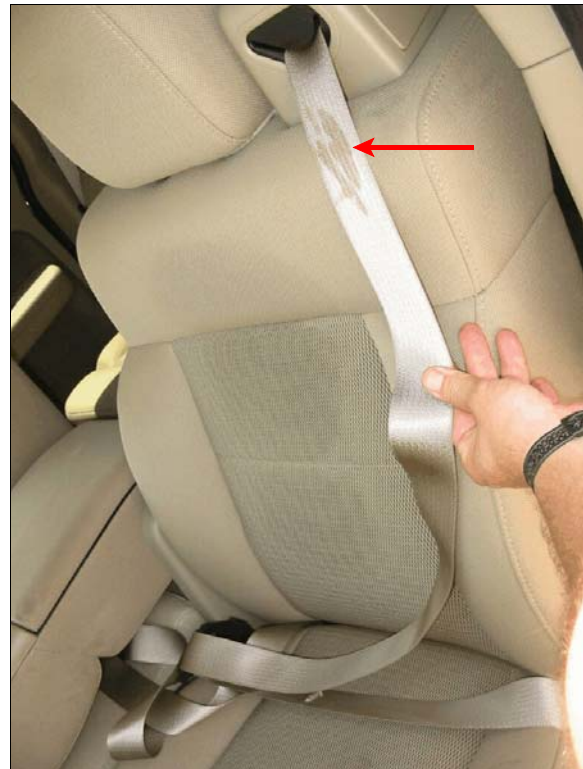
Based on the vehicle inspection, the case vehicle's driver was restrained by his manual three-point, lap-and-shoulder, safety belt system. There were blood stains on the shoulder belt in a location that was consistent with the safety belt extended out of the retractor (**Figure 13**) and used in the crash.

Figure 13: Case vehicle driver's safety belt, arrow shows blood stains on shoulder belt, location of blood indicates belt usage in crash because that portion of belt would be inside retractor if belt was not worn in crash
