Certified Advanced 208-Compliant Air Bag and Hybrid Vehicle Investigation
Vehicle to Objects
Dynamic Science, Inc. / Case Number: DS06023
2006 Lexus RX440h
Washington
September 2006

1. Report No. DS06023		2. Government Accession No.		3. Recipient Catalog No.	
4. Title and Subtitle Certified Advanced 208-Compliant Air Bag and Hybrid Vehicle Investigation				5. Report Date March 28, 2007

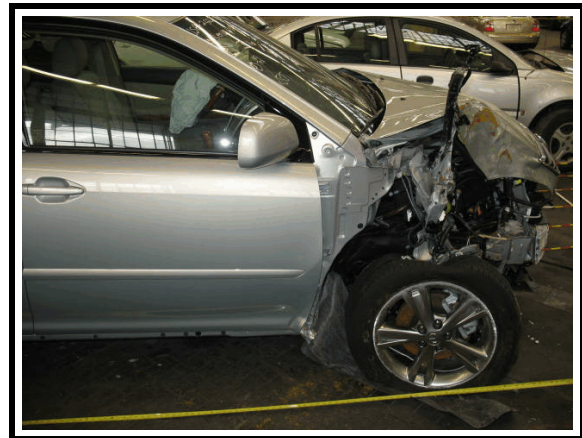
Figure 2. Right front damage

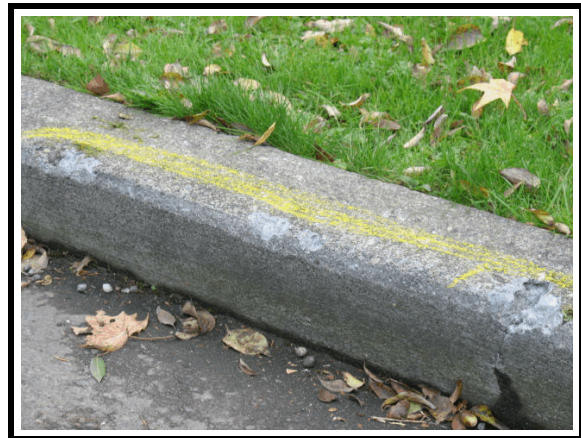
The driver fell asleep, likely prior to entering the curved section of roadway and failed to negotiate the curve. Just prior to the Lexus' roadway departure, the case vehicle's right tires contacted the curb several times, resulting in damage to both tire rims. The right front tire sidewall was holed (12RFWS1) as a result of the curb contact. The right rear tire sustained gouging/scuffing to the rim (12RBWS1). There were three distinct and separate sections of damaged curb documented during the scene inspection.

Figure 6. One section of curb damage

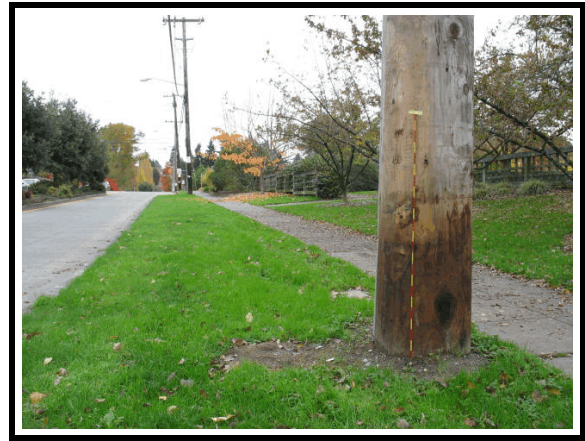
The WinSmash results appear to be low. This may be attributed to the fact that there was narrow end engagement at the right front bumper corner, resulting in minimal front bumper crush from the pole impact. During this crash event, the pole traveled past the bumper corner and became wedged between the engine compartment and the right front tire. The Lexus came to final rest still in contact with the pole, facing southeast.

Figure 7. Impacted pole (east)

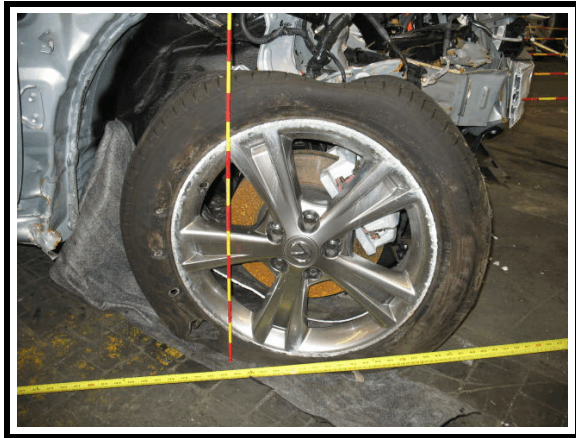
Position	Measured Pressure	Measured Tread Depth	Restricted	Damage
LF	200 kPa (29 psi)	7 mm (9/32 in)	No	None
LR	207 kPa (30 psi)	7 mm (9/32 in)	No	None
RR	207 kPa (30 psi)	7 mm (9/32 in)	No	No tire damage; rim scrapes
RF	Flat	7 mm (9/32 in)	Yes	Separated from axle, holed, gouged; rim scrapes

Figure 10. Damage to right front tire

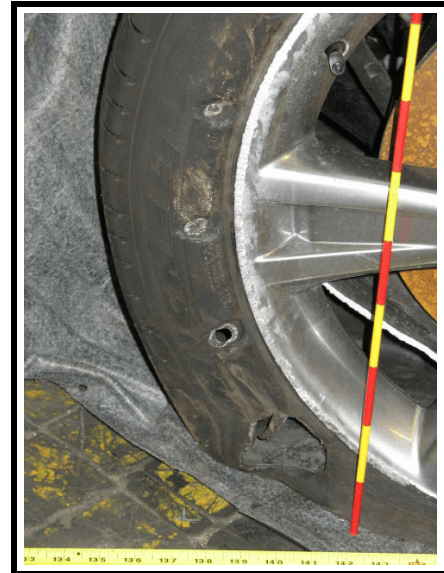
Figure 11. Closer view of holed/damaged RF tire sidewall

Damage Description: The 2006 Lexus RX440h sustained moderate tire damage as a result of impacting the concrete curb. Both of the case vehicle's right tires contacted the curb several times, resulting in significant rim damage. The right front tire sidewall was also gouged and holed as a result of the curb contact. The Collision Deformation Classification (CDC) for this impact was 12RFWS1. There was contact to the right rear tire. The CDC for this impact was 12RBWS1. The Lexus RX440h sustained moderate front end damage as a result of the impact with the utility pole. The case vehicle sustained 26.0 cm (10.2 in) of direct damage beginning 50.0 cm (19.7 in) right of the precrash center point of the vehicle, extending along the front bumper to the right. During this impact, the pole traveled past the right front bumper corner and became wedged between the engine compartment and the right front tire. The right front tire separated from the axle and was restricted post-crash. The right wheelbase was shortened by 2.0 cm (0.8 in).

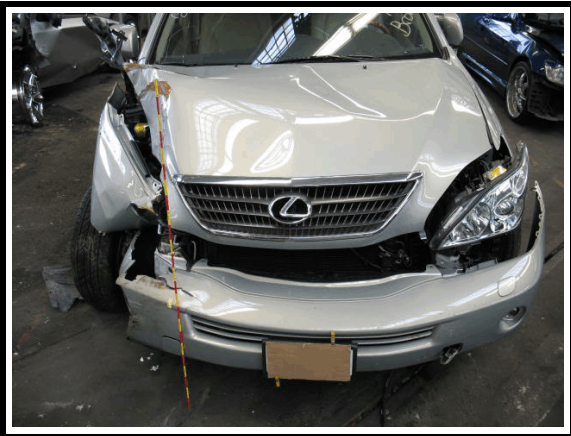
Figure 12. Front damage (bumper cover & right fender found inside vehicle)

The bumper cover was dislodged and was found inside the passenger compartment at the inspection. The additional freespace was accounted for in the crush profile. Six crush measurements were documented along the front bumper backing bar as follows: C1=0.0 cm (0.0 in), C2=3.0 cm (1.2 in), C3=6.0 cm (2.4 in), C4=8.0 cm (3.1 in), C5=9.0 cm (3.5 in), C6=16.0 cm (6.3 in). The bumper backing bar had a width of 122.0 cm (48.0 in). The location of maximum crush was at the right front bumper corner. The direct damage from this impact extended 88.0 cm (34.6 in) down the right side of the Lexus. The CDC for this impact was 12FREE5.

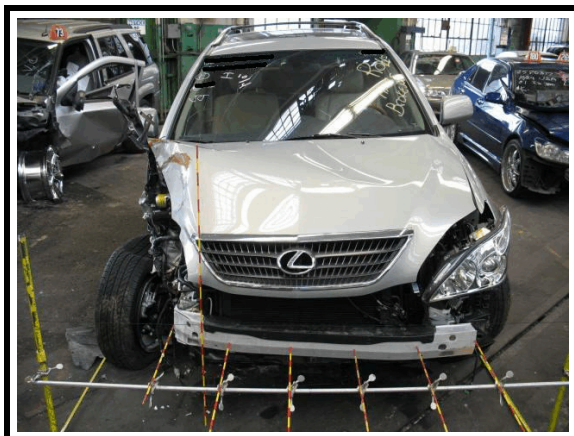
Figure 13. Front crush profile - 2006 Lexus RX440h

CDC (Impact 1):	12RFWS1	
(Impact 2):	12RBWS1	
(Impact 3):	12FREE5	
Delta V (Impact 3):	Total	15.0 km/h (9.3 mph)
	Longitudinal	-15.0 km/h (-9.3 mph)
	Latitudinal	0.0 km/h (0.0 mph)
	Energy	21,237 Joules (15,664 ft lb)

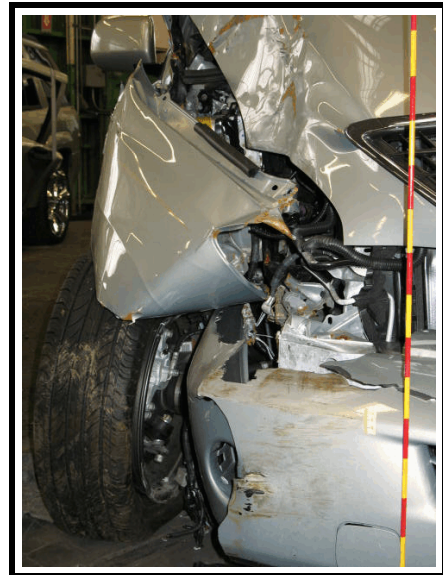
Figure 15. Close-up of direct damage from pole impact

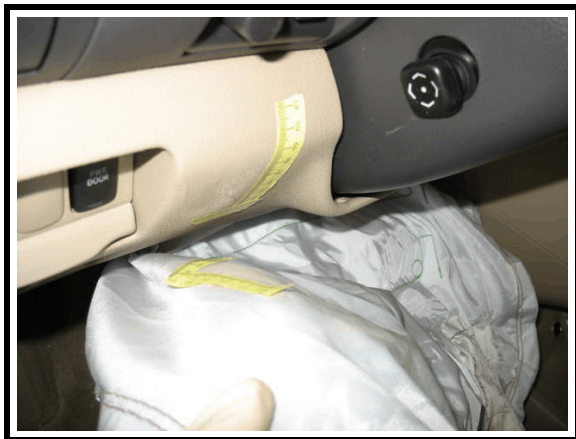
The driver's retractor pretensioner actuated during the crash and was locked in place post-impact. The lower left instrument panel was scuffed near the steering column due to contact with the deploying driver knee air bag. There was a tan transfer located on the knee air bag that directly matched up with the location of the instrument panel scuff. During the driver interview, the driver reported that he was wearing khakis at the time of the crash, but given the location of the tan transfer on the knee air bag, it is more likely the transfer was due to contact between the bag and the instrument panel, not the driver's clothing.

Figure 16. Deployed knee air bag and instrument panel scuff

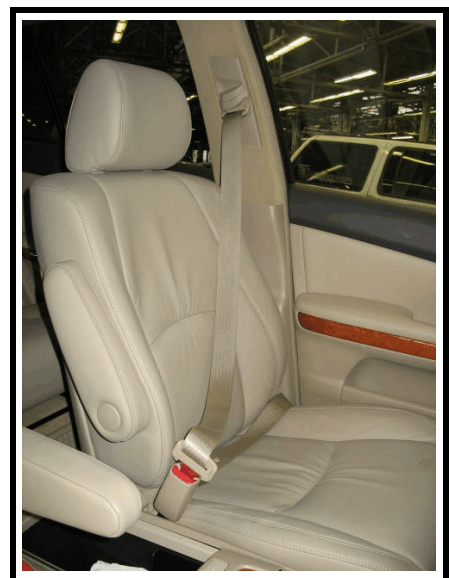
The 2006 Lexus RX440h was configured with manual 3-point lap and shoulder belts for each of the five seating positions. Both front seat belts were equipped with retractor pretensioners and force limiters. The driver's pretensioner actuated during the crash. The passenger side pretensioner did not actuate; there was no occupant in this seating position. The left front seat belt anchorage adjustment was found in the center position and the right front adjustment was in the full up position. The driver's safety belt was configured with a sliding latch plate and an emergency locking retractor (ELR). All of the other seating positions were equipped with sliding latch plates and switchable ELR/automatic locking retractors.

Figure 17. Driver's seat belt (retractor pretensioner actuated)

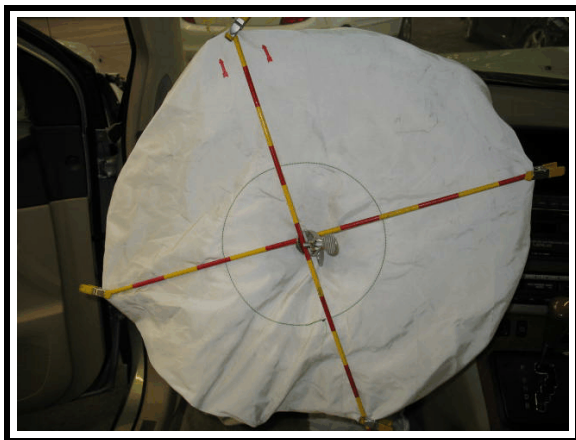
Figure 18. Driver front air bag (arrows point to top of bag)

The deployed air bag was circular in shape and measured 60.0 cm (23.6 in) high/wide in its deflated state. The maximum excursion of the deflated front air bag measured 34.0 cm (13.4 in) from the module face. The longitudinal distance between the module face and the driver's seat back as it was found at the inspection was 68.0 cm (26.8 in). The air bag had two internal tethers and there were two vent ports located on the back of the bag at the 11 and 1 o'clock positions. There was no damage to the air bag or air bag module cover flaps. There were a few cover flap deployment streaks found in the upper right quadrant on the front of the deployed air bag.

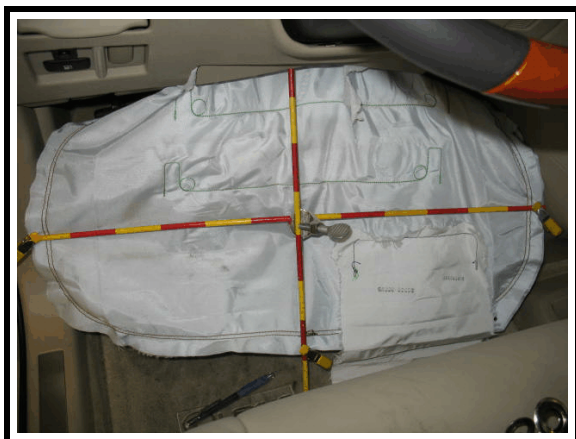
There was no damage to the module cover flaps. There was some dirt on the left half of the front of the deployed knee air bag. There was a faint tan transfer to the upper left quadrant on the front of the bag. The location of the transfer directly matched up with the location of a scuff to the lower left instrument panel and likely occurred during the deployment.

Figure 20. Driver's deployed knee air bag
