ON-SITE CHILD AIR BAG-RELATED FATALITY INVESTIGATION

CASE NUMBER - IN-06-025

VEHICLE - 1994 FORD MUSTANG

CRASH DATE - May 2004

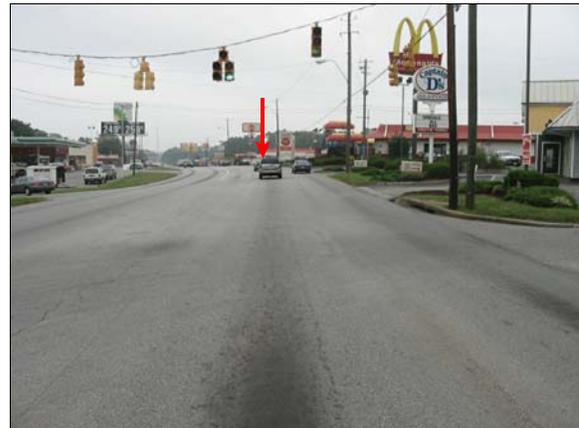
Pre-Crash: The case vehicle was traveling northwest in the inside northwestbound through lane and was stopped for the traffic signal at the intersection (**Figure 1**). The case vehicle driver's 8-year-old son and 6-year-old step daughter were both seated in the front right seat. The 8-year-old male was seated on the outboard portion of the seat and the 6-year-old female was seated on the inboard portion of the seat. Both passenger's were most likely restrained by the manual, three-point lap-and-shoulder belt at this time.

Figure 1: Approach of case vehicle northwestbound through intersection to area of impact (arrow)

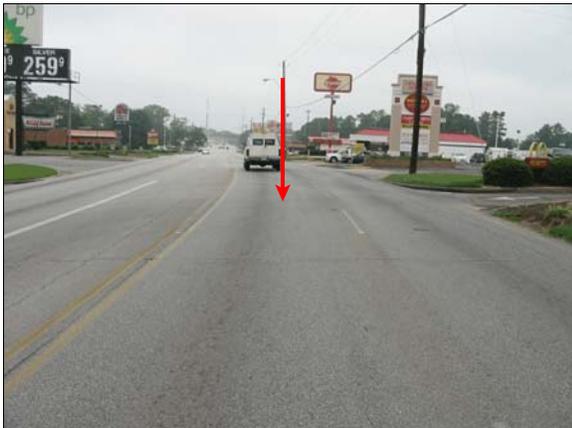
stopped in front of her. The driver stated she applied the brakes in an attempt to avoid the crash. The crash occurred in the northwestbound inside through lane (**Figure 2**).

Figure 2: Overview of area of impact (arrow) in northwestbound inside through lane

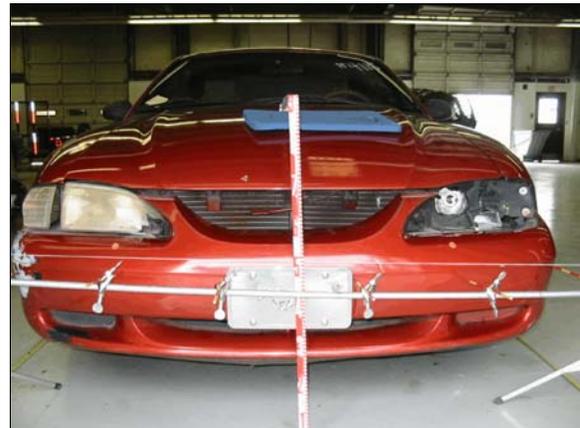
Figure 3: Damage to front of case vehicle from impact with back of Windstar

Crash: The front of the case vehicle (**Figure 3**) impacted the back of the Windstar (**Figure 4** and **Figure 5**) causing the case vehicle’s driver and front right passenger air bags to deploy. The impact damage to both vehicle’s indicated that the case vehicle was offset to the right of the Windstar’s centerline at impact. The damage indicated that approximately 80% of the case vehicle’s front bumper engaged the back bumper of the Windstar. The case vehicle driver’s pre-crash braking caused the case vehicle’s front suspension to load, and the front of the case vehicle dipped down and underrode the back of the Windstar. The damage to the vinyl skirt (**Figure 6** below), which covered the case vehicle’s front bumper and front of the hood, indicated that the top portion of the case vehicle’s front bumper engaged

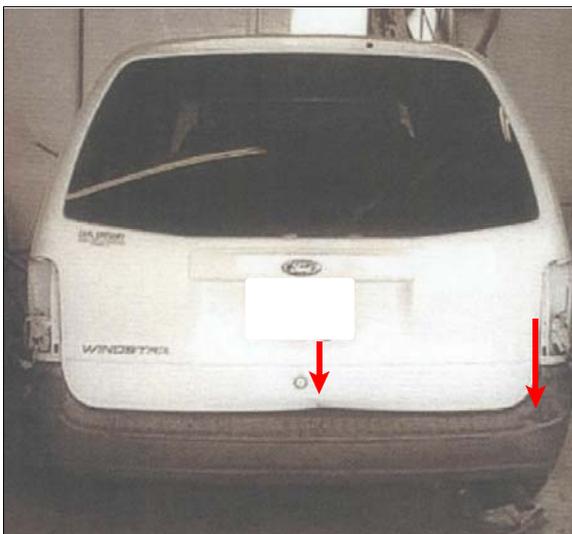
Figure 4: Attorney provided photo of overview of damage to back of Windstar from impact with case vehicle, tail lamp assemblies have been removed, arrows show damage to tailgate and bumper

Exterior Damage: The Windstar's impact with the case vehicle involved the back of the vehicle. The Windstar's back bumper and tailgate were directly damaged. Based on the Windstar collision repair records provided by the case vehicle driver's attorney, the repair work involved replacing the back bumper cover and the energy absorbing styrofoam located under the back bumper cover. In addition, the tailgate, tail pipe and muffler were replaced and the rear floor pan was repaired. There was no indication in the repair records of any repair to the Windstar's unibody structure.

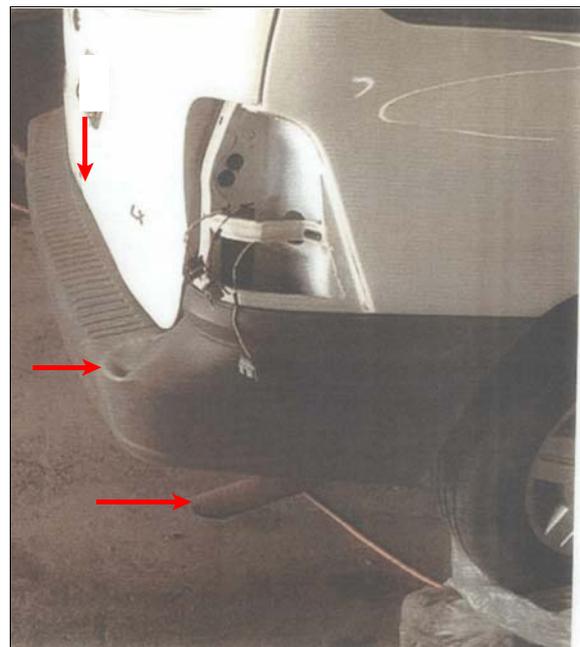
Figure 5: Attorney provided photo of right side view of damage to back of Windstar (arrows) from impact with case vehicle, right tail lamp assembly has been removed

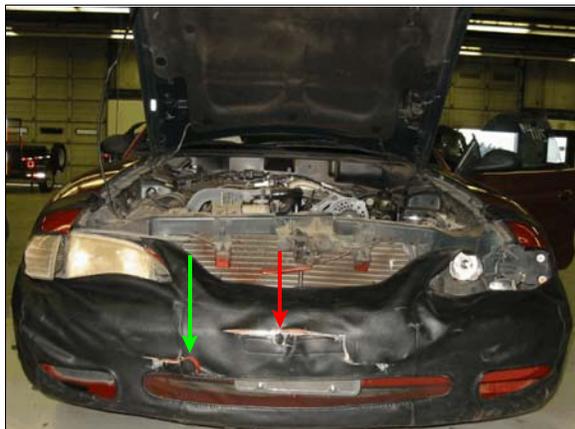
Figure 6: Front of case vehicle with vinyl skirt in place, green arrow shows cut from contact with Windstar's tail pipe, red arrow shows tear in vinyl from contact with bottom portion of Windstar's back bumper

Exterior Damage: The case vehicle's impact with the back of the Windstar involved the front of the vehicle. The vinyl front skirt, which fit over the front bumper and front of the hood, was torn in several places at the bumper level due to contact with the Windstar. The left headlamp/turn signal assembly and grille were broken out and the lower left corner of the right headlamp was broken. There was a semi-circular impression with scratches on the bumper fascia with corresponding hole in the vinyl skirt just below the lower left corner of the right headlamp due to contact to the Windstar's tail pipe. The fiber glass on the bottom side the hood was cracked in several places. In addition, the on-scene video provided by the case vehicle driver's attorney showed that the hood was bent in the left middle portion of the hood more so than was apparent at the time of the inspection. The middle portion of the upper radiator support was displaced rearward and the two air bag crash discriminating sensors were directly contacted and displaced rearward into the radiator. The direct damage began at the front left corner and extended approximately 115 centimeters (45.3 inches) across the front of the vehicle. There was no residual crush at the bumper level. Inspection of the energy absorbing styrofoam under the bumper fascia showed no residual compression of the material, and no damage was visible to any of the front unibody components. The only visible crush to the front of the case vehicle occurred to the upper radiator support. Based on measurements from an exemplar Mustang, the maximum residual crush to the upper radiator support was determined to be approximately 4 centimeters (1.6 inches) occurring at C₃ (**Figure 10**). The table below shows the crush to the upper radiator support. Again, there was no residual crush at the bumper level.

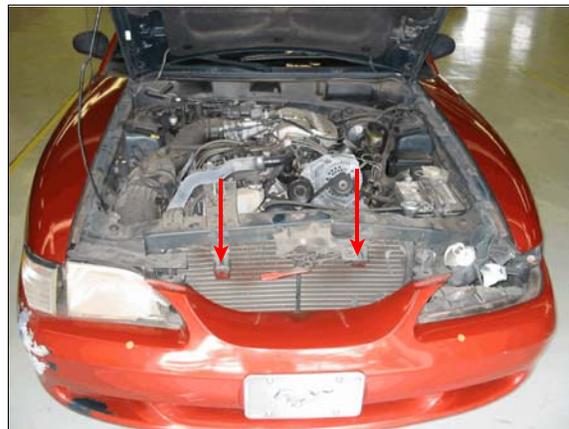
the bottom portion of the Windstar's back bumper as the underride occurred. During the underride, the case vehicle's two air bag crash discriminating sensors, which were attached to the upper radiator support (Figure 7), were directly contacted and displaced rearward into the radiator. The left sensor sustained a more severe impact than the right sensor as indicated by the deformation to the radiator condenser (Figure 8).

Figure 7: Arrows show location of air bag discriminating sensors

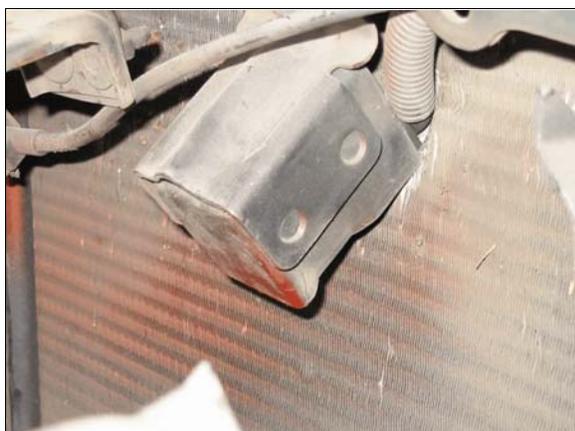
Figure 8: Close view of case vehicle's left discriminating sensor, crushed rearward into radiator condenser

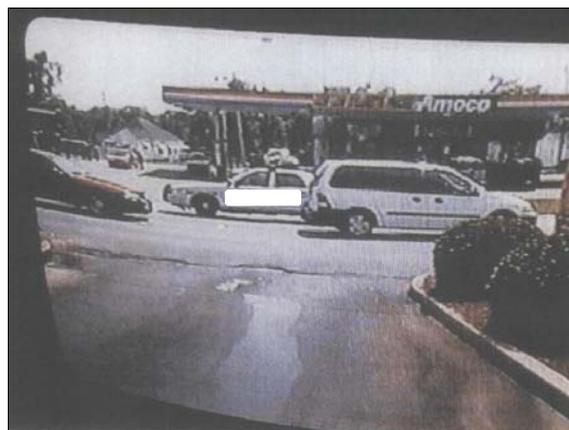
Figure 9: Attorney provided photo of frame capture from on-scene video showing final rest position of case vehicle and Windstar, view from drive-through exit of fast food restaurant

Post-Crash: Both vehicles came to rest in the inside northwestbound through lane heading northwest. An on-scene video provided by the Alabama attorney indicated that the distance between the two vehicles at final rest was approximately two-thirds of a full size car-length (Figure 9). It is not known if the driver of the Windstar pulled his vehicle forward any distance following the impact. However, the debris pattern on the roadway (which appeared to be mostly fragments of the case vehicle's left front headlamp assembly) was distributed across most of the distance between the two vehicles, indicating that the Windstar was pushed forward most of this distance due to the impact.

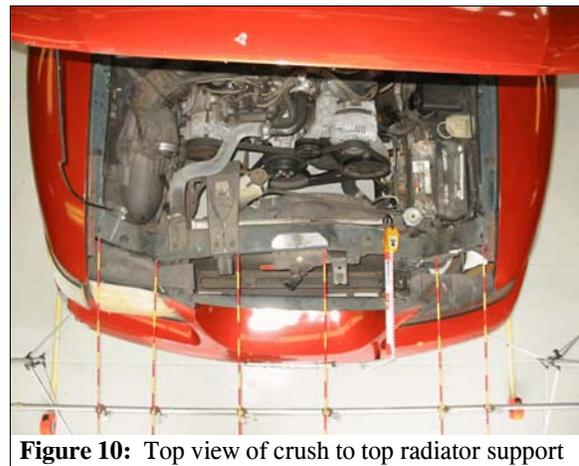
Figure 10: Top view of crush to top radiator support

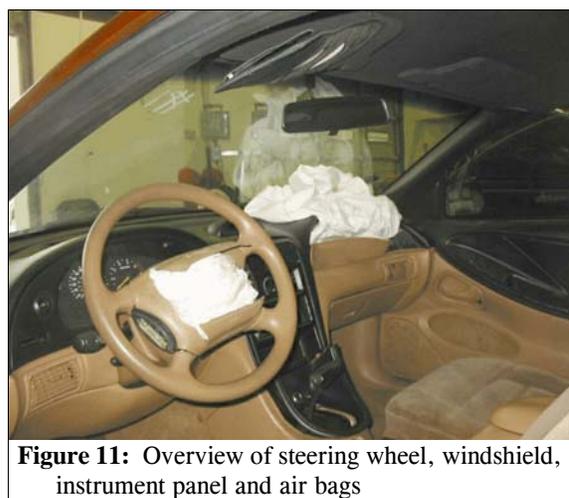
Vehicle Interior: Inspection of the case vehicle’s interior (**Figure 11**) revealed deformation of the front right passenger’s lower air bag module cover flap (**Figure 12** below). The louvers of the air vent directly below the lower cover flap’s right corner were also broken out (**Figure 12** below). In addition, a possible scuff mark was found on the right “A”-pillar. Lastly blood stains were observed on the center console and the lower left side of the front right passenger’s air bag. This likely occurred as the outboard front right passenger was taken out the case vehicle by the driver. No other occupant contact evidence was found and no intrusion of the passenger

Figure 11: Overview of steering wheel, windshield, instrument panel and air bags

compartment was observed. In addition, there was no compression of the energy absorbing steering column and no deformation of the steering wheel.

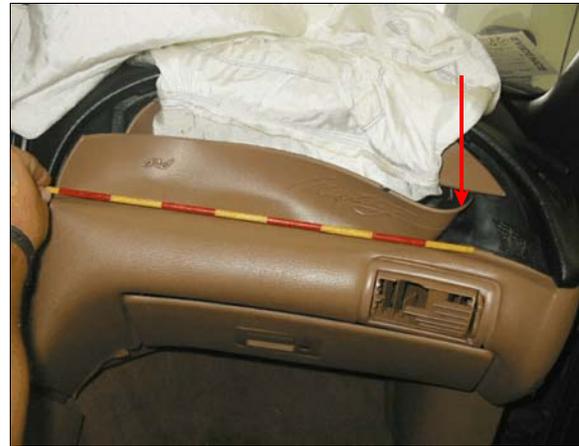
The case vehicle's front right passenger air bag was located in the middle of the right instrument panel (**Figure 12**). The air bag module cover consisted of two cover flaps. The upper cover flap was semi-circular in shape while the lower cover flap was trapezoidal-shaped. The upper cover flap was approximately 41 centimeters (16.1 inches) in length and 7.5 centimeters (3 inches) in height at the center. The lower cover flap was approximately 44 centimeters (17.3 inches) in length and 7.5 centimeters (3 inches) in height. An inspection of both module cover flaps and the air bag fabric revealed that the cover flaps opened at the designated tear points. However, the right corner of the lower cover flap was observed to be deformed. It was bent and displaced into the air bag module compartment (**Figure 12**). The distance between the front edge of the instrument panel and the leading edge of the module cover flaps was approximately 5.5 centimeters (2.2 inches). The distance between the mid-center of the front right passenger's seat back, as positioned at the time of the vehicle inspection, (seat at approximate full rear position, seat back slightly reclined) and the front surface

Figure 12: Case vehicle's front right passenger's air bag module cover flaps, arrow shows deformation of lower cover flap

The case vehicle's outboard front right passenger was most likely restrained by the manual, three-point, lap and shoulder safety belt system just prior to the pre-crash activity related to the bee in the vehicle. However, the evidence indicated that this passenger did not have the shoulder belt in the restrained position at the time of the pre-crash braking and impact. The passenger's facial injuries, autopsy photographs and damage to the lower air bag module cover flap indicated

that the right side of his face was directly contacted by the air bag module cover flaps. His head could not have reached the air bag module if his upper torso had been restrained by the shoulder belt. Based on measurements from a representative occupant [130 centimeters and 26 kilograms, (51 inches, 57 pounds)] and an exemplar vehicle inspection, it was determined that with the seat in the position indicated by the driver, it was most likely possible for the passenger's head to reach the air bag module while restrained by only the lap belt. It's this contractor's opinion that as a result of both front right passenger's movements related to the bee in the vehicle, the lap belt was most likely not snug across both passenger's hips, the outboard front right passenger got out from under the shoulder belt (which due to his height would have been positioned high on him in any case) and it was behind him at the time of the pre-crash braking and impact. Lastly, two children sharing the same seat and same safety belt system was unsafe and improper usage of the safety belt system.

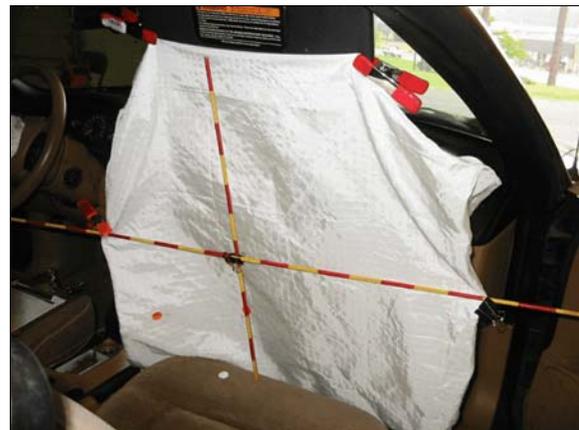
Figure 13: Overview of case vehicle's deployed front right passenger air bag

of the air bag's fabric at approximate full excursion was approximately 40 centimeters (15.7 inches). There was no evidence of damage to the air bag due to the deployment. The deployed front right passenger air bag (**Figure 13** above) was square with a height and width of approximately 65 centimeters (25.6 inches). The air bag was designed without tethers and had one vent port located on the left side of the air bag at the approximate 10:30 o'clock position (**Figure 14**). The vent port was 5.5 centimeters (2.2 inches) in diameter. Inspection of the air bag fabric revealed a few stains, which appeared to be moisture stains, on the side of the air bag and what appeared to be three small blood stains on the lower left quadrant of the air bag. No evidence of cloth or skin transfer was observed on the air bag.

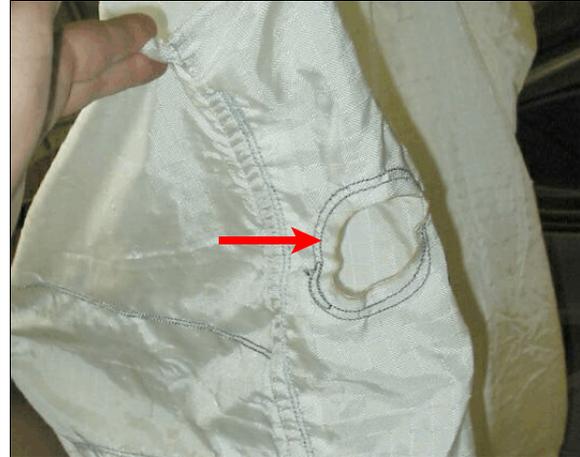
Figure 14: Case vehicle's front right passenger air bag vent port (arrow)
