Certified Advanced 208-Compliant Air Bag Investigation/ Vehicle to Objects
Dynamic Science, Inc. / Case Number: DS06025
2006 Hyundai Elantra
Oregon
September 2006

Dynamic Science, Inc.
Crash Investigation
Case Number: DS06025

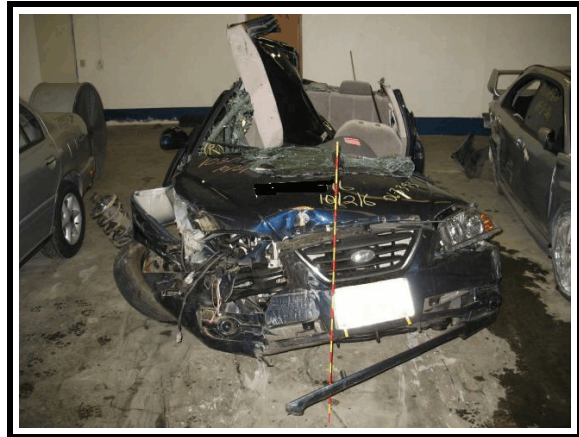
Figure 1. Front - 2006 Hyundai Elantra

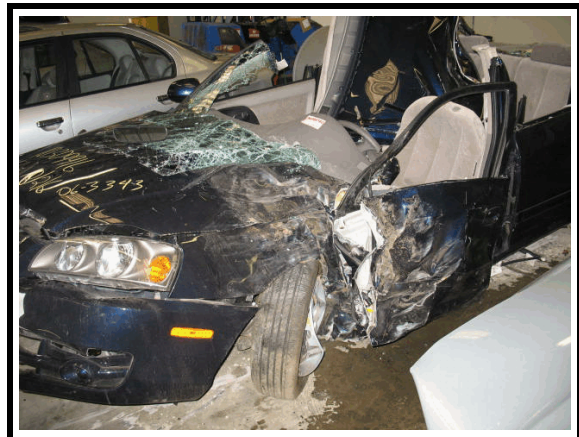
Figure 2. Front/Left - 2006 Hyundai Elantra (LF door repositioned for photo)

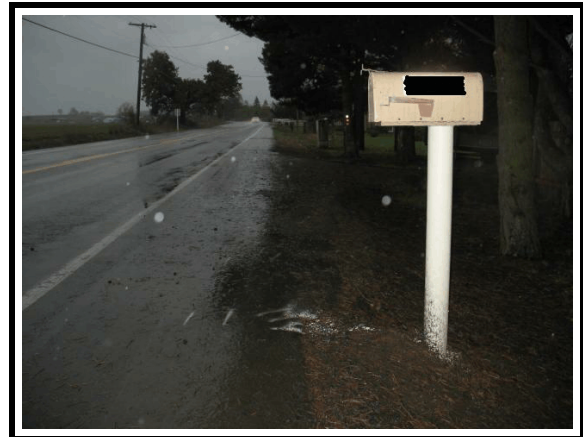
The Elantra's front end (12FZEN1) impacted a wooden mailbox post, shearing it from its base. The side of the post that was struck had a width of 18.0 cm (7.1 in). The impact severity was fairly light and was likely a low delta V event.

Figure 5. First struck object (wooden mailbox post replaced with PVC pipe)

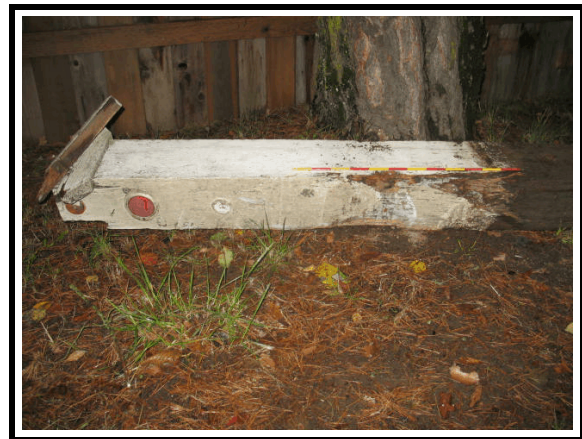
Figure 6. Damaged/replaced mailbox post

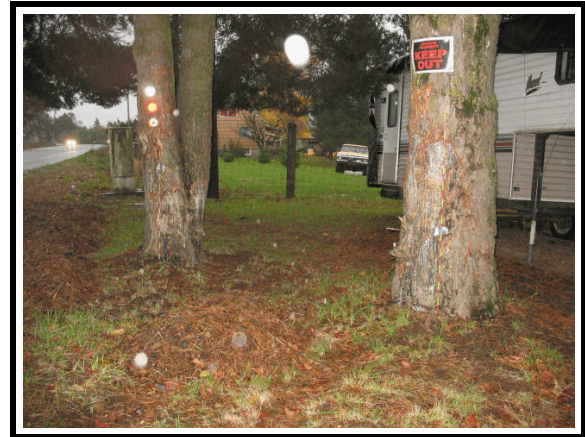
After striking the post, the Elantra continued in a southerly direction, traveling further off the roadway. The right front bumper corner (12FREE4) struck a large tree trunk, resulting in the deployment of the driver's front air bag. There was narrow end engagement at the right front bumper corner. During this impact, the tree moved past the bumper corner and between the engine compartment and the right front tire. The tree snagged on the Elantra's right front axle, ripping the tire from the axle and causing the Elantra to rotate clockwise.

The Elantra's left side (11LYAW4) impacted a second tree, causing damage to the left fender, left front door, left A pillar and windshield header. The second tree impact was not completely horizontal. When the Elantra's right front axle snagged on the first tree trunk, the Elantra rotated and began to tilt to the left. As the vehicle struck the second tree, it tilted further to the left, causing damage to the Elantra's left A pillar, windshield header and roof.

Figure 8. Trees struck by the Elantra (south)

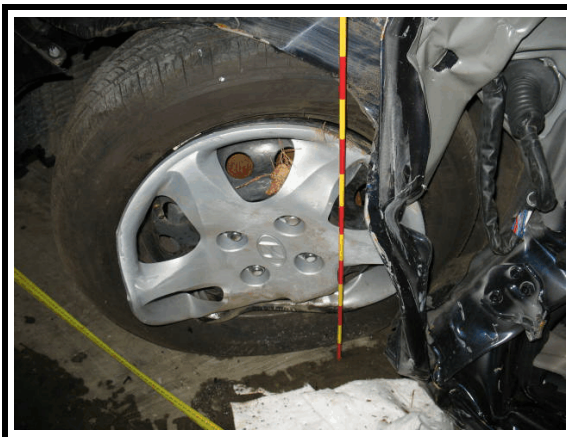
Position	Measured Pressure	Measured Tread Depth	Restricted	Damage
LF	Flat	6 mm (8/32 in)	Yes	Tire debanded; dented rim
LR	186 kPa (27 psi)	7 mm (9/32 in)	No	None
RR	207 kPa (30 psi)	7 mm (9/32 in)	No	None
RF	Flat	6 mm (8/32 in)	No	Tire debanded & torn from axle

Figure 9. LF tire damage

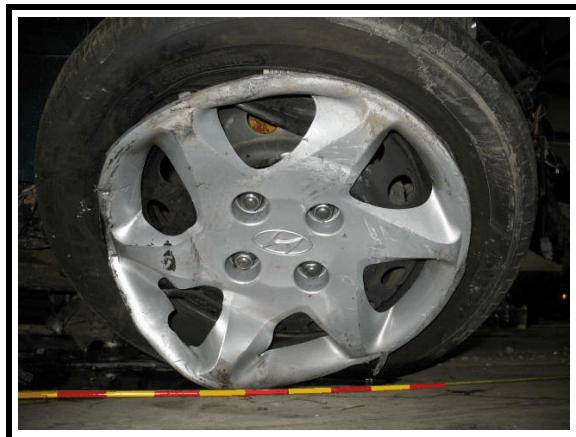
Figure 10. RF tire damage

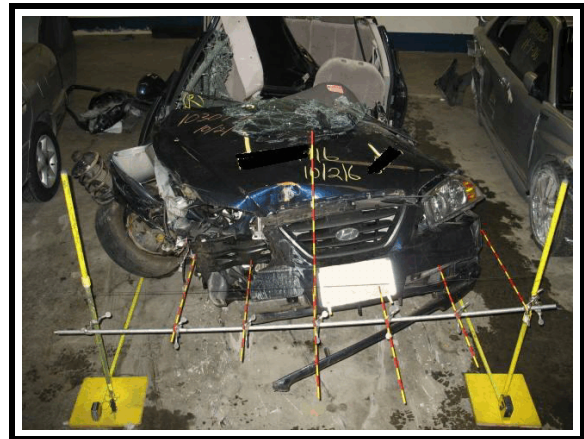
The 2006 Hyundai Elantra sustained light front damage as a result of the impact with the mailbox post. The Elantra sustained 28.0 cm (11.0 in) of direct damage beginning 20.0 cm (7.9 in) right of the pre-crash center point of the vehicle, extending along the front bumper to the right.

The Elantra sustained moderate front end damage as a result of the impact with the first tree. There was 4.0 cm (1.6 in) of direct damage beginning 61.0 cm (24.0 in) right of the pre-crash center point of the vehicle, extending along the front bumper to the right. The tree narrowly engaged the front right bumper corner and swiped down the right side of the vehicle, leaving 91.0 cm (35.8 in) of direct damage. The tree impacted the right front tire, breaking it off the axle and debanding it. Six crush measurements were documented along the front bumper as follows: C1=20.0 cm (7.9 in), C2=18.0 cm (7.1 in), C3=11.0 cm (4.3 in), C4=15.0 cm (5.9 in), C5=23.0 cm (9.1 in), C6=8.0 cm (3.1 in). Measurements at C5 and C6 were adjusted to account for a missing section of the bumper cover and energy absorbing material.

Figure 11. Front crush profile

The Collision Deformation Classification (CDC) for the impact with the mailbox post was 12FZEN1. The CDC for the front impact with the first tree was 12FREE4.

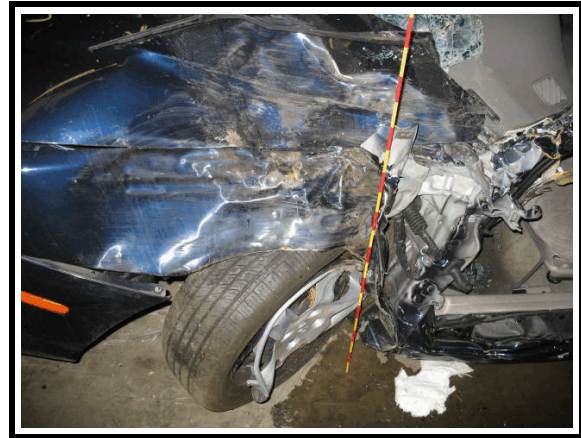
The Hyundai Elantra sustained moderate left side damage as a result of the impact with the second tree. There was 151.0 cm (59.4 in) of direct damage beginning 122.0 cm (48.0 in) forward of the left rear axle, extending forward along the left side of the vehicle. The left front tire was restricted, debanded and the rim was damaged. The left wheelbase was shortened by 32.0 cm (12.6 in).

Figure 12. Left fender, hood and tire damage from the second tree impact

This impact appears to have occurred while the Elantra was partially tilted to its left. When the first tree impact ripped the front right tire from the axle, the snag caused the Elantra to rotate sharply clockwise and tilt left. This crash event resulted in direct damage to the left fender, left front door panel, left A pillar and windshield header. The contact between the tree and the area of the Elantra located above the belt line resulted in significant longitudinal and lateral passenger compartment intrusion. The contact between the tree and the Elantra’s left windshield header and roof resulted in rippled sheet metal damage to a significant area of the roof. The left front door was jammed shut due to damage and was cut off by rescue personnel. The location of maximum lateral crush was located 209.0 cm (82.3 in) forward of the left rear axle. There was 23.0 cm (9.1 in) of lateral crush in this location. The CDC for this event was 11LYAW4.

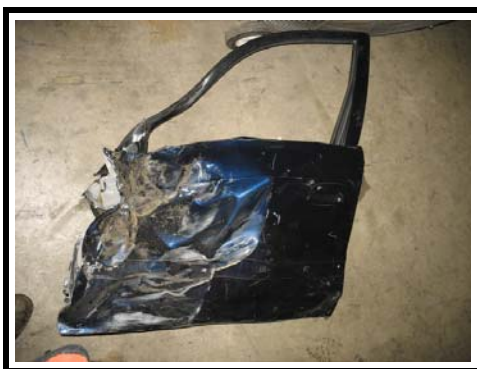
Figure 13. LF door damage (door cut off vehicle by rescue personnel)

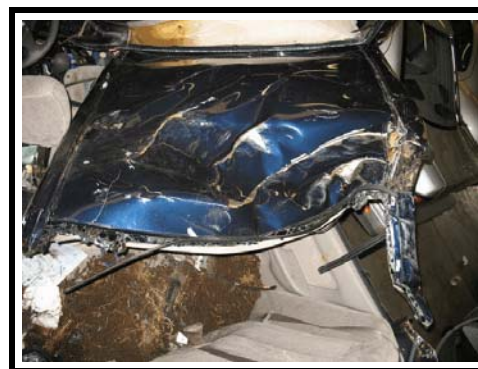
Figure 14. Roof damage (cut off by rescue personnel)

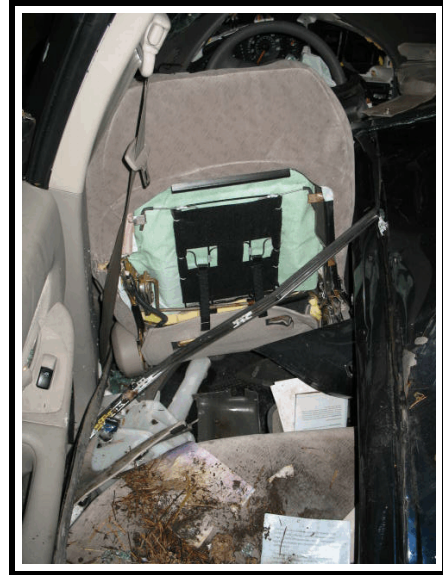
The driver's seat back locks were cut by rescue personnel, presumably to assist in extricating the deceased driver. The driver's seat back and seat cushion were angled slightly to the left, giving the appearance of lateral intrusion of the left B pillar. It appeared that the driver's seat had been moved out of position during the driver's extrication.

Figure 15. Driver's seat as found

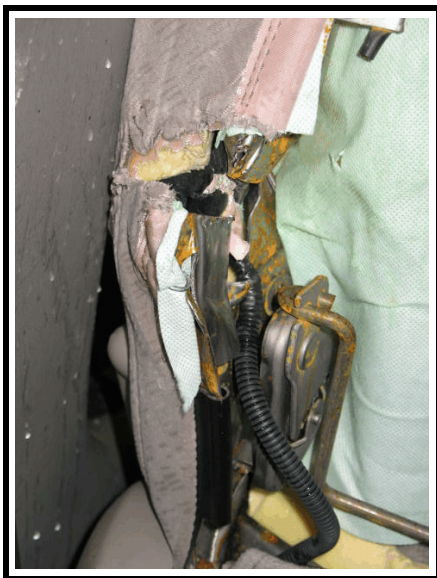
Figure 16. Driver's right seat back folding lock (cut by rescue personnel)

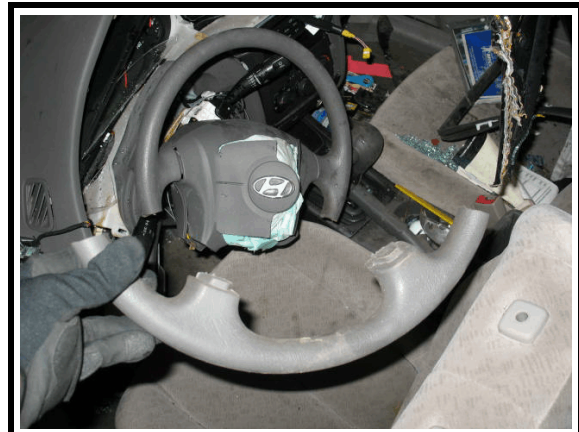
Figure 17. Bottom section of steering wheel cut off by rescue personnel

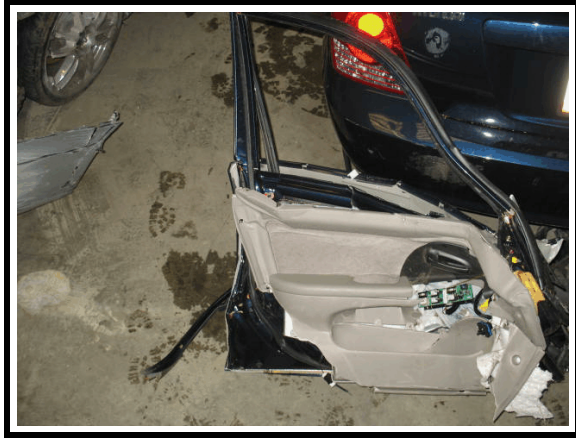
Row/Position	Intruded Component	Magnitude of Intrusion	Direction
1L	A Pillar	23.0 cm (9.1 in)	Longitudinal
1L	Roof	22.0 cm (8.7 in)	Vertical
1L	LF door panel	18.0 cm (7.1 in)	Lateral
1L	Instrument panel	16.0 cm (6.3 in)	Lateral
1L	Instrument panel	14.0 cm (5.5 in)	Longitudinal
1L	Side panel (forward of the A pillar)	13.0 cm (5.1 in)	Lateral
1L	A Pillar	12.0 cm (4.7 in)	Lateral
1L	Steering column	12.0 cm (4.7 in)	Longitudinal
1L	Windshield header	8.0 cm (3.1 in)	Longitudinal
1L	Plastic sill cover	4.0 cm (1.6 in)	Lateral
1R	Glove compartment door	7.0 cm (2.8 in)	Longitudinal
1R	A Pillar	4.0 cm (1.6 in)	Lateral
1R	Side panel (forward of the A pillar)	4.0 cm (1.6 in)	Lateral
1R	Plastic sill cover	4.0 cm (1.6 in)	Lateral
1R	Toe pan	4.0 cm (1.6 in)	Lateral

Figure 18. Left front door panel damage/intrusion (door cut off by rescue personnel)

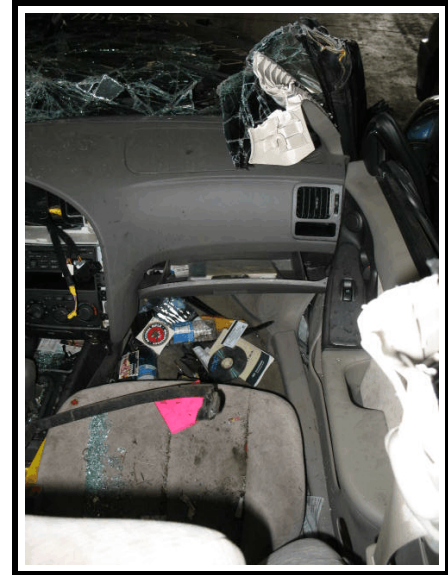
Figure 19. Intrusion/damage in RF seating area

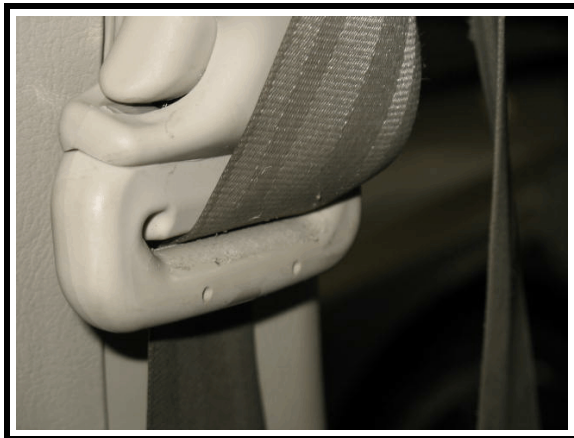
Figure 20. Evidence of occupant loading to driver's D-ring

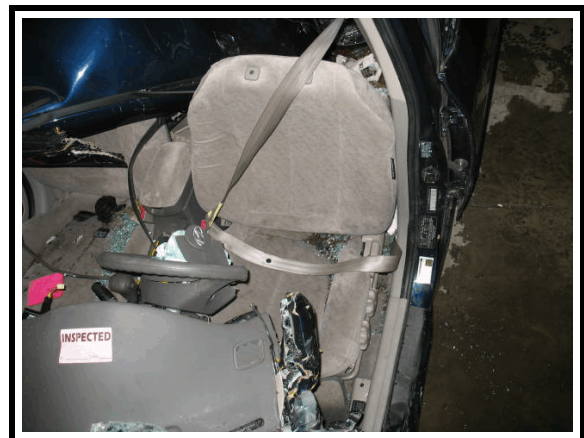
The 2006 Hyundai Elantra was configured with manual 3-point lap and shoulder belts for each of the five seating positions. The front row seat belts were equipped with retractor pretensioners; at the time of the inspection, neither retractor was found to be locked in place. The driver's safety belt was configured with a sliding latch plate and an emergency locking retractor (ELR). There was evidence of occupant loading to the driver's seat belt webbing near the latchplate and also on the D-ring.

Figure 21. Driver's seat belt (evidence of occupant loading at the D-ring and near the latch plate)

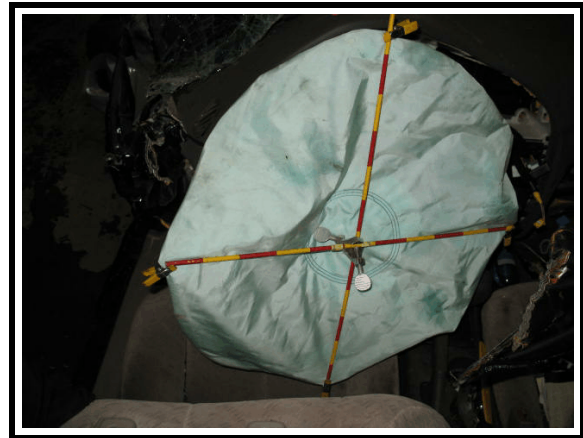
Figure 22. Deployed driver front air bag

The driver's front air bag was mounted in the center of the steering wheel hub. The air bag module cover flaps had a backwards C configuration. Both the left and right flaps measured 7.0 cm (2.8 in) wide at the top and bottom edges and were 12.0 cm (4.7 in) high along the outer edges. The inner section of each flap consisted of a 7.0 cm (2.8 in) circular section, with two 3.0 cm (1.2 in) high straight sections above and below it. The air bag was circular in shape and measured 60.0 cm (23.6 in) high/wide in its deflated state. The maximum excursion measured 25.0 cm (9.8 in) from the module face. The distance between the module face and the front left seat back was 40.0 cm (15.7 in). The air bag had two internal tethers. There were two circular vent ports on the back of the bag at the 10 and 2 o'clock positions. There was no damage to the air bag or cover flaps, but the front and back of the deployed bag were dirty due to scene and vehicle debris that had been placed in the left front seating area after the crash.

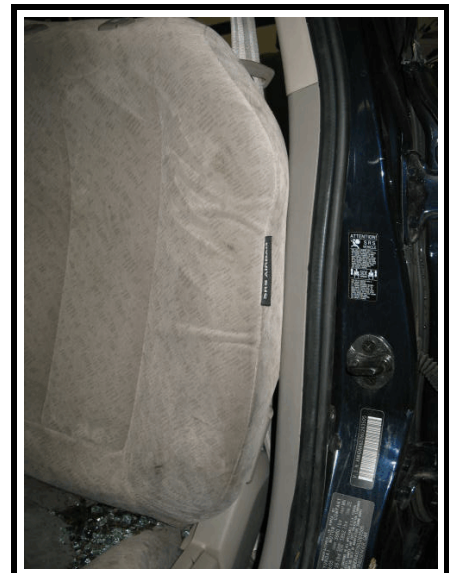
Figure 23. Location of the driver's seat back mounted side air bag (nondeployed)

This vehicle was also equipped with front row seat back mounted side air bags. They did not deploy during the crash.

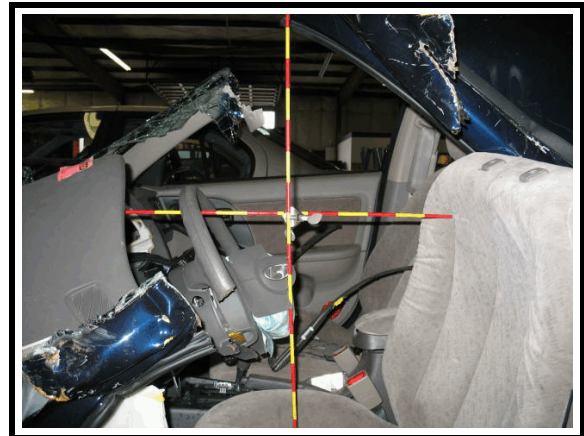
Figure 25. Driver's area; post-crash distance between the steering wheel and the driver's seat back

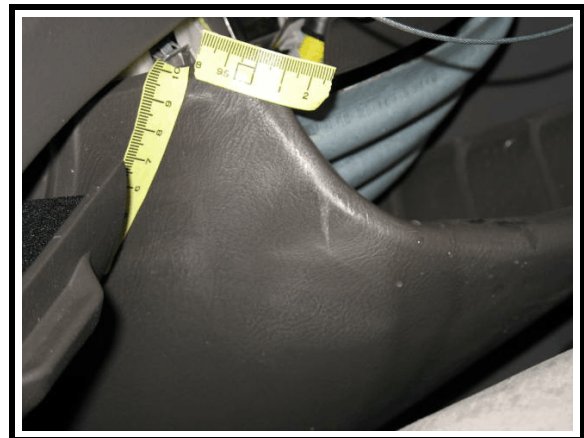
Figure 26. Occupant contact to lower steering column

During this impact, there was narrow end engagement at the right front bumper corner and the vehicle sideswiped the tree trunk. The trunk snagged on the Elantra's right front tire, ripping the tire from the axle and sending the Elantra into a clockwise rotation. During this snag and rotation, the driver jerked abruptly forward and then pitched rearward and to his left. The Hyundai Elantra then impacted a second tree with its left side, causing the driver to pitch forward and to the left. The Elantra tipped slightly upward and to the left, resulting in contact to the Elantra's left A pillar and windshield header. As a result of this impact, the left A pillar, windshield header, roof and left instrument panel intruded into the driver's seating area. The driver's trajectory during this event, as well as the intruding instrument panel, caused the driver's left knee to contact the lower steering column, leaving evidence of occupant contact.

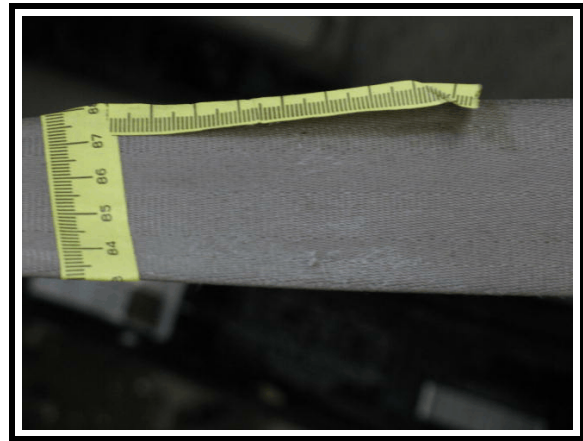
Figure 27. Close-up of occupant loading evidence on the driver's seat belt webbing
