Booster Seat Investigation / Vehicle to Vehicle  
Dynamic Science, Inc. / Case Number: DS06027  
1999 Lincoln Navigator  
California  
November 2006

1. Report No. DS06027	2. Government Accession No.		3. Recipient Catalog No.	
4. Title and Subtitle Booster Seat Investigation		5. Report Date May 6, 2007

**Dynamic Science, Inc.**  
**Crash Investigation**  
**Case Number: DS06027**

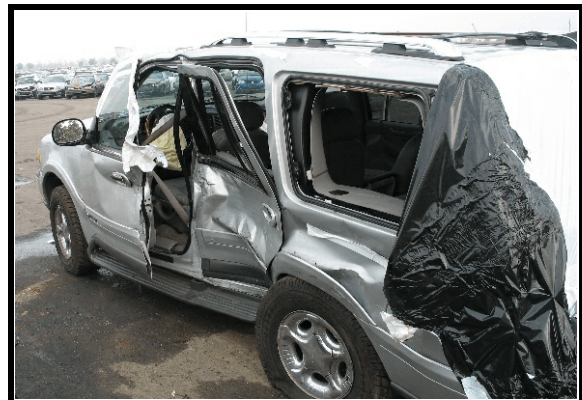
The 1999 Lincoln Navigator sustained moderate left side damage as a result of the impact with the Ford Club Wagon (see Figure 5). The direct damage began 74.0 cm (29.1 in) rear of the left rear axle and extended 221.0 cm (87.0 in) forward along the left side plane. The maximum lateral crush was located at C4, at the sill level, and measured 30.0 cm (11.8 in). The left front door remained closed after the crash, but was forced open during extrication. The left rear door was jammed shut. The right side doors and the tailgate remained closed and operational. The combined direct and induced damage began 74.0 cm (29.1 in) rear of the left rear axle and extended forward

**Figure 5.** Left side damage, 1999 Lincoln Navigator

310.0 cm (122.0 in) along the left side plane. The glazing for the second row left window, third row left window, and tailgate disintegrated. The upper door frame for the left rear door was displaced laterally outward 18.0 cm (7.1 in). This formed a gap beginning at the base of the C pillar and ending at the top of the B pillar (see Figure 6). Six crush measurements were documented at the mid-door level as follows: C1 = 0 cm (0 in), C2 = 9.0 cm (3.5 in), C3 = 24.0 cm (9.4 in), C4 = 28.0 cm (11.0 in), C5 = 5.0 cm (2.0 in), C6 = 0 cm (0 in). Measurements were also documented at the sill level for C3, measuring 37.0 cm (14.6 in), and for C4, measuring 30.0 cm (11.8 in).

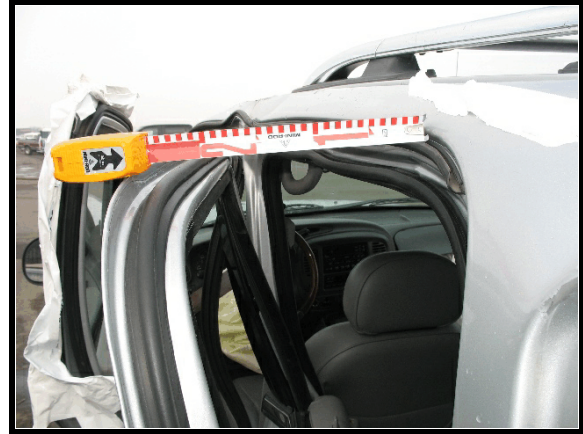
**Figure 6.** Gap at second row left door

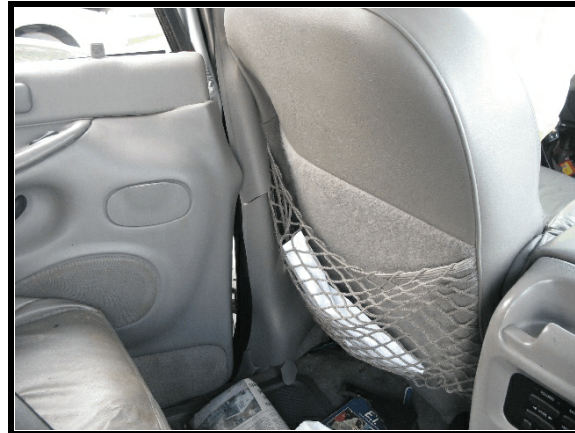
The 1999 Lincoln Navigator sustained moderate interior damage as a result of passenger compartment intrusion (see Figure 7). The left B pillar, left side door, left side panel, and left sill sustained lateral intrusion. As a result of the lateral intrusion, the second row left and third row left seats were compressed. The specific passenger compartment intrusions were documented as follows:

Position	Intruded Component	Magnitude of Intrusion	Direction
Left front	B pillar	8.0 cm (3.1 in)	Lateral
2 <sup>nd</sup> row left	Door	11.0 cm (4.3 in)	Lateral
2 <sup>nd</sup> row left	B pillar	8.0 cm (3.1 in)	Lateral
2 <sup>nd</sup> row left	Sill	6.0 cm (2.4 in)	Lateral
3 <sup>rd</sup> row left	Side panel	5.0 cm (2.0 in)	Lateral

There were indications of loading to the middle third row lap belt. The left side panel was cracked due to intrusion. There was blood found on the side panel and in the third row left seating area.

**Figure 7.** B pillar and left rear door intrusion

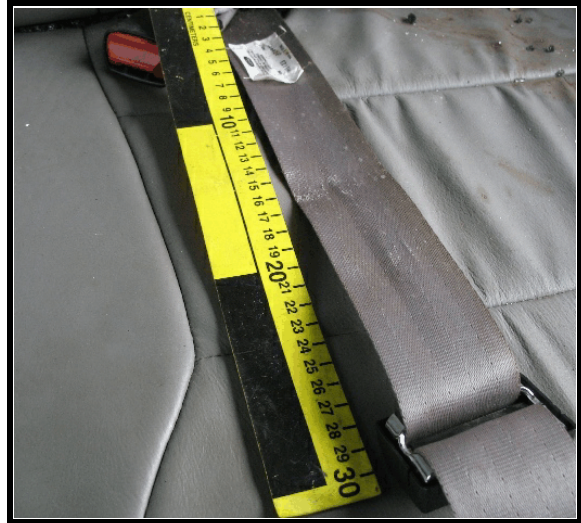
The third row center lap belt was being used with a backless booster seat. The belt was configured with a locking latch plate. There were indications of loading to the belt webbing (see Figure 8). The distance from the base of the webbing to the latch was 34.0 cm (13.4 in). A lateral marking was located 14.0 cm (5.5 in) from the latch and was between 3.0-4.0 cm (1.2-1.6 in) wide.

**Figure 8.** Third row middle lap belt

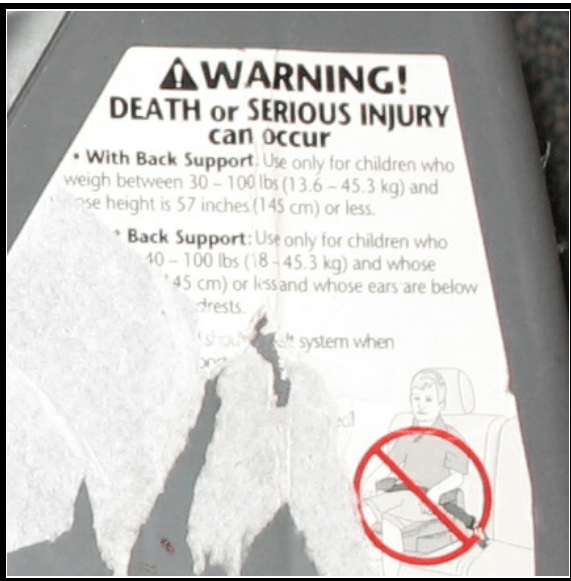
The manual further states that: "When using this booster seat, NEVER use a lap belt only (see Figure 11). You MUST use vehicle seat belts that have a lap/shoulder combination."

**Figure 11.** LAP BELT ONLY warning label found on booster seat

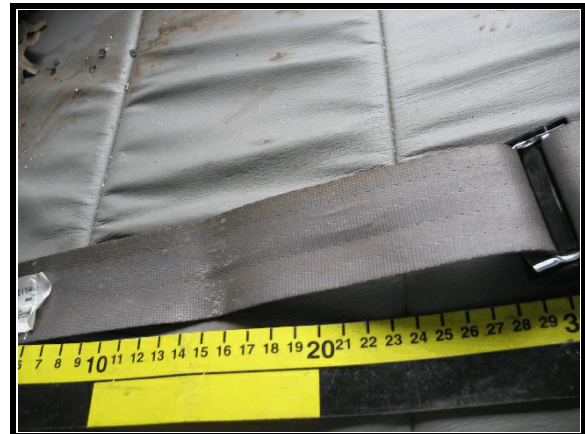
The booster seat was being used without the backrest in the third row middle seat position. The middle seat lap belt was being used at the time of the crash (see Figure 12).

**Figure 12.** Load marks on lap belt

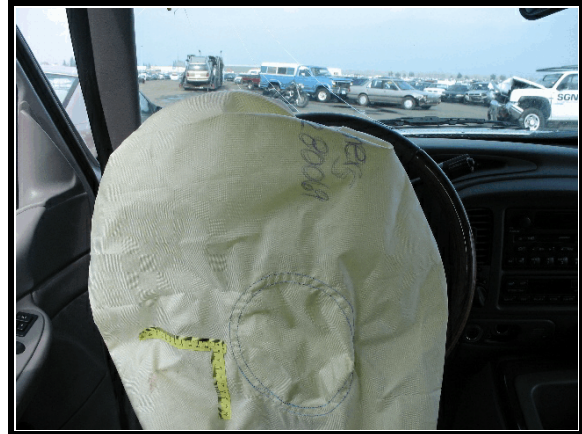
The driver's air bag deployed from the center of the steering wheel hub through H-configuration module cover flaps (see Figures 13-15). The top flap measured 12.0 cm (4.7 in) in height and 19.0 cm (7.5 in) in width. The bottom flap measured 4.0 cm (1.6 in) in height and 19.0 cm (7.5 in) in width. The deployed driver's air bag measured 59.0 cm (23.2 in) in its deflated state. The air bag was tethered by a single internal strap. The tether was attached to circular stitching in the center of the air bag face. Two circular vent ports were located at the 11 and 1 o'clock aspects on the rear of the air bag. There were eight vertical folds across the air bag face. There was a 12.0 cm (4.7 in) wide by 11.0 cm (4.3 in) high pattern of make up and lip stick transfers immediately below the center stitching (see Figure 13). There was a small accumulation of melted plastic found on the top surface of the air bag near the inflator at the base of the top module cover (see Figure 15).

**Figure 13.** Front of driver's air bag

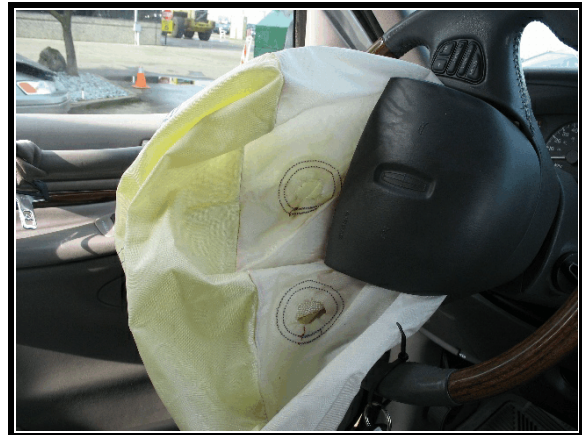
**Figure 14.** Driver's air bag, showing vent ports and top module cover

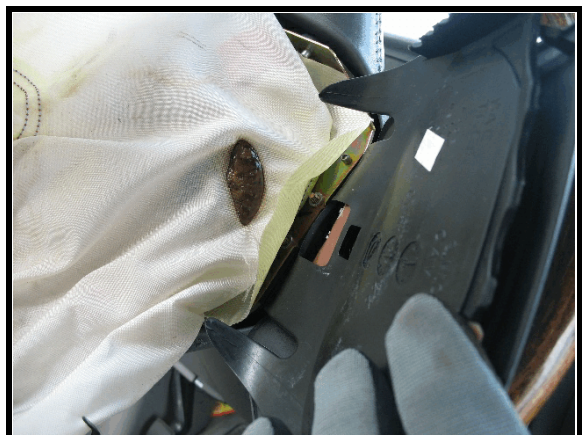
**Figure 15.** Melted plastic near inflator

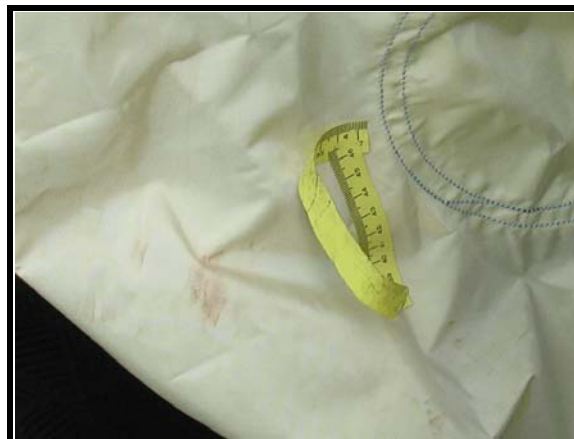
**Figure 18.** Lipstick/makeup contact to air bag face

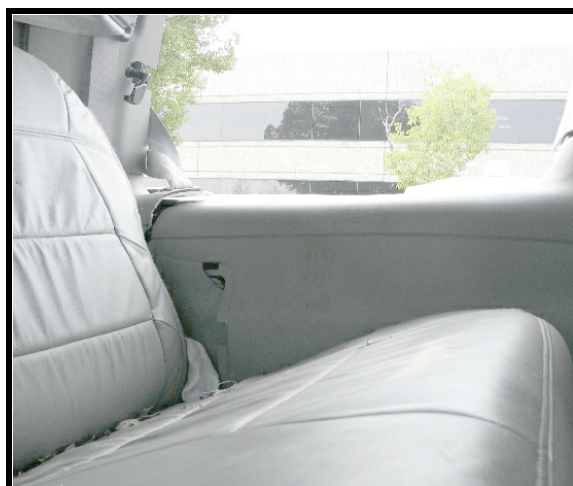
The 5-year-old female child was restrained in the booster seat by the manual lap belt. The booster seat was installed in the third row middle seat position. This booster seat was not designed to be used with a lap belt. At impact, the child initiated a lateral and slightly forward trajectory to the left. She loaded the lap belt and likely flexed over the belt to the left and struck the side panel with the left side of her face. She sustained a deep laceration to the upper eye lid that went all the way to the bone. As her head struck the panel, her torso continued moving causing an atlanto-axial fracture dislocation with a spinal cord injury. Given an estimated seated height of 59.8 cm<sup>1</sup> (23.5 in), and the mid seat position to side panel distance of 62.5 cm (24.6in), it appears that the child likely struck the side panel while still in the confines of the lap belt.

**Figure 19.** Left side panel/third row
