ON-SITE CERTIFIED ADVANCED 208-COMPLIANT VEHICLE INVESTIGATION

CASE NUMBER - IN-06-027

VEHICLE - 2006 PONTIAC G6 SE1

CRASH DATE - June 2006

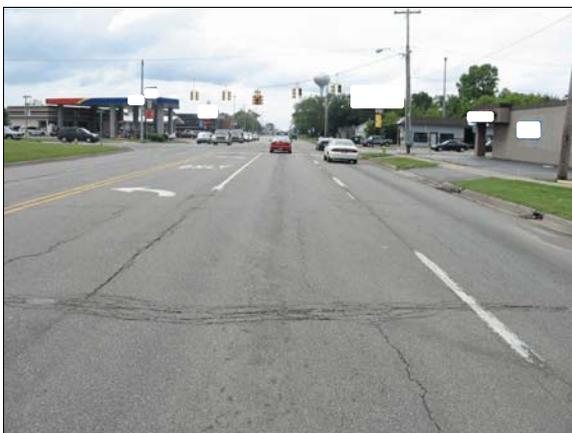
Pre-Crash: The case vehicle's driver stated she was southbound in the inside through lane (**Figure 1**) and was intending to continue southbound through the intersection. The driver estimated she was traveling approximately 64 km.p.h. (40 m.p.h.). The case vehicle's EDR data indicated that the case vehicle's pre-crash travel speed was 72 km.p.h. (45 m.p.h) slowing to 62 km.p.h. (42 m.p.h.) just prior to the crash. It also indicates she may have been changing lanes from the outside to the inside lane as she was approaching the intersection. The Chevrolet was traveling west in the left turn lane (**Figure 2**). The Chevrolet's driver was intending to turn left and travel southbound. The case vehicle's driver stated that she recalled taking no actions to avoid the crash. However, the case vehicle's EDR data indicated the driver steered right and applied the brakes just prior to the crash. The crash occurred within the intersection.

Figure 1: Approach of case vehicle to intersection, southbound in inside through lane

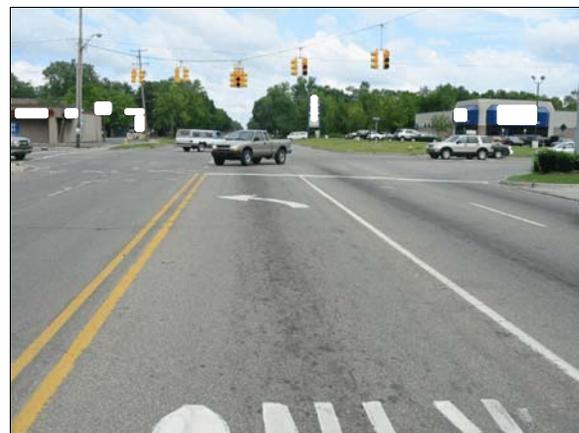
Figure 2: Approach of Chevrolet to intersection, westbound in left turn lane

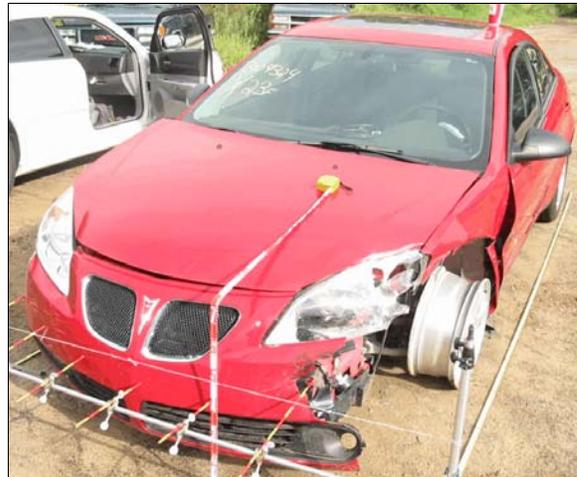
Crash: The case vehicle's front left corner (Figures 3 and 4) impacted the Chevrolet's right front corner causing a first stage deployment of the case vehicle driver's air bag. The case vehicle's front right air bag did not deploy because there was no front right passenger in the case vehicle. The sensors in the front right seat properly determined the absence of an occupant and suppressed deployment of the front right air bag.

Figure 3: Overview of damage to front left corner of case vehicle from impact with right front corner of Chevrolet, increments on tape measure in 10ths of meter, each increment on rods is 5 cm (2 in)

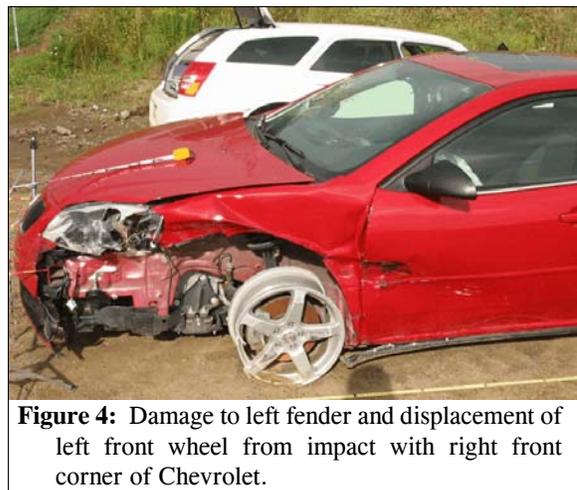
Figure 4: Damage to left fender and displacement of left front wheel from impact with right front corner of Chevrolet.

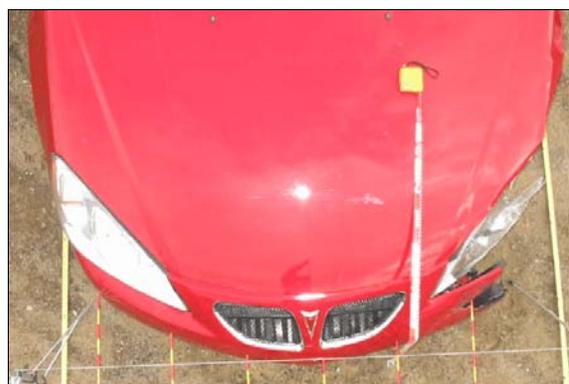
Exterior Damage: The case vehicle’s impact with the Chevrolet involved the left corner of the front bumper. The bumper fascia and a small portion of the bumper bar were directly damaged and the bumper fascia was torn off at the corner. In addition, the direct damage involved the left headlamp/turn signal assembly, left fender, left front wheel and front portion of the left front door. The left front wheel was significantly engaged and crushed rearward. The direct damage began at the left corner of the bumper fascia and extended approximately 38 centimeters (15 inches) across the bumper fascia. Since the impact occurred right at the corner, there was only minimal engagement of the bumper bar, which did not extend out to the corner of the bumper fascia. The maximum residual crush occurred at the left corner of the bumper bar (**Figure 5**) and was approximately 2 centimeter (0.8 inch). However the left front wheel (**Figure 6**) was heavily engaged and crushed rearward 16 centimeters (6.3 inches) shortening the left side wheelbase by this amount. The right side wheelbase was extended 2.0 centimeters (0.8 inch). Induced damage involved the left front door and hood. The table below shows the crush profile to the front bumper bar.

Figure 5: Top view of minimal crush to front of case vehicle, left corner of bumper fascia was torn off from impact with Chevrolet and minimal engagement of case vehicle’s bumper bar, each increment on rods in 5 cm (2 in)

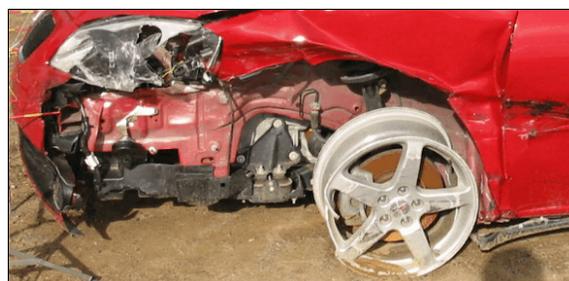
Figure 6: Rearward displacement of case vehicle’s left front wheel due to engagement with the Chevrolet’s right front corner during impact

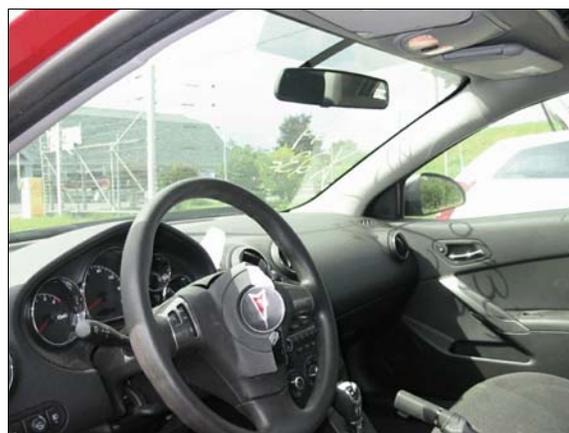
Vehicle Interior: Inspection of the case vehicle’s interior (Figures 7 and 8) revealed two small areas of discoloration on the top half of the driver’s air bag that may have been driver contact marks. No other occupant contact marks were found. There was no evidence of compression of the energy absorbing steering column or deformation of the steering wheel (Figure 9 below). In addition, no passenger compartment intrusions noted.

Figure 7: Overview of steering wheel, windshield and instrument panel

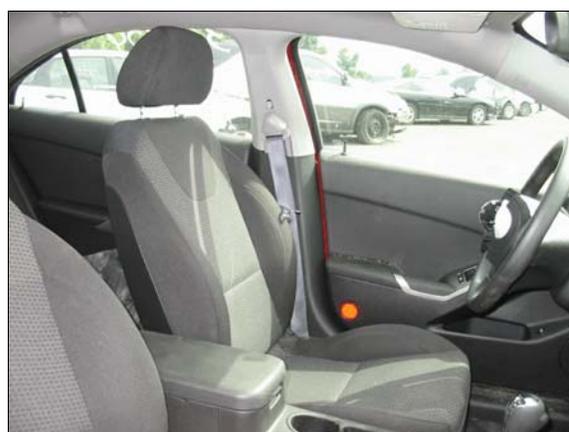
Figure 8: Overview of case vehicle driver’s seat as found and left front door, seat is in rear-most position, subsequently determined that driver had seat adjusted to between middle and forward-most position at time of crash

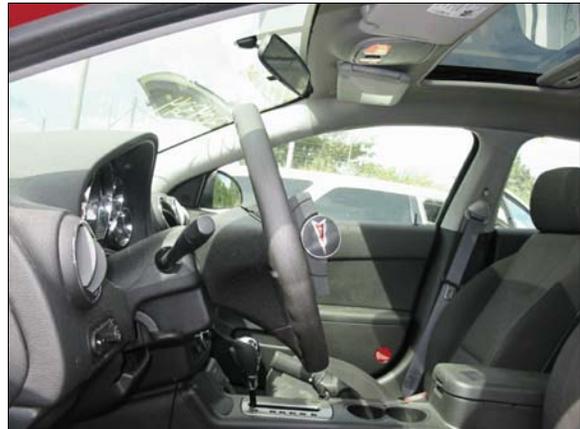
Figure 9: Left side view of steering wheel and steering column showing lack of deformation

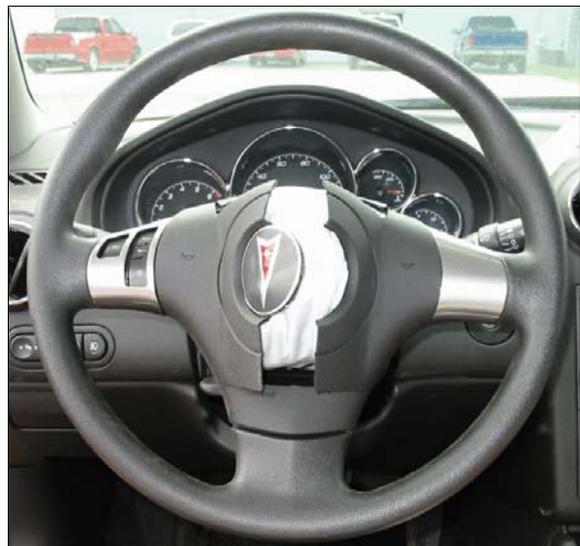
The case vehicle's driver air bag was located in the steering wheel hub. The air bag module cover consisted of essentially "I"-configuration cover flaps made of medium thickness vinyl (**Figure 10**). Both the left and right cover flaps were convex at the top and square at the bottom. There was a circular manufacturer's logo located in the center of the left flap. A corresponding semi-circular cut-out was located in the center of the left cover flap to accommodate the logo. Each flap was approximately 14 centimeters (5.5 inches) in height along the vertical center tear seam, 6.5 centimeters (2.6 inches) in width along the top tear seam and 4.5 centimeters (1.8 inches) in width along the bottom tear seam. An inspection of the air bag module cover flaps and the air bag fabric revealed that the cover flaps opened at the designated tear points. There was no evidence of damage during the deployment to the air bag module cover flaps or the air bag fabric. The deployed driver's air bag (**Figure 11**) was round with a diameter of about 60 centimeters (23.6 inches). The air bag was designed with four tethers, each approximately 5.5 centimeters (2.2 inches) in width and had two vent ports, each approximately 4 centimeters (1.6 inches) in diameter, located at the 11 and 1 o'clock positions. The distance between the mid-center of the driver's seat back, as positioned as the time of the vehicle inspection (i.e., seat at the rear-most track position, seat back slightly reclined), and the front surface of the air bag's fabric at approximate

Figure 10: Case vehicle's steering wheel and air bag module cover flaps

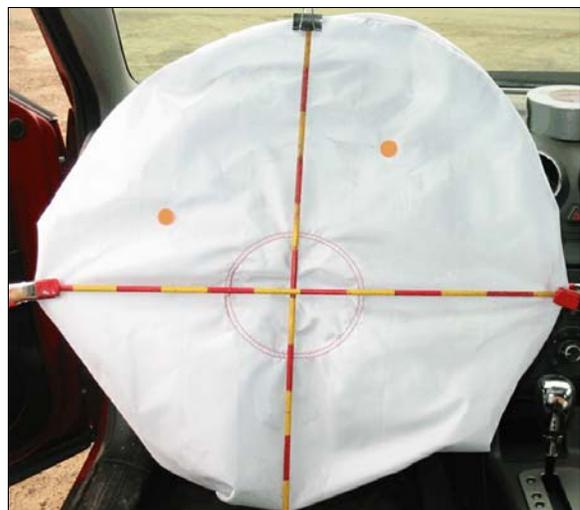
Figure 11: Case vehicle's driver air bag

full excursion was 37 centimeters (14.6 inches). Inspection of the air bag fabric revealed two small areas of discoloration on the top half of the air bag that may have been related to driver contact. No other occupant contact marks were noted on the air bag.

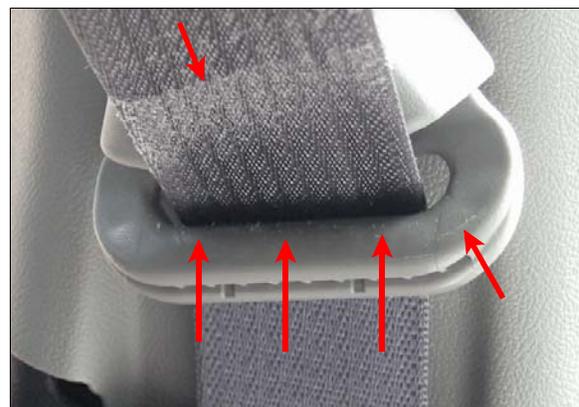
Based on the vehicle inspection and supported by the EDR data, the case vehicle's driver was restrained by her manual, three-point, lap-and-shoulder safety belt system. The adjustable upper anchor was found adjusted to its lowest position. Inspection of the safety belt assembly revealed load marks on the shoulder belt and “D” ring (Figure 12). In addition, the driver also reported belt pattern contusions to her left shoulder, chest and hips.

Figure 12: Load marks on case vehicle driver’s shoulder belt and “D” ring (arrows)

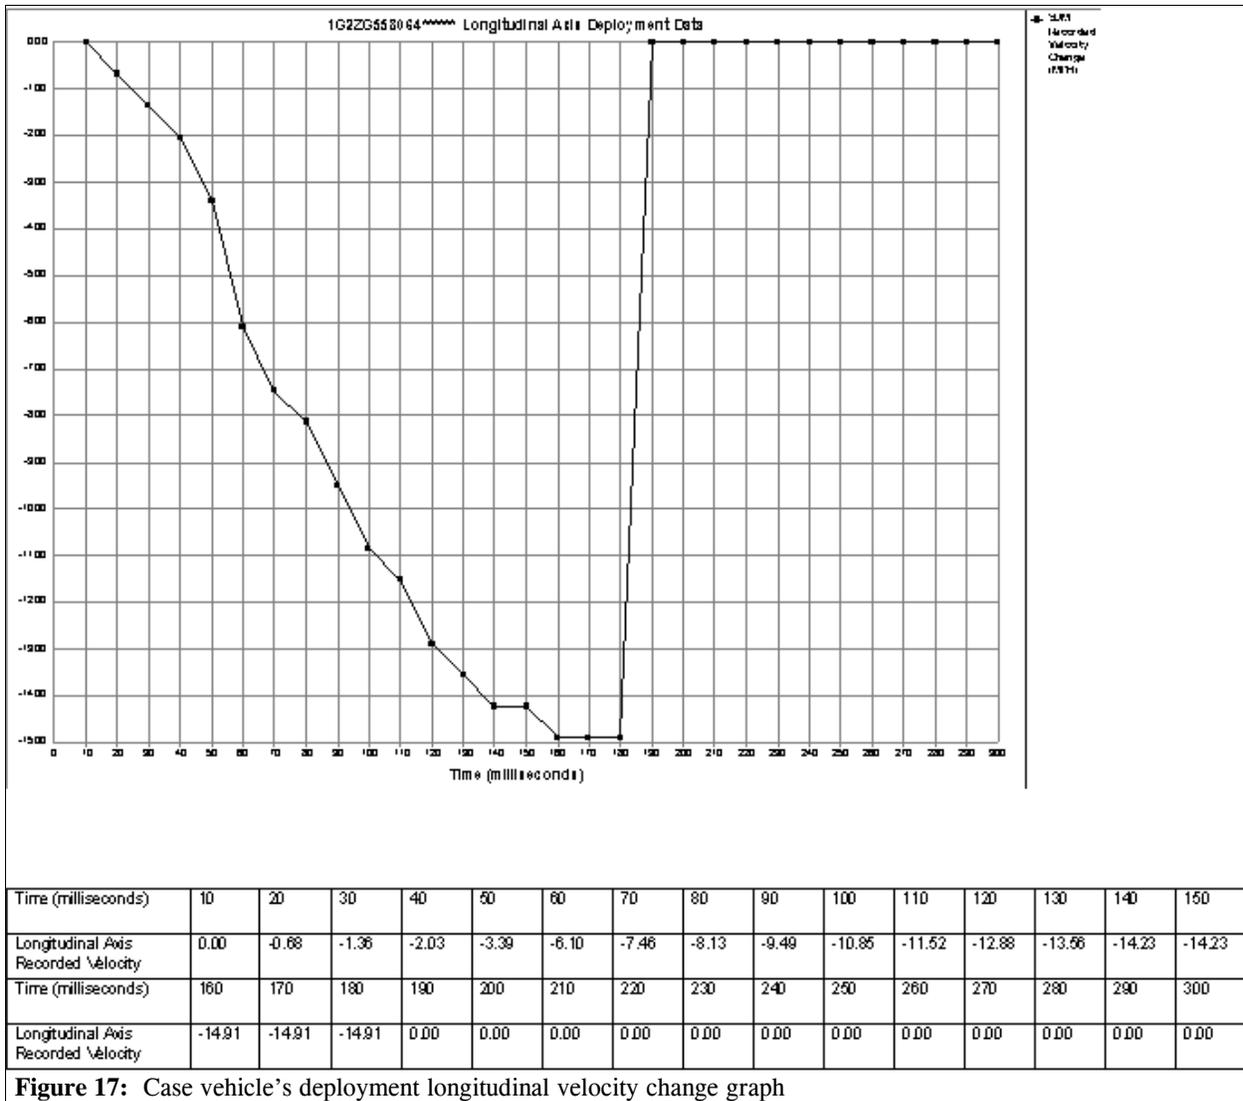
The download of the case vehicle’s EDR was done during the vehicle inspection via direct connection to the SDM. The EDR recorded a deployment event. The EDR reports are presented at the end of this report (Figures 13-18). The System Status at Deployment report (Figure 16 below) shows the SIR warning lamp was off, the driver’s seat belt switch circuit was recorded as buckled, the driver’s pretensioner actuated and the front right passenger’s air bag was suppressed. The system status report also shows that a first stage deployment was commanded at 52 milliseconds after algorithm enable (AE), and the air bag’s second stage was disposed. Interpretation of the longitudinal velocity change data (Figure 17 below) indicated that AE occurred at the approximate 30 millisecond sample point on the graph. The maximum recorded longitudinal velocity change was recorded as -24.0 km.p.h. (-14.91 m.p.h.) occurring at the 160 millisecond sample point on the graph.

Figure 17: Case vehicle's deployment longitudinal velocity change graph

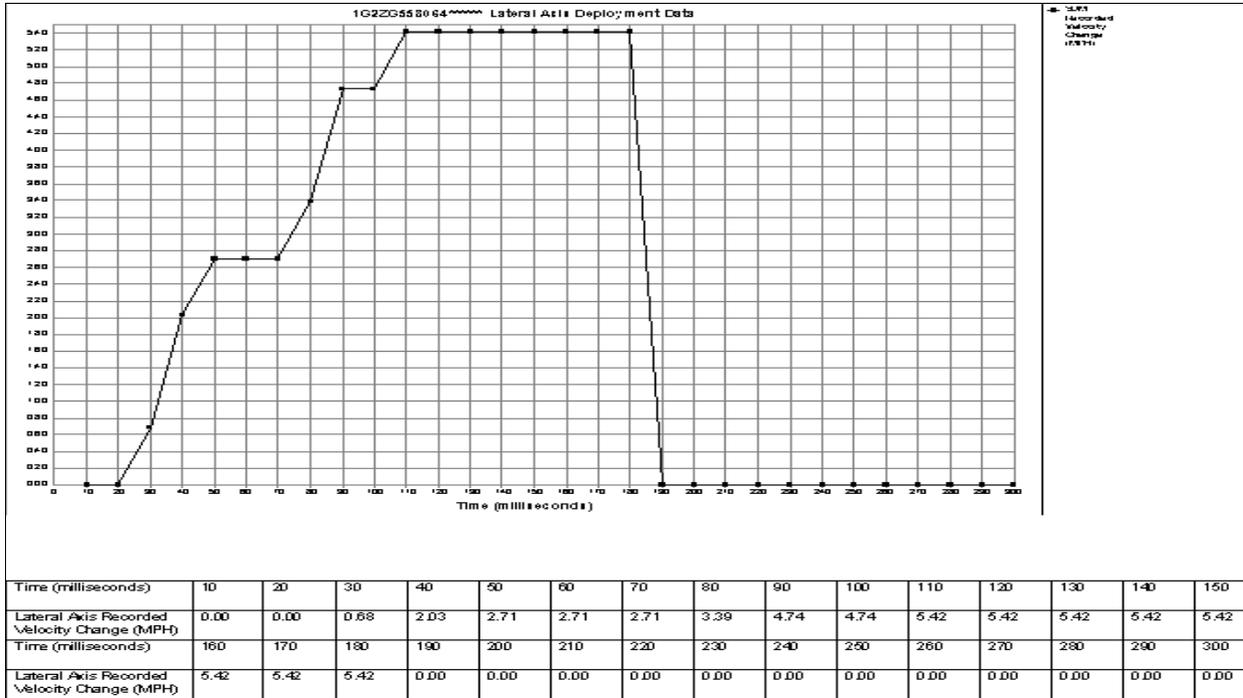
Figure 18: Case vehicle's deployment lateral velocity change graph
