**CALSPAN ON-SITE CHILD SAFETY SEAT  
CRASH INVESTIGATION**

**CASE NO: CA06-027**

**VEHICLE: 1998 CHEVROLET LUMINA**

**CRASH DATE: OCTOBER 2006**

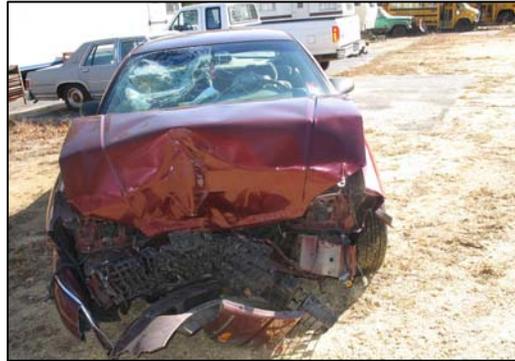
**Figure 1 - Subject Vehicle - 1998 Chevrolet Lumina**

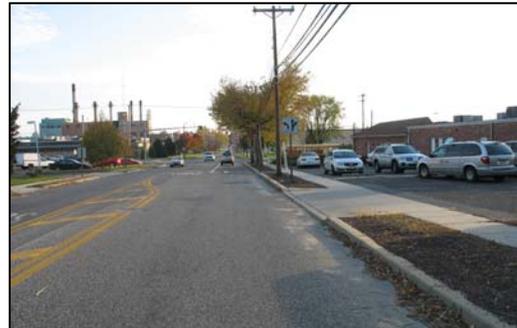
The 20-year old female driver of the Chevrolet Lumina was traveling in a southerly direction on the two-lane north/south roadway and was approaching stopped traffic at a signalized four-leg intersection (**Figure 2**). The Plymouth Voyager was stopped at the intersection in the left turn lane with the Toyota 4-Runner directly behind. As the Chevrolet approached the intersection, the driver's contact lens became dislodged from her eye and the driver attempted to reapply the lens. A witness who was traveling behind the Chevrolet contended that the vehicle proceeded to the initial impact without initiating any avoidance measures.

**Figure 2 – Southbound approach of Chevrolet.**

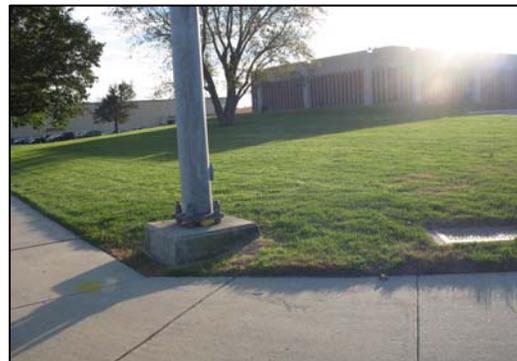
**Figure 3 - Impacted light standard.**

The impacted light standard was mounted on a 22 cm (8.5") concrete base. The Chevrolet had a bumper clearance of 40 cm (15.5"); therefore it is improbable that the front plane of the vehicle contacted the concrete base. The vehicle's undercarriage did engage the base of the light standard evidenced by black transfers on the concrete base. The vehicle came to final rest against the light standard.

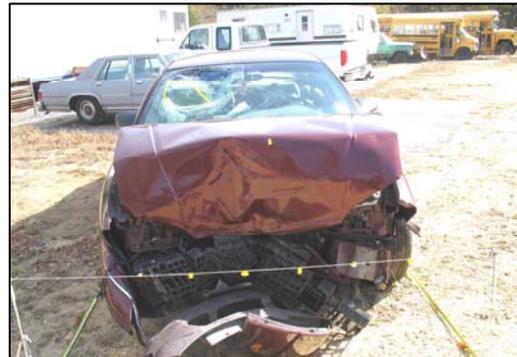
The 1998 Chevrolet Lumina sustained moderate damage as a result of the impact with the Toyota 4-Runner and the light standard (**Figure 4**). One crush profile was generated for the two events due to overlapping damage. An analysis of the damage pattern reveals that the majority of the crush was caused by the impact with the Toyota due in part to the uniformity of the damage across the full width of the hood. Isolating this damage, the SCI inspection revealed that the direct contact damage and induced damage encompassed the width of the bumper beam and measured 109 cm (43") in width. The maximum crush was located 4 cm (1.6") right of the vehicle's centerline and measured 64 cm (25") in depth. The crush profile consisted of six equidistant crush measurements taken along the bumper beam and was as follows: C1 = 10 cm (3.9"), C2 = 42 cm (16.5"), C3 = 59 cm (23.2"), C4 = 64 cm (25"), C5 = 36 cm (14.2"), C6 = 11 cm (4.3"). The estimated Collision Deformation Classification (CDC) for the impact with the Toyota was 12-FDEW-2.

**Figure 4 - Damaged 1998 Chevrolet Lumina.**

The direct damage for the impact with the light standard began 3 cm (1") right of the vehicle's centerline and measured 34 cm (13.5") in width. The CDC for this impact was 12-FCEN-2.

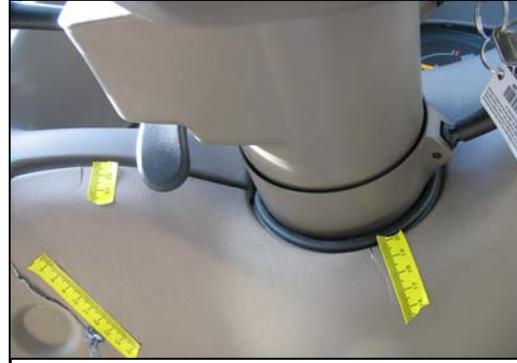
The 1998 Chevrolet Lumina sustained minor interior damage as a result of occupant contact. The contact was confined to the front left knee bolster and was in the form of three fractures to the rigid plastic knee bolster covering (**Figure 5**). The first fracture was located 14 cm (5.5") inboard of the left aspect of the instrument panel and 3 cm (1") below the top of the knee bolster. The vertical fracture was 8 cm (3") in length top to bottom. The fracture had associative blue jean fabric transfers embedded into the crack that resulted from the loading of the driver's left knee. The second fracture was located 20 cm (8") inboard of the left aspect of the instrument panel and was vertically located on the mid-seam separating the instrument panel from the knee bolster covering. The second fracture was 1 cm (0.5") in length and probably resulted from the deformation of the plastic panel during the knee contacts. The third fracture was located 38 cm (15") inboard of the left aspect of the knee bolster and directly underneath the base of the steering column. This vertical fracture was 3 cm (1.25") in length and probably resulted from the loading of the driver's right knee. The underlying energy absorption material was deformed as a result of the first and third panel fractures.

**Figure 5 - Damaged knee bolster.**

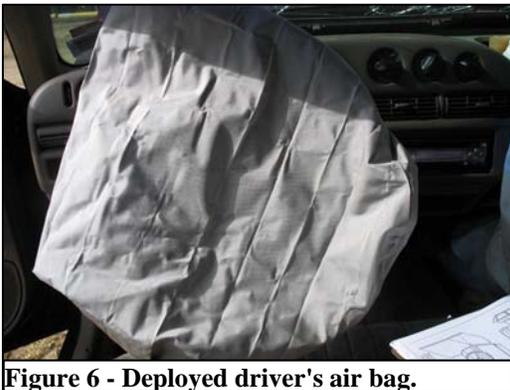
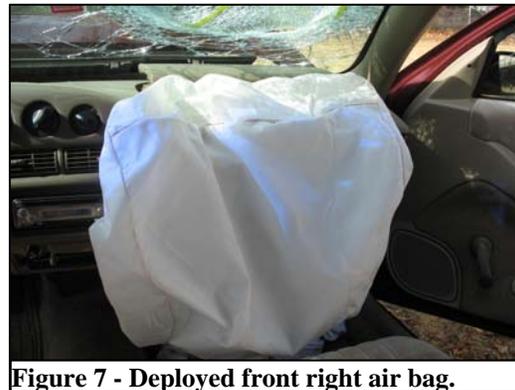
The front right air bag (**Figure 7**) deployed from a top-mount module configured with a single rectangular cover flap that was tethered at the top aspect. The cover flap measured 40 cm (15.5") horizontally and 25 cm (10") vertically and had an excursion of 23 cm (9"). The front right air bag measured 69 cm (27") horizontally and 51 cm (20") vertically in its deflated state. The bag was vented by two circular ports located in the 10 and 2 o'clock sectors of the back aspect of the bag and was tethered by two 6 cm (2.5") straps. Shards of glass were present on the membrane of the air bag due to contact with the windshield.

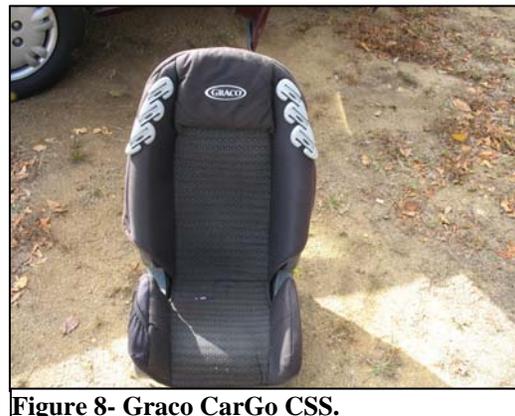
A Graco CarGo CSS (**Figure 8**) was installed forward-facing in the rear right position of the 1998 Chevrolet Lumina. The CSS was present inside the vehicle at that location during the SCI inspection. The model number of the CSS was 8481SVD and the date of manufacture was 03/03/2004. The CSS was rated for children between 14 and 45 kg (30 –

100 lb) in weight and within 89 and 137” (35 – 54”) in height and whose ears are below the top of the booster seat. The subject child weighed 20 kg (44 lb) which was within the range of usage of this product; however, the driver was uncertain of the child’s height and ear location with respect to the back of the CSS.

The high back booster CSS was configured with a shoulder belt positioner on the upper aspect of the CSS seat back. During the SCI interview, the driver stated that the positioner was used to fasten the belt in place. The CSS was purchased new by the driver who also installed it into the vehicle.

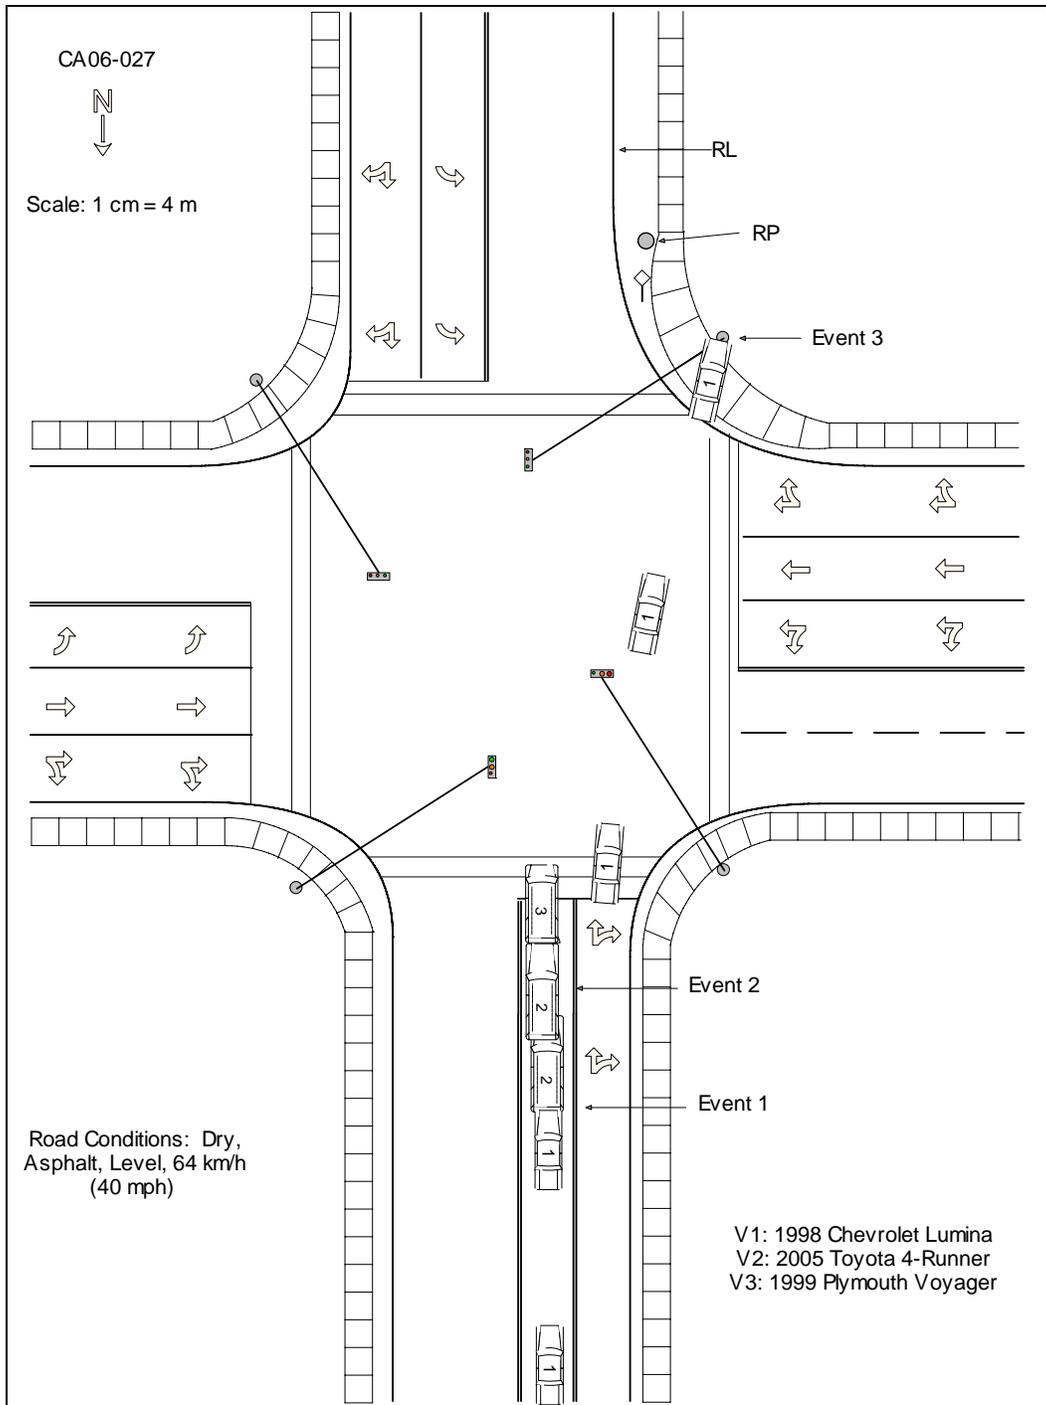
**Figure 9 – Scene Schematic.**

This three vehicle crash occurred on a well traveled level three-lane urban roadway at the mouth of an active four-leg intersection in October 2006. The north/south roadway was configured with one lane in each direction and transitioned to three lanes 40.4 m (133') prior to the intersection to accommodate a center left-turn lane. The lanes were delineated by a double yellow painted centerline. The east/west roadway was configured with two lanes in each direction. At the time of the crash, the asphalt roadway was dry and level and there were no adverse weather conditions. Concrete curbs that were 10 cm (4") in height enclosed the roadway and the roadside environment consisted of multiple businesses and private dwellings in a setting that was mostly developed. The posted speed limit for north/south traffic was 64 km/h (40 mph). The SCI scene schematic is included as **Figure 9** at the end of this narrative report.
