# INDIANA UNIVERSITY

## ON-SITE CERTIFIED ADVANCED 208-COMPLIANT VEHICLE INVESTIGATION

CASE NUMBER - IN-06-028

VEHICLE - 2006 JEEP GRAND CHEROKEE LAREDO

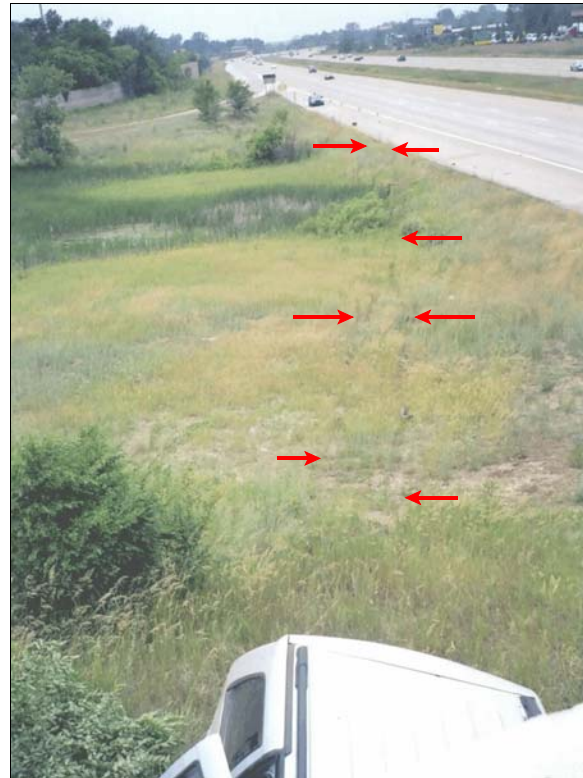
**Pre-Crash:** The case vehicle was traveling east in the outside eastbound lane (**Figure 1**). The driver was intending to continue eastbound. The driver became drowsy and fell asleep. The case vehicle drifted to the right, crossed the shoulder and departed the road (**Figure 2**). The scene evidence indicated the driver made no steering or braking avoidance actions prior to the crash. The police crash report indicated that the results of a blood alcohol test were negative. The driver's medical records indicated he tested positive for marijuana, cocaine and amphetamines. The crash occurred off the road on the south side of the Interstate.

**Figure 1:** Police on-scene photo showing opposite approach of case vehicle from overpass bridge, arrows show case vehicle's tire marks

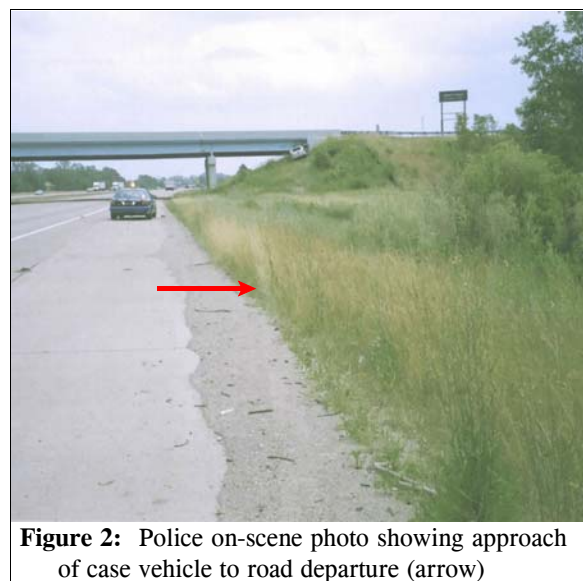
**Figure 2:** Police on-scene photo showing approach of case vehicle to road departure (arrow)

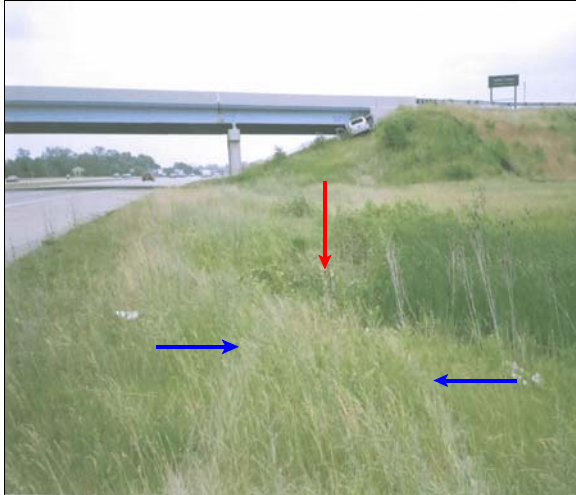
**Crash:** The case vehicle departed the shoulder, traveled through the grass and the front center impacted a clump of two small trees [(event 1), **Figure 3** below] located approximately 5.5 meters (18 feet) off the road. The case vehicle was then airborne across a marshy area and the lower front bumper and front undercarriage plowed into a small embankment on the far side of the marshy area [(event 2), **Figure 4**, below] as the vehicle touched down. This impact most likely deployed the first stage of the driver's and front right passenger's multi-stage air bags. The case vehicle continued through a field and up an embankment toward an Interstate overpass bridge (**Figure 5** below). As the case vehicle reached the top of the embankment is vaulted and became airborne. The right front wheel (**Figure 6** below) impacted and sideswiped the corner of the overpass bridge abutment [(event 3), **Figure 7** below]. The front of the case vehicle (**Figure 8** below) then immediately impacted the steel bridge deck support beam [(event 4), **Figure 9** below]. The evidence indicates the case vehicle was rolled left approximately 15 degrees when it impacted the bridge deck support beam.

**Figure 3:** Police on-scene photo showing case vehicle approach to marshy area and impact with two small trees (red arrow), blue arrows show left and right side tire tracks in grass

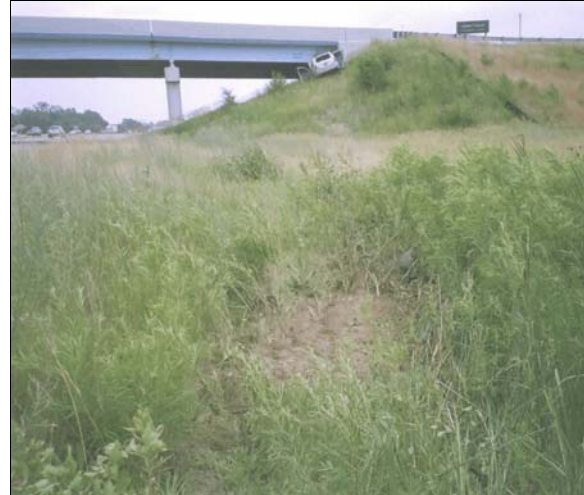
**Figure 4:** Case vehicle's lower front bumper and undercarriage impacted embankment on east side or marshy area

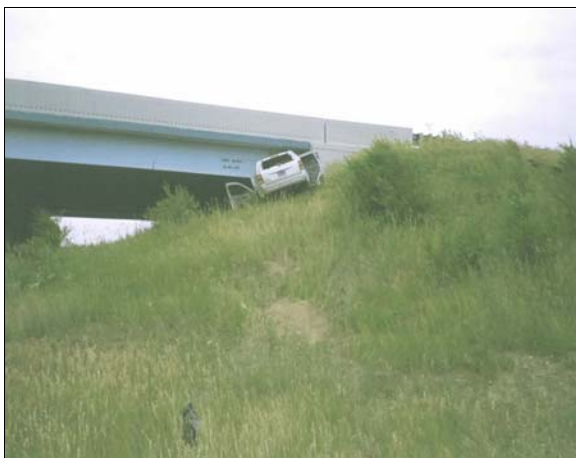
**Figure 5:** Police on-scene photo showing approach of case vehicle up embankment to impact with overpass bridge

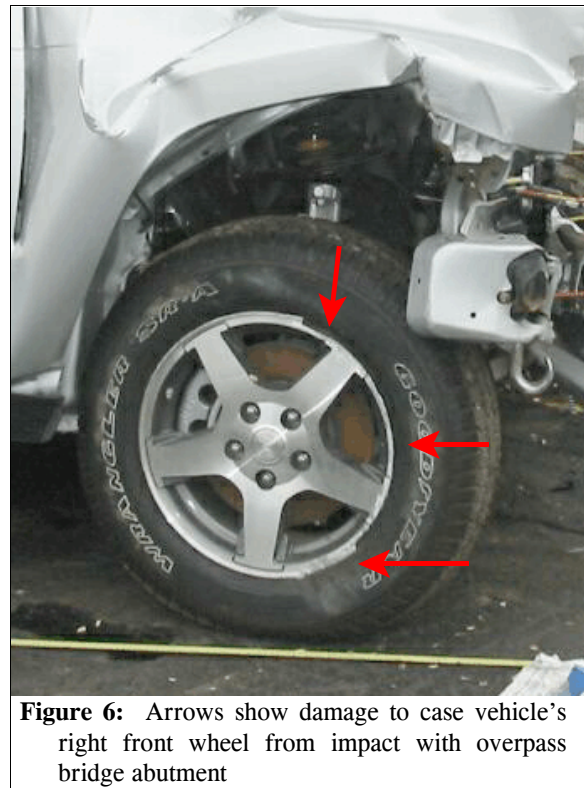
**Figure 6:** Arrows show damage to case vehicle's right front wheel from impact with overpass bridge abutment

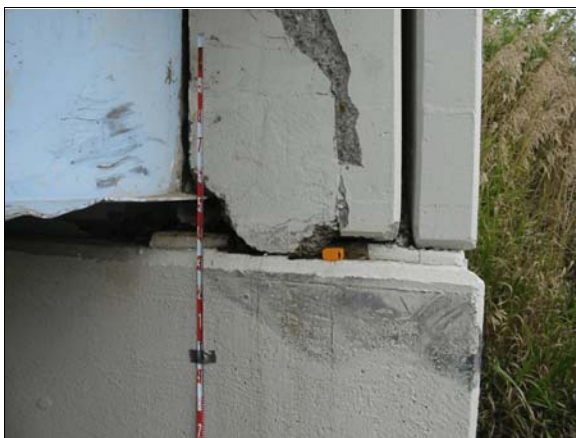
**Figure 7:** Arrow shows right front wheel impact to overpass bridge abutment, measurement rod graduated in tenths of meter

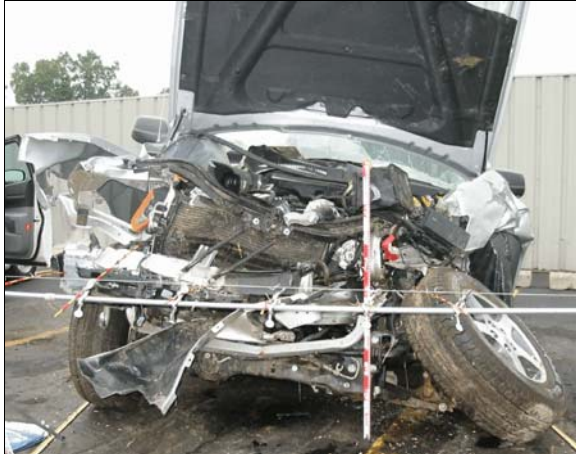
**Figure 8:** Damage to front of case vehicle primarily from impact with steel bridge deck support beam

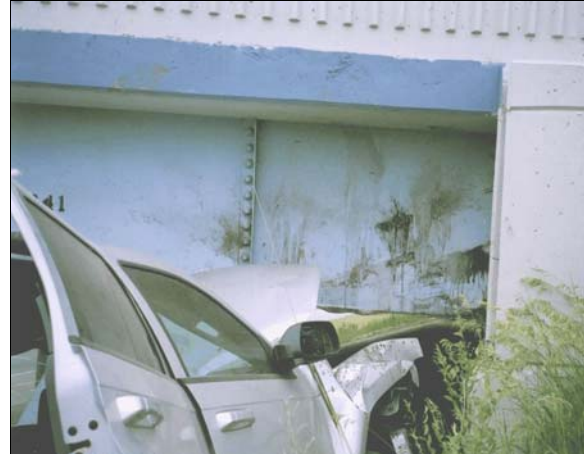
**Figure 9:** Police on-scene photo showing impact impression to steel bridge support beam

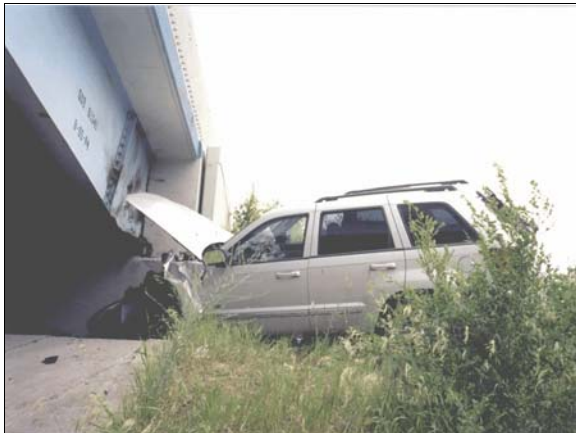
**Post-Crash:** Following the impact with the bridge deck support beam, the case vehicle dropped down to the ground and came to rest heading southeast (**Figure 10** below).

**Figure 10:** Police on-scene photo showing case vehicle's final rest position

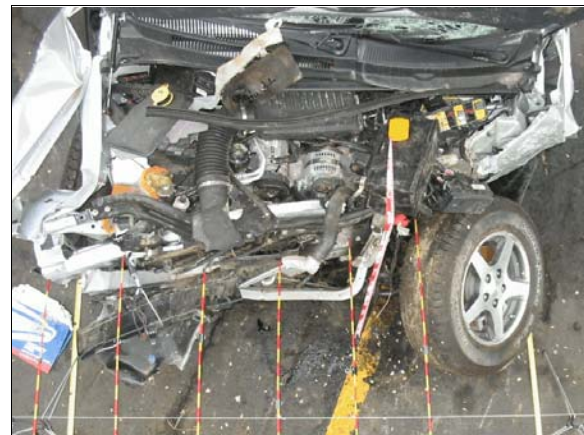
**Exterior Damage:** The case vehicle’s impact with the two small trees most likely involved a small area in the center of the front left bumper. Due to the absence of the front bumper fascia and overlapping damage from the embankment and steel bridge deck support beam impacts, a direct damage length could not be determined. The case vehicle’s impact with the embankment most likely involved the lower portion of the front bumper and the front undercarriage. The direct damage most likely extended across the full width of the lower portion of the front bumper. Dirt and grass were jammed into the front cross member and front undercarriage components. The case vehicle’s right front wheel sideswipe to the bridge abutment scuffed the tire and heavily abraded and fractured the lip of the wheel rim. The front impact with the steel bridge deck support beam involved the entire front end. The front bumper, both headlamp/turn signal assemblies, the grille, hood and both fenders were directly damaged and crushed rearward. The direct damage began at the front left bumper corner and extended 137 centimeters (53.9 inches) across the front end. A crush profile was taken to document the totality of the front crush due to the embankment and steel bridge deck support beam impacts. The majority of the crush was related to the bridge deck support beam impact. The residual maximum crush was measured as 72 centimeters (28.4 inches) occurring at C<sub>1</sub> (**Figure 11**). The table below shows the case vehicle’s front crush profile.

**Figure 11:** Top view of crush to front of case vehicle, each increment on rods is 5 cm (2 in)

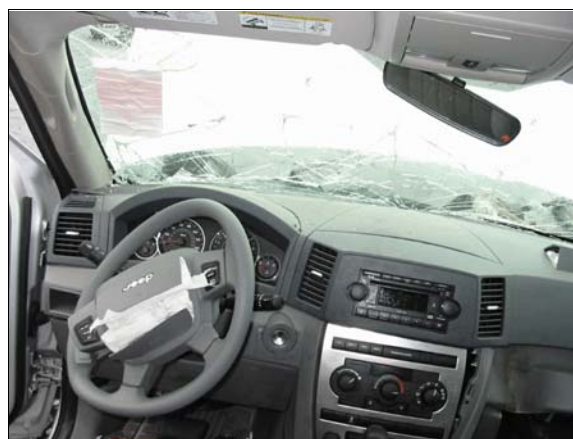
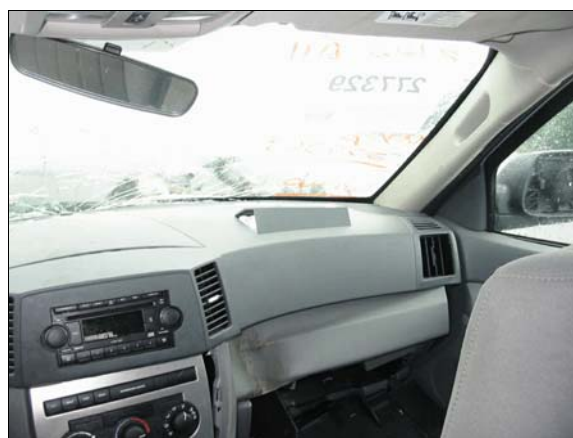
**Vehicle Interior:** Inspection of the case vehicle’s interior (Figures 12 and 13) revealed heavy deformation of the steering wheel and forward displacement of the energy absorbing steering column (Figure 14 below) due to driver loading. The driver’s “D” ring was heavily abraded due to loading from the driver’s shoulder belt, and the driver’s buckle-mounted pretensioner had actuated. The front right passenger’s knee bolster was heavily deformed due to loading by the front right passenger’s left knee. The front right passenger’s “D”-ring was also heavily abraded and his pretensioner had actuated. The front right passenger’s seat back was displaced forward (Figure 14 below), and there were skin transfers on the back of the seat back and scuffs on the right “B”-pillar due to contact by the back right passenger. In addition, the head restraint was knocked off the front right seat. The back of the center console was also cracked, possibly due to contact by the back right passenger’s left leg. Blood stains and a possible occupant contact scuff were found on the driver’s air bag. Blood stains and a probable cloth transfer were found on the front right passenger’s air bag. A “star burst” type fracture was noted to the right front windshield. No other occupant contacts were noted. Lastly, The windshield intruded into the driver’s occupant space approximately 5 centimeters (2 inches) due to hood contact, and the

Figure 12: Overview of case vehicle’s steering wheel, instrument panel and windshield

Figure 13: Overview of center and right instrument panel and the windshield

instrument panel intruded approximately 7 centimeters (2.8 inches). In addition, the brake pedal intruded 14 centimeters (5.5 inches) longitudinally and the front right seat back intruded forward approximately 15 centimeters (5.9 inches).

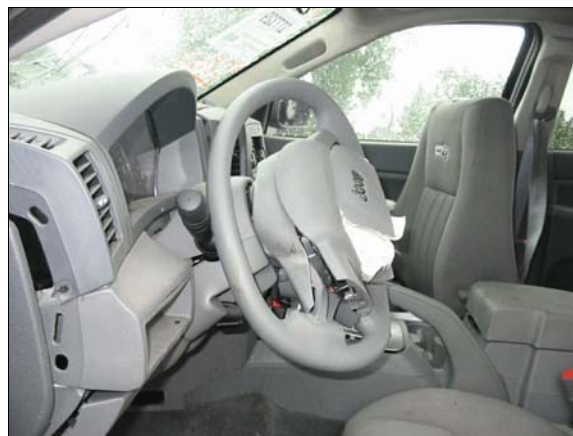
**Figure 14:** Left side view of damage to steering wheel and overview of forward displacement of front right seat back

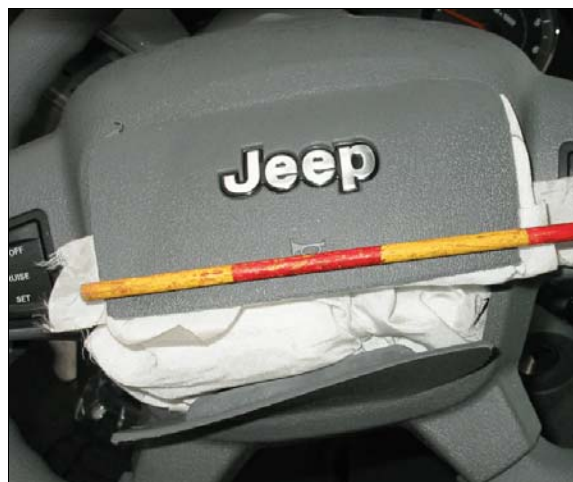
The case vehicle's driver air bag was located in the steering wheel hub. The air bag module cover consisted of essentially "H"-configuration cover flaps (**Figure 15**). The upper cover flap was 15 centimeters (5.9 inches) in width and 8 centimeters (3.1 inches) in height. The lower cover flap was 14.5 centimeters (5.7 inches) in width and 4.5 centimeters (1.8 inches) in height. An inspection of the air bag module cover flaps and the air bag fabric revealed that the cover flaps opened at the designated tear points. There was no evidence of damage during the deployment to the air bag or the cover flaps. The driver's air bag was designed with two tethers each 15

**Figure 15:** Case vehicle's driver air bag module cover flaps

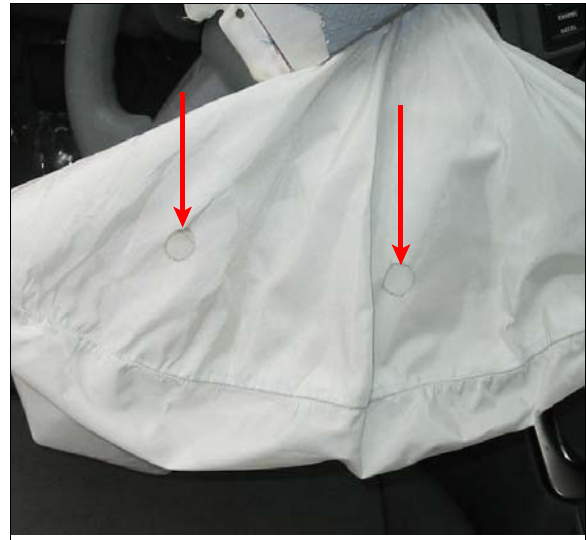
centimeters (5.9 inches) in width and had two vent ports (Figure 16 below), each approximately 2.5 centimeters (1 inch) in diameter, located at the 11 and 1 o'clock positions. The deployed driver's air bag (Figure 17) was round with a diameter of approximately 59 centimeters (23.2 inches). The distance between the mid-center of the driver's seat back, as positioned as the time of the vehicle inspection (i.e., seat between middle and rear-most track position, seat back slightly reclined), and the front surface of the air bag's fabric at approximate full excursion was 38 centimeters (14.9 inches). Inspection of the driver's air bag revealed a few blood stains on the bottom central portion of the air bag and a possible occupant contact scuff on the bottom right portion of the air bag.

Figure 16: Case vehicle driver's air bag vent ports (arrows)

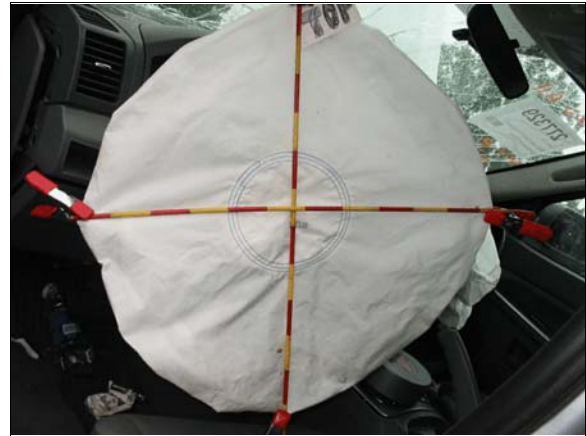
Figure 17: Case vehicle driver's air bag

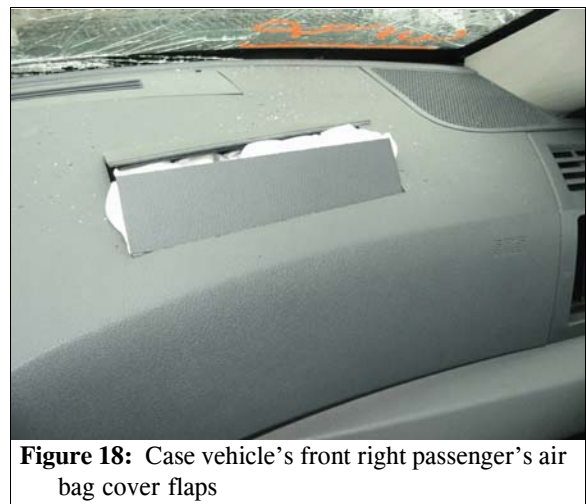
The front right passenger air bag was located in the top of the instrument panel. The air bag module cover (Figure 18) consisted of "H"-configuration cover flaps, although the lower flap was slightly trapezoidal-shaped. The upper cover flap was 21 centimeters (8.3 inches) in width and 5 centimeters (2 inches) in height. The lower flap was 21 centimeters (8.3 inches) in width, 5 centimeters (2 inches) in height on the left and 4 centimeters (1.6 inches) in height on the right. An inspection of the air bag module cover flaps revealed that the cover flaps opened at the designated tear points. There was no evidence of damage to the cover flaps or the air bag fabric. The deployed front right passenger's air bag (Figure 19 below) was approximately oval in shape. The deployed air bag was approximately 56 centimeters (22 inches) in height and approximately 60 centimeters in width (23.6 inches) at the center. The air bag was designed with 2 tethers, each 17 centimeters (6.7 inches) in width. There were two vent ports, one on each side of the air bag, at the approximate 3 and 9 o'clock positions. Each vent port was 5 centimeters (2 inches) in diameter. Inspection of the air bag fabric revealed some blood stains and probable cloth transfers on the lower left portion of the air bag.

Figure 18: Case vehicle's front right passenger's air bag cover flaps

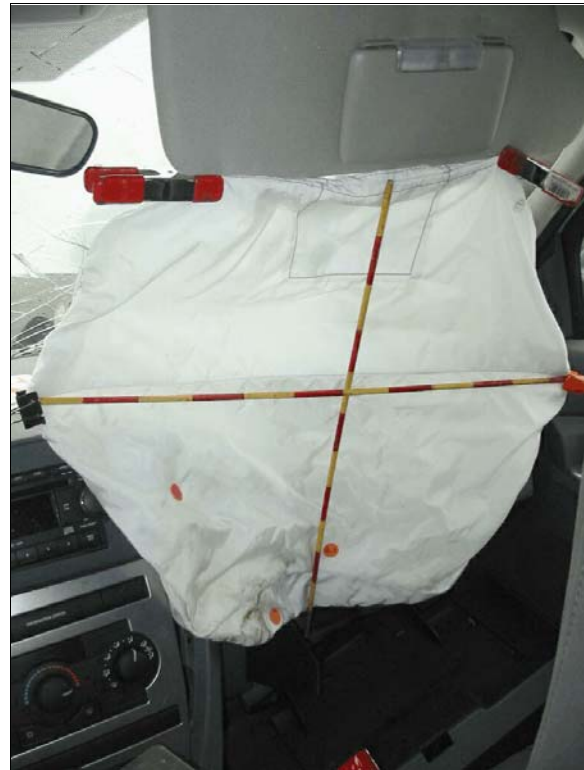
Figure 19: Front right passenger air bag

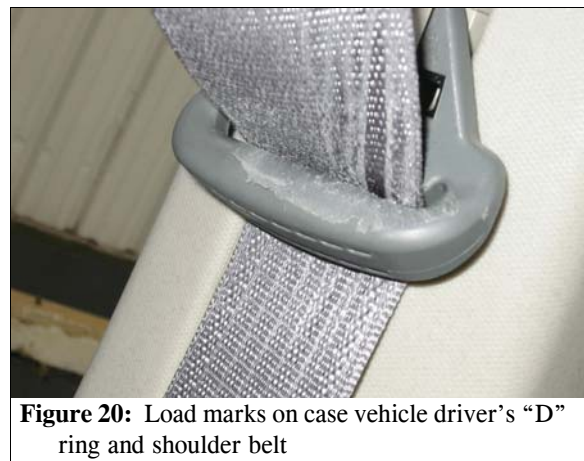
Based on this contractor's vehicle inspection, the case vehicle's driver was restrained by his manual, three-point, lap-and-shoulder safety belt system. Heavy load abrasions were found on the "D"-ring (**Figure 20**) and there were abrasions on the shoulder belt. In addition, the safety belt system was equipped with a buckle-mounted pretensioner (**Figure 21** below) and energy management feature, which actuated during the crash. Measurements from an exemplar vehicle indicated that the driver's pretensioner piston moved approximately 5 centimeters (2 inches) during the crash.

Figure 20: Load marks on case vehicle driver's "D" ring and shoulder belt

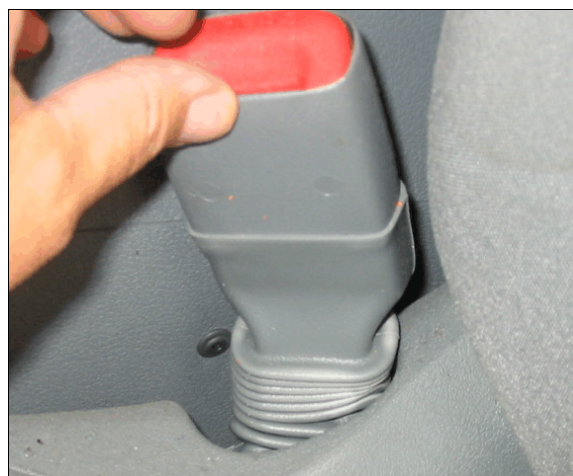
**Figure 21:** Driver’s buckle-mounted pretensioner actuated compressing the buckle stalk cover

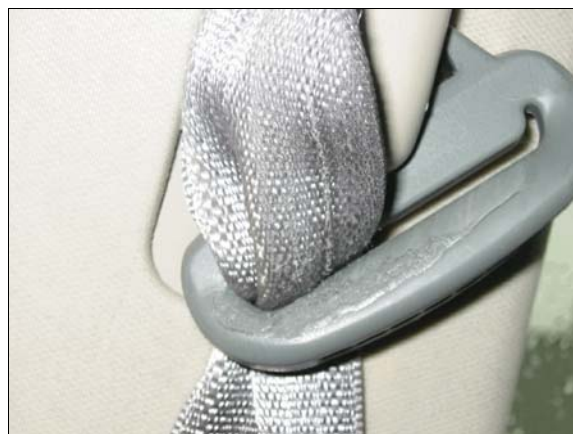
Based on this contractor's vehicle inspection, the case vehicle's front right passenger was restrained by his manual, three-point, lap-and-shoulder safety belt system. Heavy load abrasions were found on the "D"-ring, there were abrasions on the shoulder belt and the shoulder belt was bunched-up in the forward corner of the "D"-ring (**Figure 22**). In addition, the safety belt system was equipped with a buckle-mounted pretensioner and energy management feature, which actuated during the crash. Measurements from an exemplar vehicle indicated that the front right passenger's pretensioner piston moved approximately 2 centimeters (0.8 inch) during the crash.

**Figure 22:** Front right passenger's shoulder belt jammed in front corner of "D"-ring and load marks on "D" ring

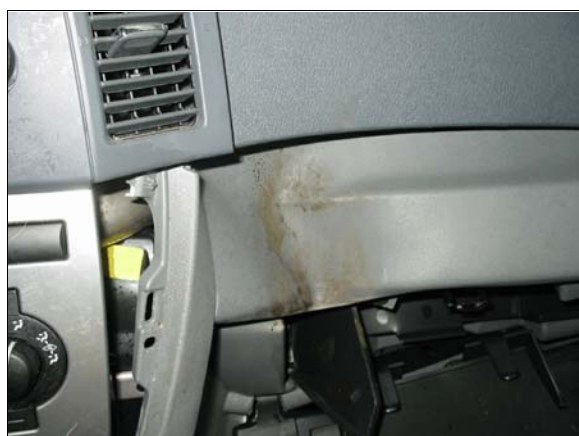
Figure 23: Dent in passenger knee bolster from impact by front right passenger’s left knee

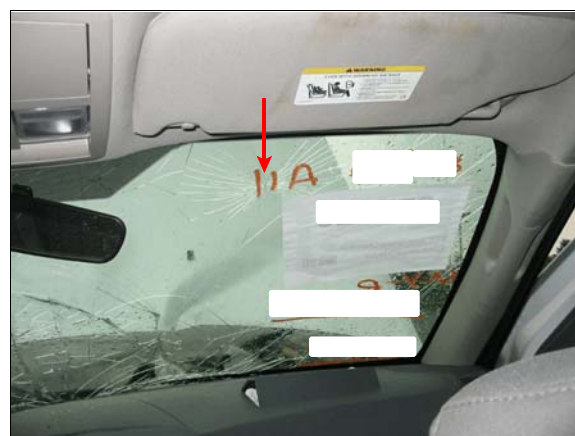
paid-out the safety belt. Abrasions on the safety belt indicated that it paid-out of the retractor approximately 61 centimeters (24 inches). A “star burst” fracture was observed on the windshield (Figure 24), which was likely caused by contact from the back right passenger, who likely traveled over the driver’s seat back and impacted the windshield during the impact with the bridge deck support beam. The front right passenger remained in his seat as the case vehicle came to final rest. The front right passenger’s medical records indicated he opened his door and rolled out of the vehicle following the crash.

Figure 24: Arrow shows “star burst” fracture in right windshield

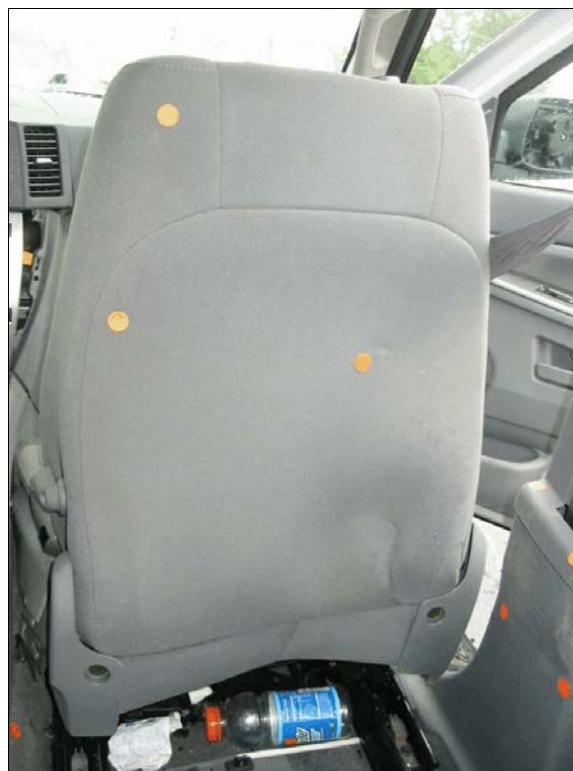
**Figure 25:** Contact marks on back of front right seat back from impact by back right passenger

decelerated violently. The passenger heavily loaded the front right passenger’s seat back deforming the seat back and displacing it forward (**Figure 25** above). The contact to the front right seat back fractured the back right passenger’s right forearm and fractured the neck of his left femur. The back right passenger likely continued over the top of the front right passenger’s seat and impacted and fractured the windshield (**Figure 24** above). The passenger most likely rebounded into the back seat following the bridge support beam impact. The back right passenger was removed from the case vehicle by emergency medical personnel.
