ON-SITE CHILD SAFETY SEAT INVESTIGATION

CASE NUMBER - IN-06-030

VEHICLE - 1989 PONTIAC GRAND AM

CRASH DATE - September 2006

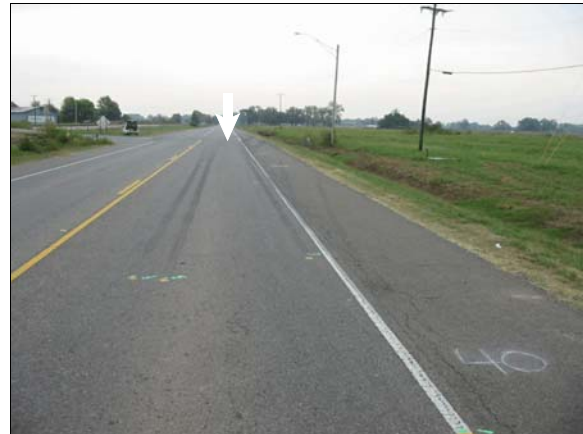
Pre-Crash: The case vehicle was traveling southeast in the southeastbound lane (**Figure 1**). The case vehicle’s driver was intending to turn left at the “T” intersection. A witness stated that the case vehicle stopped abruptly. The witness indicated she saw the case vehicle’s left turn signal come on. The Western Star was also traveling southeast and was behind the case vehicle. The Western Star’s driver was intending to continue straight ahead. Meanwhile, the Chevrolet was traveling northwest in the northwestbound lane and was approaching the “T” intersection (**Figure 1**). The initial impact occurred in the southeastbound lane (Figure 2). The second impact occurred in the northwestbound lane (**Figure 3**). It is unlikely that the case vehicle's driver made any avoidance maneuvers prior to the initial impact. The Chevrolet’s EDR data indicated that the Chevrolet’s driver applied the brakes just prior to the impact with case vehicle.

Figure 1: Approach of case vehicle and Western Star southeastbound to area of impact (arrow), skid marks from Western Star, number on shoulder shows meters to initial impact area

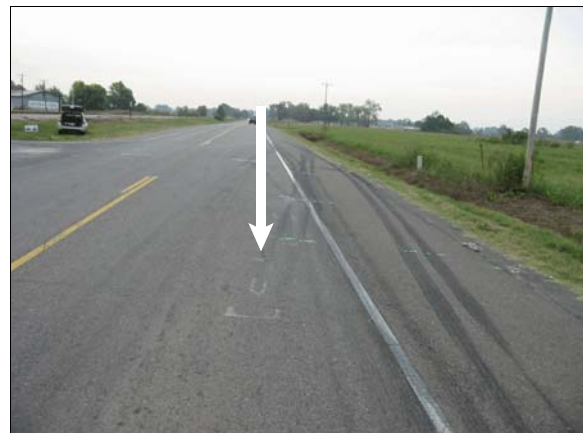
Figure 2: Arrow shows impact location of case vehicle and Western Star

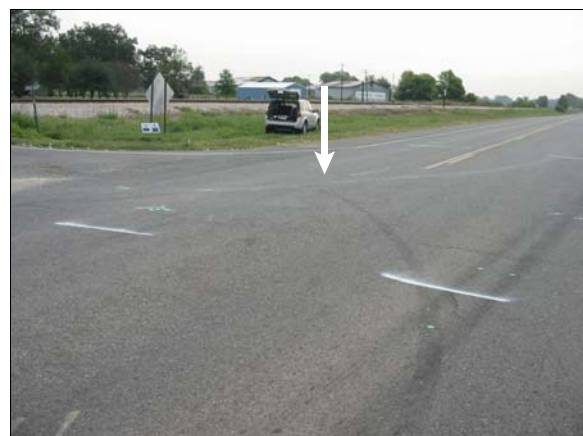
Figure 3: Post-impact travel of case vehicle approaching area of second impact (arrow)

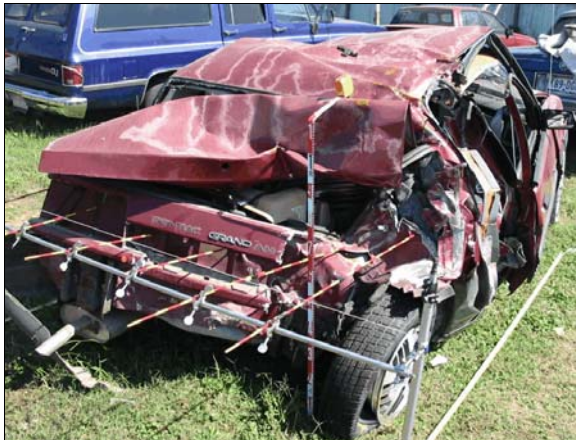
Crash: The front left of the Western Star impacted the back right of the case vehicle [event 1 (**Figure 4** below)]. The impact accelerated the case vehicle forward and caused it to rotate counterclockwise approximately 240 degrees and it crossed into the northwestbound lane (**Figure 3**). The front of the Chevrolet (**Figure 5** below) then impacted the left side of the case vehicle [event 2, (**Figure 6** below)]. The impact caused the case vehicle and the Chevrolet to rotate clockwise and the left quarter panel of the case vehicle impacted the right front door of the Chevrolet [event 3 (**Figure 7** below)].

Figure 4: Damage to back of case vehicle from impact with Western Star, vertical scale in tenths of meter, each increment on rods is 5 cm (2 in)

Exterior Damage: The case vehicle’s impact with the Western Star (event 1) involved the back right corner. The case vehicle’s back bumper, trunk lid, right tail lamp assembly, and the right quarter panel were all directly damaged and crushed forward. The back bumper was knocked off the case vehicle during the crash, so the crush measurements were taken to the panel behind the bumper. Direct damage began at the back right corner and extended 39 centimeters (15.4 inches) along the back of the vehicle. Crush measurements were taken at the bumper level. The residual maximum crush was measured as 80 centimeters (31.5 inches) occurring at C₅ (Figure 9). The induced damage from this impact involved the trunk lid, right C-pillar, right front door, and roof. In addition, all the right side and backlite glazing was broken out. The table below shows the case vehicle’s back crush profile.

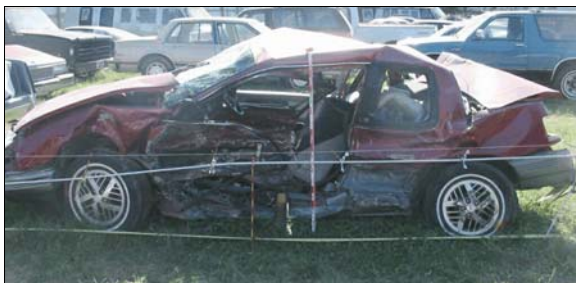
Figure 6: Damage to left side of case vehicle from impact with front of Chevrolet

The case vehicle’s impact with the Chevrolet (event 2) involved the left side. The left fender, left front door, left “A” and “B”-pillars and left quarter panel were all directly damaged and crushed inward. Direct damage began approximately 255 centimeters (100.4 inches) rear of the left front axle and extended approximately 289 centimeters (113.8 inches) along the left side of the vehicle. The impact separated the left front door latch and striker, so crush measurements were taken at both the sill and mid-door levels. Residual maximum crush at the sill level was measured as 23 centimeters (9.1 inches) occurring at C₃. The residual maximum crush at the mid-door level was measured as 89 centimeters (35 inches) occurring 27 centimeters forward of C₃. The side-slap impact with the Chevrolet (event 3) also involved the left quarter panel. The damage from the two impacts overlapped, but the side-slap impact was minor and did not appreciably alter the crush profile. The table below shows the average of the two levels of crush.

The case vehicle’s left side wheelbase was shortened 12 centimeters (4.7. inches) while the right side wheelbase was extended 10 centimeters (3.9 inches). Induced damage due to the left side impact involved the hood, left fender, roof and left quarter panel.

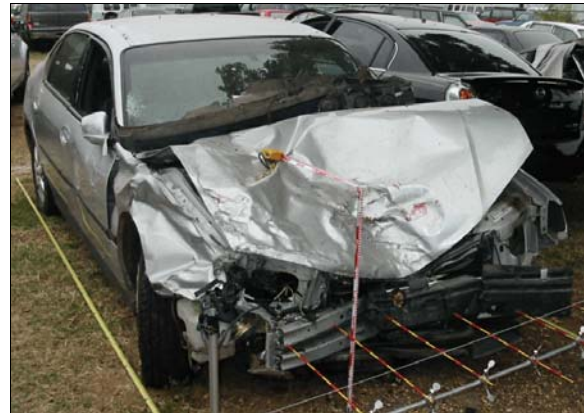
Figure 5: Overview of damage to front of Chevrolet from impact with left side of case vehicle

Exterior Damage: The Chevrolet's impact with the left side of the case vehicle (event 2) involved the front of the vehicle. The front bumper, left headlamp/turn signal assembly, front of the left fender, hood and grille were directly contacted and crushed rearward. The direct damage began at the front right bumper corner and extended 110 centimeters (43.3 inches) across the front end. Crush measurements were taken at the bumper level, and the maximum residual crush was measured as 40 centimeters (15.7 inches) occurring at C₄ (**Figure 14** below). The table below shows the Chevrolet's front crush profile.

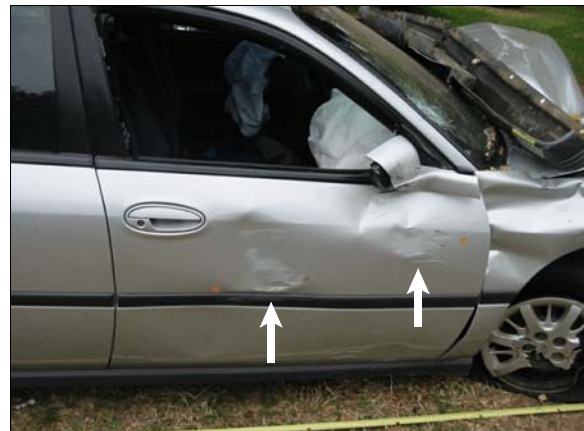
Figure 7: Damage to Chevrolet's right front door due to side-slap impact with case vehicle

The side-slap impact involved the Chevrolet’s right front door. The direct damage began 146 centimeters (57.5 inches) forward of the right rear axle and extended 79 centimeters (31.2 inches) along the door. The residual maximum crush was determined to be approximately 2 centimeters (0.8 inch) occurring approximately 11 centimeters forward of C₂. The table below shows the Chevrolets right front door crush profile.

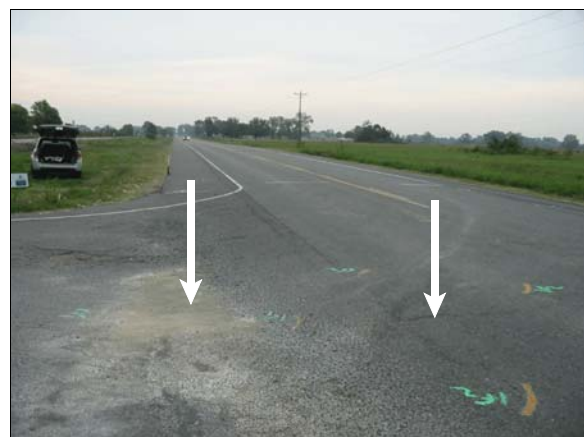
Post-Crash: The case vehicle and Chevrolet remained engaged and traveled north coming to rest in the mouth of the intersecting county road (Figure 8). The case vehicle was heading northwest at final rest. The Chevrolet was heading north at final rest. Meanwhile, the Western Star skidded to final rest on the west shoulder heading southeast with the tractor in the southeastbound lane and the trailer on the west shoulder.

Figure 8: View southwest to area of final rest of case vehicle and Chevrolet and opposite view of Chevrolet's approach, arrow on right shows Chevrolet's area of final rest, arrow of left shows case vehicle's area of final rest, police marks on pavement show wheel positions

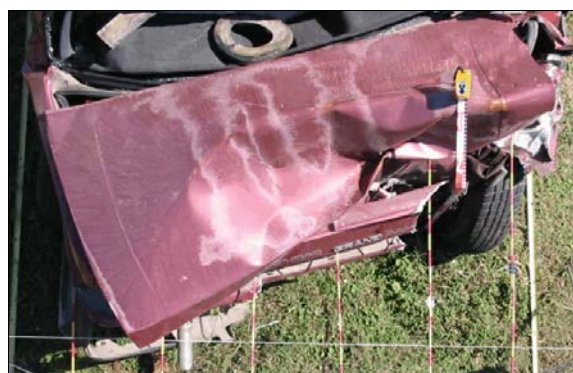
Figure 9: Top view of crush to back of case vehicle

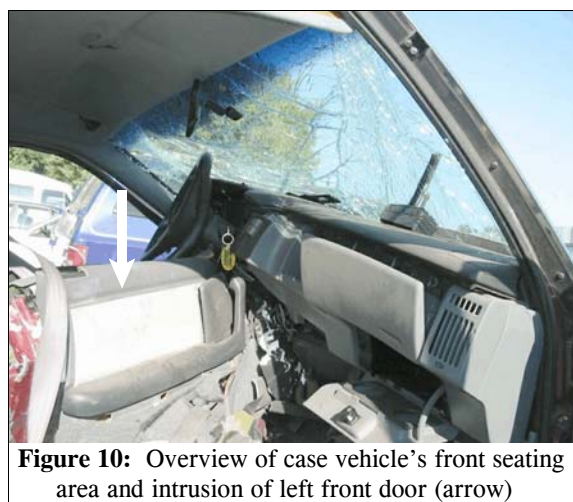
Vehicle Interior: Inspection of the case vehicle’s interior revealed an occupant contact scuff on the driver’s door arm rest and left front window sill. In addition, the driver’s seat back was displaced rearward due to driver loading as a result of the back end impact by the Western Star. The case vehicle’s passenger compartment sustained numerous intrusions. The most severe intrusion involved the lateral displacement of the driver’s door (Figure 10). It intruded a total of 79 centimeters (31.1 inches) into the front seating row, which was 7 centimeters (2.8 inches) more than half the width of the front seating row. The side panel rear of the left “B”-pillar intruded 41

Figure 10: Overview of case vehicle’s front seating area and intrusion of left front door (arrow)

centimeters (16.1 inches) laterally into the back seating row. The rear seat back intruded longitudinally 56 centimeters (22 inches) and 48 centimeters (18.9 inches) respectively into the back right and back center seat positions.

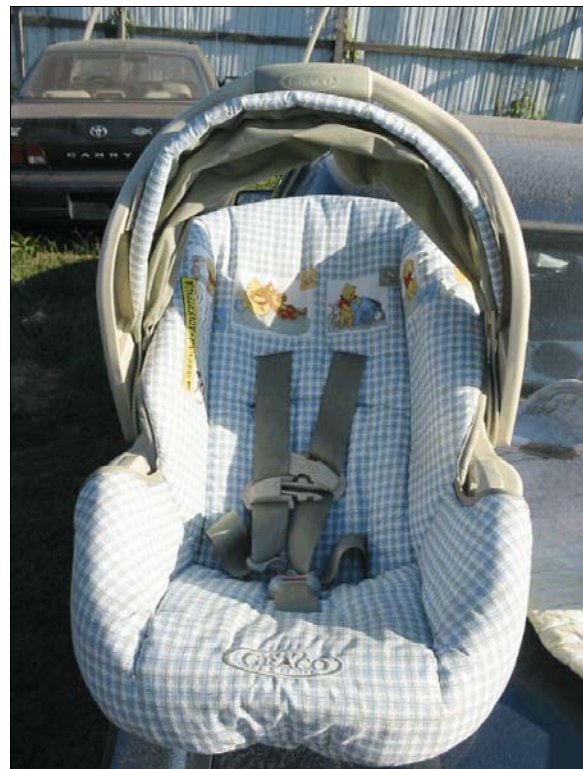
The back right passenger was seated in a Graco "Snug Ride" rear-facing infant seat (**Figure 11**), which was being used without the base. The infant seat was manufactured by Graco Children's Products Inc., on November 9, 2005 and was identified by model number 7241DDH2. The infant seat consisted of a plastic, one-piece shell with a padded cloth cover approximately 2 centimeters (0.8 inch) thick, a five-point harness with harness retainer clip, a carrying handle and a level indicator located on the left side of the infant seat. The infant seat was designed with two sets of harness slots located in the seat back. The harness straps were threaded through the top slot. A belt path was located on each arm rest so the infant seat could be secured with a vehicle's manual safety belt system. In addition, a locking clip was stored in a slot on the bottom of the infant seat. The infant seat's height and weight limits were indicated respectively as: 73

Figure 11: Case vehicle's back right passenger's rear-facing infant seat

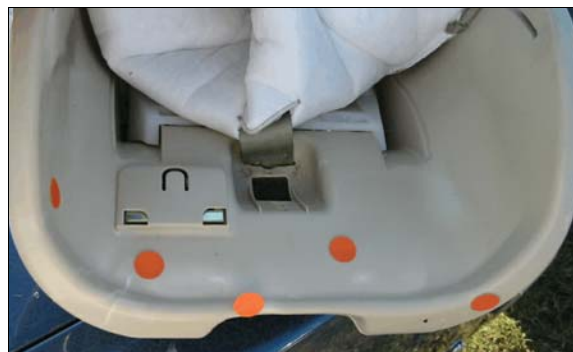
Inspection of the infant seat revealed evidence the seat was loaded during the crash. There were numerous locations on the infant seat where the plastic was lighter in color (**Figure 12**) indicating the plastic shell had been loaded during the crash stressing the plastic. This was most likely the result of the longitudinal intrusion of the case vehicle's seat back loading against the seat as it was held in place by the case vehicle's safety belt. Otherwise, the infant seat was intact and unremarkable.

Figure 12: Orange dots show some of stress spots on the back left passenger's infant seat

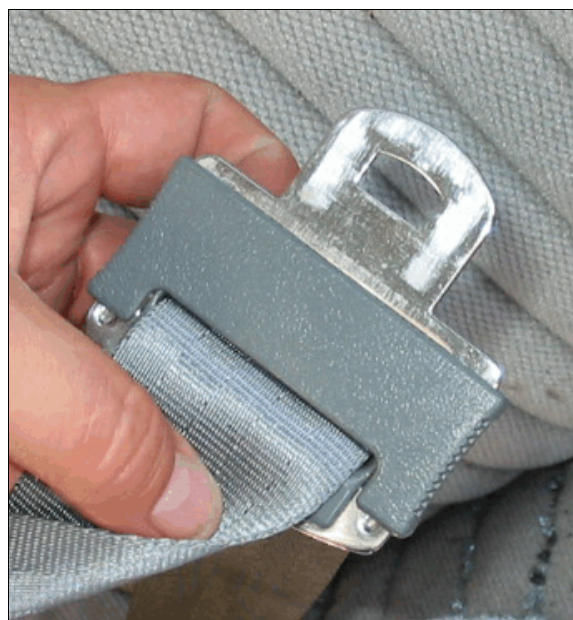
The case vehicle's back outboard seating positions were equipped with three-point, lap-and-shoulder safety belt systems with emergency locking retractors and lightweight locking latch plates (**Figure 13**). The infant seat was secured with the lap portion of the safety belt system, which was positioned through the safety belt paths located at the back of the infant seat's arm rests.

Figure 13: Back right lightweight locking latch plate

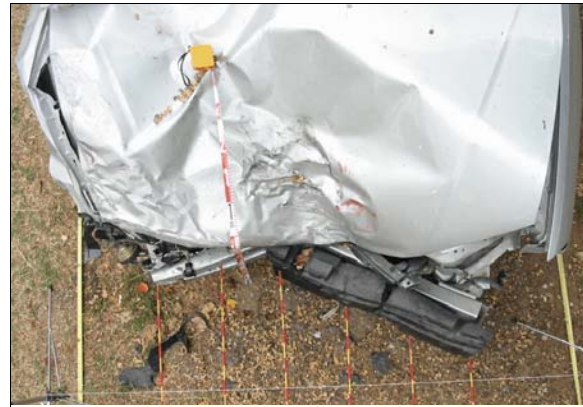
Figure 14: Top view of crush to front of Chevrolet from impact with the left side of the case vehicle

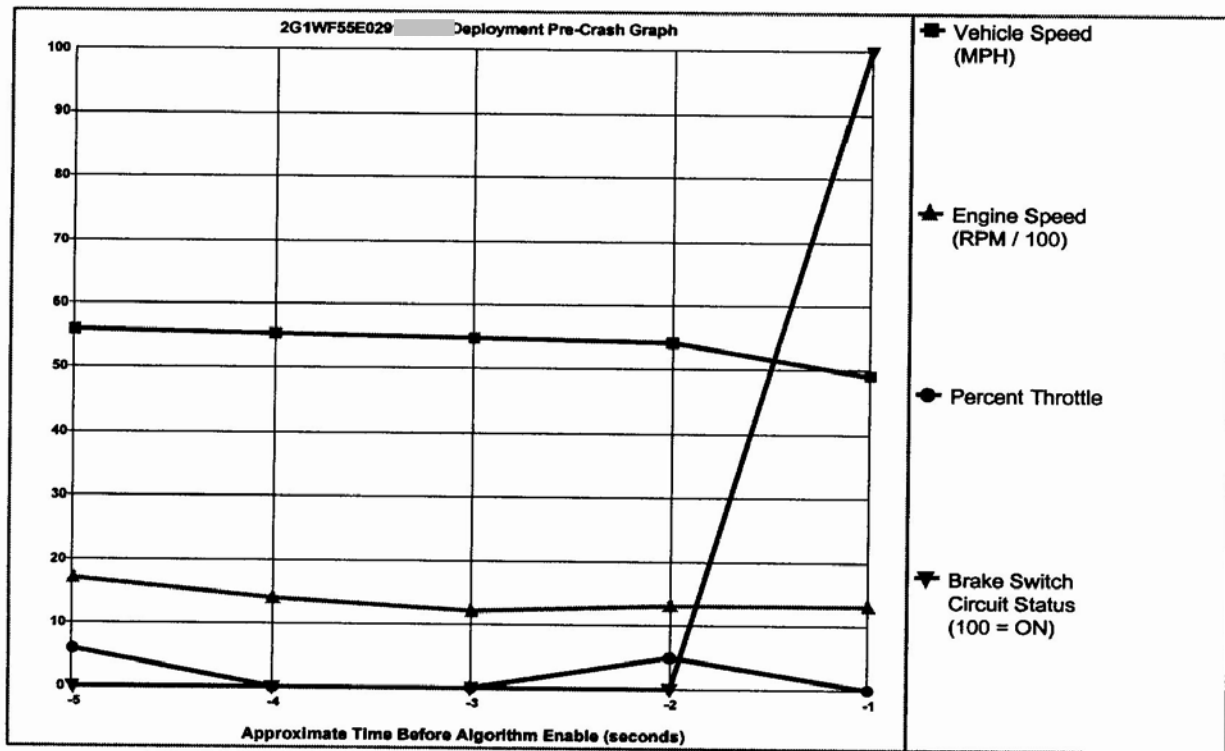
Figure 16: Chevrolet's System Status at Deployment and Deployment Pre-Crash Data

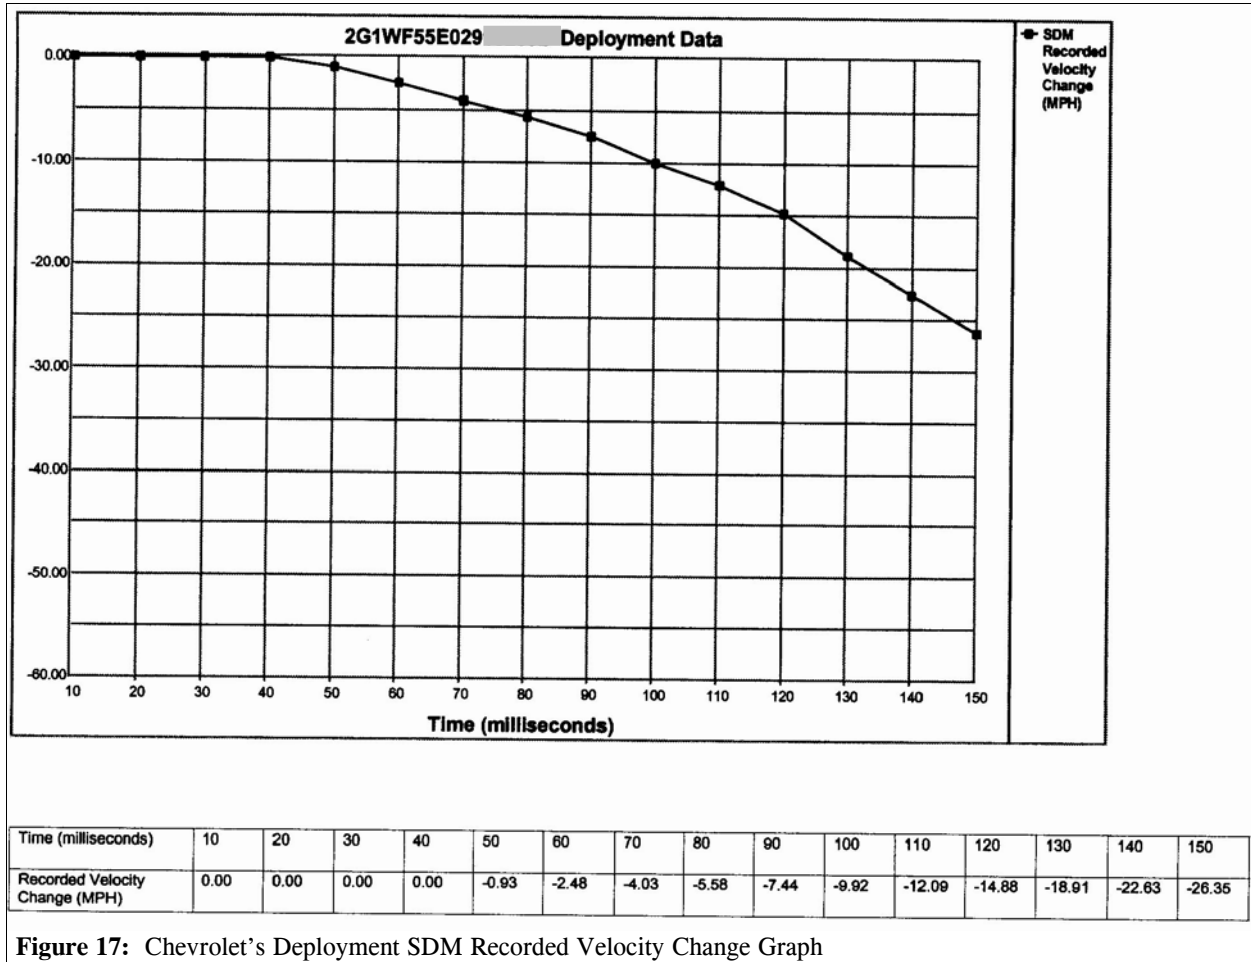
Figure 17: Chevrolet's Deployment SDM Recorded Velocity Change Graph

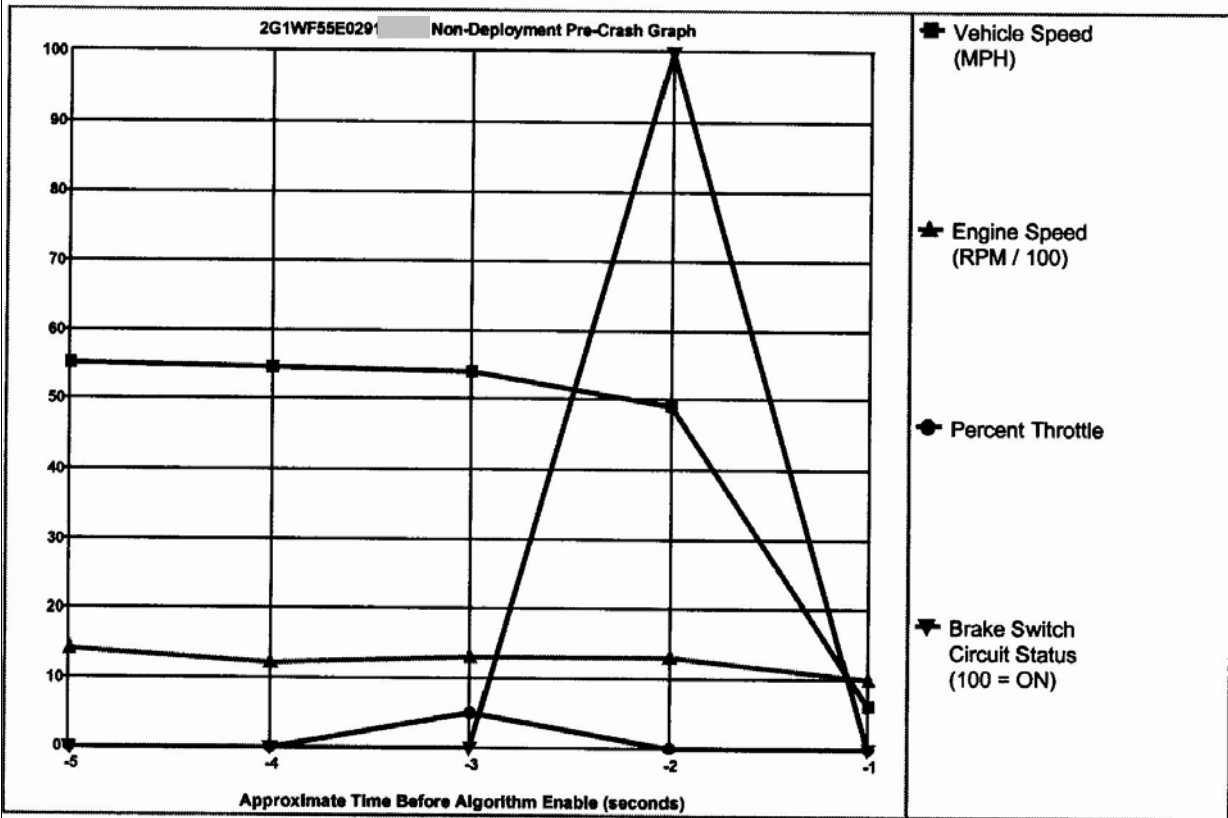
Figure 18: Chevrolet's System Status at Non-Deployment and Non-Deployment Pre-Crash Data
