ON-SITE CERTIFIED ADVANCED 208-COMPLIANT VEHICLE INVESTIGATION

CASE NUMBER - IN-06-032

VEHICLE - 2005 HONDA ACCORD

CRASH DATE - August 2006

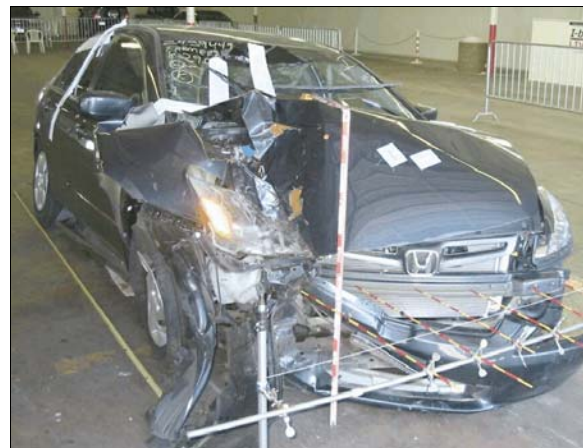
traveled through the grass and landed in a concrete drainage basin (**Figure 3**). The center left portion of the front bumper impacted a telephone utility box (event 4) north of the drainage basin. The front right of the case vehicle (**Figure 4**) then impacted a utility pole [**Figure 5** (event 5)] breaking it off at the base. The utility pole impact caused both stages of the case vehicle driver's front air bag to deploy. In addition, the driver's side curtain air bag and seat back-mounted side impact air bag deployed.

Figure 4: Overview of damage to front of case vehicle from impact with utility pole, vertical scale in tenths of meter, each increment on rods is 5 cm (2 in)

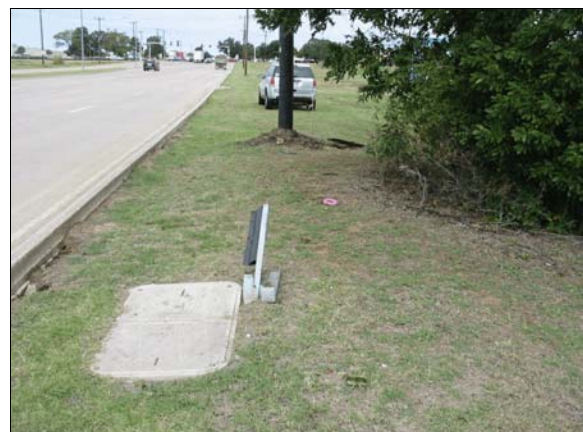
Figure 5: Overview of telephone utility box impact and utility pole impact (pole has been replaced)

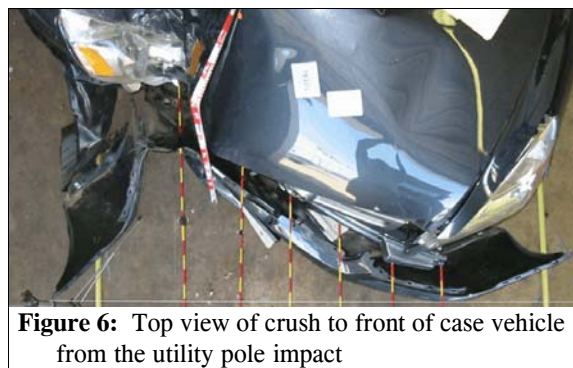
Exterior Damage: The case vehicle’s impact with the curb damaged the right front, left front and left rear wheels. The right front and left rear wheel rims were dented and the tires debanded. The left front tire was debanded and the wheel rim slightly deformed. The case vehicle’s front impact with the telephone utility box involved a narrow area of the center left portion of the front bumper. The impact caused only scratches on the bumper fascia. The case vehicle’s impact with the utility pole involved the front right of the vehicle. The front bumper, right headlamp/turn signal assembly, right corner of the hood and front of the right fender were directly damaged and crushed rearward. Direct damage began at the front right bumper corner and extended 16 centimeters (6.9 inches) across the bumper. Residual maximum crush was measured as 67 centimeters (26.4 inches) occurring at C₆ (**Figure 6**). The table below shows the case vehicle’s front crush profile for the utility pole impact.

Figure 6: Top view of crush to front of case vehicle from the utility pole impact

The case vehicle’s right side wheelbase was reduced 24 centimeters (9.4 inches) while the left side wheelbase was extended 4 centimeters (1.6 inches). Induced damage involved the hood, left portion of the front bumper, both fenders, right sill, left corner of the back bumper fascia, and the windshield was fractured.

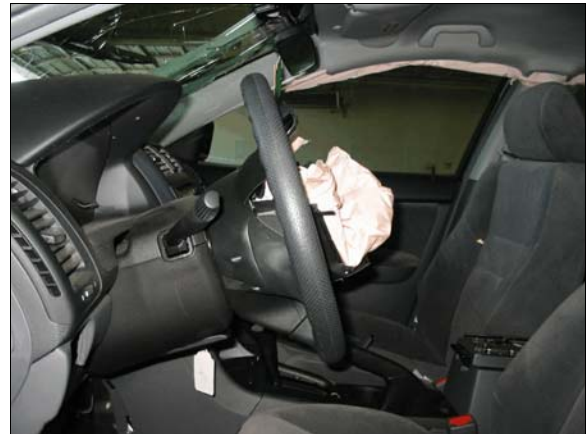
Vehicle Interior: Inspection of the case vehicle’s interior (Figures 7 and 8) revealed occupant contact evidence on the driver’s knee bolster and a lip stick print on the upper left quadrant of the driver’s air bag. No other occupant contacts were noted. There was no evidence of occupant compartment intrusions and no deformation of the steering wheel or compression of the energy absorbing steering column (Figure 9 below).

Figure 9: Left side view of case vehicle's steering assembly

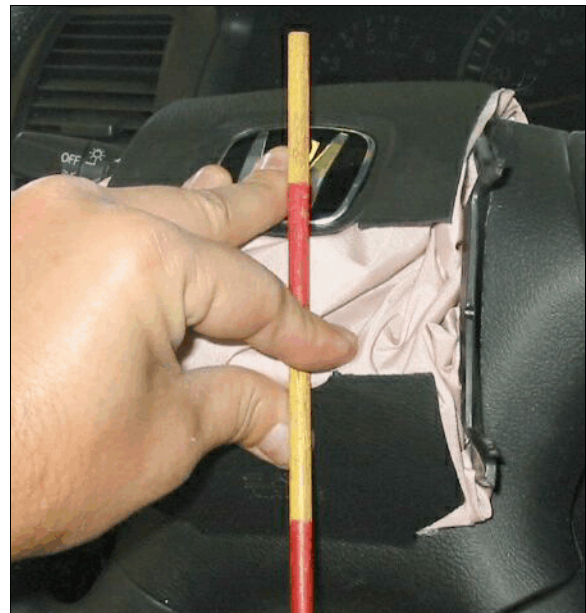
The case vehicle's driver air bag was located in the steering wheel hub. The air bag module cover consisted of two asymmetrical flaps made of semi-pliable vinyl. The upper flap was approximately rectangular in shape with a manufacturer's logo located in the center of the flap. A portion of the logo extended from the bottom of the flap and fit into a cut-out at the center top of the lower flap. The upper flap was 12 centimeters (4.7 inches) in width and 8 centimeters (3.1 inches) in height. The lower flap was 12 centimeters (4.7 inches) in width at the top, 8 centimeters (3.1 inches) in width at the bottom and 7 centimeters (2.8 inches) in height. An inspection of the air bag module cover flaps (**Figure 10**) and the air bag fabric revealed that the cover flaps opened at the designated tear points, and there was no evidence of damage during the deployment to the air bag or the cover flaps. The driver's air bag was designed with two

Figure 10: Case vehicle driver's air bag cover flaps

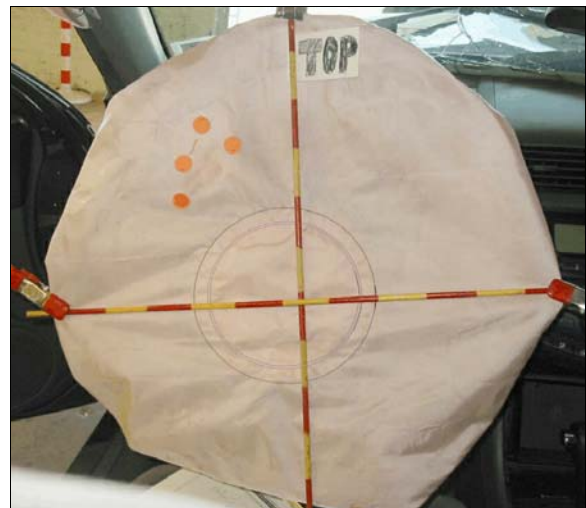
Figure 11: Case vehicle driver's air bag, orange dots show lip stick imprint

tethers, each approximately 7 centimeters (2.8 inches) in width, and had two vent ports, each approximately 5 centimeters (2 inches) in diameter, located approximately at the 10 and 2 o'clock positions near the center of the back of the air bag. The deployed driver's air bag (**Figure 11** above) was round with a diameter of approximately 57 centimeters (22.4 inches). An inspection of the driver's air bag fabric revealed a lip stick print (**Figure 11** above) and blood stain on the upper left quadrant and blood stains on the lower left and right quadrant.

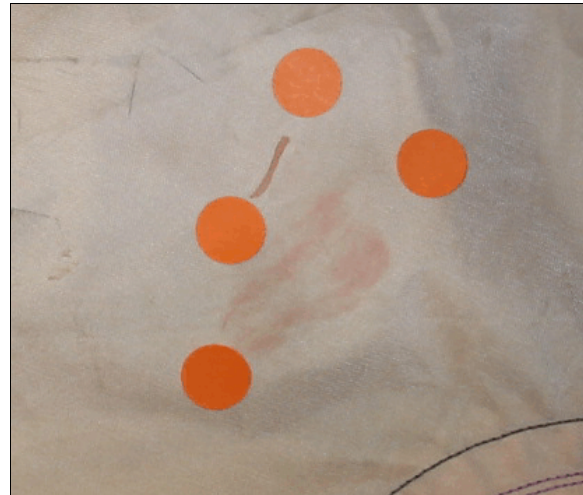
Figure 15: Lip stick imprint on upper left quadrant of driver's air bag

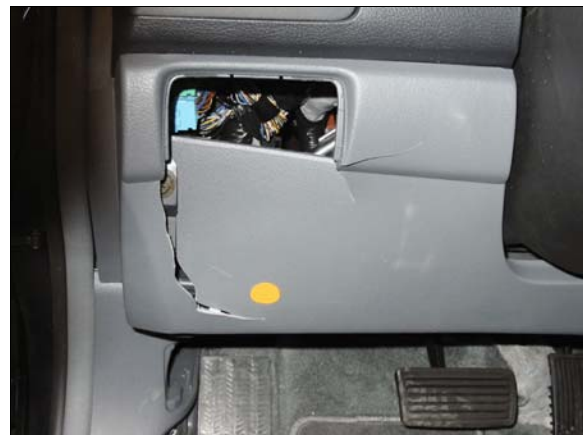
Figure 16: Damage to case vehicle driver's left knee bolster from driver's left knee impact

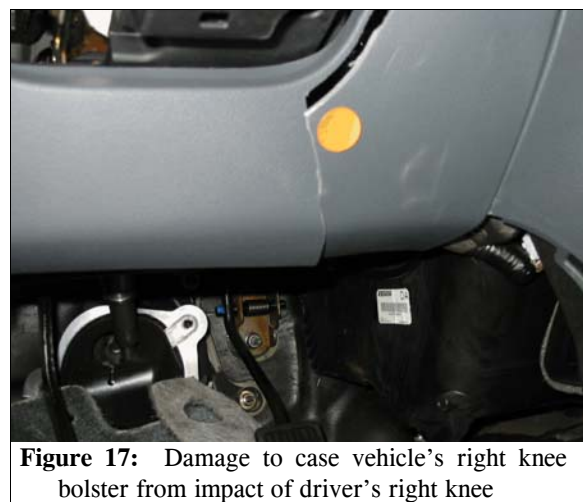
Figure 17: Damage to case vehicle's right knee bolster from impact of driver's right knee
