ON-SITE AIR BAG NON-DEPLOYMENT INVESTIGATION

CASE NUMBER - IN-06-033
LOCATION - WISCONSIN
VEHICLE - 2005 CHEVROLET COBALT
CRASH DATE - October 2006

Revised: March 31, 2008

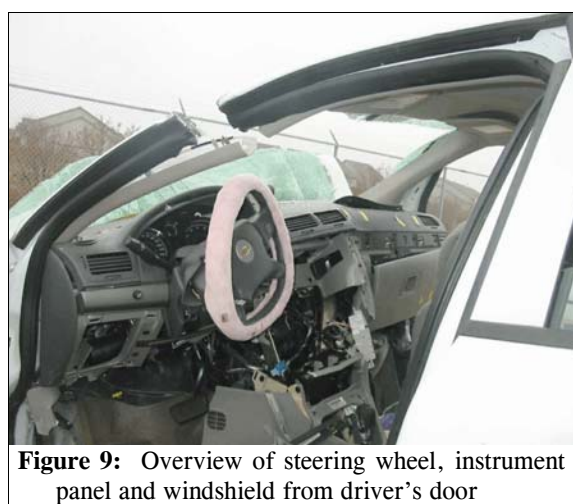
Vehicle Interior: Inspection of the case vehicle’s interior (**Figure 9** and **Figures 10** and **11** below) revealed that primarily the right half of the steering wheel was severely bent forward and the steering column was crushed forward and upward (**Figure 12** below) due to driver loading. The driver’s knee bolsters had been heavily contacted by the driver’s knees and broken out. There were scuff marks on the right instrument panel and the glove box door due to loading by the front right passenger. The front right passenger’s seat back was also intruded forward nearly to the instrument panel (**Figure 10** below) due to loading by the unrestrained back right passenger. Passenger compartment intrusion involved the driver’s and front right passenger’s toe pans, which intruded longitudinally 18 centimeters (7.1 inches) and 23

Figure 9: Overview of steering wheel, instrument panel and windshield from driver’s door

centimeters (9 inches) respectively. The brake pedal also intruded longitudinally 18 centimeters (7.1 inches), and the right instrument panel intruded 18 centimeters (7.1 inches) longitudinally into the front right passenger's occupant space.

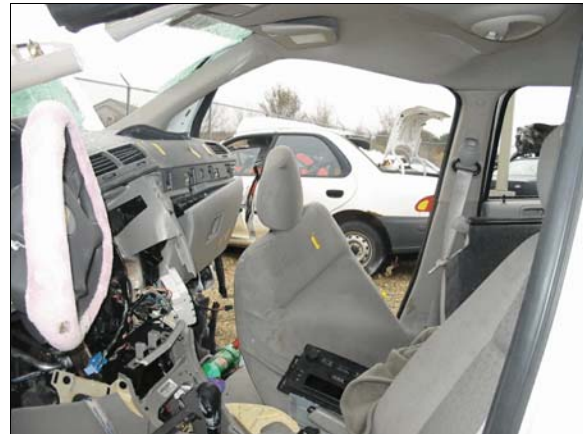
Figure 10: Left side view of steering wheel, instrument panel and displacement of front right seat back and head restraint due to the back right passenger loading the seat back into the front right passenger

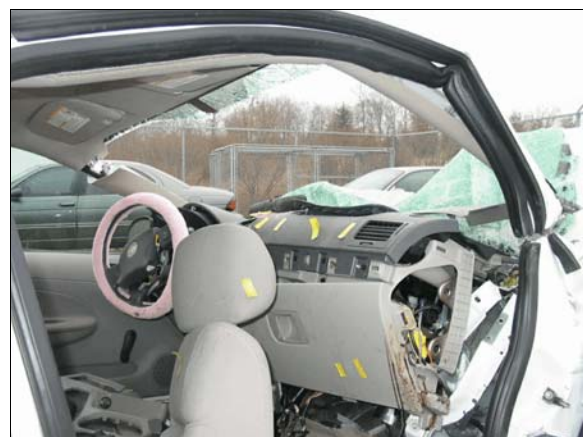
Figure 11: Right side view of case vehicle's front seating row, instrument panel, steering wheel and windshield

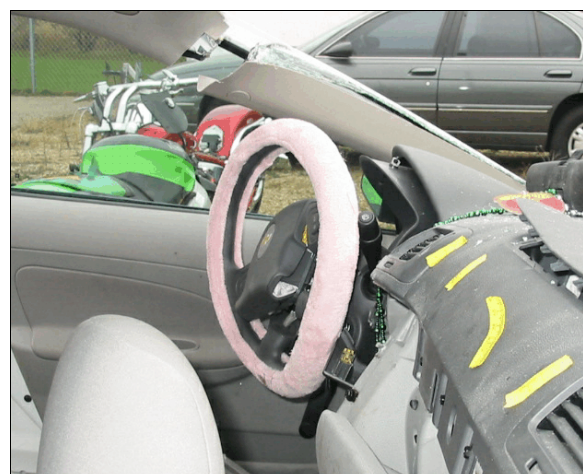
Figure 12: Right side view of deformation to steering wheel and steering column
