ON-SITE CHILD SAFETY SEAT INVESTIGATION

CASE NUMBER - IN-06-035

VEHICLE - 2000 PONTIAC MONTANA

CRASH DATE - November 2006

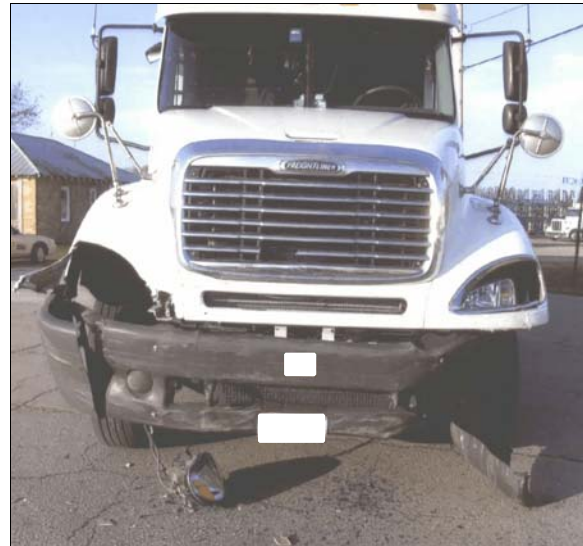
Figure 4: Sheriff department's on-scene photo of damage to front of Freightliner from impact with case vehicle

Exterior Damage: The Freightliner's impact with the right side of the case vehicle involved the bumper and lower portion of the hood. There was direct contact across the full width of the front bumper.

Damage Classification: Based on the sheriff department's on-scene photographs and post-impact trajectory of the case vehicle, the TDC for the Freightliner was estimated to be: **11-FDEW-1 (330 degrees)**.

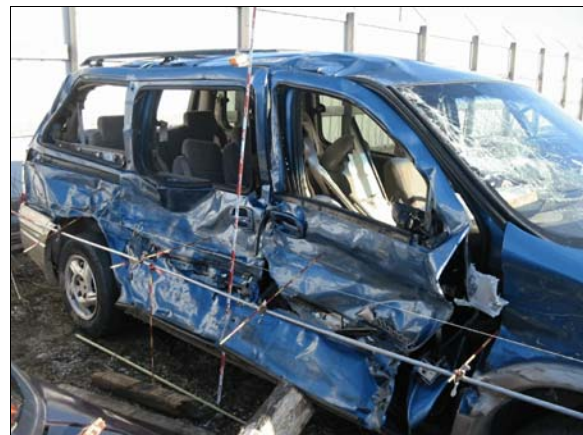
Exterior Damage: The case vehicle's contact with the Freightliner involved the right side of the vehicle. The right fender, right side doors, and the front portion of the right quarter panel were directly contacted and crushed inward. The direct damage began 16 centimeters (6.3 inches) forward of the right front axle and extended 353 centimeters (140 inches) rearward along the right side of the vehicle. Residual maximum crush was measured as 34 centimeters (13.4 inches) occurring at C₃ (**Figure 7** below). The table below shows the case vehicle's right side crush profile.

Figure 5: Damage to right side of case vehicle from impact by front of Freightliner, vertical scale increments in tenths of meter

Damage Classification: Based on the vehicle inspection, the CDC for the case vehicle’s right side impact with the Freightliner was determined to be: **02-RDAW-3 (60 degrees)**. The primary contact area due to the rollover involved the right side of the case vehicle. The rollover damage partly overlapped the damage from the Freightliner impact. The rollover CDC was estimated to be: **00-RDAO-2**. Collisions between heavy trucks and light vehicles are out-of-scope for the WinSMASH reconstruction program. However, the WinSMASH reconstruction program, barrier algorithm, was used to determine a Barrier Equivalent Speed (BES) for the case vehicle based on the crush to the right side. The WinSMASH program calculated the BES as: 26.6 km.p.h. (16.5 m.p.h.). The case vehicle’s EDR recorded a maximum longitudinal Delta V of 14.5 km.p.h. (9 m.p.h.). Using the assigned 60 degree direction of principal force angle, the Total and Lateral Delta Vs at the time of the peak longitudinal Delta V were calculated respectively as 29.9 km.p.h. (18.6 m.p.h.) and -25.9 km.p.h. (-16.1 m.p.h.). The case vehicle was towed due to damage.

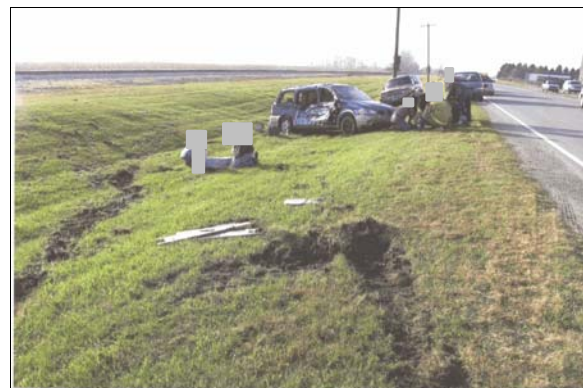
Post-Crash: The case vehicle came to final rest on its wheels in the ditch on the southwest corner of the intersection heading northwest (**Figure 6** below). The Freightliner came to final rest in the intersection heading south.

Figure 6: View southwest to case vehicle's rest position and tire furrows leading to rollover

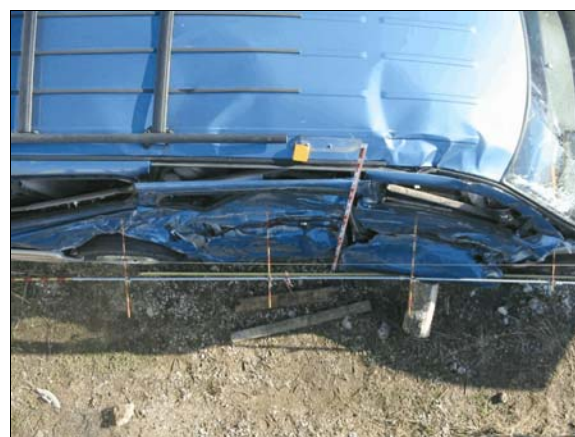
The case vehicle’s right side wheelbase was reduced 1 centimeter (0.4 inches) as a result of the impact with the Freightliner while the left side wheelbase was unchanged. Induced damage from the impact with the Freightliner and the rollover involved the hood, roof, tailgate, left quarter panel and left fender. In addition, the backlite was broken out and the windshield was cracked due to the deployment of the front right passenger air bag.

Figure 7: Top view of crush to right side of case vehicle’s passenger compartment due to Freightliner’s front impact, each increment on rods is 5 cm (2 in)

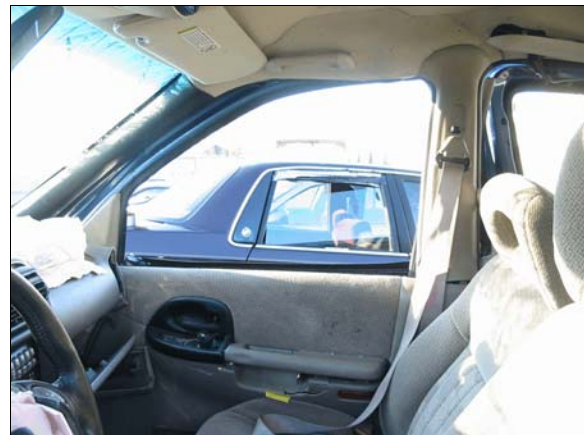
Vehicle Interior: Inspection of the case vehicle’s interior (**Figures 8, 9, and 10** below) revealed evidence of occupant contact to the right front door. The arm rest was dented and the plastic below the arm rest was broken. Load marks were observed on the driver’s shoulder belt. The safety belt in the second row right seat had been cut by rescue. There were numerous intrusions to the case vehicle’s right side. The most severe intrusions were 27 centimeters (10.6 inches) of

Figure 9: Overview case vehicle’s right front door and front right seat

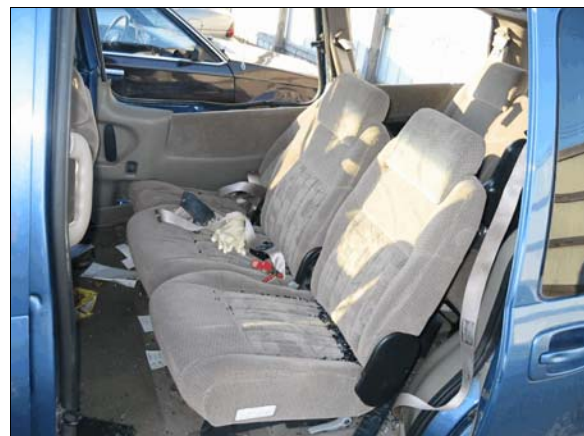
lateral door intrusion into the second row right seat position, 23 centimeters (9.1 inches) of lateral “B”-pillar intrusion into the front right seat position and 15 centimeters (5.9 inches) of lateral door intrusion into the front right seat position. There was no deformation of the steering wheel or compression of the energy absorbing steering column.

Figure 10: View from left side of case vehicle’s second seat row

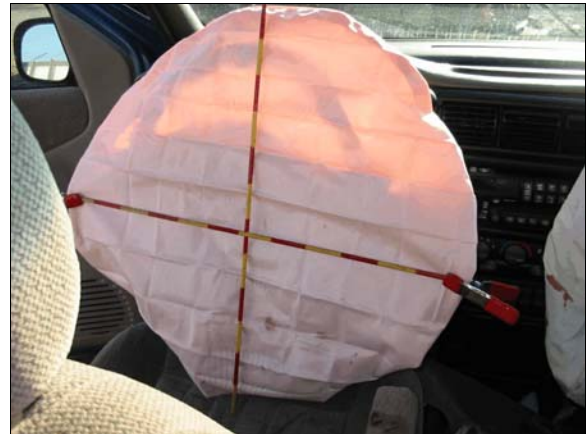
The case vehicle driver's air bag was located in the steering wheel hub. An inspection of the air bag module cover flaps and the air bag fabric revealed that the cover flaps opened at the designated tear points. There was no evidence of damage to the air bag or the cover flaps due to the deployment. The deployed driver's air bag (**Figure 11**) was round with a diameter of approximately 65 centimeters (25.6 inches), and was designed without tethers or vent ports. Inspection of the air bag revealed no evidence of occupant contact. There were several parallel black marks on the top and bottom, which appeared to be related to the back of the cover flaps. In addition, a few blood stains were observed on the air bag, which were most likely blood splatter and not direct contact.

Figure 11: Case vehicle driver's air bag

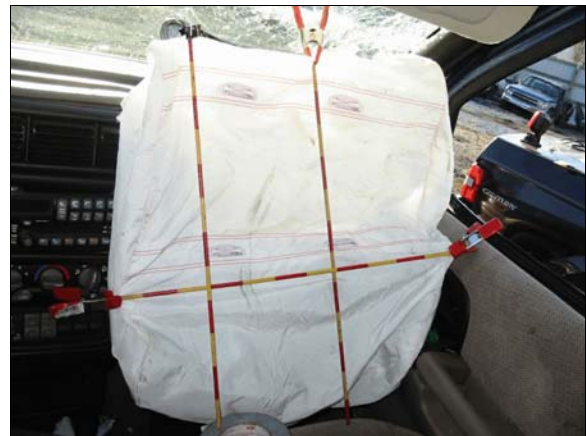
The front right passenger's air bag was located in the top of the instrument panel. An inspection of the air bag module cover flap revealed that the cover flap opened at the designated tear points. The cover flap was bent during the deployment. There were numerous small holes in the air bag due to contact by flying glass during the crash. In addition, there was a small tear in the top of the air bag, which was most likely due to contact with the broken windshield glass. The windshield was fractured due to the right side impact as well as contact by the air bag as it deployed. The deployed front right passenger air bag (**Figure 12**) was rectangular in shape and was approximately 66 centimeters (26 inches) in height and 54 centimeters (21.3 inches) in width. The air bag was designed with four tethers, each 8 centimeters (3.1 inches) in width. There were two vent ports, each 3 centimeters in diameter located on each side of the air bag at the approximate 10 and 2 o'clock positions. Inspection of the air bag revealed a few blood stains due to blood splatter but no obvious occupant contact marks. In addition, there was a black scuff on the front and right side of the air bag, which appeared to be due to the deployment.

Figure 12: Overview of case vehicle's front right passenger air bag

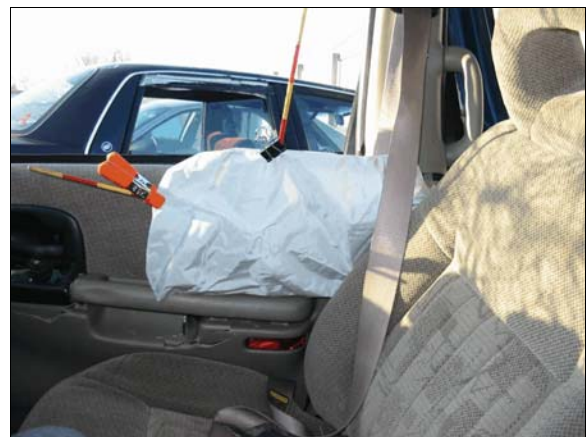
Figure 13: Case vehicle front right passenger's seat back-mounted side impact air bag

The front right passenger’s seat back-mounted side impact air bag was located in the outboard side of the passenger’s seat back. The deployed air bag (**Figure 13** above) was approximately rectangular in shape and was approximately 36 centimeters (14.2 inches) in width and 28 centimeters (11 inches) in height. The air bag was designed without tethers or vent ports. There was no damage due to deployment. The front right passenger loaded into the air bag during the side impact; however, there was no residual contact evidence noted on the air bag.

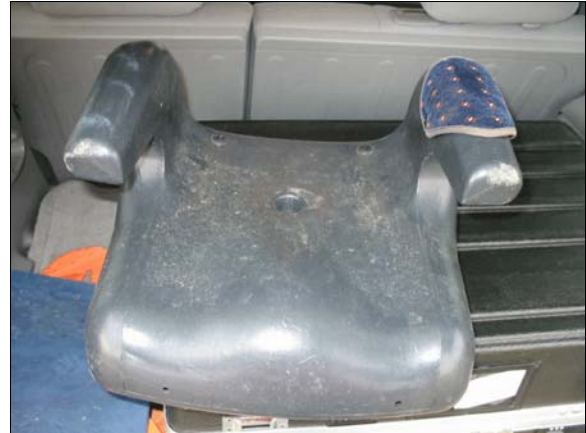
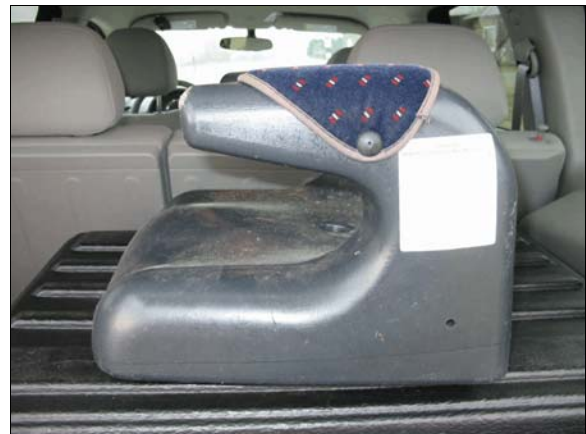
A no-back belt-positioning booster seat (**Figures 14 and 15**) was used to restrain the 2-year-old male seated in the second row left seat position. The booster seat was made in France and imported by Car Seat Specialty, Inc., of Rock Hill, South Carolina. The make/model and manufacture date label had faded and the information could not be read. Subsequent information was obtained that indicated the child safety seat was an “Uno/Polo booster seat, Model 204188, and was manufactured in late 2002 or 2003. The booster seat consisted of a single molded plastic shell with two padded arm rests. The booster seat sustained no damage in the crash and was unremarkable.

Figure 14: Front view of second seat left passenger’s no-back belt-positioning booster seat

Figure 15: Left side view of no-back belt-positioning booster seat
