**CALSPAN REMOTE AIR BAG NON-DEPLOYMENT CRASH INVESTIGATION**

**NASS/SCI CASE NO: 2007-04-114C**

**VEHICLE: 2004 HONDA CIVIC**

**CRASH DATE: OCTOBER 2007**

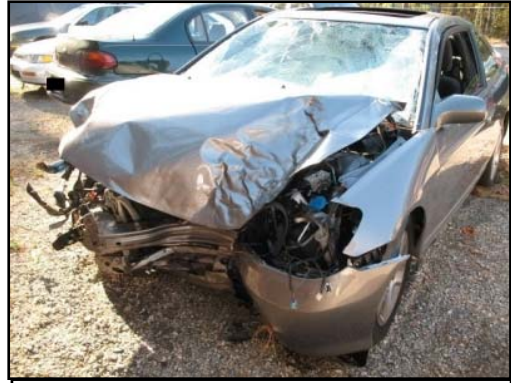
This remote investigation focused on the crash dynamics and the non-deployment of the frontal air bags in a 2004 Honda Civic (**Figure 1**). The Honda was equipped with a redesigned frontal air bag system and retractor mounted safety belt pretensioners. The vehicle was occupied by a 17-year-old female driver and a 17-year-old female front right passenger. Both occupants were restrained at the time of the crash by the vehicle's three-point lap and shoulder belt systems. The crash occurred when the Honda departed the left side of the road and the front and right side of the Honda's impacted six small diameter trees and a large diameter tree. This impact sequence did not deploy the frontal air bag system; however, it did result in the actuation of the safety belt pretensioners. The driver sustained police reported incapacitating injuries and was transported to a hospital where she was admitted for treatment. The front right passenger suffered police reported minor injuries. She was transported to a trauma center where treatment was administered. However, it's unknown if she was treated and released or hospitalized. Both the driver and passenger were transported to medical facilities that are non-cooperating with the National Automotive Sampling System (NASS) program. Therefore, the medical records were not obtained for this investigation.

**Figure 1: Front oblique view of the Honda.**

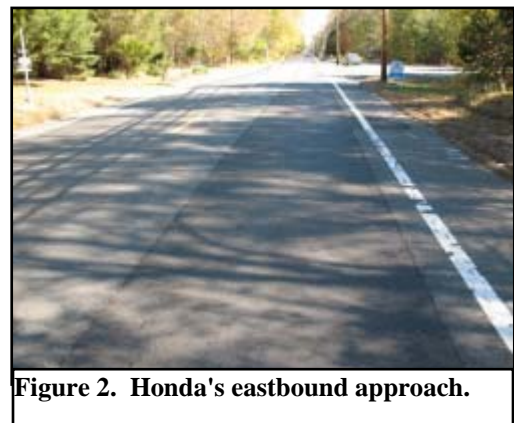
The Honda was driven by a 17-year-old restrained female that was operating the vehicle eastbound (**Figure 2**). Although the driver was interviewed by both the NASS researcher and the investigating police officer, she would not discuss the details of the crash. However, the front right passenger stated to the police investigator that as the driver operated the vehicle, she threw a lit cigarette out of the open left front window. As a result of the vehicle in motion, the wind blew back some of the lit ashes into the vehicle and down the back of the driver’s shirt. The driver struggled to get the lit ashes out of her shirt and in the process allowed the vehicle to depart the right road side. Once off-road, the driver applied a left steering input returning the vehicle to the roadway. The Honda traversed the travel lanes and departed the left roadside. Two witnesses that were riding bicycles on the westbound lane observed the vehicle’s pre-crash trajectory. They stated to the investigating officer that the Honda approached at what

**Figure 2. Honda's eastbound approach.**

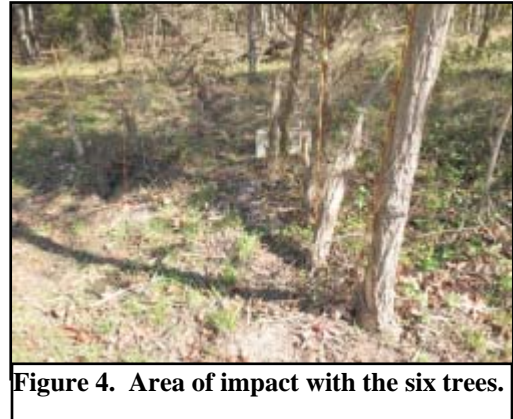
The Honda travelled off-road in a northeast trajectory approximately 23 m (75 ft) where the front and right side planes impacted and overrode a cluster of six small diameter trees (**Figure 3**). The second and third trees in the crash resulted in swiping contact down the right side of the vehicle. The sixth tree in this cluster was slightly larger and resulted in damage to the front right corner of the Honda. This impact resulted in damage to the front right satellite sensor of the air bag system. In addition to the damage, this impact triggered the actuation of the front retractor mounted safety belt pretensioners. The Honda continued the northwest trajectory approximately 8 m (26 ft) and impacted a larger diameter tree with the center front aspect (**Figure 4**).

**Figure 4. Area of impact with the six trees.**

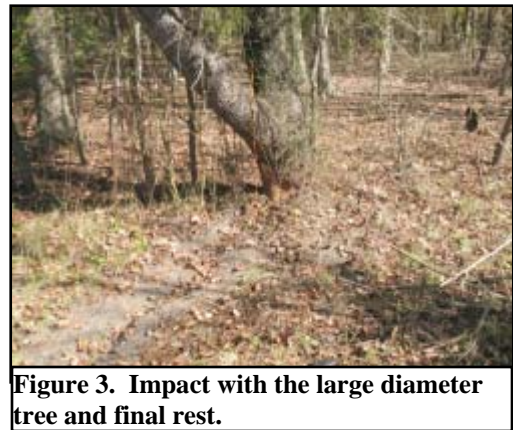
Although the vehicle sustained multiple overlapping impacts, a delta-V was calculated using the frontal crush and the Barrier Equivalent Algorithm of the WINSMASH model. The resultant delta-V was 48 km/h (30 mph). The dynamics of this crash were beyond the limits of the WINSMASH model due to the narrow objects coupled with the multiple closely spaced overlapping impacts. The frontal air bags in the vehicle did not deploy as a result of the impact.

**Figure 3. Impact with the large diameter tree and final rest.**

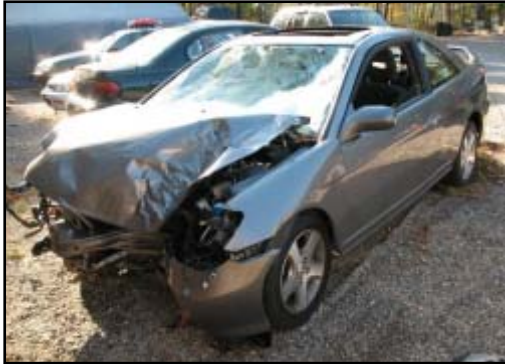
The exterior damage to the Honda consisted of moderate impact damage to the front and right side planes as a result of the multiple tree impacts. The first impact was to a small diameter tree and the resultant damage was overlapped from the other tree impact and could not be located on the vehicle. Therefore, a crush profile was not documented for this impact. **Figures 5 and 6** are overall views of the residual damage and frontal crush profile.

**Figure 5. Residual frontal damage.**

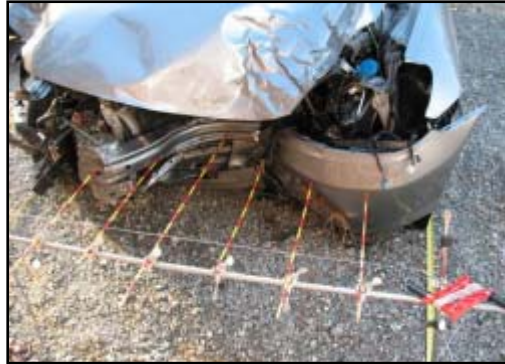
**Figure 6. Frontal crush profile.**

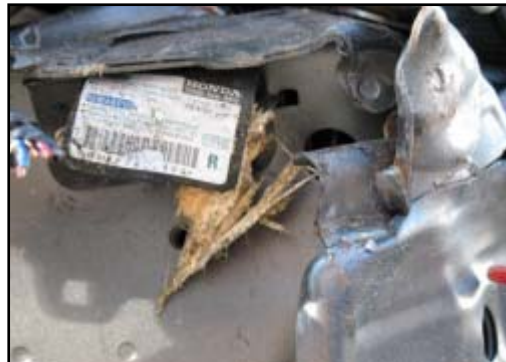
**Figure 7. Damaged front right satellite air bag sensor.**

The following scenario is a possible cause for the non-deployment of the air bag system. The pre-impact steering maneuvers and the off-road travel prior to the impact phase of the crash probably woke-up the air bag control module. During the initial impacts with the small diameter trees, the air bag control module commanded the actuation of the pretensioners. However, the frontal plane of the Honda was penetrated and the front right satellite sensor was contact by the sixth tree which was the largest in this cluster. The penetration resulted in

damage to the front right sensor, cutting of the wiring harness, and a fracture of the connector. **Figures 7 and 8** are images of the damaged right sensor.

The Honda traveled approximately 8 m (26 ft) over the comparatively rough terrain to the final impact. During this off-road trajectory, the sensing algorithm probably continued to analyze the long duration event. During this period, the system either did not reset or timed-out, thereby suppressing the deployment of the air bag system. Additionally, the Honda was not equipped side impact air bags.

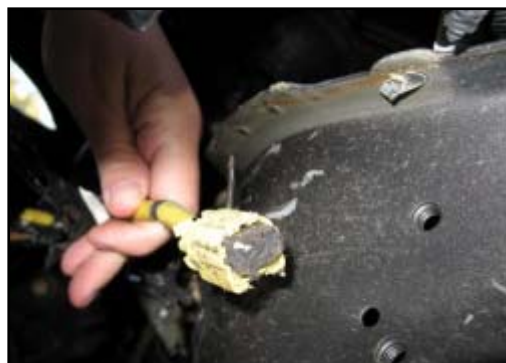
**Figure 8. Front right satellite air bag sensor fractured connector.**

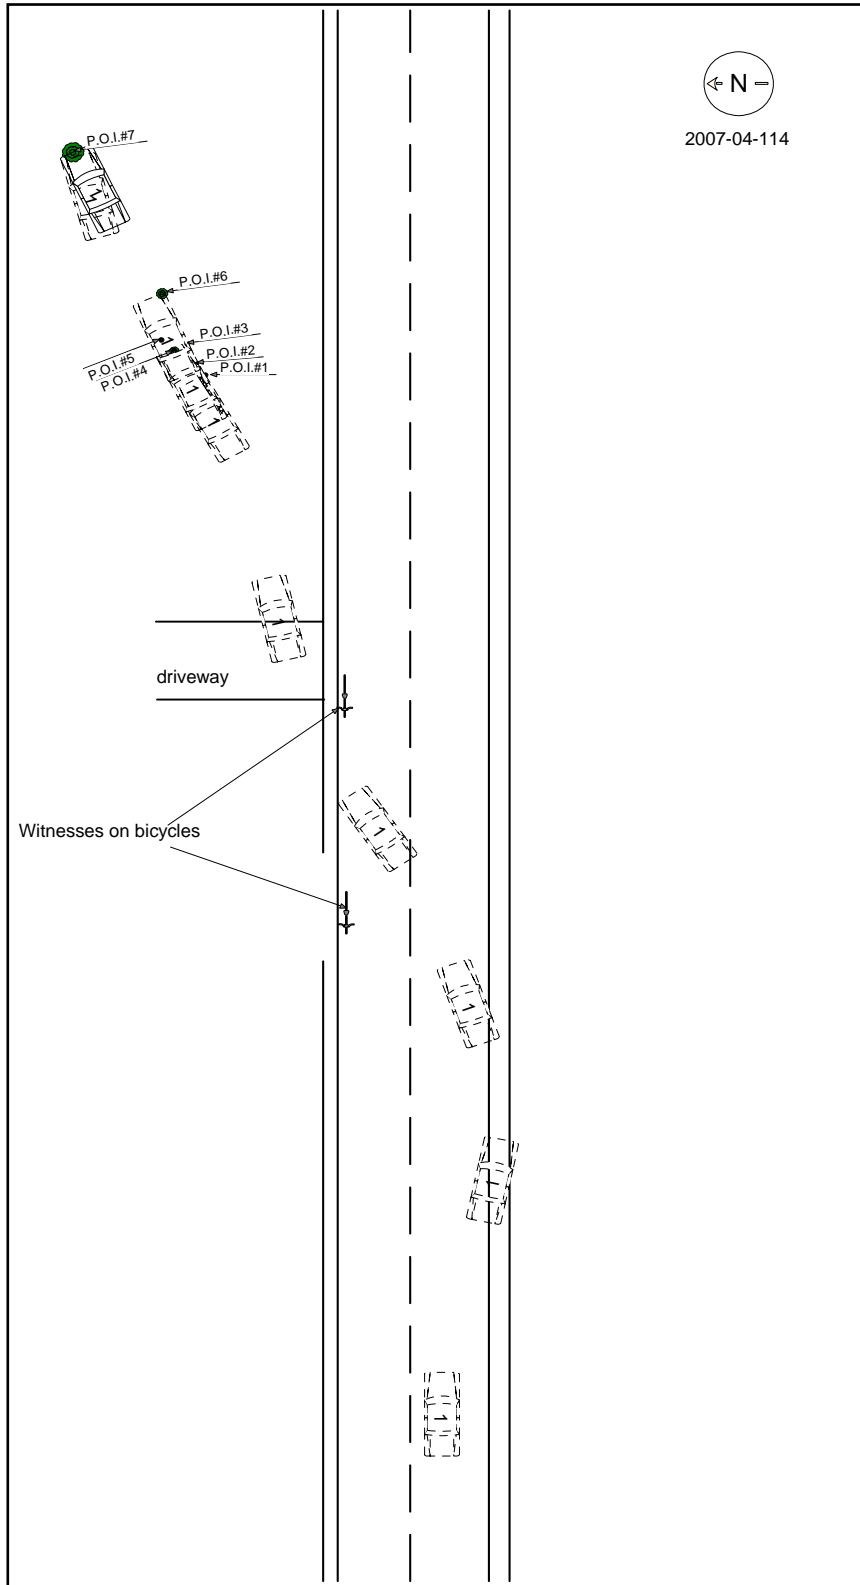
side of the road was level immediately outboard the road edge and consisted of grass and trees. The struck trees were located from 5.5 meters (18 feet) to 12 meters (39 feet) north of the road edge and varied in diameter from approximately 15-61 cm (6-24”). The crash schematic is included in this report as **Figure 9**.

**Figure 9: Scene Schematic**
