**CALSPAN REMOTE REAR OCCUPANT PROTECTION PROGRAM CRASH
INVESTIGATION**

NASS/SCI COMBO CASE NO.: 2007-08-118B

VEHICLE: 2003 SUBARU LEGACY

CRASH DATE: JULY 2007

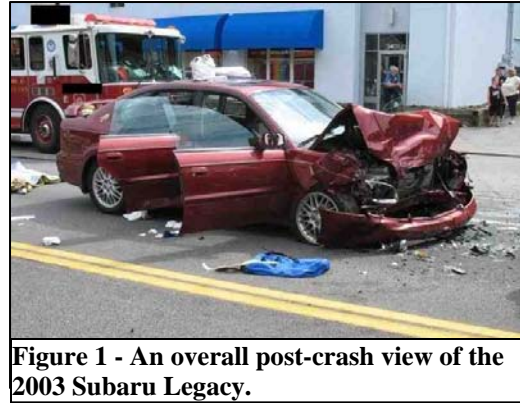
Figure 1 - An overall post-crash view of the 2003 Subaru Legacy.

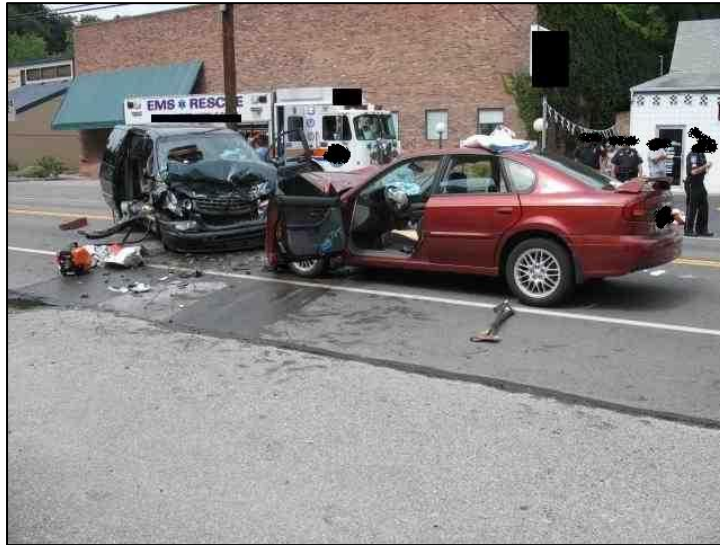
delta-V of 53 km/h (33 mph) for the Subaru. The total delta-V for the Chrysler was 48 km/h (29.8 mph). The specific longitudinal and lateral velocity changes were -53 km/h (-33 mph) and 0 km/h for the Subaru. The Chrysler's longitudinal and lateral velocity changes were -48 km/h (-30 mph) and 0 km/h. The Subaru was displaced slightly rearward and came to rest facing in northbound direction. The Chrysler rotated approximately 20 degrees clockwise and came to rest facing in a slight southwest direction. Both vehicles remained on the southbound lane post-crash (**Figure 4**).

Figure 4 - Post-crash positions of both vehicles.

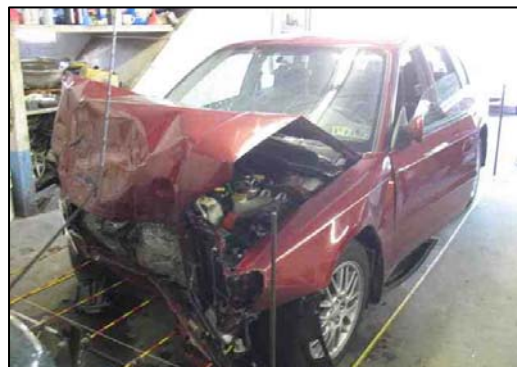
The 2003 Subaru Legacy (**Figure 5**) sustained severe frontal damage as result of a head-on impact with the 2000 Chrysler Voyager. The direct contact damage encompassed the full frontal plane and measured 140 cm (55”) in length. The maximum crush was located at the front right bumper corner and measured 68 cm (26.8”) in depth. The impact caused the frontal bumper cover and energy absorption material to separate from the vehicle. Therefore, the NASS investigator

Figure 5 - Frontal damage to the Subaru Legacy.

measured the crush profile to the bumper beam and later made adjustments to the profile. The crush profile consisted of six equidistant measurements taken along the bumper beam and were as follows: C1 = 22 cm (8.7”), C2 = 39 cm (15.4”), C3 = 57 cm (22.4”), C4 = 63 cm (24.8”), C5 = 67 cm (26.4”), C6 = 68 cm (26.8”). The Collision Deformation Classification (CDC) was 12-FDEW-3.

The damage was more prominent on the right aspect of the bumper beam; as a result, the right side wheelbase was compressed 20 cm (7.9”) and the left side wheelbase was elongated 4 cm (1.6”). The right fender deformed rearward and the right front tire was aired-out and restricted by the deformed frontal components.

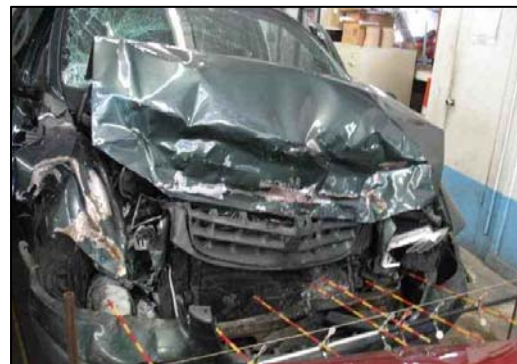
The 2000 Chrysler Voyager sustained (**Figure 6**) severe damage as a result of the impact with the 2003 Subaru Legacy. The direct contact damage encompassed the full frontal width and measured 124 cm (49”) in length. The maximum crush was located 5 cm (2”) right of the vehicle’s centerline and measured 53 cm (20.8”) in depth. The impact caused the frontal bumper cover and energy absorption material to separate from the vehicle. The NASS investigator measured the crush profile to the

Figure 6 - Damaged frontal plane of the Chrysler Voyager.

bumper beam and later made the proper adjustments to the profile. The crush profile consisted of six equidistant measurements to the bumper beam and was as follows: C1 = 38 cm (15”), C2 = 42 cm (16.5”), C3 = 51 cm (20”), C4 = 48 cm (18.9”), C5 = 43 cm (17”), C6 = 42 cm (16.5”). The CDC for the impact with the Subaru was 12-FDEW-3.

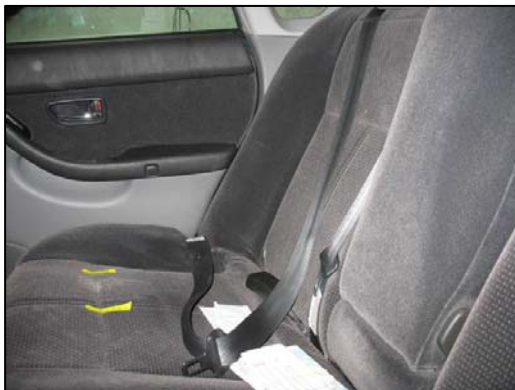
The second row belts were configured with sliding latch plates and switchable ELR/ALR retractors. The NASS case reported no loading evidence to the rear right belt; however, the investigation did conclude that the belt was utilized. During a review of the NASS case, it was evident that the belt was utilized as it was appreciably stretched and remained spooled out from its retractor. Additionally, a review of the images revealed a linear pattern of loading evidence along the shoulder aspect of the belt system. **Figures 7 and 8** illustrate the post-crash right rear belt system.

Figure 7 - Rear right lap and shoulder belt.

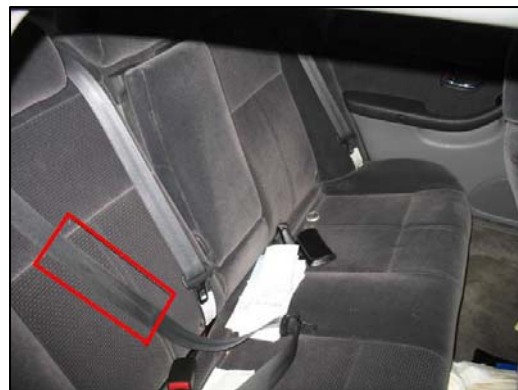
Figure 8 - Rear right lap and shoulder belt with potential loading evidence highlighted.

The restrained 86-year old male rear right passenger of the 2003 Subaru Legacy was seated in an upright posture. At impact with the 2000 Chrysler Voyager, he initiated a forward trajectory responding the 12 o'clock direction of force and loaded the 3-point lap and shoulder belt. This was evidenced by severe stretching to the belt system and the webbing's inability to retract post-crash. As a result of the belt loading, the rear right passenger sustained lacerations to the myocardium, coronary artery, aorta and pericardium regions of the heart and a laceration of the spleen. The belt loading also resulted in a right lung contusion, multiple soft tissue injuries to his chest, right shoulder, and abdomen as well as a fracture to the sternum and symmetrical fractures of the second through fifth ribs bilaterally. As he continued in a forward trajectory, his lower extremities contacted the front right seat back resulting in bilateral ankle contusions and right foot and lower left leg abrasions. Due to the asymmetrical loading of the belt, the crash forces caused the rear right passenger's upper torso to flex over the shoulder belt and the rapid movement of his torso and head resulted in an offside fracture of the left clavicle, a basilar skull fracture, a posterior subarachnoid hemorrhage, and a cerebral intraventricular hemorrhage. The rear right passenger was removed from the vehicle by emergency personnel and transported to a regional trauma center. He was pronounced deceased prior to admission.
