**CALSPAN REMOTE CHILD AIR BAG RELATED FATALITY CRASH  
INVESTIGATION**

**NASS/SCI COMBO CASE NO.: 2007-48-274B**

**VEHICLE: 1997 MERCURY SABLE**

**CRASH DATE: DECEMBER 2007**

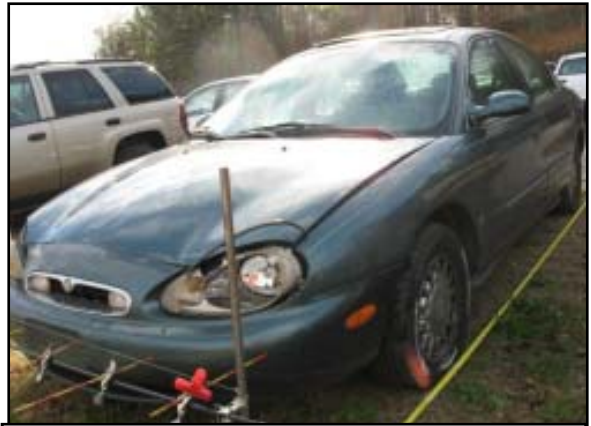
**Figure 1. 1997 Mercury Sable.**

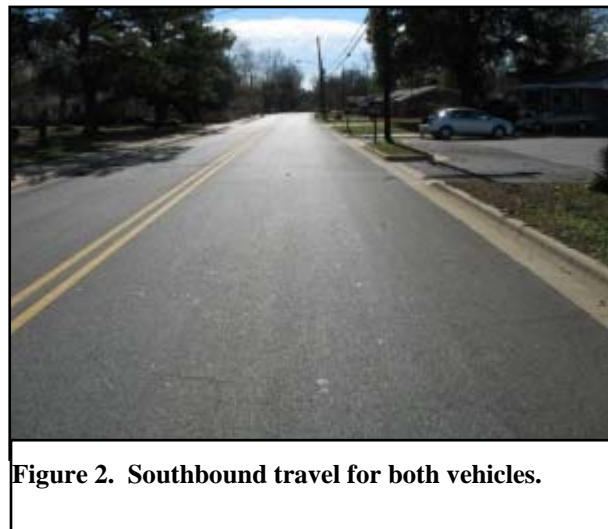
**Figure 2. Southbound travel for both vehicles.**

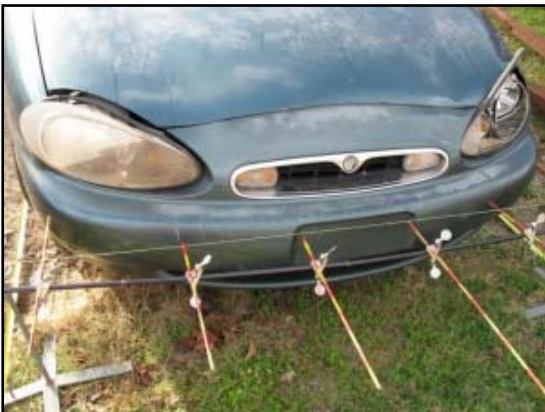
The Mercury Sable sustained minor severity frontal damage as result of the crash with the Chevrolet (**Figures 3 and 4**). The damaged components included the bumper fascia, bumper beam, the hood, and the headlight assemblies. The direct contact damage on the bumper fascia measured 147 cm (57.9”) which began at the front left corner and extended to the right bumper corner. The maximum crush measured 4 cm (1.6”) and was located at the left bumper corner. The direct contact damage and crush profiles were documented at the level of the bumper. The crush profile documented at the bumper level was follows: C1 = 4 cm (1.6”), C2 = 3 cm (1.2”), C3 = 1 cm (0.4”), C4 = 0 cm, C5 = 0 cm, C6 = 0 cm. The Collision Deformation Classification (CDC) for this impact was 12-FDEW-1.

**Figure 3. Resultant frontal damage and crush profile.**

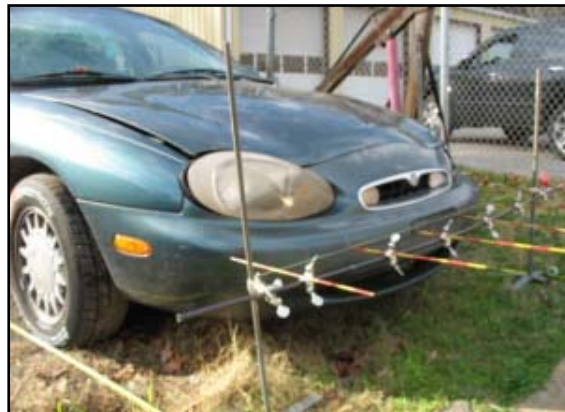
**Figure 4. Oblique view of the frontal damage.**

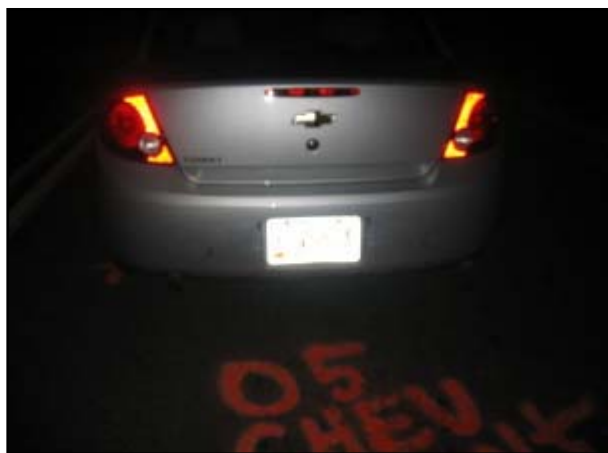
Direct contact damage in the form of abrasions was apparent on the rear bumper fascia. There did not appear to be crush damage to the rear plane of the vehicle. Lateral views of the rear of the Cobalt showed that the bumper fascia was not displaced from its mounting points. Based on the residual damage, the SCI revised CDC for this impact was 06-BDEW-1.

**Figure 5. Police on-scene image of the damage to the Chevrolet.**

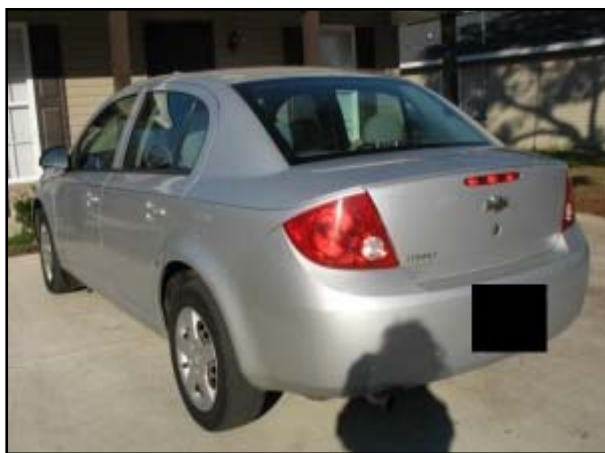
The 2005 Chevrolet Cobalt sustained minor damage as result of the impact with the Mercury (Figures 5 and 6). The Chevrolet was repaired prior to the NASS case assignment; therefore, the damage was based on police on-scene images of the vehicle. A partial inspection of the repaired Cobalt was obtained for this investigation.

**Figure 6. Chevrolet in its repaired state.**

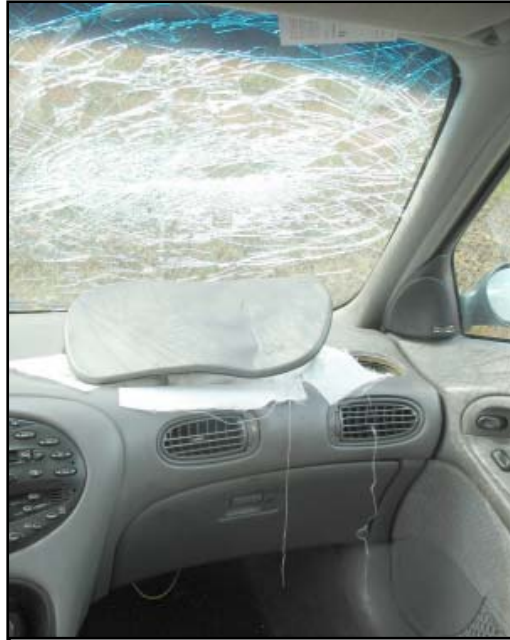
The windshield fracture was initially attributed to a head strike from the front right passenger. However, the exhibited fracture pattern was consistent with contact from the front right air bag cover flap. A skin transfer and body fluid evidenced the sun visor/roof area contacts points. Both of these contacts were linked to the front right passengers head. The right instrument panel contained a red colored transfer centered between the air vents; this contact was initially attributed to the passenger's chest. However, the air bag membrane was positioned between the passenger and the instrument panel; therefore, this transfer was not likely a result from contact by the passenger.

**Figure 7. Right front passenger space.**

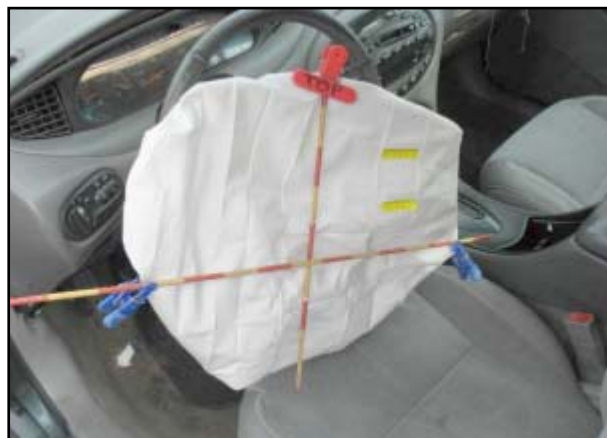
The driver's air bag was contained within the four-spoke steering wheel and was concealed by two symmetrical H-configuration cover flaps (**Figure 8**). Body fluid was noted on the air bag membrane at the 2 o'clock sector from possible contact by the driver. No damage or malfunctions were noted to the driver's air bag system.

**Figure 8. Deployed driver's air bag.**

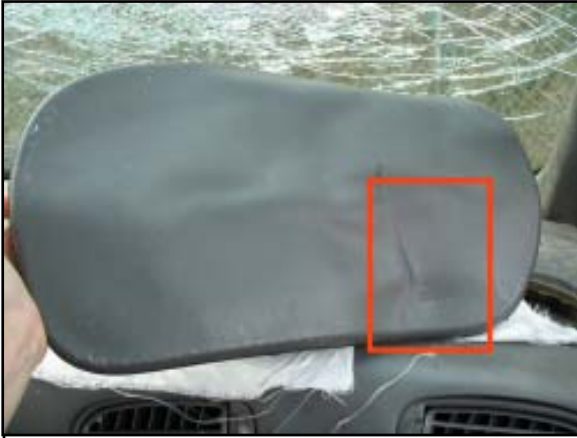
cover flap was constructed of a vinyl top with a steel backer panel. The lower right corner of the cover flap (**Figure 9**) was deformed in a V-shaped crease. A tissue transfer was noted on the leading edge of the flap within the deformation. The deformation occurred as a result of an interaction with the unrestrained front right passenger during the early stages of the deployment sequence.

**Figure 9. Damaged front right air bag cover flap.**

At impact with the Chevrolet, the front right air bag deployed with the 4-year-old male against the instrument panel with his head positioned over the front right air bag cover flap. As the cover flap opened, it contacted his chin resulting in the laceration to this area. This interaction was evidenced by a tissue transfer on the leading edge of the cover flap and deformation of the vinyl flap and steel backer panel. The deformation of the vinyl top and steel backer panel formed a V-shaped crease that was located on the leading edge right of center.

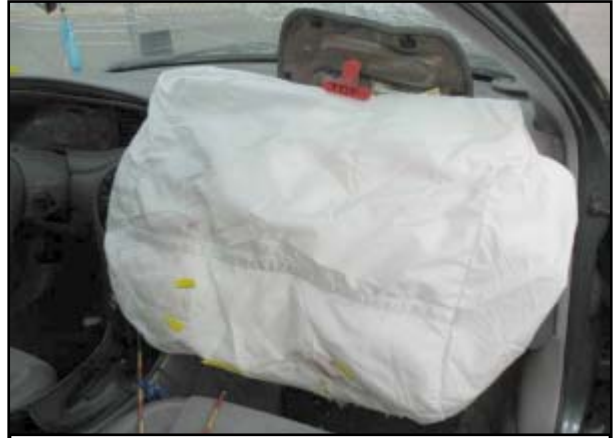
**Figure 10. Front right air bag membrane.**

The front right air bag membrane was rectangular in shape (**Figure 10**). Tissue transfers were noted on the left aspect of the bottom panel of the air bag. In addition, a dark colored fabric transfer was also noted on the left aspect of the bottom panel. Body fluid was present on the face of the membrane above the center seam left of the center line and on the bottom panel right of the center line. The numerous transfers were indicative of occupant contact during the air bag expansion.
