Remote Combination ODI Side Curtain Non Deployment Investigation  
Dynamic Science, Inc. (DSI), Case Number 2007-75-041J  
2005 Volkswagen Touareg  
Colorado  
April 2007

1. Report No. 2007-75-041J	2. Government Accession No.		3. Recipient Catalog No.	
4. Title and Subtitle  Remote Combination ODI Side Curtain Non Deployment Investigation			5. Report Date September 11, 2008

**Dynamic Science, Inc.**  
**Crash Investigation**  
**Case Number: 2007-75-041J**

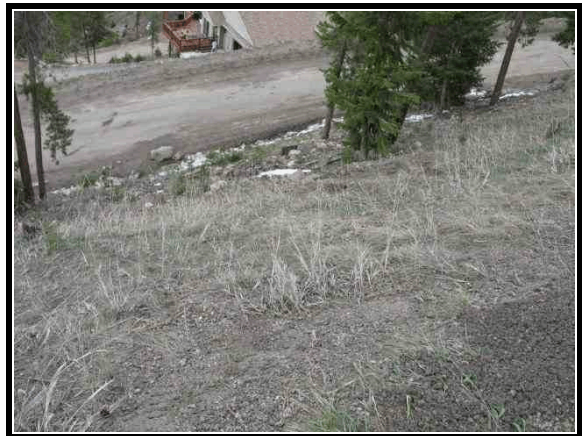
The vehicle traveled down the embankment for 19.6 m (64.4 ft) before engaging a low-lying boulder with its left side (**Figure 4**). The vehicle tripped, then rolled four quarter turns with its left side leading for 24.9 m (82.0 ft). The driver was ejected through the sun roof at some point during this initial roll, probably between the second and third quarter turns. The ejection point was based on the area of the initial overturn relative to the ejected driver's final rest. The Touareg rolled two more quarter turns for 3.6 m (28.4 ft) before coming to rest on its roof facing east. During the crash, the right side air curtain deployed. There were no other air bag/side curtain deployments.

**Figure 4.** Path down embankment (north)

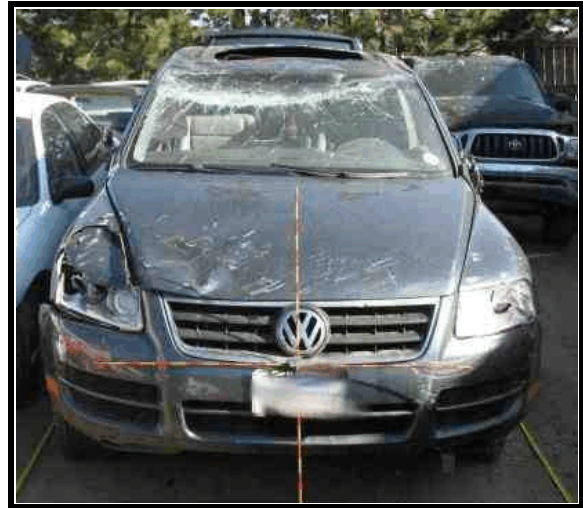
The 2005 Volkswagen Touareg sustained moderate top damage as a result of the rollover event (Figures 5-6). The vehicle rolled a total of six quarter turns with the Touareg coming to rest on its roof. There was direct contact damage to the roof and both sides of the vehicle. The left rear door was jammed shut. The windshield was cracked from impact forces but remained in place. The glazing was disintegrated for the left front window, the right rear window, the second right rear window, the sun roof and the backlight.

Figure 5. Overview of rollover damage

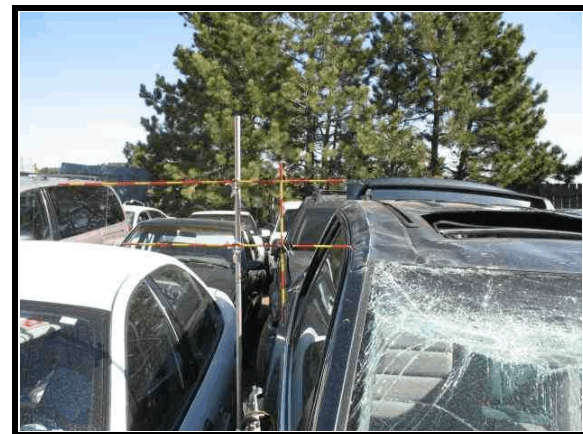
The maximum vertical crush was located at the right windshield header and measured 7 cm (2.8 in). The Collision Deformation Classification (CDC) for the rollover event was 00TDDO3. The maximum lateral crush was located at the right A-pillar and measured 2 cm (0.8 in).

Figure 6. Area of maximum crush

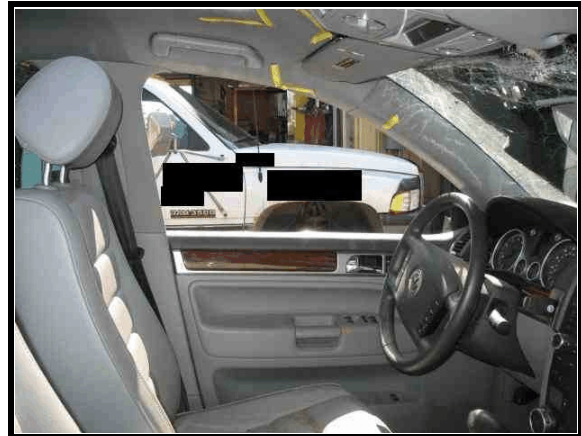
The 2005 Volkswagen Touareg sustained minor interior damage as a result of passenger compartment intrusion and occupant contacts (**Figure 7**). There were occupant related scuffs located on the roof console, the left side roof rail, the left A pillar, the roof and the sunroof.

**Figure 7.** Overview of occupant contacts

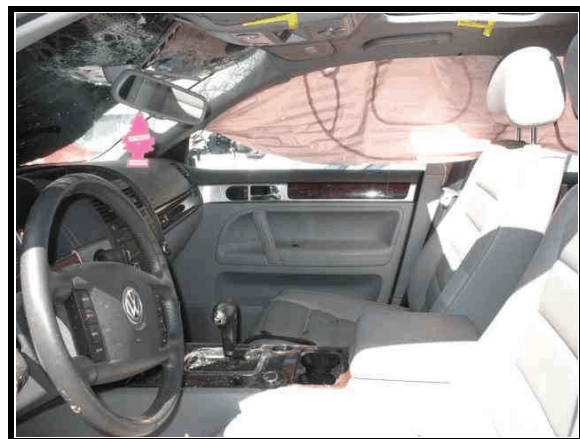
During the rollover event, the right side curtain air bag deployed (**Figure 9**). There were no other air bag deployments.

**Figure 9.** Right side air curtain

According to the manufacturer the side curtain air bags are designed to deploy in rollover situations. The inspection revealed no evidence as to why the left side curtain air bag did not deploy.

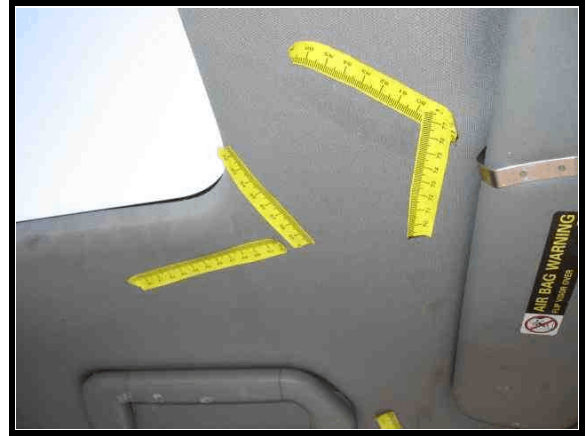
As the Volkswagen Touareg began its left side roll, the driver was displaced to the left and upward. There were scuff marks along the left A pillar area, leading onto the interior roof, and toward the sun roof. During the rollover, the sun roof disintegrated upon contact with the ground. The driver was fully ejected through the sun roof (**Figure 10**), probably during the second and third quarter turns. The driver sustained a skull fracture, multiple brain injuries, a rib fracture, and multiple contusions, abrasions, and lacerations. He was transported to a local trauma center where he arrived with a GCS of 12. He was hospitalized for 12 days.

**Figure 10.** Contact path to sun roof
